Professor Malcolm Hollis Lecture

In the lecture Professor Malcolm Hollis used a selection of real case studies that he had been involved in and he explained his thoughts and ideas on building pathology and his general pursuit of raising the standards in surveying. The examples very much show that it's not always what you first see that is important and that you do have to follow the trail of evidence.

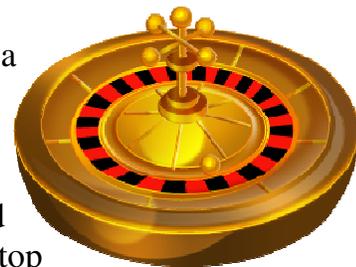
Casino and wet rot example

The casino was let on a lease and was part of a dilapidations claim. Dry rot was found. The casino was let only at ground floor level and there was a basement beneath it that was the landlord's responsibility. The argument was did the dry rot come from the bottom up or from the top down.

Interestingly, dry rot moves approximately 900mm a year (originally 3 foot in old money) and in bad conditions it can be made to move faster! The possible causes of the drama were looked into; from the leaking pipes discharging efflorescence and warm water into the basement, which were primarily efflorescence and warm water from the blocked pipes. Whose responsibility was it?

They also looked into the pattern of how the dry rot grew and ultimately this claim led to the original casino tenant going bankrupt and the new landlord, who interestingly was a casino owing company, taking over and moving one of their casinos in.
