# SCHEDULE OF CONDITION

## **SCHEDULE OF CONDITION**

**Address:** XXXXXX

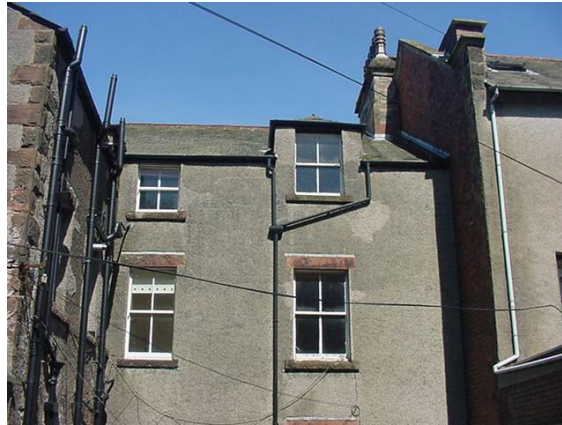
## REAR ELEVATION

DESCRIPTION	CONDITION	ACTION REQUIRED
<p><b>Chimney:</b></p> <p>See front elevation</p>		
<p><b>Roofs:</b></p> <p>Pitched slate roof Dormer roof not visible</p>	Average	
<p><b>Gutters and Downpipes:</b></p> <p>Cast iron with some plastic</p>

Damaged downpipe	<p>Clear vegetation. Ensure all gutters are watertight and falling towards the downpipe. Repair and secure as necessary, ensure downpipes are clear.</p>
<p><b>Soil and vent Pipe:</b></p> <p>Not visible assumed within toilet area</p>	Signs of leaks	<p>A close circuit TV camera report is recommended of the drains.</p>

<p><b>Walls:</b></p> <p>Roughcast render with hairline cracks visible</p>

<p>Hairline cracking to render</p>

<p>Lower render area starting to deteriorate</p>	<p>General repairs to render to make watertight.</p>
<p><b>Joinery/Detailing:</b></p> <p><b>Windows:</b> Sliding sash single glazed</p>	<p>Dirty and some windows painted shut</p>	<p>Repair, prepare, ease and adjust, redecorate and clean.</p>

<p>Repairs to hairline cracking that has taken place on render</p>

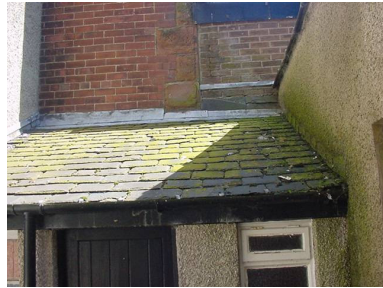
**Left hand side outbuilding**

DESCRIPTION	CONDITION	ACTION REQUIRED
<p><b>Left hand side outbuilding - external:</b></p> <p>Single pitched slate roof</p>

<p>Lead tingles were noted to the roof indicating that the fixings could be deteriorating.</p>	<p>Check whether fixings are deteriorating and replace roof if they are.</p>

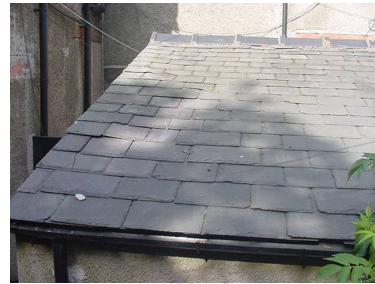
**Rear outbuilding**

<p><b>Left hand side outbuilding - internal:</b></p> <p>Toilets</p>	<p>Dampness found to the floor and the walls</p>    	<p>Solve dampness problem. The ceiling needs to be opened up to check the condition of the timbers.</p> <p>Upgrade to modern standards.</p>
<p><b>Rear outbuilding – External:</b></p> <p>Single pitched slate roof</p>	<p>We noted that there was slight undulation in the roof; we also noted to the left hand side (all directions given as you face the front of the property) there was a poor parapet and wall detailing which may be allowing water in.</p>   <p>View from the back</p>	
<p><b>Rear outbuilding - Internal:</b></p>	<p>Dampness noted.</p>  	<p>The ceiling needs to be opened up to check the condition of the timbers.</p>

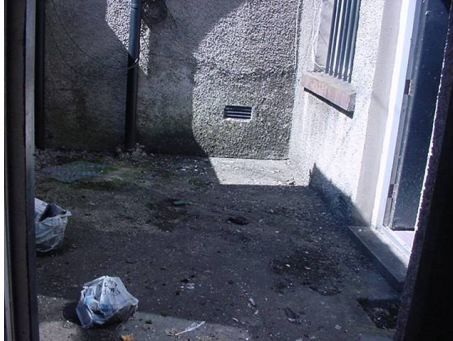
**Rear yard**

DESCRIPTION	CONDITION	ACTION REQUIRED
<p><b>Front area:</b></p> <p>Small frontage before the footpath</p>

<p>Overgrown and algae/lichens/moss build up</p>	<p>Power clean, clear and weed killer</p>
<p><b>Rear yard:</b></p>	<p>Rubbish has been thrown and placed in the area, this needs to be cleared. Overgrown and algae/lichens/moss build up.</p>

<p>Just outside the rear yard there was a walkway where the drain was duly lifted and found to be free flowing nevertheless we would recommend a close circuit TV camera report.</p>	<p>Power clean, clear and weed killer. In addition clear gulleys to the rear and rubbish from area. It may be necessary to add a French Drain around the outside of the property to lower the ground level to allow the insertion of airbricks to the rear of the property to allow a through flow of air underneath the property. It also may be necessary to put a gulley into the yard area to direct the water.</p>

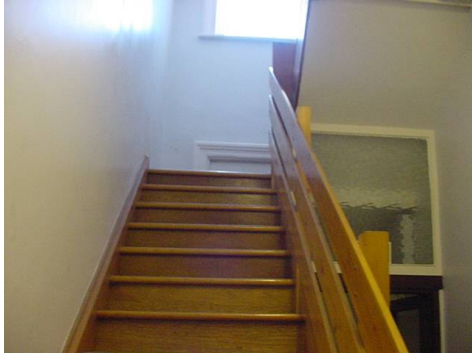
**Stairway**

DESCRIPTION	CONDITION	ACTION REQUIRED
<b>Ceilings:</b> Painted	Dirty and dated.	Repair, prepare and redecorate.
<b>Walls:</b> Painted

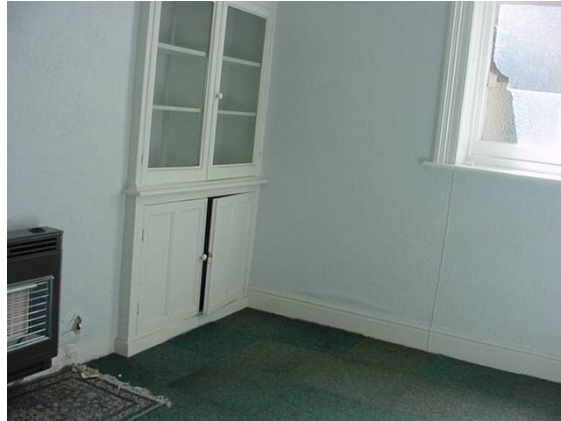
**Rear office – proposed kitchen and toilet facilities**

DESCRIPTION	CONDITION	ACTION REQUIRED
<b>Ceilings:</b> Ceiling tiles

Replace ceiling tile system including lighting.
<b>Walls:</b> Painted	Dampness found	Eliminate damp, repair, prepare and redecorate.
<b>Floors:</b> Carpets tiles	Dated	Clean and/or replace
<b>Joinery/Detailing:</b> Windows  Doors		Ease and adjust, repair, prepare and redecorate.  Repair, prepare and redecorate.

<b>Services:</b>		
Lighting	Lights not to modern standards	Replace
Electrics		Re-wire
Heating		We would recommend new heating is added.
Fire alarm system	None.	Add.

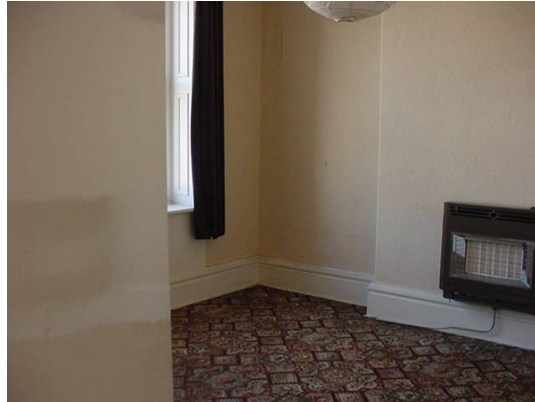
## Front office

DESCRIPTION	CONDITION	ACTION REQUIRED
<b>Ceilings:</b> Painted	Dirty and dated	Repair, prepare and redecorate.
<b>Walls:</b> Painted	Marked and signs of lateral dampness coming through	Stop dampness, repair, prepare and redecorate.
<b>Floors:</b> Carpets	Excessive deflection in floor indicating that there is rot to the joist ends or the floor joists or both	Open up floors; add appropriate structural support/replace timbers.
<b>Joinery/Detailing:</b> Windows  Doors		Ease and adjust, repair, prepare and redecorate.  Ensure that doors are half hour fire resistance ideally one hour or as stated by the Fire Officer
<b>Services:</b> See Services section Electrics: Re-wire Heating: We would recommend new heating is added. Lighting: Lights not to modern standards - replace Fire alarm system: Add

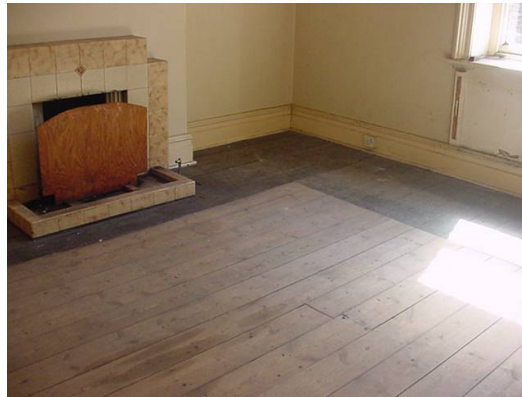
## Rear office

DESCRIPTION	CONDITION	ACTION REQUIRED
<b>Ceilings:</b> Painted	Dirty and dated	Repair, prepare and redecorate.
<b>Walls:</b> Painted	Marked and signs of lateral dampness coming through	Stop dampness, repair, prepare and redecorate.
<b>Floors:</b> Bare timber	Excessive deflection in floor indicating that there is rot to the joist ends or the floor joists or both	Open up floors; add appropriate structural support/replace timbers.
<b>Joinery/Detailing:</b> Windows  Doors	Dated	Ease and adjust, repair, prepare and redecorate.  Ensure that doors are half hour fire resistance ideally one hour or as stated by the Fire Officer
<b>Services:</b> See Services section Electrics: Re-wire Heating: We would recommend new heating is added. Lighting: Lights not to modern standards - replace Fire alarm system: Add

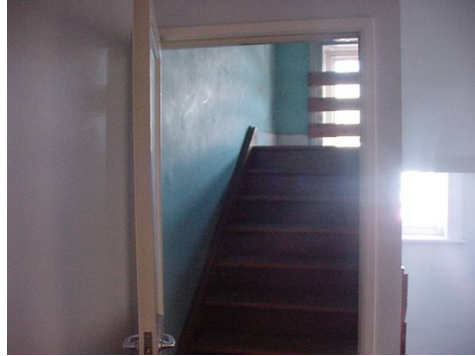
## Landing Area

DESCRIPTION	CONDITION	ACTION REQUIRED
<b>Ceilings:</b> Painted	Redecorate	Repair, prepare and redecorate.
<b>Walls:</b> Painted	Redecorate	Repair, prepare and redecorate.
<b>Floors:</b> Timber floorboards that run from front to the back, i.e. joists run side to side		Check condition of floor by opening up
<b>Joinery/Detailing:</b> Doors		Repair, prepare and redecorate.
<b>Services:</b> Lighting Electrics Heating Fire alarm system	Lights not to modern standards  None.	Replace Re-wire We would recommend new heating is added. Add.

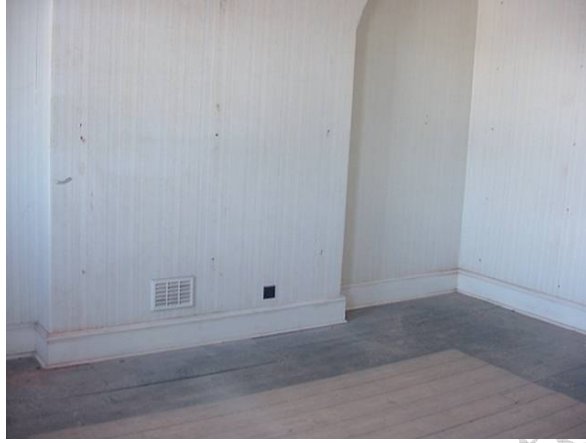
**Rear office**

<b>DESCRIPTION</b>	<b>CONDITION</b>	<b>ACTION REQUIRED</b>
<p><b>Ceilings:</b></p> <p>Painted</p>	<p>Water damaged. The roof has been letting in water.</p>

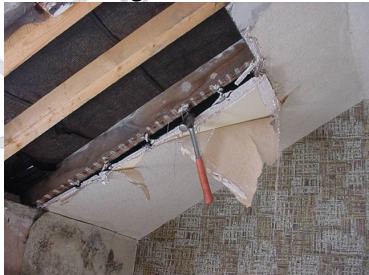
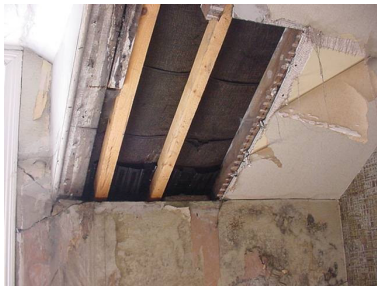
<p>Underside of roof</p>	<p>Ensure watertight, repair, prepare and redecorate.</p>

<p>Crack to wall</p> <p>Marked and signs of lateral dampness coming through</p> <p>Rear right hand corner there has been a repair with dampness coming in,</p>	<p>Make an insurance claim with regards to the crack to the rear wall; investigate via the adjoining property</p> <p>.</p> <p>Stop dampness, repair, prepare and redecorate.</p> <p>The plaster needs to be made good, re-skim and redecorate.</p>
<p><b>Floors:</b></p> <p>Timber floorboards that run from front to the back, ie. joists run side to side</p>	<p>Excessive deflection in floor indicating that there is rot to the joist ends or the floor joists or both</p>	<p>Add appropriate structural support.</p>
<p><b>Joinery/Detailing:</b></p> <p>Windows</p> <p>Doors</p>		<p>Ease and adjust, repair, prepare and redecorate.</p> <p>Ensure that doors are half hour fire resistance ideally one hour or as stated by the Fire Officer</p>

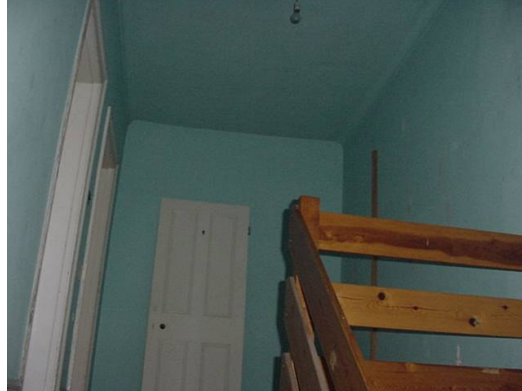
## Landing Area

DESCRIPTION	CONDITION	ACTION REQUIRED
<b>Ceilings:</b> Painted	Redecorate	Repair, prepare and redecorate.
<b>Walls:</b> Painted	Redecorate	Repair, prepare and redecorate.
<b>Floors:</b> Timber floorboards that run from front to the back, i.e. joists run side to side		
<b>Small access hatch:</b>

We were only able to carry out a head and shoulders inspection due to its location and size.	We recommend a large access hatch is formed in a safe area and the roof is re-inspected.
<b>Joinery/Detailing:</b> Doors		Repair, prepare and redecorate.

<b>Services:</b>		
Lighting	Lights not to modern standards	Replace
Electrics		Re-wire
Heating		We would recommend new heating is added.
Fire alarm system	None.	Add.
