# SCHEDULE OF CONDITION

## Of a Restaurant In Hertfordshire

**Miss Q**

**INDEPENDENT CHARTERED SURVEYORS**

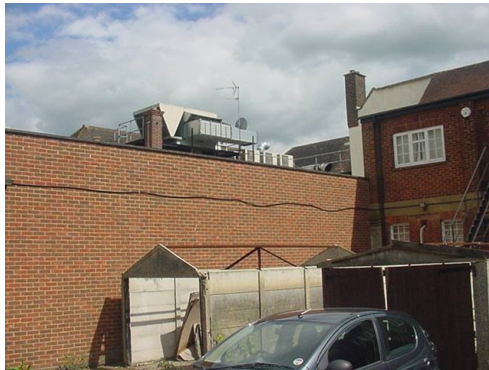
Rear left hand side

| DESCRIPTION | CONDITION | ACTION REQUIRED |
|---|--|---|
| <b>Roofs:</b><br><br>Pitched clay tile roof – see front elevation<br><br>Profile metal sheeting | <br><br><br><br><br>Leaks to box gutter side | <br><br><br><br><br>Repair and make watertight |
| <b>Gutters and Downpipes:</b><br><br>Downpipe from box valley gutter – mixture of cast iron and plastic | <br><br>Leaking | <br><br>Ensure all box gutters are watertight and falling towards the downpipe. Repair and secure as necessary, ensure downpipes are clear. |

| Brickwork parapet wall | Due to the lighter colour we believe it may have been damaged by water or rebuilt. | Repair and make watertight |
| Painted rendered in Stucco style | Render deteriorating | Repair, prepare and redecorate |
| Four Georgian six x six windows. | Deteriorating | Clean, repair, prepare and redecorate. |
| Three picture windows at ground floor level<br>Third picture window has a fire exit in it. | Deteriorating | Repair, prepare and redecorate |
| Timber cills to base | Deteriorating | Repair, prepare and redecorate |

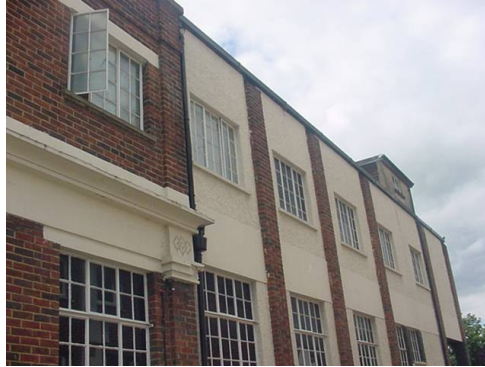
| <p><b>Walls:</b></p> <p>Stretcher Bond brickwork</p> <p>Five rendered panels<br/>Rough cast render</p> | <p>Some lateral dampness coming in.</p> <p>Lateral water damage is occurring in this area. It may relate to the box gutter or the render.</p> | <p>Repoint as necessary and check box gutter above.</p> <p>Check box gutter and also repair render as necessary to stop dampness coming in.</p> |
| <p><b>Windows and Doors:</b></p> <p>Five metal Crittle style casement windows</p> <p>Two casement windows with exposed concrete lintels</p> | <p>Crittle window</p> | <p>Ease and adjust, apply a rust stop paint and repair, prepare and redecorate.</p> <p>Clean, repair, prepare and redecorate.</p> |

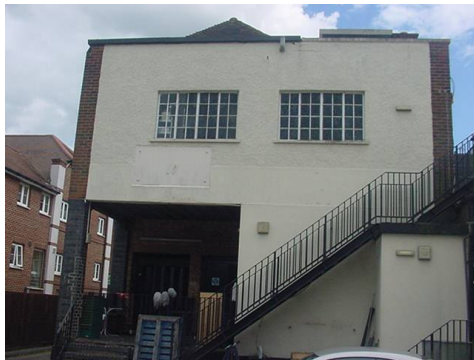
Rear ground floor

| DESCRIPTION | CONDITION | ACTION REQUIRED |
|--|--|--|
| <b>Roofs:</b><br><br>Clay tiles | Badly damaged roof tiles<br><br>Damaged tiles | Repair roof tiles; approximately 25% of the entire roof that was visible needed repairing. |

| Smooth render at lower level (ground to first floor level) | Marked | Repair, prepare and redecorate. |
| Concrete painted black plinth along base | Vertical cracking to end and general vegetation | Repair, prepare and redecorate. |
| Concrete column, clad in brickwork | Extensive damage, including a vertical crack that runs height of building, indicating movement in structure | Exclude from lease |

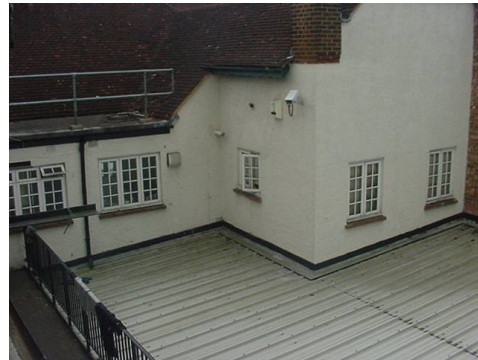
Rear first floor

| Rough cast render at high level (first to second floor level) | Splits to top of render | Repair, prepare and redecorate. |
| Variety of casement windows at first floor level | Marked and deteriorating | Clean, repair, prepare and redecorate. |

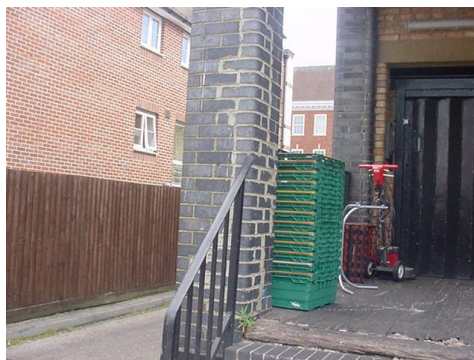
## **LOADING BAY AREA**

| DESCRIPTION | CONDITION | ACTION REQUIRED |
|---|--|--|
| <p><b>Loading Area:</b></p> <p>A raised area with timber decking and brick columns. We assume these are around a structural frame</p> <p>Parking and loading bay, used as a bin store</p> | <p>Cracking to column</p> <p>Cracking to column</p> | <p>Open up and investigate reason for cracking. It could relate to problems with the structural frame. We recommend the structural frame is excluded from the lease.</p> |
| <p><b>Sitting Out Area:</b></p> <p>Pre-cast concrete</p> | <p>Minor deterioration</p> <p>Sitting out area</p> | <p>Repair</p> |

| <b>Joinery:</b><br>Double timber entrance doors | Marked | Repair, prepare and redecorate. |

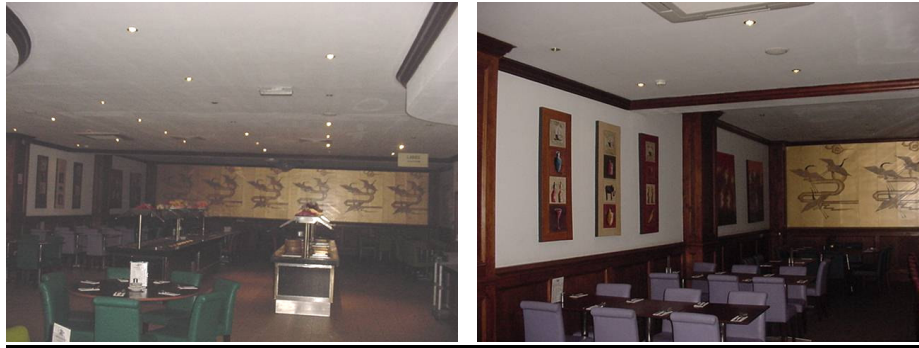
**Restaurant Area**  
**Banqueting Area to Left**

| DESCRIPTION | CONDITION | ACTION REQUIRED |
|---|---|---|
| Painted | Dated and marked | Repair, prepare and redecorate. |
| Painted at high level | Dated and marked | Repair, prepare and redecorate |
| Stained timber dado at low level | Marked | Re-stain |

| Inner double stained timber fire exit doors to right hand side | Marked | Re-stain |
| Outer double stained timber fire exit doors | Marked, particularly to base. | Re-stain<br><br>It was noted the fire exit was not working – ensure that fire alarm system is working fully. |

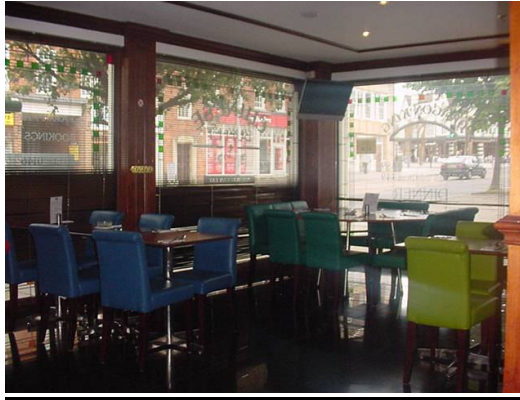
## **Restaurant Area** **Raised Area to Left**

| DESCRIPTION | CONDITION | ACTION REQUIRED |
|--|--|---|
| <b>Ceilings:</b><br><br>Painted plaster with decorative moulding with inset lights | Some areas look to have been repaired | Repair, prepare and redecorate. |
| <b>Walls:</b><br><br>Timber floor to ceiling with mirrors | Minor marks | Repair, prepare and redecorate |
| <b>Floors:</b><br><br>Black tiles | Joints gone in some areas<br>Some cracked tiles | Re-joint and repair/replace |
| <b>Joinery:</b><br><br>Picture windows<br><br>Single fire exit door on left | Marked<br><br>Limited access due to cars parked in this area | General clean and redecorate.<br><br>Recommend external signage |

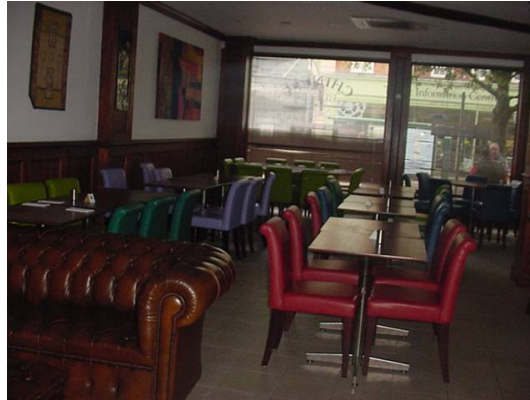
**Restaurant Area**  
**Waiting Area / Casual Dining to Right**

| DESCRIPTION | CONDITION | ACTION REQUIRED |
|---|---|--|
| <b>Ceilings:</b><br><br>Painted with timber coving<br>Inset lights | Marked | Repair, prepare and redecorate |
| <b>Walls:</b><br><br>Painted<br><br>Timber dado at low level to approx one metre in height<br><br>Two large Chesterfields | Marked<br><br>Damaged<br><br><br>Damage to timber dado | Repair, prepare and redecorate<br><br>Repair, prepare and redecorate |
| <b>Joinery:</b><br><br>Picture window | Marked | Clean |

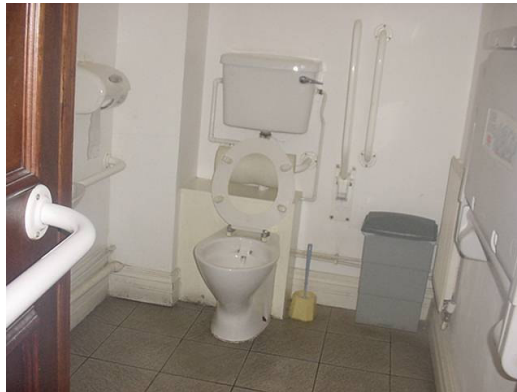
### Less able/Disabled Toilets / Baby Changing Area

| DESCRIPTION | CONDITION | ACTION REQUIRED |
|---|---|---|
| <b>Ceilings:</b><br>Painted with extract fan and bulk head light | Marked | Repair, prepare and redecorate. |

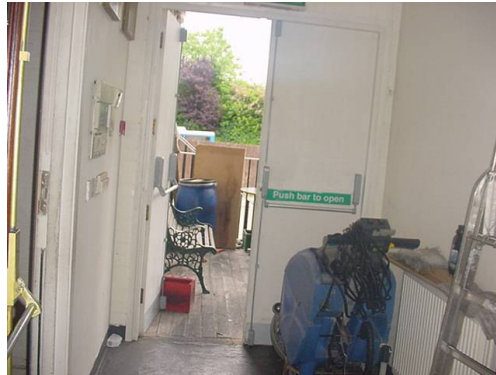
**Outer Lobby Area**  
(giving access to fire doors)

| DESCRIPTION | CONDITION | ACTION REQUIRED |
|--|--|---|
| <b>Ceilings:</b><br><br>Painted | <br><br>Marked | <br><br>Repair, prepare and redecorate. |
| <b>Walls:</b><br><br>Painted | <br><br>Heavily marked | <br><br>Repair, prepare and redecorate. |
| <b>Floors:</b><br><br>Vinyl | <br><br>Damaged | <br><br>Repair/replace |
| <b>Joinery:</b><br><br>Double painted timber door which is a fire exit | <br><br>Damage around push/pull bar and marked | <br><br>Repair, prepare and redecorate. |

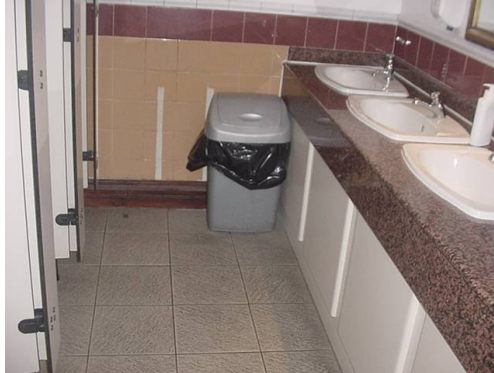
## Ladies Toilets and Associated Lobby Area

| DESCRIPTION | CONDITION | ACTION REQUIRED |
|--|--|--|
| <b>Ceilings:</b><br><br>Painted with four bulk head lights and four inset lights.<br>Timber arcatraves<br><br>Roof void access | Areas where it has been repainted and marked areas<br><br>Not viewed | Repair, prepare and redecorate. |
| <b>Walls:</b><br><br>Painted<br><br><br><br><br><br><br><br><br>Orange and burgundy tile to a tiled dado | Marked<br>Heavy water staining to right hand side near entrance door<br><br>Leaking from shower above?<br><br>Missing tiles | Identify staining, repair, prepare and redecorate.<br><br>We did not note any extraction fans so add a working extract system.<br><br><br>Repair/replace |

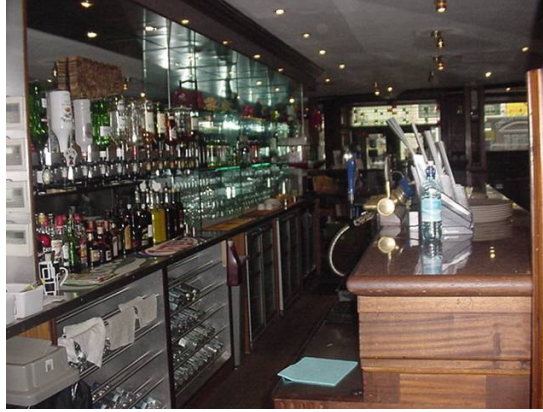
## Central Bar

| DESCRIPTION | CONDITION | ACTION REQUIRED |
|---|--|---|
| <b>Ceilings:</b><br><br>Painted plaster with decorative moulding with inset lights<br><br>Access into ceiling | Some areas look to have been repaired | Repair, prepare and redecorate. |

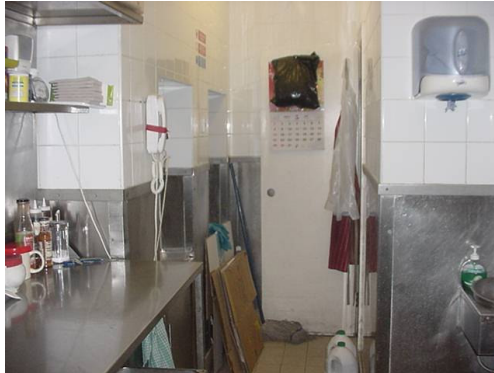
## Wash Up and Food Preparation Area

| DESCRIPTION | CONDITION | ACTION REQUIRED |
|--|--|--|
| <b>Ceilings:</b><br><br>Painted | Marks where previous repairs have been carried out | Repair, prepare and redecorate. |

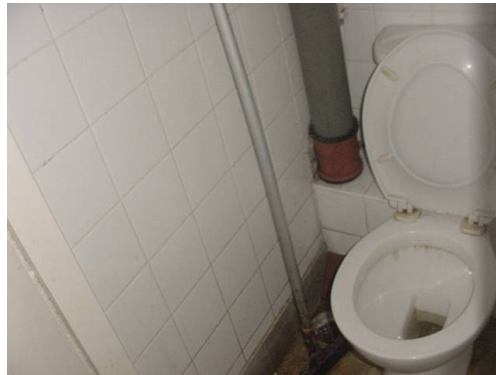
## WC

| DESCRIPTION | CONDITION | ACTION REQUIRED |
|---|---|---|
| <b>Ceilings:</b><br><br>Painted | Mould<br><br>Mould to ceiling | Re-plaster, prepare and redecorate and fit light. |
| <b>Walls:</b><br><br>Tiled<br><br>Extract fan | Marked<br><br>Not working at time of inspection | Repair, prepare and redecorate.<br><br>Repair and add as large an extract fan as possible |

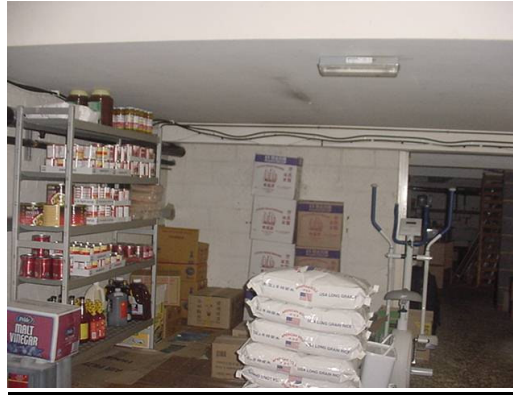
**Food Storage Area**  
(right hand side)

| DESCRIPTION | CONDITION | ACTION REQUIRED |
|--|---|---|
| <b>Ceilings:</b><br><br>Plasterboard | Marked | Repair, prepare and redecorate. |
| <b>Walls:</b><br><br>Painted English Bond brickwork to external and blockwork internally<br><br><br>Two cold storage units | Cracks to blockwork from floor to ceiling; slightly raking through the joints and through blockwork<br><br><br>Crack in wall | Repair, prepare and redecorate. |

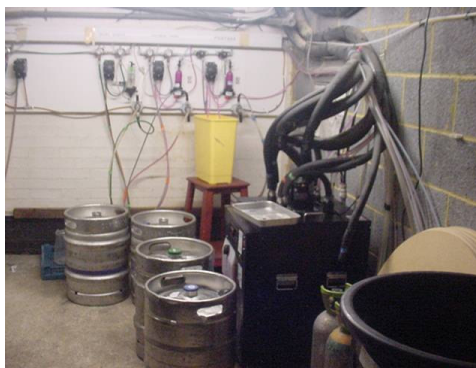
## **Beer Store**

| DESCRIPTION | CONDITION | ACTION REQUIRED |
|--|--|---|
| <b>Ceilings:</b><br><br>Low plasterboard | Marked | Repair, prepare and redecorate. |
| <b>Walls:</b><br><br>Painted and unpainted blockwork<br>Brickwork to perimeter | Vertical crack to approx three quarters of a metre | Repair, prepare and redecorate. |
| <b>Floors:</b><br><br>Concrete | Marked | Repair, prepare and redecorate |

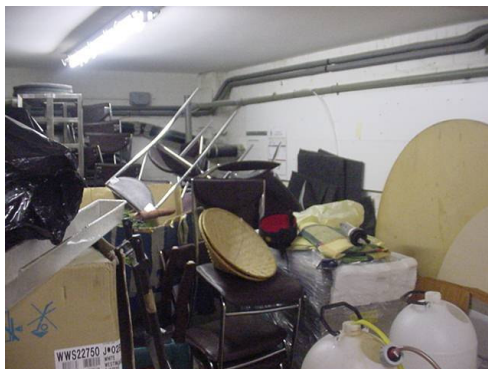
**Furniture Store**  
**(formerly cold cellar)**

| DESCRIPTION | CONDITION | ACTION REQUIRED |
|--|---|--|
| <b>Ceilings:</b><br><br>Plasterboard | Marked | Repair, prepare and redecorate. |

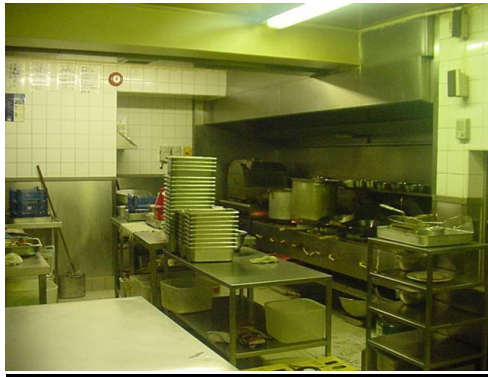
## Catering Kitchen

| DESCRIPTION | CONDITION | ACTION REQUIRED |
|---|---|--|
| <b>Ceilings:</b><br><br>Painted | Marked and grease stained | Clean, repair, prepare and redecorate. |

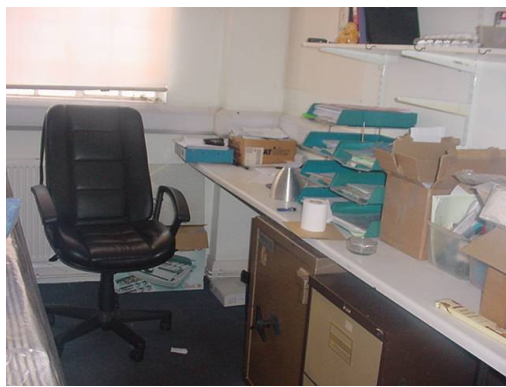
### Manager's Office

| DESCRIPTION | CONDITION | ACTION REQUIRED |
|---|---|--|
| <b>Ceilings:</b><br><br>Painted | Marked | Repair, prepare and redecorate. |

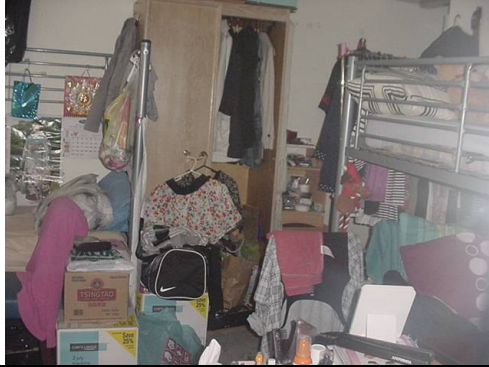
**Ladies' Living Quarters**  
**(Includes shower and WC within it)**

| DESCRIPTION | CONDITION | ACTION REQUIRED |
|--|--|---|
| <b>Ceilings:</b><br>Painted | Dated | Repair, prepare and redecorate. |

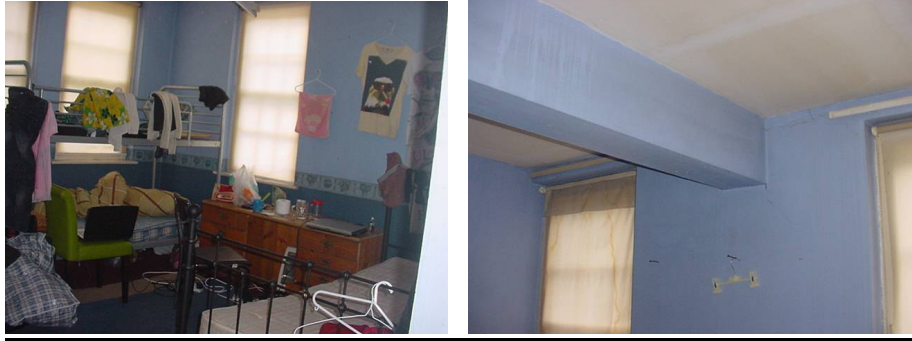
## Corner Bedroom

| DESCRIPTION | CONDITION | ACTION REQUIRED |
|---|---|---|
| <b>Ceilings:</b><br><br>Painted | Marked | Repair, prepare and redecorate. |

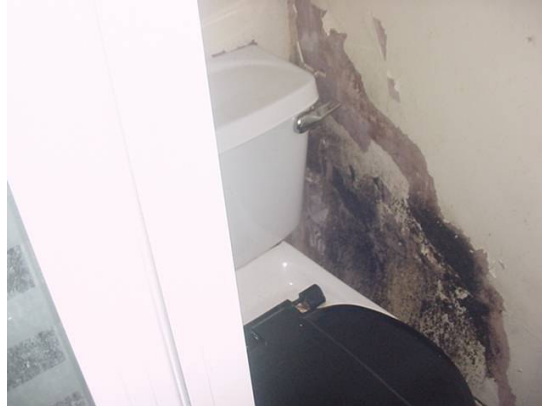
## Shower and WC

| DESCRIPTION | CONDITION | ACTION REQUIRED |
|--|--|--|
| <b>Ceilings:</b><br>Painted | Marked | Repair, prepare and redecorate. |

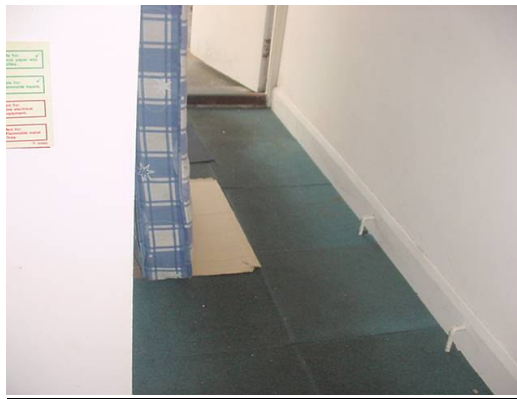
## **Lobby Area to Fire Escape**

| DESCRIPTION | CONDITION | ACTION REQUIRED |
|---|---|---|
| <b>Ceilings:</b><br><br>Painted | Dated | Repair, prepare and redecorate. |

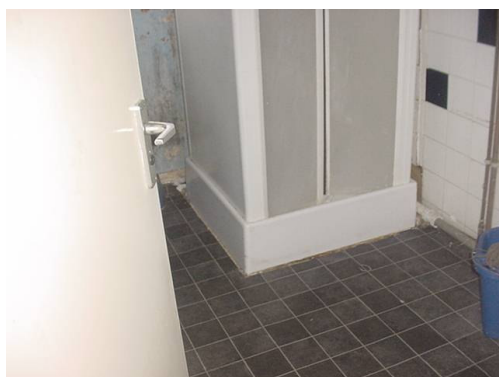
**WC with Shower**  
**(blue painted walls)**

| DESCRIPTION | CONDITION | ACTION REQUIRED |
|---|---|--|
| <b>Ceilings:</b><br><br>Painted | Marked and condensation and lateral dampness<br><br><br>Damp ceiling | Add additional extraction and repair, prepare and redecorate. |

| <b>Sanitary Ware:</b><br><br>One WC and shower | Service duct works to WC have been opened up<br><br><br>Ductwork open | Close duct works |

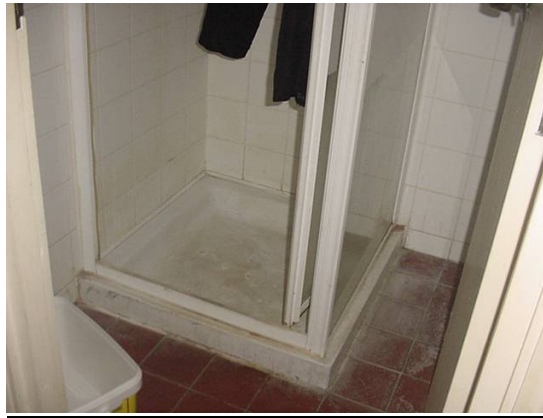
## Shower

| DESCRIPTION | CONDITION | ACTION REQUIRED |
|--|---|---|
| <b>Ceilings:</b><br>Painted | Dated | Repair, prepare and redecorate. |

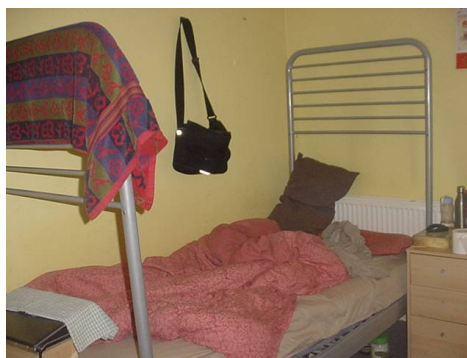
## Bedroom

| DESCRIPTION | CONDITION | ACTION REQUIRED |
|--|---|--|
| <b>Ceilings:</b><br><br>Painted | Dated | Repair, prepare and redecorate. |

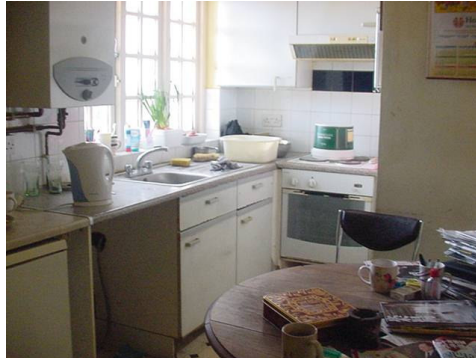
## Domestic Kitchen

| DESCRIPTION | CONDITION | ACTION REQUIRED |
|---|--|--|
| <b>Ceilings:</b><br><br>Painted | Heavily stained and cracking | Repair, prepare and redecorate and check reason for cracking |
