SCHEDULE OF CONDITION
OF
A Listed Tudor 16th/17th Public House
And Restaurant

SCHEDULE OF CONDITION

Listed Public House and Restaurant

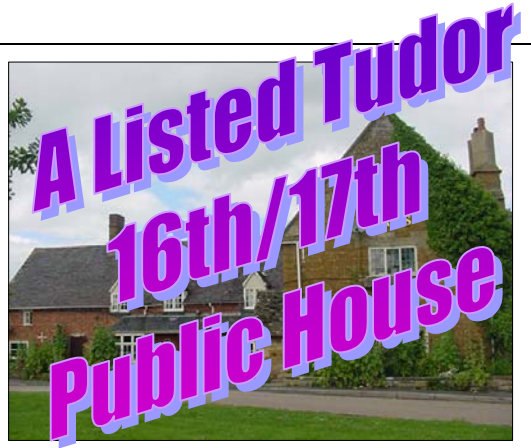
FRONT ELEVATION

DESCRIPTION	CONDITION	ACTION REQUIRED
Chimneys: Two brick and one stone	Below average	Re-point and new lead flashings
Roof: Tiles: Clay and Stone	Slightly below average	General overhaul and removal of moss and replacement of slipped and broken tiles
Gutters and Downpipes: Cast Iron and Plastic	Below average	Renew, repair and redecorate rusting cast iron and repair displaced plastic gutters.
Walls: Brickwork and Stonework	Poor	Re-point in an appropriate lime mortar and repair bricks and stonework.
External Joinery: Timber casement windows	Poor. Extensive wet rot.	Splice and cut-in new timber.

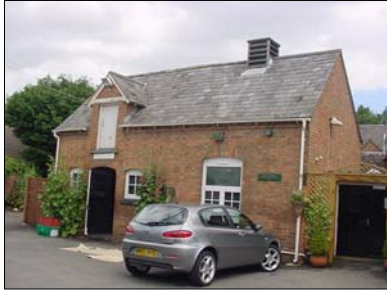
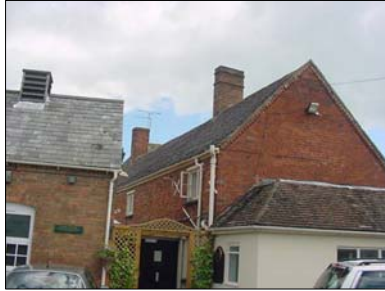
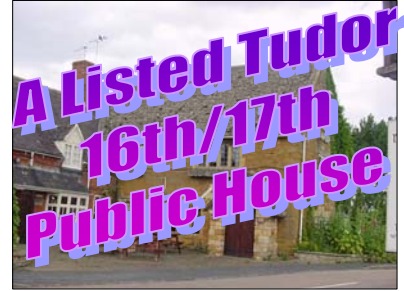
LEFT HAND SIDE ELEVATION

DESCRIPTION	CONDITION	ACTION REQUIRED
<p>Chimneys:</p> <p>One brick chimney</p>	Below average	Re-point and renew with a lead flashing
<p>Roof:</p> <p>Slate roof. Clay tile roof Felt flat roof</p>	Average to poor	<p>Main Felt Roof: Renew and repair detailing End Flat Roof: Renew</p>
<p>Gutters and Downpipes:</p> <p>Cast Iron and Plastic</p>	Below average	Renew, repair and redecorate rusting cast iron and repair displaced plastic gutters.
<p>Walls:</p> <p>Brickwork, painted render and stonework</p>	Average to Poor	Re-point in a lime based mortar and repair stonework.
<p>External Joinery:</p> <p>Timber casement windows</p>	Poor to Average	Splice and cut-in new timbers and repair and replace windows.

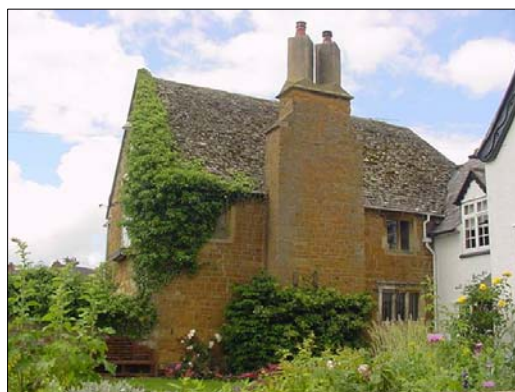
RIGHT HAND SIDE ELEVATION

DESCRIPTION	CONDITION	ACTION REQUIRED
Chimneys: Stone chimney	Average to below average. Some dampness internally	Check chimney; likely to need some re-pointing and work to the flashings
Roof: Stone slates with rear valley gutter	Average	General maintenance and cut back vegetation and check valley gutter
Gutters and Downpipes: Cast Iron and Plastic	Below average	Renew, repair and redecorate rusting cast iron and repair displaced plastic gutters. Cut back vegetation.
Walls: Stonework	Average to Poor. Note diagonal cracking to stonework	Re-point in a lime based mortar and repair stonework
External Joinery: Stone mullions and transoms.	Poor to Average	Repair

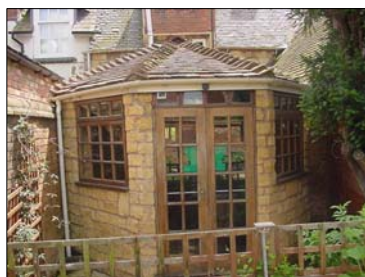
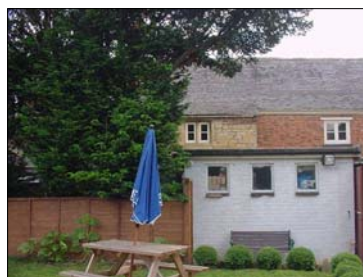
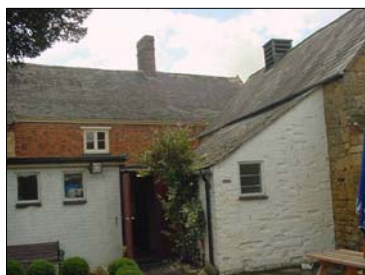
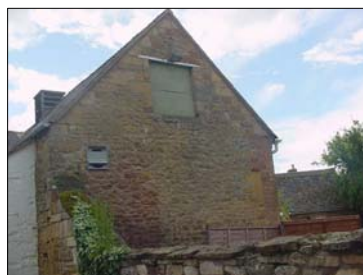
REAR ELEVATION

DESCRIPTION	CONDITION	ACTION REQUIRED
<p>Chimneys:</p> <p>Two brick chimneys</p>	Below average	Re-point and renew with a lead flashing
<p>Roof:</p> <p>Tiled clay roof</p> <p>Flat felt roof</p>	Average Below average	<p>Generally overhaul and remove moss, replace slipped and broken tiles.</p> <p>Replace felt detailing with lead detailing to flashings, upstands and around roof windows.</p>
<p>Gutters and Downpipes:</p> <p>Cast Iron and Plastic</p>	Below average	Renew, repair and redecorate rusting cast iron and repair displaced plastic gutters.

<p>Walls:</p> <p>Old brickwork, coursed and random stonework and cavity wall brickwork</p>	<p>Average to below average</p>	<p>Ad hoc re-pointing and repair to spalling brickwork</p>
<p>External Joinery:</p> <p>Timber casement windows</p>	<p>Average to poor</p>	<p>Redecorate and repair as necessary</p>

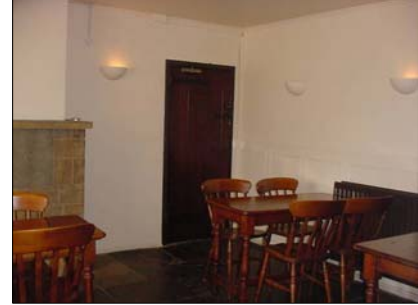
Bar Area

DESCRIPTION	CONDITION	ACTION REQUIRED
Ceilings: Artex	Average	
Walls: Papered and panted Timber panelling at low level	Average Rising damp found	
Floors: Stone flagged	Ingrained dirt	Clean
Joinery: Timber casement windows	Wet rot found in external of windows	Repair and redecorate

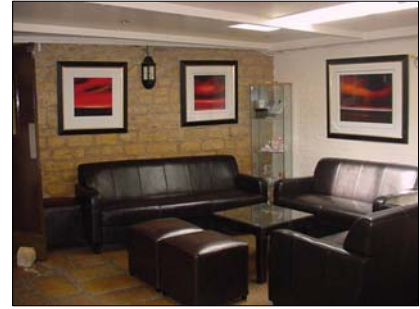
Internal Bar – Waiting Room

DESCRIPTION	CONDITION	ACTION REQUIRED
Ceilings: Painted	Average	
Walls: Painted and stonework	Average	
Floors: Stone slabs	Ingrained dirt	Clean
Joinery: Georgian wire polish plated roof window / roof light	Newish paintwork over joinery that looks to require making good	Check, as we believe the roof window / roof light may be leaking

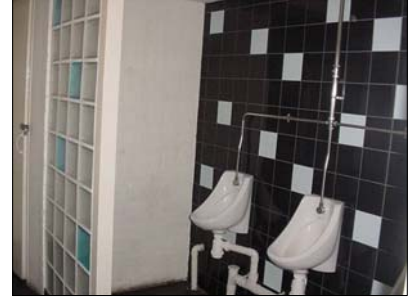
Gentlemen's Toilets

DESCRIPTION	CONDITION	ACTION REQUIRED
<p>Ceilings:</p> <p>Painted</p> <p>Access hatch in the area</p>	<p>Marked and signs of water damage</p>	<p>Paint</p>
<p>Walls:</p> <p>Painted brickwork</p> <p>Tiling to the urinals</p> <p>False wall to the w.c.</p>	<p>Average, minor marks</p> <p>Average / dated</p> <p>Rising Damp</p>	
<p>Floors:</p> <p>Tiled</p>	<p>Average</p>	
<p>Sanitary Ware</p> <p>3 Urinals</p> <p>1 W.C.</p> <p>1 Wash hand basin</p>	<p>Average / dated</p> <p>Average / dated</p> <p>Average / dated</p>	
<p>Joinery:</p>	<p>Average</p>

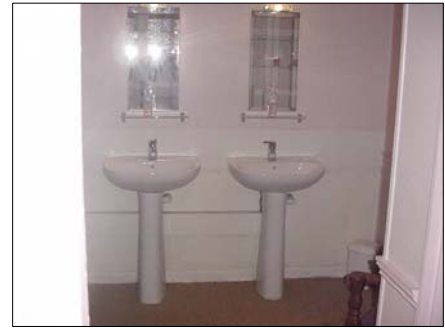
Ladies' Toilets

DESCRIPTION	CONDITION	ACTION REQUIRED
Ceilings: Painted pink	Average	
Walls: Painted pink Black wall paper	Average, minor marks Average	
Floors: Hessian flooring Wood boarding to W.C.s	Average	
Sanitary Ware: Two W.C.s Two wash hand basins	Average / dated Average / dated

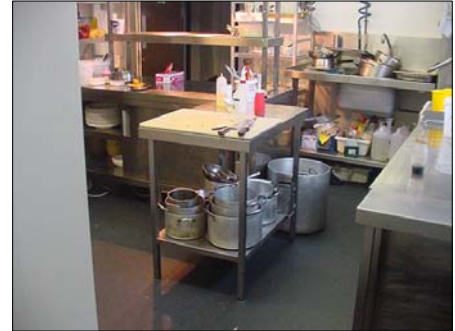
Temporary Catering Kitchen and Store

DESCRIPTION	CONDITION	ACTION REQUIRED
Ceilings:	Average	
Walls:	Average	
Floors: Safety-style floor	Average	
Joinery:	Average	
Catering Equipment: We have assumed that the catering equipment meets Local Authority approval and is appropriate for use. The catering equipment has not been inspected, as we are not expert in this area.		Check to see if an EHO Notice has been issued

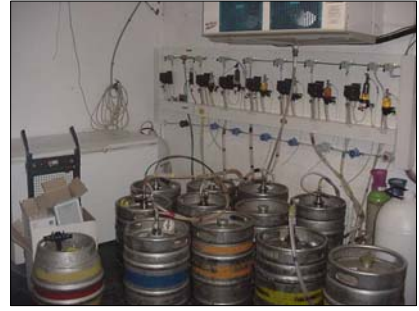
Cellar Area

DESCRIPTION	CONDITION	ACTION REQUIRED
Ceilings: Painted	Average	
Walls: Painted	Average	
Floors: Painted	Rising damp

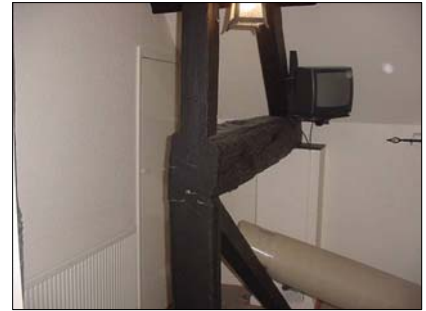
Letting Room One

DESCRIPTION	CONDITION	ACTION REQUIRED
Ceilings: Painted	Newly decorated	
Walls: Painted	Newly decorated	
Floors: Carpet	Being laid at the time of the survey	
Joinery: Timber windows	Below average	Redecorate
Services: Emergency lighting Fire alarm system	Work was being carried out at the time of our inspection	You need to ensure that the work meets appropriate standards

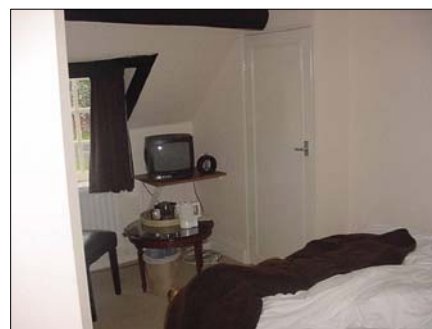
Letting Room Two

DESCRIPTION	CONDITION	ACTION REQUIRED
Ceilings: Painted	Hairline cracking	
Walls: Painted embossed	Average	
Floors: Carpet	Slightly marked	
Joinery: Timber windows	Below average	Redecorate
Services: Emergency lighting Fire alarm system	Work was being carried out at the time of our inspection	You need to ensure that the work meets appropriate standards

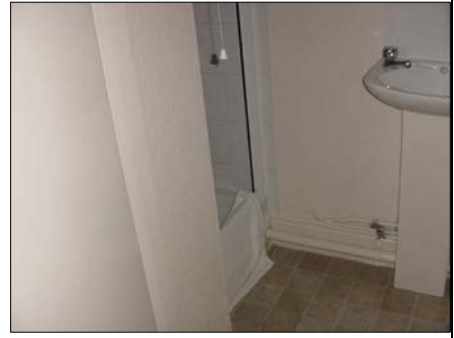
Letting Room Two En Suite

DESCRIPTION	CONDITION	ACTION REQUIRED
Ceilings: Painted	Average	
Walls: Painted	Average	
Floors: Vinyl	Average	
Sanitary Ware: One shower One small wash hand basin One w.c.	Average Average Average	
Joinery:	Average	
Services: Extract fan	In need of cleaning	Requires cleaning

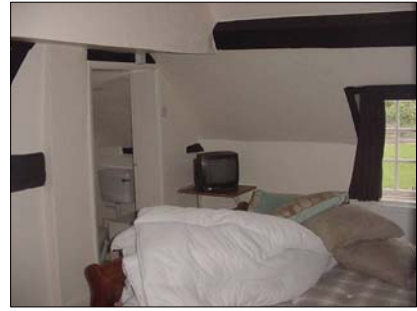
Letting Room Three

DESCRIPTION	CONDITION	ACTION REQUIRED
Ceilings: Painted paper	Average	
Walls: Painted embossed paper with timber beams	Average	
Floors: Carpet	Average	
Joinery: Casement windows Old style fire door	Below average.	Redecorate
Services: Emergency light missing Smoke detector present Radiator under the window	Work was being carried out at the time of our inspection	You need to ensure that the work meets appropriate standards

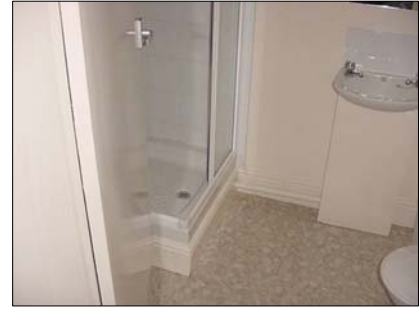
Letting Room Three En Suite

DESCRIPTION	CONDITION	ACTION REQUIRED
Ceilings: Painted embossed paper, partly sloping	Average	
Walls: Painted embossed	Average	
Floors: Vinyl	Average	
Sanitary Ware: One shower One small wash hand basin One w.c.	Average Average Average	
Joinery:	Average	
Services: Extract fan	In need of cleaning

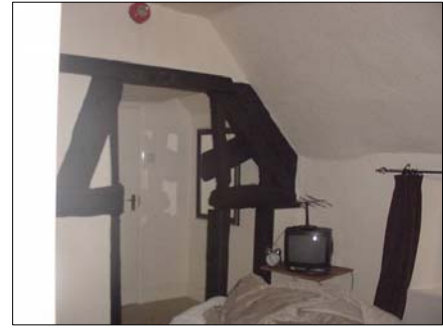
Letting Room Four

DESCRIPTION	CONDITION	ACTION REQUIRED
Ceilings: Painted paper, part embossed	Average	
Walls: Painted embossed paper	Average	
Floors: Carpeted	Some minor marks	
Joinery: Casement windows	Below average.	Redecorate
Services: Fire alarm system and emergency light Internal radiator	Work was being carried out at the time of our inspection	You need to ensure that the work meets appropriate standards

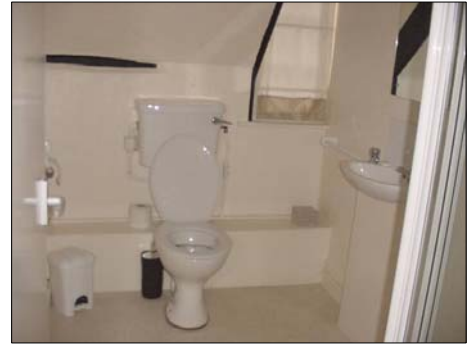
Letting Room Four En Suite

DESCRIPTION	CONDITION	ACTION REQUIRED
Ceilings: Painted paper, part embossed This area is sloping	Average	
Walls: Painted embossed paper	Average	
Floors: Vinyl	Average	
Sanitary Ware: One shower One small wash hand basin One w.c.	Slightly dated Slightly dated Slightly dated	
Joinery: Casement window	Below average.	Redecorate
Services: Extract fan	In need of cleaning	Requires cleaning

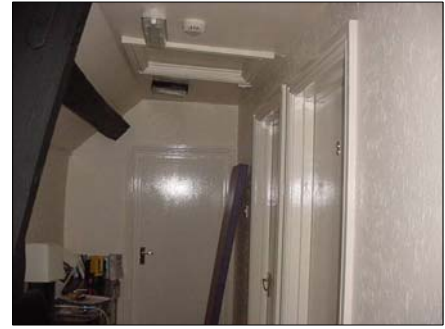
Access Corridor

DESCRIPTION	CONDITION	ACTION REQUIRED
Ceilings: Painted	Average	
Walls: Painted embossed paper with some timber beams	Average	
Floors: Carpet	Some minor marks	
Joinery: Casement windows	Below average.	Redecorate
Services: Emergency lights Fire protector	Work was being carried out at the time of our inspection	You need to ensure that the work meets appropriate standards

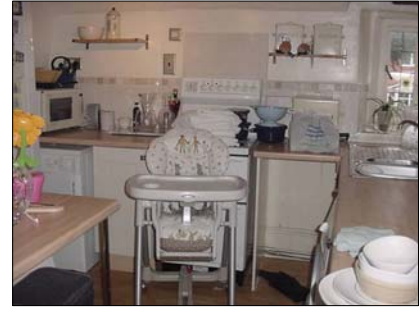
Kitchen

DESCRIPTION	CONDITION	ACTION REQUIRED
Ceilings: Painted with timbers including original beam	Marks where old light fitting was	Some making good
Walls: Partly tiled and partly painted Chimney breast	Average. Some hairline cracking to external wall	
Floors: Vinyl	Average	
Joinery: Timber casement window	Below average.	Redecorate.
Catering Equipment:	Not Tested

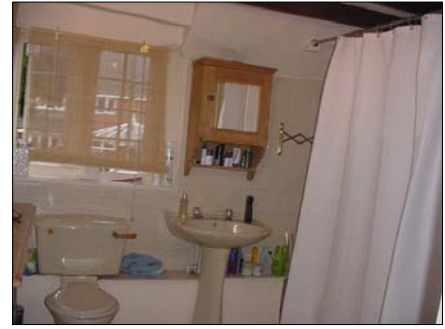
Bathroom

DESCRIPTION	CONDITION	ACTION REQUIRED
<p>Ceilings:</p> <p>Painted with timber (imitation) beams.</p>	Some marks	Redecorate
<p>Walls:</p> <p>Papered</p> <p>Tiled around bath, w.c. and wash hand basin</p>	<p>Some marks and some paper coming away</p> <p>Some mould</p>	<p>Redecorate</p> <p>Clean</p>
<p>Floors:</p> <p>Vinyl</p>	Average	
<p>Sanitary Ware:</p> <p>w.c. Wash hand basin bath / shower</p>	<p>Average / dated</p> <p>Average / dated</p> <p>Average / dated</p>	
<p>Joinery:</p> <p>Metal framed window</p>	Some flaking paintwork	
<p>Services:</p> <p>No extract fan</p> <p><u>Cupboard:</u> Hot water cylinder with jacket</p>	Handle missing to cupboard

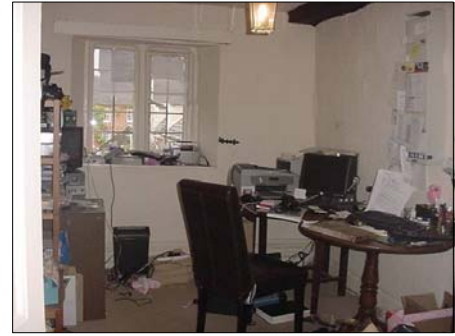
Study / Bedroom

DESCRIPTION	CONDITION	ACTION REQUIRED
Ceilings: Painted	Average	
Walls: Painted	Average	
Floors: Carpeted	Average	Clean
Joinery: Stone windows	Average

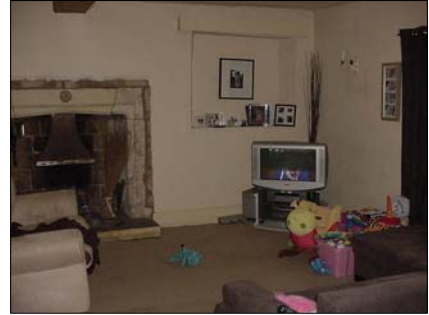
Lounge

DESCRIPTION	CONDITION	ACTION REQUIRED
Ceilings: Painted	Average	Redecorate
Walls: Painted	Some marks, for example an old border has been removed	Redecorate
Floors: Carpeted	Average	Clean
Joinery:	Average

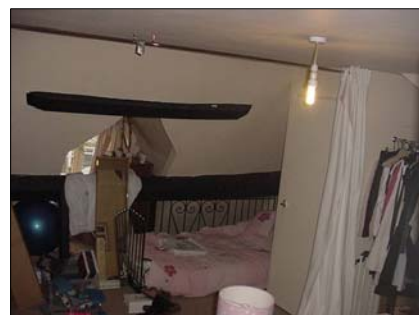
Walk-through Bedroom / Landing

DESCRIPTION	CONDITION	ACTION REQUIRED
<p>Ceilings:</p> <p>Painted</p>	<p>Average</p> <p>Signs of flaking paint to ceiling around chimney, indicating dampness</p>	<p>Redecorate</p>
<p>Walls:</p> <p>Painted at an angle with beams</p> <p>Chimney breast</p>	<p>Some marks and dust</p> <p>Dampness coming in and also to the end wall.</p>	<p>Redecorate</p>
<p>Floors:</p> <p>Carpeted</p>	<p>Average</p>	<p>Clean</p>
<p>Joinery:</p>	<p>Average</p>

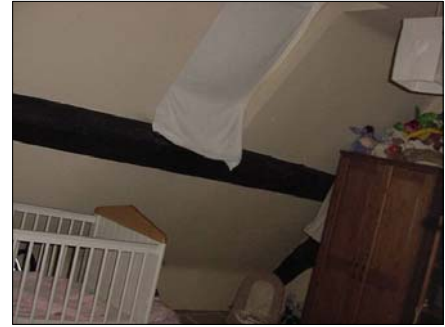
Box Bedroom

DESCRIPTION	CONDITION	ACTION REQUIRED
Ceilings: Painted	Average	
Walls: Painted with timbers at an angle	Average, with some marks	
Floors: Carpeted	Marked	Clean
Joinery: Two Internal windows from master bedroom Sky light (covered at the time of the survey)		Check that permission has been obtained to fit a sky light
Services: Internal radiator Box – we could not identify what was within this.

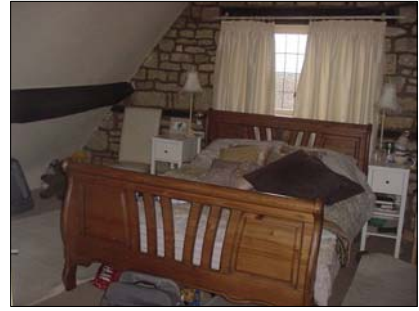
Master Bedroom

DESCRIPTION	CONDITION	ACTION REQUIRED
<p>Ceilings:</p> <p>Painted paper and vaulted ceiling Beams</p>	<p>Average Average – some paint marks</p>	<p>Redecorate</p>
<p>Walls:</p> <p>At an angle and part of the vaulted ceiling. Painted paper and beams</p>	<p>Minor dampness coming through Average</p>	<p>Redecorate</p>
<p>Floors:</p> <p>Carpeted</p>	<p>Slight marks</p>	<p>Clean</p>
<p>Joinery:</p> <p>Timber framed with lead in glass</p> <p>Internal timber window</p> <p>Painted ledge and brace door</p>	<p>Old and slightly deteriorating paint</p> <p>Average</p> <p>Average</p>	<p>Redecorate</p>

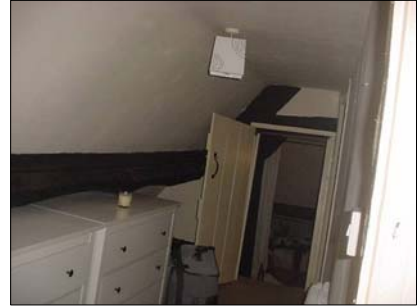
Top Floor Access Corridor

DESCRIPTION	CONDITION	ACTION REQUIRED
Ceilings: Painted paper	Average	
Walls: Painted paper with beams at an angle	Average	
Floors: Carpeted	Average	Clean
Joinery:	Average
