SCHEDULE OF CONDITION

Commercial Property in Wandsworth, London

**Commercial Survey
of a Public House**

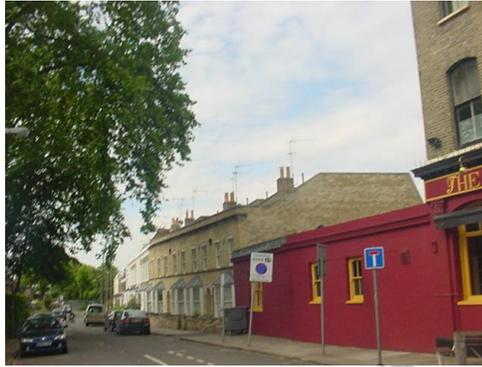
LEFT OF LEFT HAND ELEVATION

DESCRIPTION	CONDITION	ACTION REQUIRED
Roofs:		
Felt flat roof	Leaking	Repair and make watertight and redecorate
Single storey pitched roof clad with slates	Leaking	Re-slate
Rendered parapet wall	Allowing lateral dampness into pub below	Repair parapet wall and associated flashings
Walls:		
Render	Paint flaking and marked	Repair, prepare and redecorate.
Windows and Doors:		
Timber windows	Average	Ease and adjust and redecorate

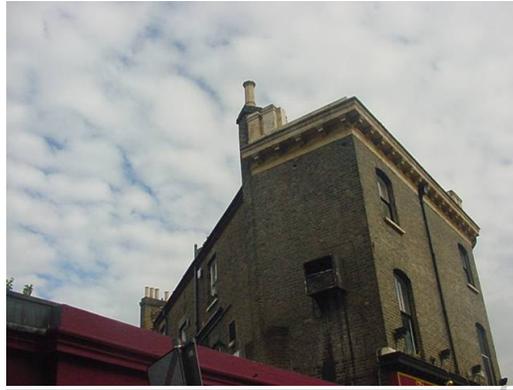
REAR ELEVATION

DESCRIPTION	CONDITION	ACTION REQUIRED
<p>Chimneys:</p> <p>See front elevation</p>		
<p>Roofs:</p> <p>See front elevation</p>		
<p>Gutters and Downpipes:</p> <p>Cast iron</p> <p>Soil and vent pipe</p>	<p>Leaking and causing dampness into kitchen</p> <p>Leaking</p>

<p style="text-align: center;">Leaking soil and vent pipe</p>	<p>Ensure all gutters are watertight and falling towards the downpipe. Repair and secure as necessary, ensure downpipes are clear.</p>
<p>Walls:</p> <p>Flemish Bond brickwork</p>	<p>Originally pointed in a lime mortar and repointed in cement mortar. Areas of pointing weathered</p>	<p>Repoint in appropriate mortar</p>

<p>Windows and Doors:</p> <p>Timber sliding sash windows</p>	<p>Wet rot clearly visible in some areas and plants growing from window cills.</p>	<p>Ease and adjust and redecorate</p>
<p>Fire Escape:</p> <p>Metal fire escape The two fire escapes from first floor level give an alternative means of escape should there be a fire.</p>	<p>Note: no fire escape to top floor level</p>

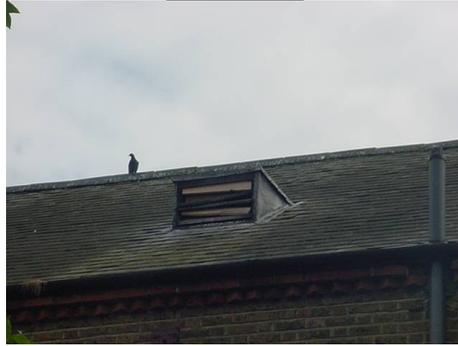
Main roof

DESCRIPTION	CONDITION	ACTION REQUIRED
<p>Roofs: Main pitched slate roof</p>	<p>Believe to be leaking due to lateral dampness visible in some of the external walls. It may also related to the guttering.</p>	<p>Repair and make watertight</p>
<p>Rear single storey pitched roof clad with slates</p>	<p>Damaged with slates missing and cracked slates</p> <div style="text-align: center;">

<p>Debris on roof needs clearing</p> </div>	<p>Re-roof</p>

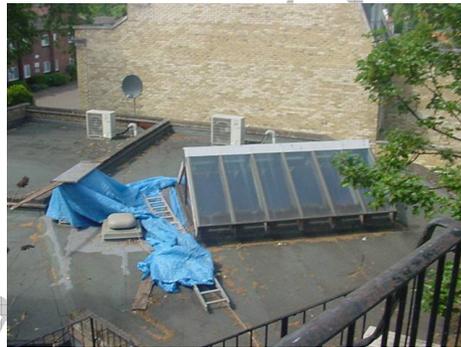
Rear flat roof

Rear felt flat roof	Leaking. Presently repaired with a tarpaulin and liquid bitumen in some areas. Part of the flat roof is lead in poor condition.	Re-roof
Associated Parapet Walls	Literally plants growing out of some of the parapet walls	Repair parapet walls
Low Pitched Glazed Pool Room Roof: Glazed	Dirty and marked with surrounding ivy

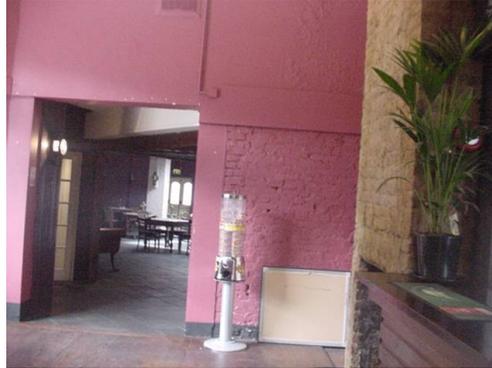
Left Hand Side Main Bar

DESCRIPTION	CONDITION	ACTION REQUIRED
<p>Ceilings:</p> <p>Plaster finish with decorative moulding</p>	Marked	Repair, prepare and redecorate
<p>Walls:</p> <p>Painted, plaster and brickwork</p> <p>One central chimney with exposed brick</p>	<p>Marked</p> <p>Dampness coming in to right hand side of chimney from septic tank outside</p> <div style="text-align: center;">

<p>lateral dampness coming in left hand side wall left side of main bar</p> </div>	Repair, prepare and redecorate

<p>Floors:</p> <p>Wood boarded</p>	<p>Marked</p>

<p>General deterioration of wooden floor</p>	<p>Clean and sand if necessary</p>
<p>Joinery:</p> <p>Windows</p>	<p>Marked</p>	<p>Repair, prepare and redecorate.</p>

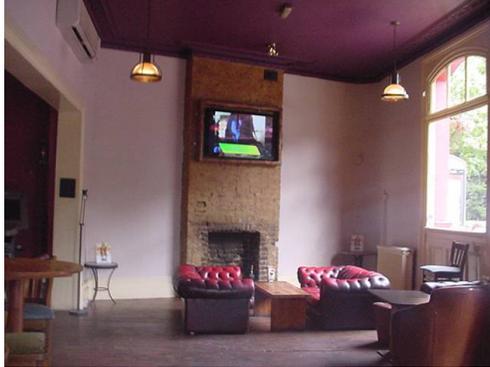
Right Hand Side Main Bar

DESCRIPTION	CONDITION	ACTION REQUIRED
Ceilings: Plaster finish with decorative moulding	Marked	Repair, prepare and redecorate
Walls: Painted	Marked	Repair, prepare and redecorate
Floors: Wood boarded	Marked	Clean and sand if necessary
Joinery: Windows Doors	Marked Marked	Repair, prepare and redecorate. Repair, prepare and redecorate.

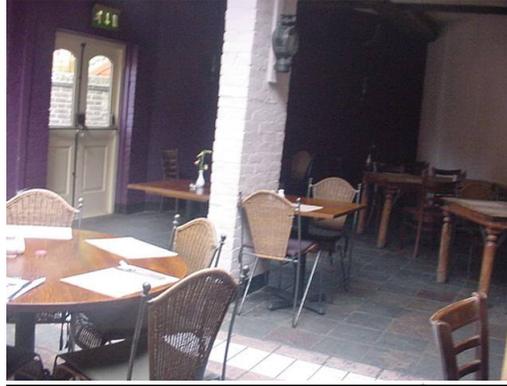
Restaurant Area

DESCRIPTION	CONDITION	ACTION REQUIRED
<p>Ceilings:</p> <p>Parjeting plaster with mock timber beams</p>	<p>Dampness visible in some areas</p>	<p>Repair roof, then repair, prepare and redecorate.</p>
<p>Walls:</p> <p>Painted brickwork</p>	<p>Marked and dampness coming in to restaurant area</p> <div style="text-align: center;">

<p>Dampness coming into restaurant area</p> </div>	<p>Repair, prepare and redecorate.</p>

<p>Floors:</p> <p>Tiled</p>	<p>Ingrained dirt</p>

<p>Ingrained dirt to tiles</p>	<p>Deep clean</p>
<p>Joinery:</p> <p>Windows</p> <p>Doors</p>	<p>Marked</p> <p>Marked</p>	<p>Repair, prepare and redecorate.</p> <p>Repair, prepare and redecorate.</p>

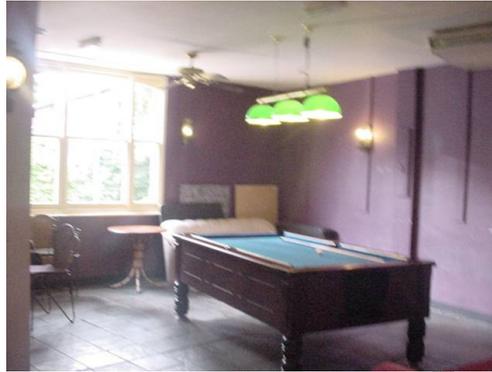
Games Area (darts and pool)

DESCRIPTION	CONDITION	ACTION REQUIRED
Ceilings: Painted	Marked	Repair, prepare and redecorate.
Walls: Painted	Heavily marked	Repair, prepare and redecorate.
Floors: Tiled	Ingrained dirt	Deep clean
Joinery: Windows	Marked	Repair, prepare and redecorate.

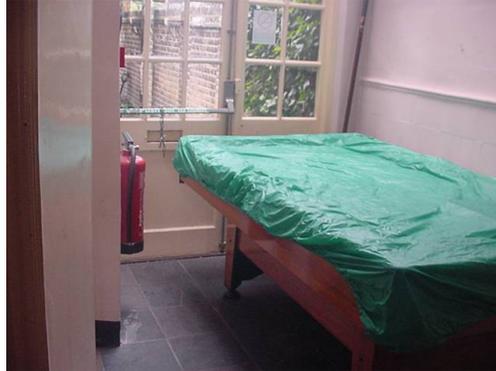
Pool Area
(to rear right hand side)

DESCRIPTION	CONDITION	ACTION REQUIRED
Ceilings: Glazed	Marked	Clean
Walls: Partly glazed, partly painted	Marked	Clean, repair, prepare and redecorate.
Floors: Quarry tiles	Ingrained dirt	Deep clean
Joinery: Windows	Marked	Repair, prepare and redecorate.
Emergency doors	Marked Blocked by pool table	Repair, prepare and redecorate.

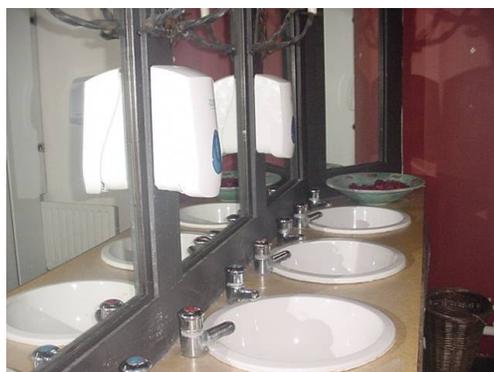
Ladies' Toilets

DESCRIPTION	CONDITION	ACTION REQUIRED
Ceilings: Painted with ceiling lights	Marked Ceiling lights falling out	Repair, prepare and redecorate
Walls: Painted and tiled	Marked Hole in tile by entrance	Repair, prepare and redecorate.
Floors: Tiles	Ingrained dirt	Deep clean
Sanitary Ware Four WC's, four wash hand basins set within a vanity unit	One WC out of order and marked vanity unit	Repair and deep clean
Joinery: Windows Glazed entrance doors	Marked Marked	Repair, prepare and redecorate. Repair, prepare and redecorate.

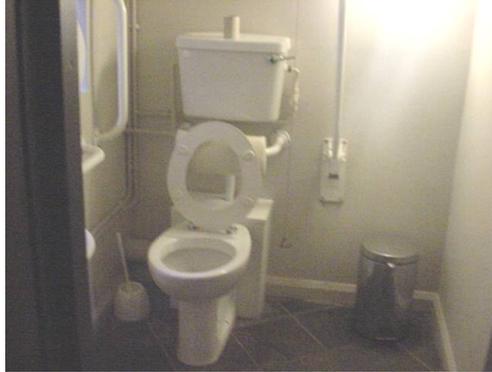
Less Able / Disabled Toilets

DESCRIPTION	CONDITION	ACTION REQUIRED
Ceilings: Low plasterboard ceiling	Marked	Repair, prepare and redecorate
Walls: Painted	Marked and damage around door handle as it is onto a studwork wall	Repair, prepare and redecorate
Floors: Tiles	Ingrained dirt	Deep clean
Sanitary Ware: Adapted WC and small wash hand basin	Marked	Deep clean
Joinery: Two sash windows Doors	Marked Marked	Repair, prepare and redecorate. Repair, prepare and redecorate.

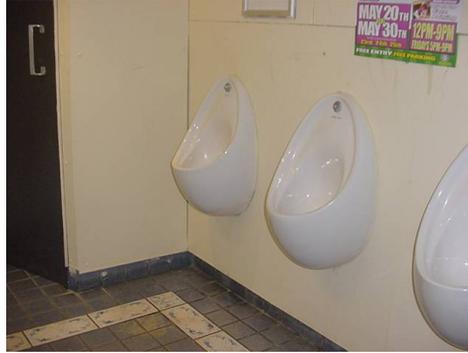
Gentlemen's Toilets
(two lobby entrances: one from restaurant and one from bar)

DESCRIPTION	CONDITION	ACTION REQUIRED
Ceilings: Painted	Marked with holes	Repair, prepare and redecorate
Walls: Painted	Marked and water damage to top of wall above urinals	Repair, prepare and redecorate
Floors: Small quarry tiles	Ingrained dirt	Deep clean
Sanitary Ware: Four urinals, three wash hand basins, two WC's	Graffiti in one WC cubicle	Deep clean
Joinery: Windows Doors	Marked Marked	Repair, prepare and redecorate. Repair, prepare and redecorate.

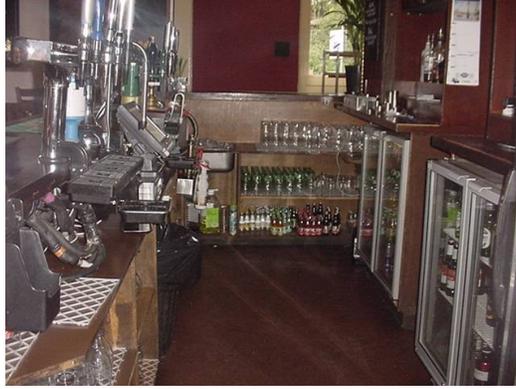
Central Bar Servery Area

DESCRIPTION	CONDITION	ACTION REQUIRED
Ceilings: Painted with glass back	Marked	Repair, prepare and redecorate
Walls: Glass back	Marked	Clean.
Floors: Altro style flooring	Ingrained dirt	Repair and deep clean
Services: Electrics

Electrics in bar area	Landlord to supply test report and certificate

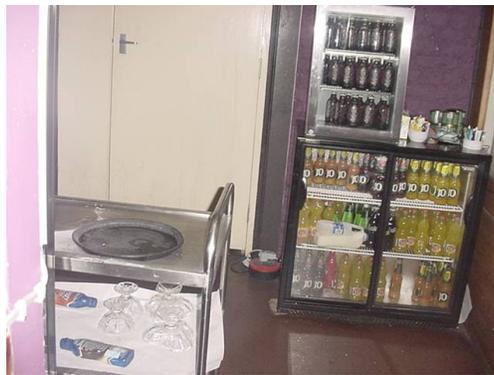
Prep Area

DESCRIPTION	CONDITION	ACTION REQUIRED
Ceilings: Painted	Average	
Walls: Painted	Marked	Repair, prepare and redecorate.
Floors: Altro style flooring	Ingrained dirt	Repair and deep clean

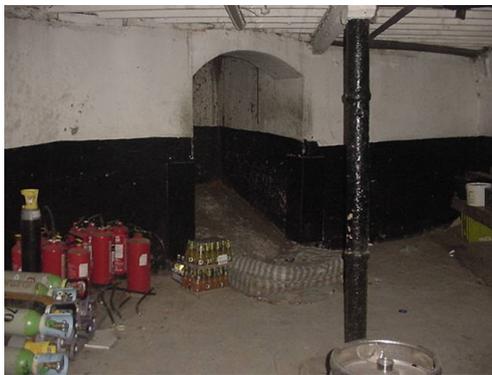
Cellar Drop Area

DESCRIPTION	CONDITION	ACTION REQUIRED
Ceilings: Exposed joists	Stained	Recommend adding of fibreboard
Walls: Painted Two cast iron columns	Dampness getting in, particularly around waste water flooding sign Rusting	Repair, prepare and redecorate Repair, prepare and redecorate
Floors: Concrete Higher level to the size than to the centre, originally for barrels	Generally marked, items lying around	Clear, repair, prepare and redecorate
Sump Pump: We were pleased to see there was a sump pump	Is there a danger of flooding?	
Services: Calor Gas and Fire Extinguishers have been abandoned down here. Check they are safe and remove. See services section Lifting device

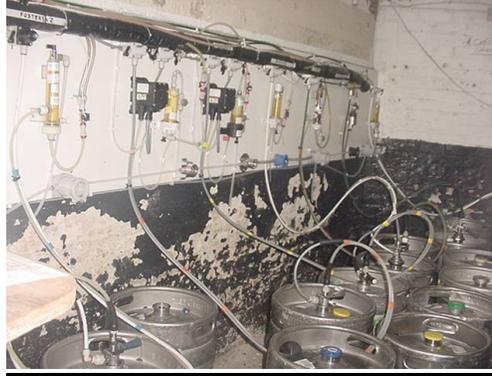
Cellar Cold Area

DESCRIPTION	CONDITION	ACTION REQUIRED
Ceilings: Fibreboard	Damaged and water leak visible	Repair and replace
Walls: Painted	Heavily marked and some dampness visible.	Repair, prepare and redecorate
Floors: Concrete	Marked	Repair, prepare and apply floor paint
Services: Please see services section

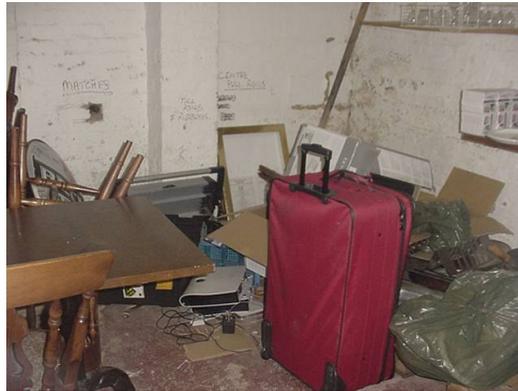
Storage Cupboard

DESCRIPTION	CONDITION	ACTION REQUIRED
Ceilings: Painted	Old water staining area in corner	Repair, prepare and redecorate
Walls: Painted Stored items	Marked and dampness coming through	Repair, prepare and redecorate
Floors: Concrete	Starting to break up	Replace

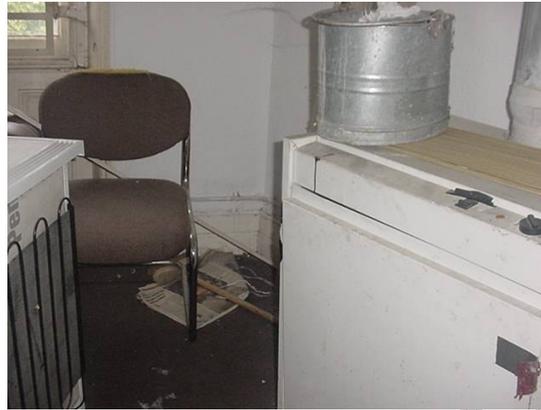
Rear Boiler Room
(rear right hand side)

DESCRIPTION	CONDITION	ACTION REQUIRED
Ceilings: Painted	Coming down due to water damage and hairline cracks

Damage to ceiling	Replace ceiling, prepare and redecorate
Walls: Woodchip	Marked and old fixing holes and hole adjacent to door	Repair, prepare and redecorate.
Floors: Carpet	Worn	Clean or replace

<p>Joinery:</p> <p>Sliding sash window</p> <p>Fire door</p>	<p>Has been grinded (painted) and needs been painted and adjusted</p>	<p>Ease and adjust, repair, prepare and redecorate.</p>
<p>Services:</p> <p>Potterton boiler</p> <p>Factory insulated hot water cylinder</p>	<p>No tests have been carried out</p>	<p>We refer you to services section at end.</p>

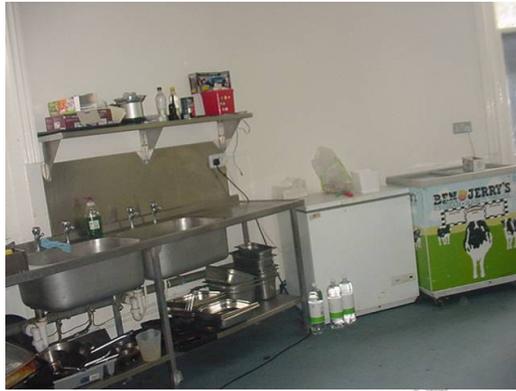
Catering Kitchen

DESCRIPTION	CONDITION	ACTION REQUIRED
<p>Ceilings:</p> <p>Suspended</p> <p>Extract fan</p>	<p>Marked and grease stained</p> <p>Leaking grease</p> <div style="text-align: center;">

</div> <p>grease leaking out of extract fan</p>	<p>Deep clean</p> <p>Deep clean and have extract fan checked and change filters.</p>

<p>Walls:</p> <p>Stainless steel clad</p>	<p>Grease stained</p>

<p>lateral water penetration coming through wall on rear</p>	<p>Deep clean</p>
<p>Floors:</p> <p>Altro style flooring</p>	<p>Ingrained dirt.</p>

<p>Cracked altro style flooring</p>

<p>Defective flooring</p>	<p>Repair or replace</p>
<p>Catering Equipment:</p> <p>Grill range</p>	<p>Equipment not tested but noted that some of the stainless steel units are not on their own legs</p>

<p>Joinery:</p> <p>Sliding sash Window</p>	<p>Difficult to view. Areas of cracked glass noted</p>

<p>Cracked window</p>	<p>Repair, prepare and redecorate</p>
<p>Appliances:</p> <p>The equipment has not been inspected, as we are not expert in this area, you should seek expert advice.</p>

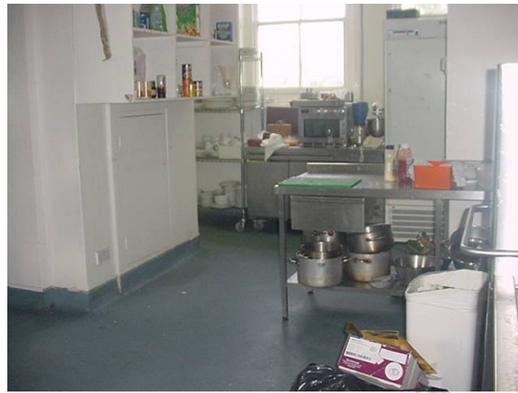
Prep / Wash Up Area
(forming part of kitchen area)

DESCRIPTION	CONDITION	ACTION REQUIRED
Ceilings: Suspended	Holes and leaking

Damaged and leaking ceiling	Repair, prepare and redecorate.
Walls: Painted	Marked	Repair, prepare and redecorate.
Floors: Altro style flooring	Ingrained dirt	Deep clean and repair
Joinery: Windows	Marked	Repair, prepare and redecorate.

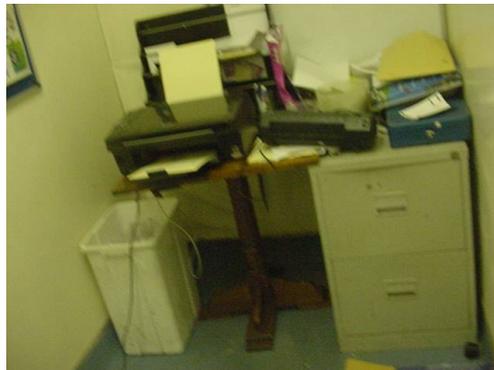
Small Office
(off kitchen)

DESCRIPTION	CONDITION	ACTION REQUIRED
Ceilings: Suspended	Heavily marked	Repair, prepare and redecorate
Walls: Painted	Marked	Repair, prepare and redecorate
Floors: Altro style flooring	Ingrained dirt	Deep clean or replace
Joinery: Doors	Marked	Repair, prepare and redecorate.

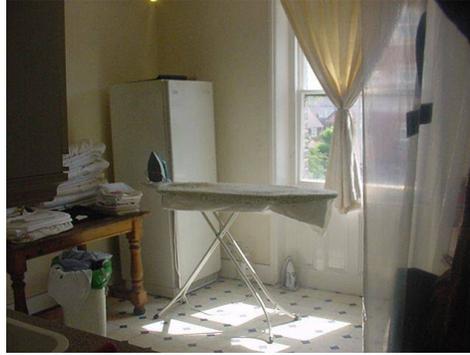
Domestic Kitchen

DESCRIPTION	CONDITION	ACTION REQUIRED
Ceilings: Painted	Hairline cracking and water staining around light	Repair, prepare and redecorate.
Walls: Woodchip Wall units and floor units	Marked	Repair, prepare and redecorate.
Floors: Vinyl Tiles around sink and cooker	Holes Tiles coming away from wall	Replace Replace
Joinery: Windows Doors	Needs easing and adjusting Marked	Ease and adjust, prepare and redecorate. Repair, prepare and redecorate.

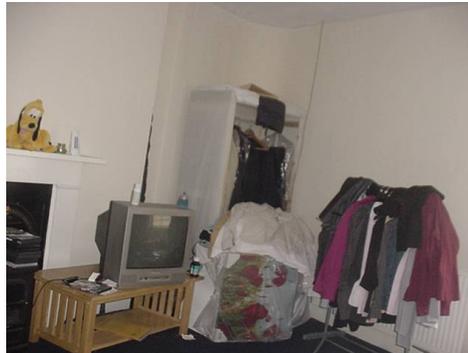
Far Right Hand Bedroom

DESCRIPTION	CONDITION	ACTION REQUIRED
Ceilings: Woodchip	Marked	Repair, prepare and redecorate.
Walls: Woodchip Chimney breast Internal radiator	Marked and dampness to perimeter wall from leaking roof	Repair, prepare and redecorate.
Floors: Carpet	Dirty	Clean or replace
Joinery: Windows Doors	Damaged extract fan in window Fire door	Repair, prepare and redecorate. Repair, prepare and redecorate.

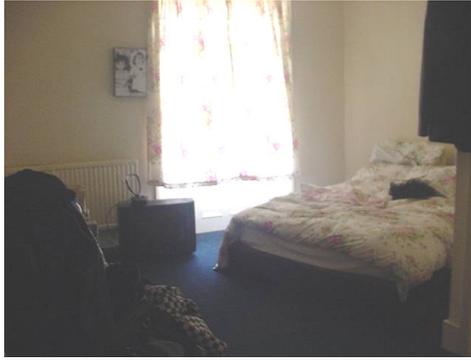
Rear Right Hand Bedroom

DESCRIPTION	CONDITION	ACTION REQUIRED
Ceilings: Painted	Marked	Repair, prepare and redecorate.
Walls: Painted	Marked	Repair, prepare and redecorate.
Floors: Carpet	Worn	Clean or replace
Joinery: Windows Doors	Marked Marked	Repair, prepare and redecorate. Repair, prepare and redecorate.

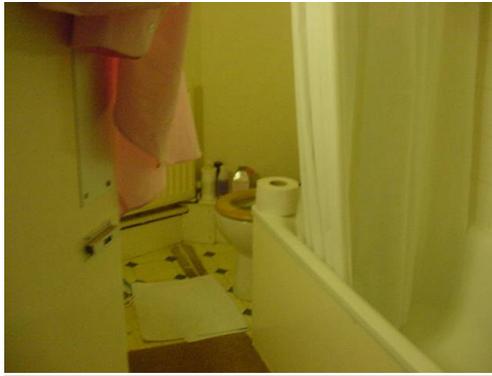
En-suite Bathroom to Rear Right Hand Bedroom

DESCRIPTION	CONDITION	ACTION REQUIRED
Ceilings: Woodchip paper	Hairline cracking	Repair, prepare and redecorate.
Walls: Woodchip paper Radiator	Marked Heavily marked	Repair, prepare and redecorate Clean
Floors: Carpet	Worn	Clean or replace
Sanitary Ware: WC, wash hand basin and bath		
Joinery: Fire Door	Door lock missing	Repair, prepare and redecorate.

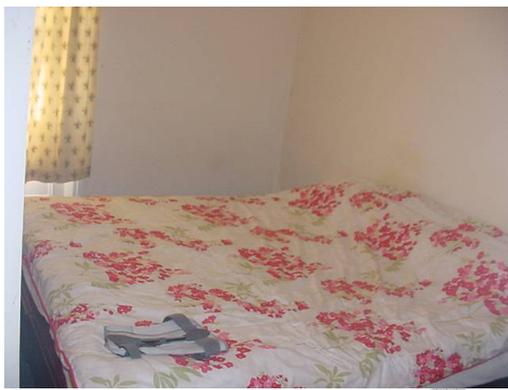
Front Bedroom

DESCRIPTION	CONDITION	ACTION REQUIRED
Ceilings: Painted	Marked	Repair, prepare and redecorate
Walls: Woodchip	Marked	Repair, prepare and redecorate.
Floors: Carpet	Worn	Clean or replace
Joinery: Windows Doors	Marked Damaged and marked	Repair, prepare and redecorate. Repair, prepare and redecorate.

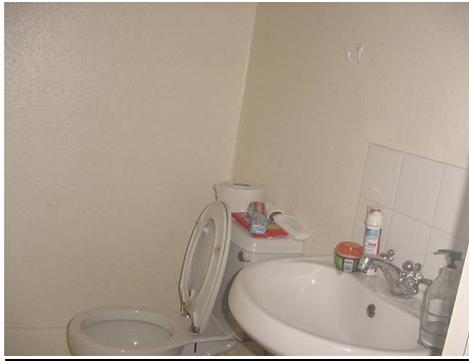
Internal WC

DESCRIPTION	CONDITION	ACTION REQUIRED
Ceilings: Painted	Marked	Repair, prepare and redecorate
Walls: Painted woodchip	Marked	Repair, prepare and redecorate
Floors: Vinyl	Ingrained dirt	Clean
Joinery: Doors	Marked	Repair, prepare and redecorate. .
Sanitary Ware: WC and wash hand basin	Marked	Deep clean

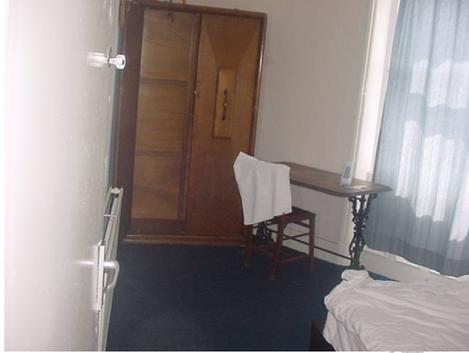
Bedroom

DESCRIPTION	CONDITION	ACTION REQUIRED
Ceilings: Painted	Marked	Repair, prepare and redecorate
Walls: Woodchip	Marked, particularly around the head of the bed	Repair, prepare and redecorate.
Floors: Carpet	Worn	Clean or replace
Joinery: Windows	Flaking paint	Repair, prepare and redecorate.
Fire Door	Door closer not working	Repair, prepare and redecorate.

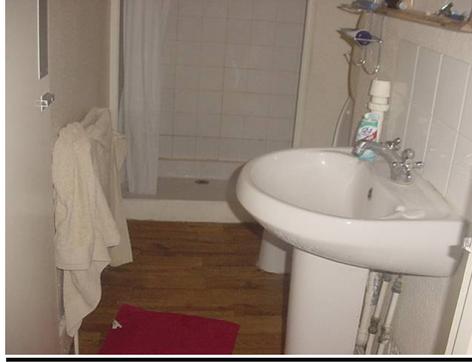
Rear Internal Shower Room
(left hand side)

DESCRIPTION	CONDITION	ACTION REQUIRED
Ceilings: Painted	Fan coming away from ceiling Hairline cracking at the walls / ceiling joint	Repair, prepare and redecorate
Walls: Tiled Woodchip	Broken within shower unit Marked	Replace Repair, prepare and redecorate
Floors: Vinyl	Worn	Clean or replace
Sanitary Ware: Shower, WC and wash hand basin	Sink is broken, leaking to floor below WC heavily stained	Replace sanitary ware
Joinery: Door	Marked	Repair, prepare and redecorate
