New Properties 2000 Plus Example Residential Building Survey

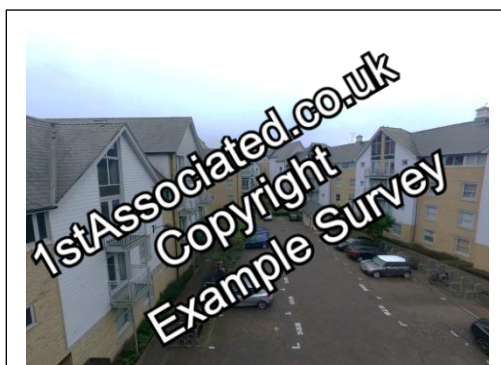
Shared parking area

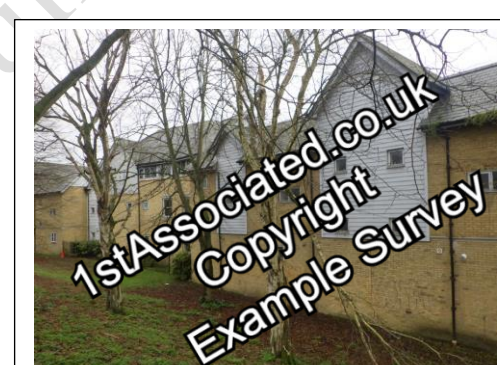
Landscaped area to rear

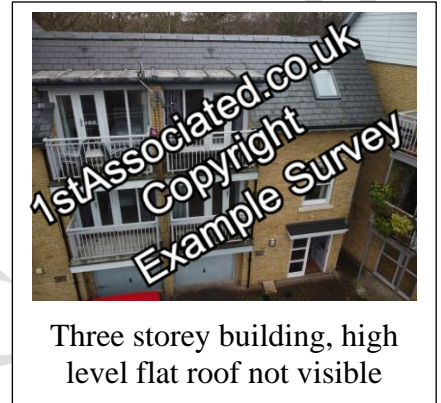
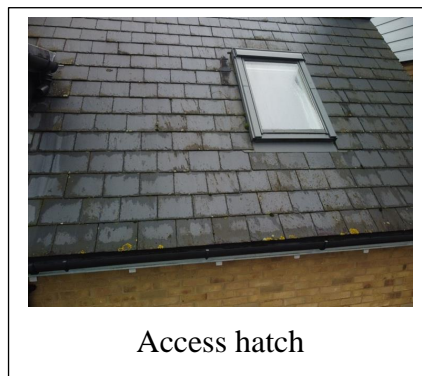
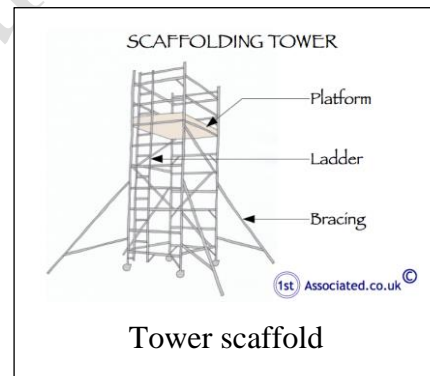
This is not really good or bad, just a statement of fact. The property is three-storey and as such will have high-level maintenance. The property does however have roof access via the hidden flat roof access hatch, which will help with maintenance of the roof area and gutters. We noted that on the roof there was a safety system for use of a harness or similar but you may wish to buy/rent a tower scaffold when carrying out high-level work.

Areas that we believe could be a risk are:

- 1) The flashings on the flat roof
- 2) The drainage of the flat roof.
- 3) We also believe that the capping stones at the top of the roof that have been both mortared on and mechanically fixed have had problems in the past as it is unusual to find them to be both mortared and mechanically fixed. We look at these in more detail in the next section.

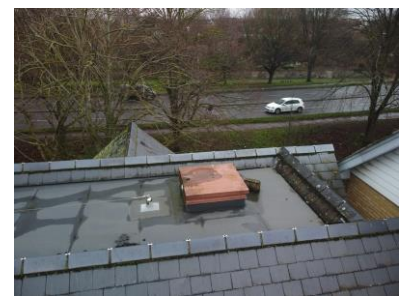
High level hidden flat roof of mono-ply construction

Our concern with a roof like this is:-

1. Does it have a good drainage point? It will need to be viewed when it is raining heavily.
2. Does it have a problem with the flashing detail due to the coping stones being both mortared and mechanically fixed?
3. The overall condition of the roof, in this case we would say it is starting to deteriorate due to the ponding/water patterns that we could see.

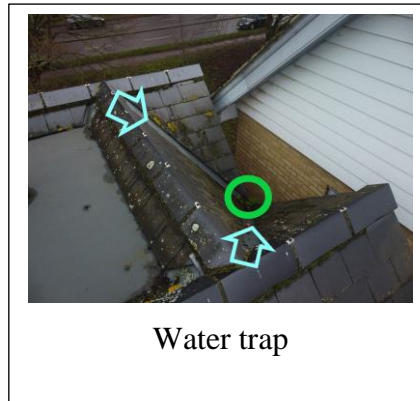
Water trap

ACTION REQUIRED: The roof needs to be viewed when it is raining heavily to see whether it is holding water or taking it away. Also, there needs to be clearance of the water trap to the right hand side.

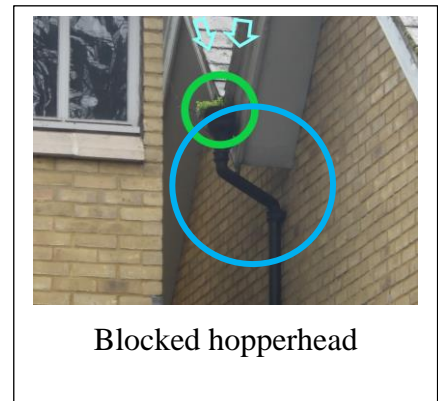
Blocked hopperhead

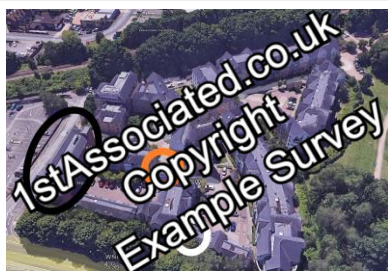
Whilst we were at the property we spoke to a surveyor representing a local commercial building who was having drains lifted advising that the residential area had blocked drains which in turn were affecting the commercial property that they were managing.

Orange – Drains lifted
Black – XXX
White - Survey Property

ACTION REQUIRED: Your legal advisor to check and confirm with the management company what the problems are in relation to the drainage and what costs are likely to be incurred in the foreseeable future and if new drains will be necessary. We would also recommend your solicitor specifically writes to Argyle Drains asking them can they advise of the work they were carrying out on the day of our survey on XXX.

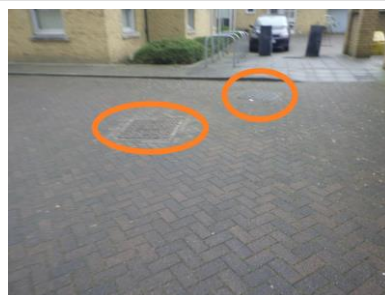
Manholes believed to be
lifted by XXX Building
Surveyor

As our building survey progressed the XXX Building Surveyor informed us that they had spoken to the Management Company of the housing estate who were aware of the problems with the pumped sewerage system breaking down. The local system is gravity fed which then goes into main drains that are pumped. It is a known about problem and the XXX Building Surveyor believed it to be a regular issue.

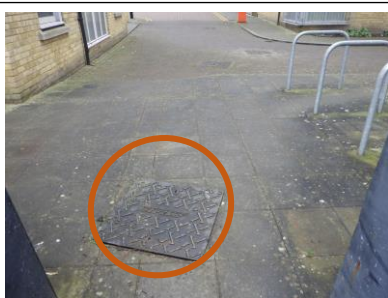
Drain at front in car parking
area

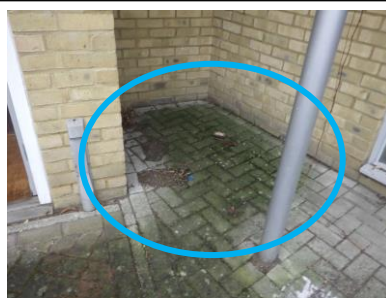
Water trap at right side of the
entrance door

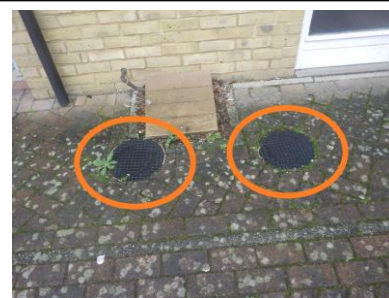
Close up of rodding eyes

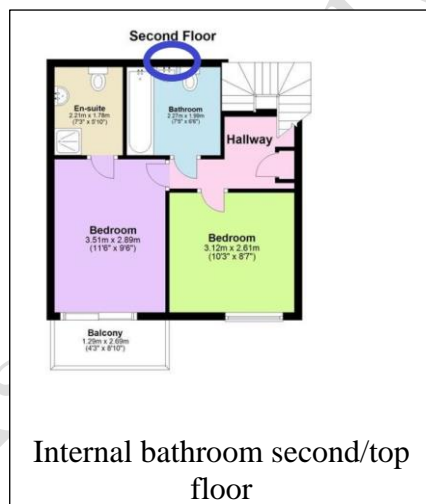
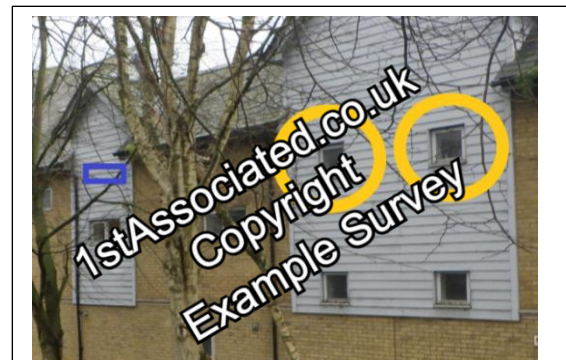
When we spoke we understand that you propose to add a window to the bathroom. We believe this is possible as shown in the photograph below.

Blue – Add window to bathroom

Yellow - Nearby windows

ACTION REQUIRED: If this alteration is considered an essential part of your proposal to purchase the property then we would recommend that your legal advisor checks if there are any restrictions or requirements with regard to fire and planning restrictions, which were either imposed when the development got planning or have been subsequently added, that stops you from having a high level window. We note that the neighbouring property has a high level window.

Your legal advisor should obtain written confirmation that the window can be added and also that your solicitor or a planning consultant speak to the planners and get it approved in writing. We would add that we would recommend it is in writing as we have had personal experience of things being verbally agreed and subsequently being a problem.

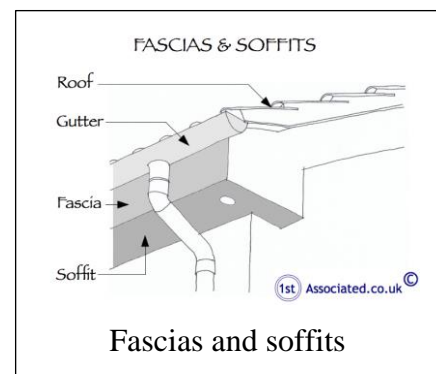
The exterior of the property has timber fascia boards and soffits. These are in below average condition and some deterioration is visible to the fascia boards and we believe this is also likely to the soffit boards as some of them have an unusual corbel style detail. You should also check the vents are clear when looking at the soffits.

We assume that the rear windows are not getting much sunlight due to the surrounding trees; generally where there are trees there is not that much air movement which tends to also cause accelerated rotting to the timber windows. In this case there looks to have been a fair amount of mastic added around the kitchen window which is very difficult to view and possibly to other windows and doors such as to the balcony doors.

ACTION REQUIRED: If painting is your responsibility we would recommend this is carried out the sooner the better ideally in the warmer months/summer of XXX. If you are not in charge of it and you have to pay into a service charge of some sort such as a sinking fund you need to check and confirm the sinking fund is up to date and payments are in order to carry out the work. We have enclosed in the Appendices a ten year plan that we would typically expect to see where it is a lease; we appreciate this is not a lease but it may be applicable to the shared areas.

ANTICIPATED COST: Budget for both repair and redecoration of the rear windows. The rear fascia board looks to be a grained plastic (or other manmade material) which generally will not perish however it does need periodic cleaning from our experience typically every three to five years depending upon location to traffic, trees, etc. We have also seen this get a mould covering as well. Please obtain quotations before legally committing to purchase the property.

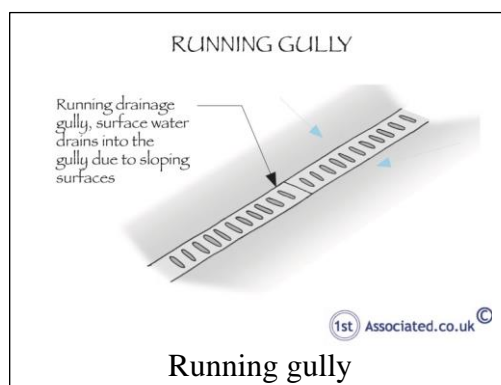
Running gully

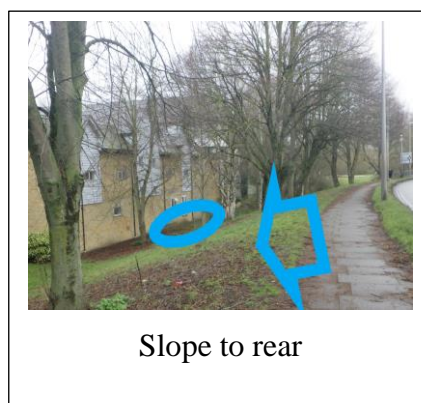
To the rear of the property there is potential for dampness as there is a considerable slope towards the building. We noted what looks like dampness on nearby properties which we wanted to make you aware of.

ACTION REQUIRED: Typically in older properties the solution to this would have been a French drain running along the rear of the property.

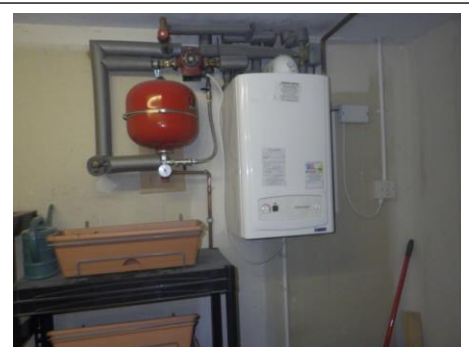
Boiler

The boiler is located in the garage, which looks dated and probably original, the owner advised in the vendor questionnaire that they think it was installed when the property was built. The vendor also advised they have had landlord's checks on it which is not a service.

ACTION REQUIRED: Your Legal Advisor to check and confirm that the boiler has been regularly serviced (not just a landlords check although the vendor advised in our questionnaire it was last serviced in XXX) and start to budget for a replacement boiler in the next few years.

We would also recommend you power flush the existing system and upgrade any older style radiators.

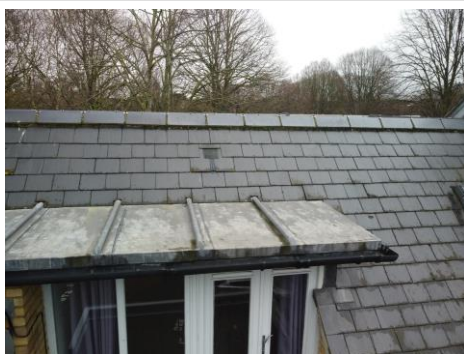
This is a high-level flat roof covered with lead. We believe this roof has a weak area/poor original detailing where the lead roof meets the pitched roof.

Roof over balcony

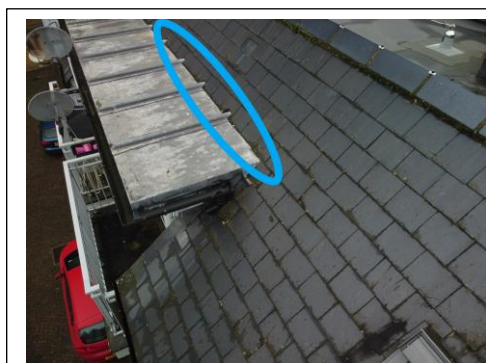
Weak area

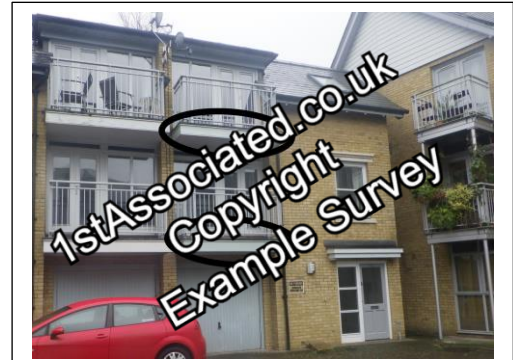
The flat balcony roofs are located to the front and are covered with asphalt.

Balcony roofs

ACTION REQUIRED: Please see our comments in the Executive Summary.

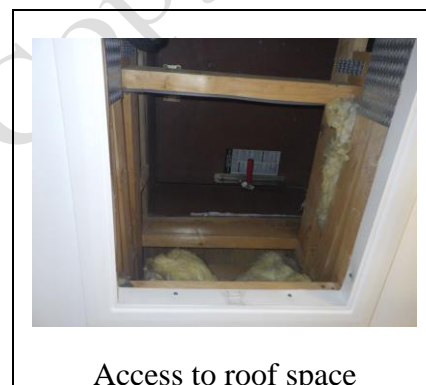
A very small proportion (five to ten percent at most) of the main roof is accessed via the loft hatch in the landing as rooms have been formed in the roof. There is no loft ladder, electric light and it is a very small opening. We recommend that these are added, as it will make the loft space safer and easier to use. The whole of the loft has been viewed by torch light.

Access to roof space

ACTION REQUIRED: Once you have moved in we would recommend that the area is lit and it would then enable you to see if there are any leaks, etc underneath it.

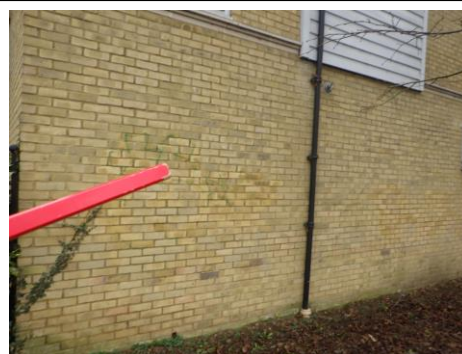
The downpipes feed directly into the ground so if there is a blockage then the drain would have to be opened up. This practice we are not particularly keen on; we would much prefer to see a gully.

Downpipe feeding into ground

ACTION REQUIRED: We would recommend you stand outside the property next time it rains heavily and see how well the drains cope with the rainwater particularly looking at the guttering and the joints. We would recommend gullies are added.

We also recommend that the gutters and downpipes are cleaned out, the joints are checked and the alignment checked to ensure that the gutters fall towards the downpipes.

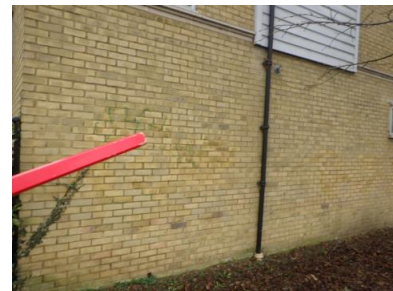
The property is finished in a Stretcher bond brickwork in a cement based mortar.

Brickwork to rear with graffiti

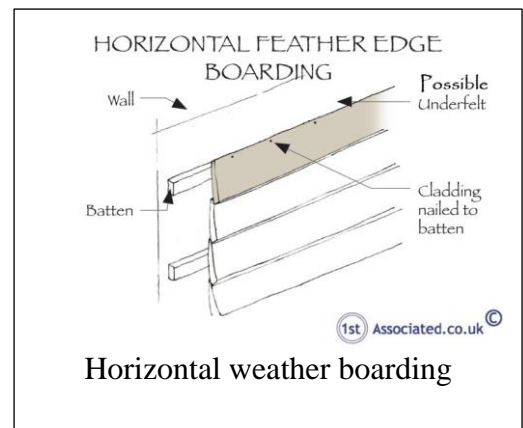
The property has painted feather edge boarding which we believe is in average condition for its age, type and style although as it is in an area where there are a lot of trees and limited sunlight and air movement could lead to moss and deterioration.

ACTION REQUIRED: Please see our comments in the Executive Summary.

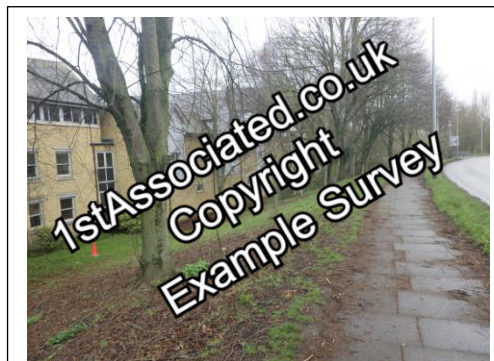
There are trees within what we would term as influencing distance but you do need to speak to your insurance company as they may have a different interpretation for insurance reasons.

Trees nearby

ACTION REQUIRED: Your legal advisor to check and confirm who is responsible for the trees, who maintains them and if there is a sinking fund or any sort of fund to pay for their maintenance.

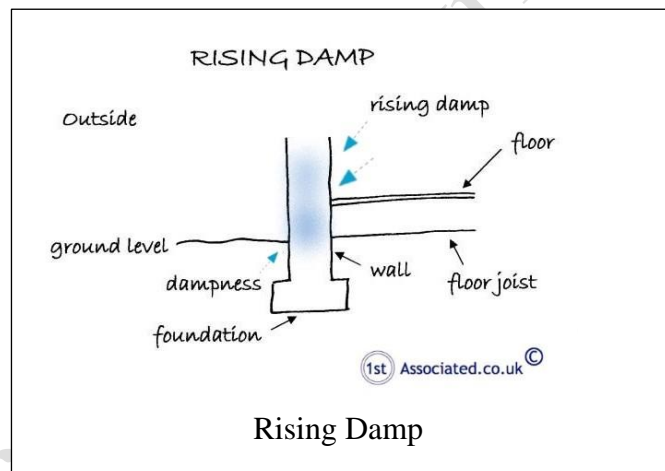
A random visual inspection and tests with a moisture meter have been taken to the perimeter walls. In this particular case, we were unable to obtain readings due to the dry lining. There is a slope to the rear which we believe will be problematic and will let dampness in; please see our comments in the Executive Summary.

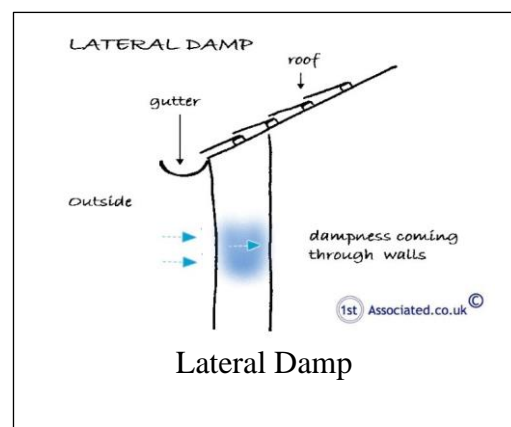
We used a resistance meter on the external walls. In this case, we were unable to obtain readings due to the dry lining.

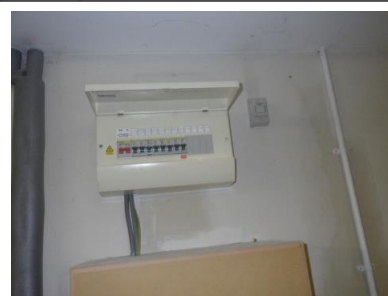
The fuse board is located in the garage and we believe is original and better are now available. We were slightly surprised there was not a metal case to the fuse board.

Fuse board in garage

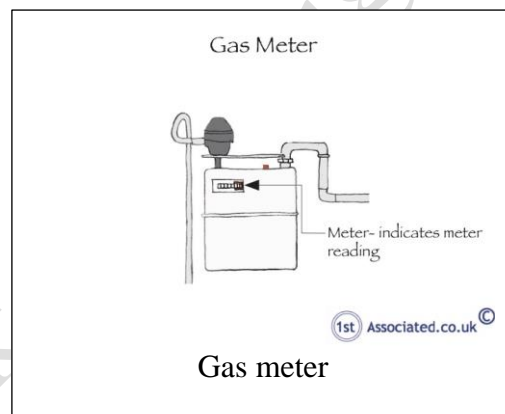
We are advised by the owner in the Vendor Questionnaire that the property has mains gas. The consumer unit is located in the garage.

ACTION REQUIRED: As a matter of course, it is recommended that the entire gas installation is inspected and made good, as necessary, by a Gas Safe registered contractor. Thereafter the installation should be serviced annually.

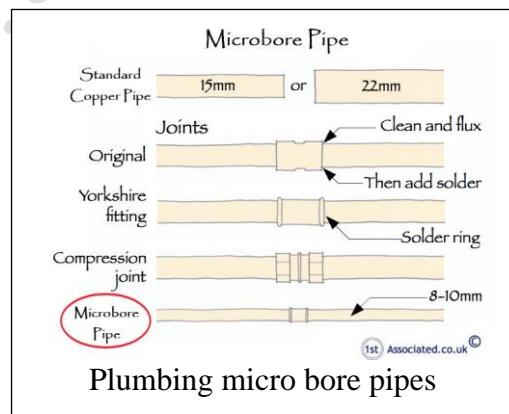
The plumbing, where visible, comprises of micro-bore pipes. From our experience these tend to get blocked more easily than a traditional heating system that uses a 12/13mm pipe. However, micro-bore pipes are cheaper than a traditional system and easier to put in from a plumbers' point of view, which is why they are so popular with plumbers!
