# RESIDENTIAL BUILDING SURVEY

Mid 1800s Detached Property

**GEM Associates Limited**

INDEPENDENT CHARTERED SURVEYORS

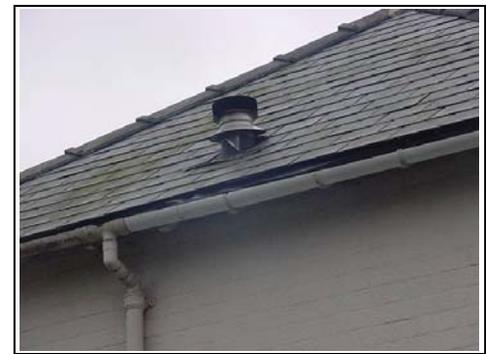
## Main Roof

The roof is pitched and clad in slate with a ridge tile. From what we could see the tiles are lying level and true and look in reasonable condition.

Deterioration tends to occur at the ridge and exposed areas such as the perimeter and so you should periodically check these areas.

Apologies for using the same photo twice, but this one equally shows the condition of the roof

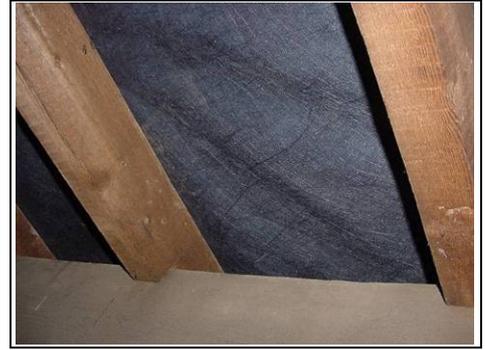
When we inspected the loft space we found a modern breathable underlayer. This type of sarking felt, as far as we are aware, has been used since 2002. It allows air flow in the loft to help prevent condensation.

This photo shows the common rafters (the ones that form the pitch of the roof) and the dark area between is the underlayer.

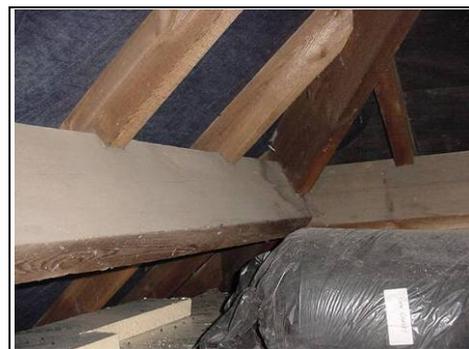
Our examination is limited by the general configuration of the roof, the insulation and stored items. As mentioned what we could see was generally found to be in an average condition considering its age. We did see some timber staining; whether this is condensation or wind driven rain getting in through the roof is difficult to tell. It is, feasible that there are problems in the roof that are hidden.

**ACTION REQUIRED:** The only way to be 100 per cent certain is to have the roof cleared and checked.

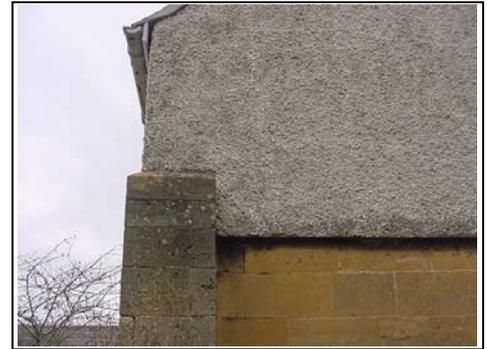
Thin joint coursed stonework to the rear of the property

Taking into consideration the age, type and style of this property we would say that the stonework and pointing overall is in average condition.

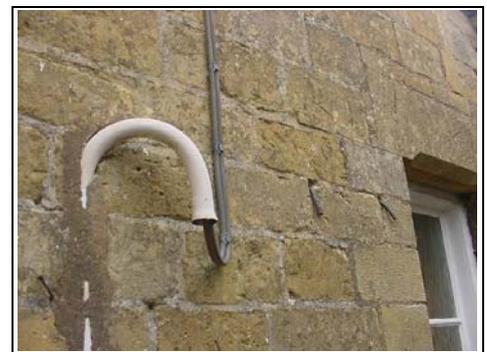
Thick joint coursed stonework to the side of the property

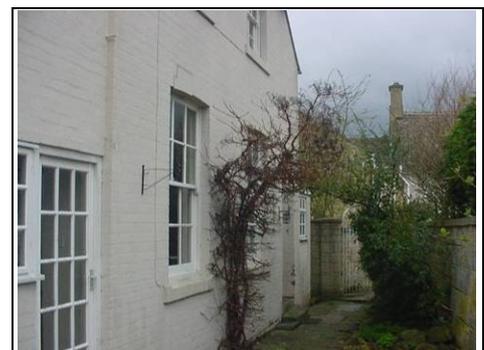
## Spalling of Brickwork and Lime Every Time

Unfortunately the brick is quite a soft red brick and is therefore starting to spall. It looks to have been repaired in the past using a cement mortar which unfortunately is making it worse and continuing the allowance of dampness into the property.

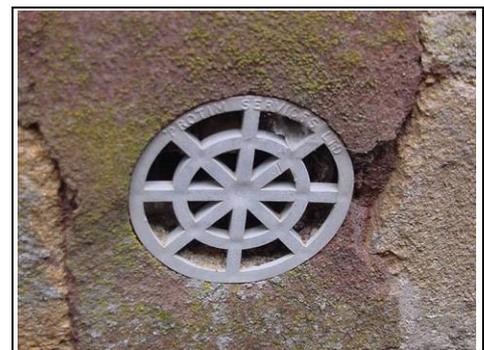
Close up of vent. The idea is that this increases ventilation to the property and therefore dry it out.

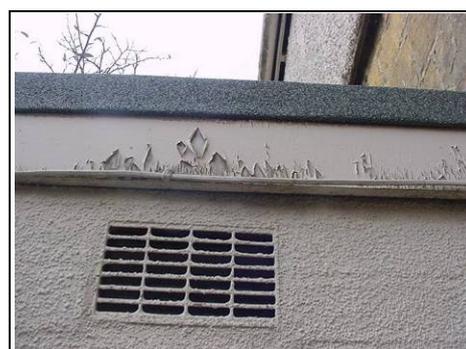
Fascia to flat roof area

There is also a fascia to the flat roof extension which is in need of redecoration.

**ACTION REQUIRED:** Repair and redecorate.

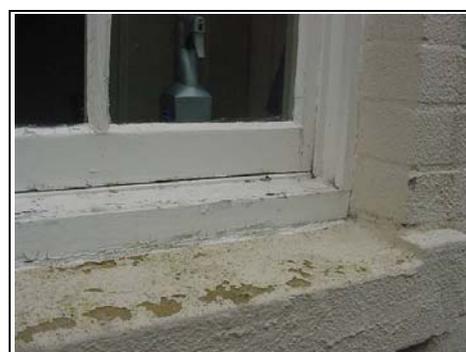
Sliding sash window

The property has some large sliding sash windows which are single glazed and have a painted timber finish and are in average condition considering their age, type and style.

We would specifically comment about the movement to the brickwork above the window and would refer you to our earlier comments.

**ACTION REQUIRED:** As is common the sliding sash windows will need some easing and adjusting by a carpenter who is used to dealing with this type of work.

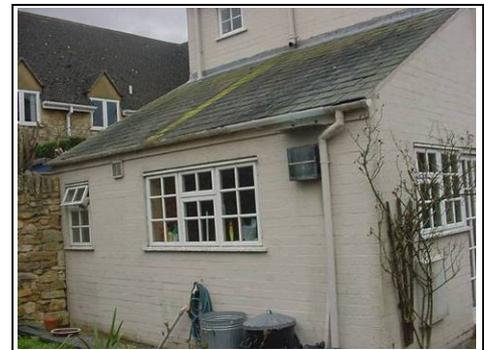
Timber casement windows

The property also has some timber casement windows, which are fairly modern; these are in average condition.

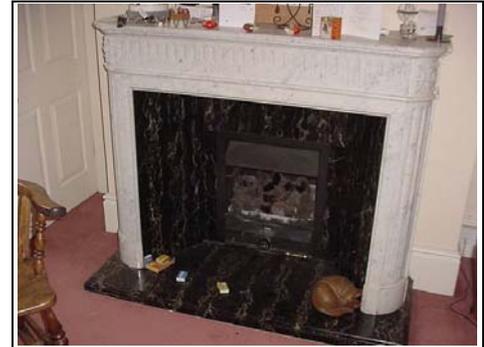
Please see our earlier comments about the height of the flue above the roof level. It can be a very real problem that there isn't a draw on the chimney which means there can be a back-fill of smoke into the room.

Finally, it is strongly recommended that flues be cleaned and checked for obstruction prior to use to minimise the risk of hazardous fumes entering the building.

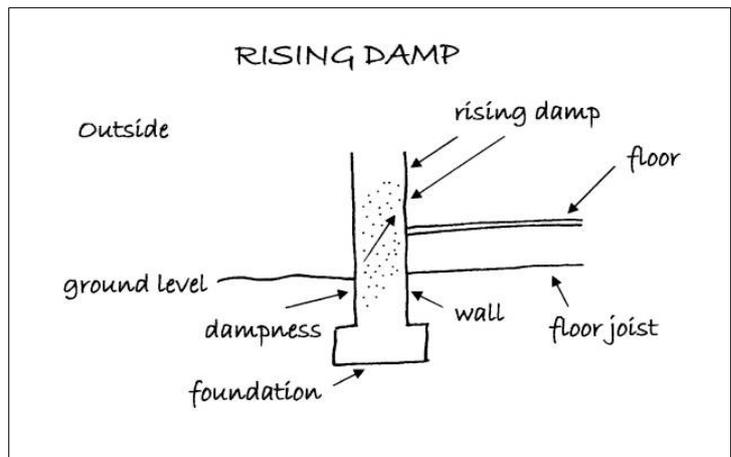
We carried out tests with a damp meter to a random selection of areas and we found damp.

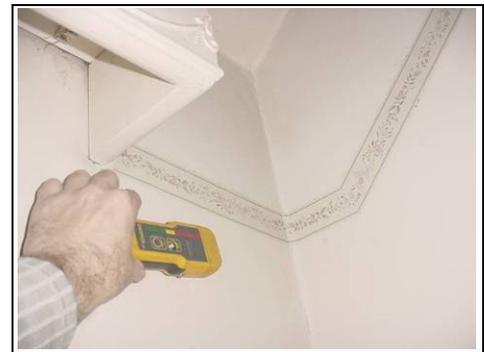
Checking for lateral and penetrating dampness

Tests were taken with a moisture meter at random points to internal walls. Our readings were in line with what we would expect for this age of property, i.e. minor damp.

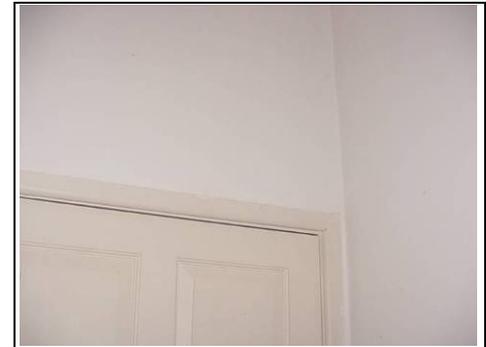
We checked the doors to ensure that there hadn't been movement in the property and they all closed reasonably well and reasonably squarely.

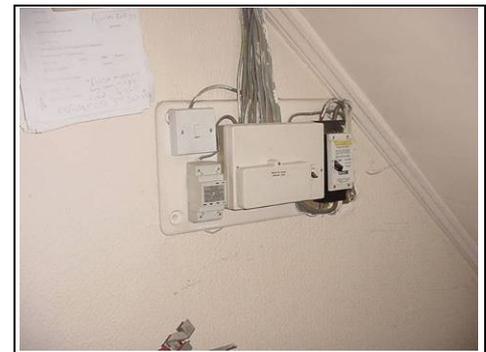
The electric fuses and consumer units were located in the alcove under the stairs. We would date the fuse board as being from the 1960s.

**ACTION REQUIRED:** Obtain a quotation to upgrade and replace the fuse board as soon as possible.

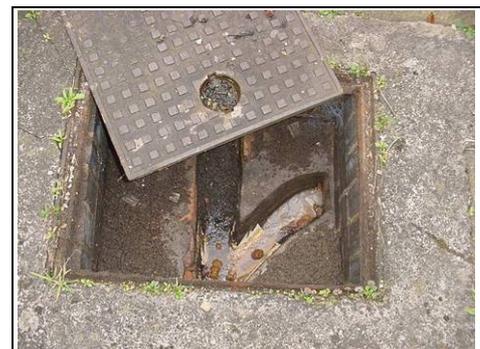
#### Inspection Chamber / Manhole One – Near Kitchen

We found this manhole to be shallow and not discharging very well; these are typically added at a later date and are certainly not considered good practice. Unfortunately there is very little you can do to improve them without major costs.

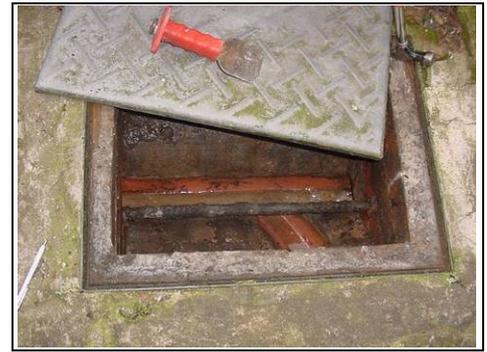
### **Inspection Chamber / Manhole Two – Nearest to the Gate**

We duly lifted the cover and found it to be shallow but clear at the time of our inspection.

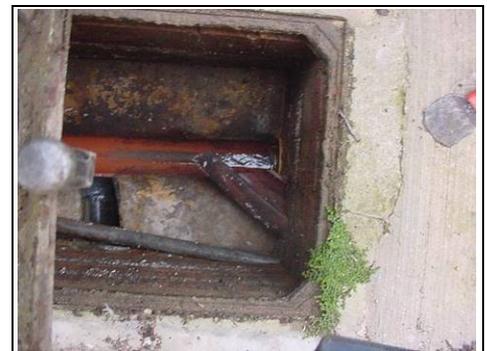
### **Inspection Chamber / Manhole Three - Passageway**

We duly lifted the cover and were pleased to find it to be deeper than the previous manholes.

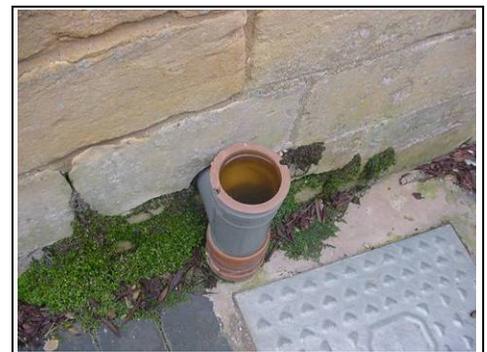
### **Full Soil and Vent Pipe in passageway**

Whilst this relates to one of your neighbour's property the water-filled soil pipe did seem unusual, particularly as it was literally in the passage way.
