RESIDENTIAL BUILDING SURVEY

Three Storey Georgian Property in Devon

Mrs Georgian

GEM Associates Limited

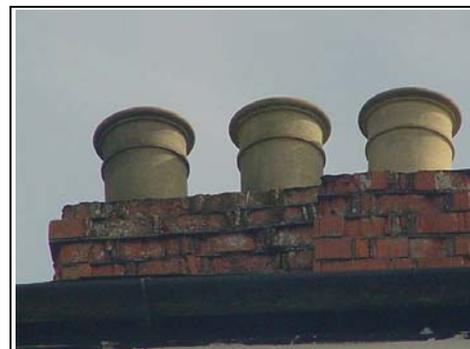
The central brick chimney has seen better days and we feel it requires some work in the next few years.

ACTION REQUIRED: Repoint within the next three years or when dampness starts to get into the property. At the time of our inspection this was minimal.

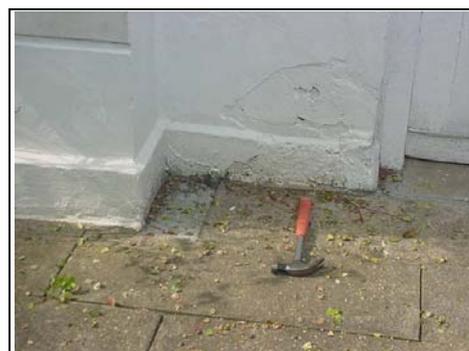
We could see that areas of the external render have been painted to cover up dampness problems and dampness issues; we would term this as 'painted to sell'.

ACTION REQUIRED: Please see our comments with regard to the bell-mouth detail at low level.

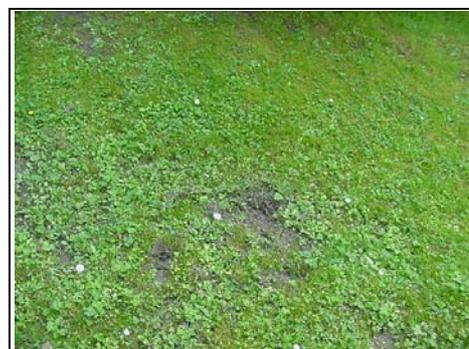
As we discussed, the rainwater is trying to get from the top of the property to the bottom and in doing so this is causing dampness to get into the property. This is ranging everything from the damp area underneath the trees, which is probably added to by the lack of sunlight, to dampness coming against the front of the building.

Dampness in the garden

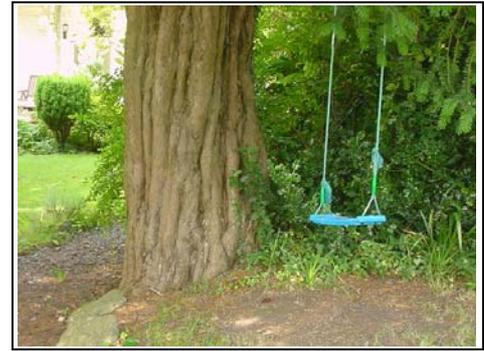
We would recommend that you instruct an arboriculturist to examine the trees (or get to know a good gardener who knows about trees) and sort out the delicate balance between the trees working with you to drain the water from the ground and working against you where the roots affect the building. If you recall there are roots within the drains.

ACTION REQUIRED: A Close Circuit TV Camera Report to be carried out on the drains.

Call an arboriculturist (not a tree surgeon, as they just cut down trees) or wise old man to advise you on the trees and kill the roots within the drains.

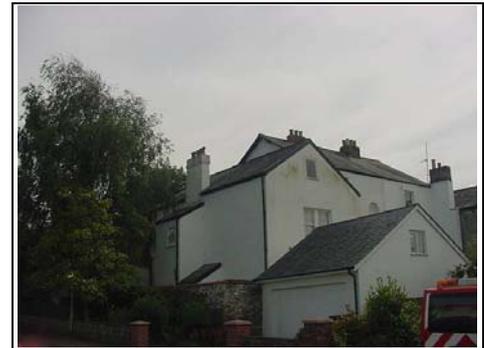
The left hand side roof is pitched and clad with quarried tiles. The slates sit fairly true and are generally in average condition considering the property's age, type and style.

ACTION REQUIRED: As with most roofs of this age this roof will need some general day-to-day maintenance. We could see some slipped and missing slates and we could also see that some parts of the ridge need re-bedding. This is all part of the general maintenance that is required on this age of property.

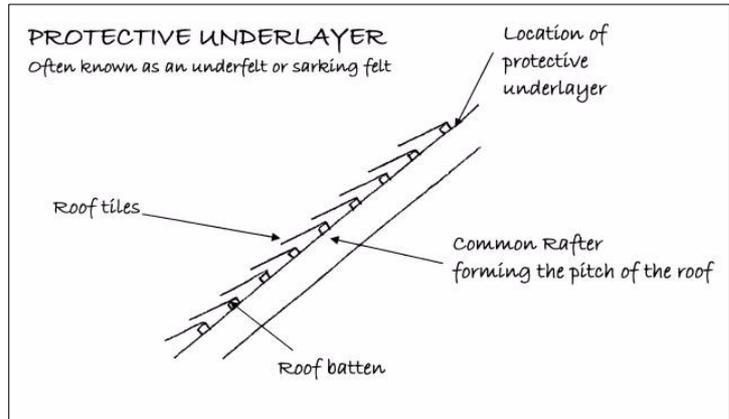
When we inspected the loft space we found a Hessian base Bitumen membrane. This type of membrane has been used since the 1960s. We generally found it to be in average condition, although it is damaged in a few places but this is not unusual considering its age.

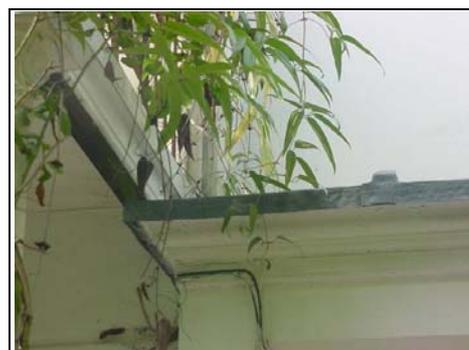
To the front of the property there is a balcony with a small flat roofed area which is clad in lead. The lead looked relatively 'new', we would estimate within the last five years; this may have been done at the same time as the roof lead to the right hand side roof.

ACTION REQUIRED: Time will tell with regard to this lead roof. It is a relatively small area in the scheme of things; you should in particular watch the flashing, which is where it beds into the render work.

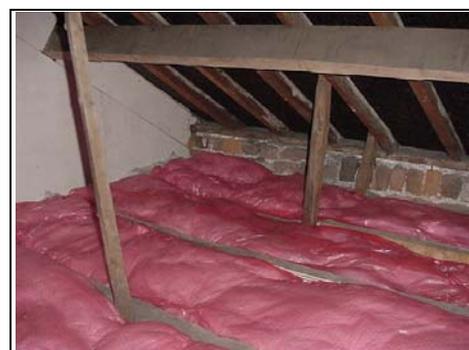
The left hand roof is accessed via the loft hatch located in the rear bedroom. There is no loft ladder or floorboards, but it does have an electric light. We recommend that a loft ladder and secured floorboards are added as this will make the loft space safer and easier to use. The roof perimeter has been viewed by torchlight which has limited our viewing slightly.

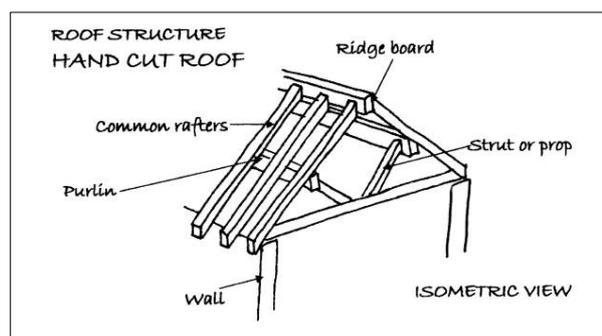
We would also add that quite unusually there are props in the roof at the side. If you look at the adjoining photo you can see props to the right hand side wall. This type of addition would have been added due to dipping in the main roof as a 'belt and braces' measure. We think the main issue here is the thinner common rafters which will be very difficult to replace without completely re-roofing the property.

Our examination was limited by the general configuration of the roof, the pink bagged insulation and some stored items. As mentioned above we found the roof in what we would term as below average condition with dampness and woodworm. Sorry to repeat ourselves but the woodworm is an issue even when taking into consideration the roof structure's age; we could see flight holes and the timber was generally soft from the woodworm.

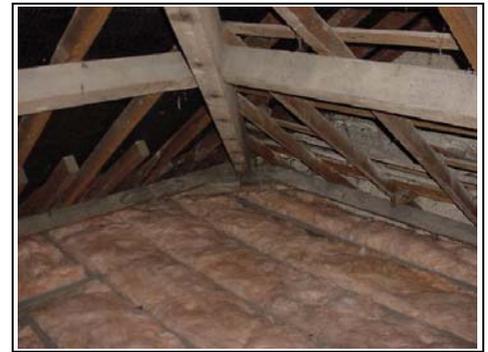
Looking towards the hip

The roof structure is a cut timber roof as the left hand main roof is, please see the previous sketch. However, this roof does have a hipped section which is what we are looking at in the sketch and photo below. As in the previous roof we found the common rafters to be thinner than we would expect.

Again, our examination was limited by the general configuration of the roof and the insulation, this roof was remarkable free of stored items. Again, we would classify the roof as being in below average condition; we found dampness and woodworm. Please see our comments in the Executive Summary.

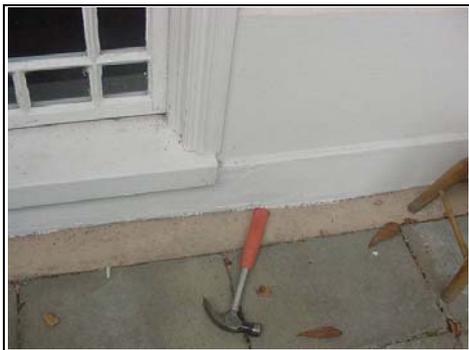
The render to the base of the wall in this instance goes down to the ground. Unfortunately this will help dampness get into the structure.

ACTION REQUIRED: Please see our comments in the Executive Summary – a bell-mouth needs to be added.

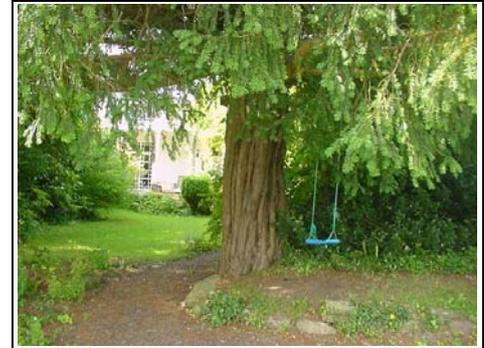
Damage to foundations and underground services can be caused by trees and shrubs. There are a number of these in the vicinity of the building, what we term within influencing distance; we could see roots in the drains and we believe that these trees may / will affect the property if not maintained regularly.

ACTION REQUIRED: You need to obtain advice from an arboriculturist (not a tree surgeon) or a good local gardener who understands the garden as a whole and how it drains etc. As discussed there is a lot of water transferring from the front of this garden to the rear of the garden. Please see our comments within the Executive Summary.

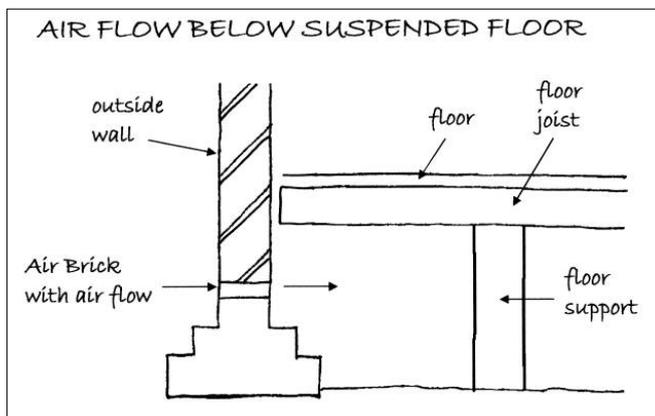
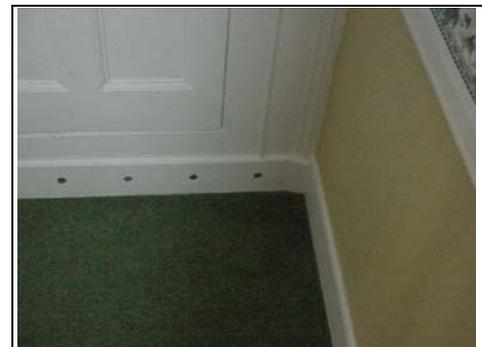
We expected to find airbricks around the property due to the suspended timber floor to the front of the property. We would recommend adding airbricks (subject to what the Conservation Officer says). We did note to the rear of the suspended timber floor, which is the front part of the property, that there were air vents, which you can see in the photo below. These need to be supplemented with air vents to the front of the property so that there is a through flow of air.

Air vents at the bottom of the cupboard at the base of the stairs.

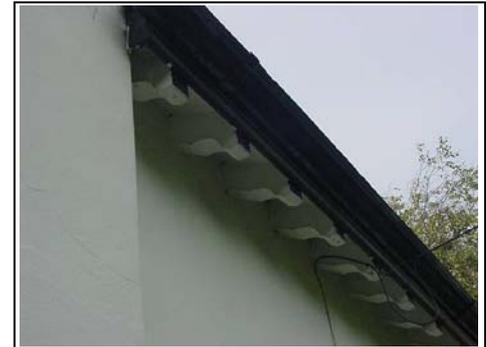
Rafter feet

The fascia and soffit detail includes exposed rafter feet. We generally find that due to the awkwardness of these they do not get painted / stained as often as they should and you may find rot if they are closely examined.

ACTION REQUIRED: Paint/ Stain in the next three years.

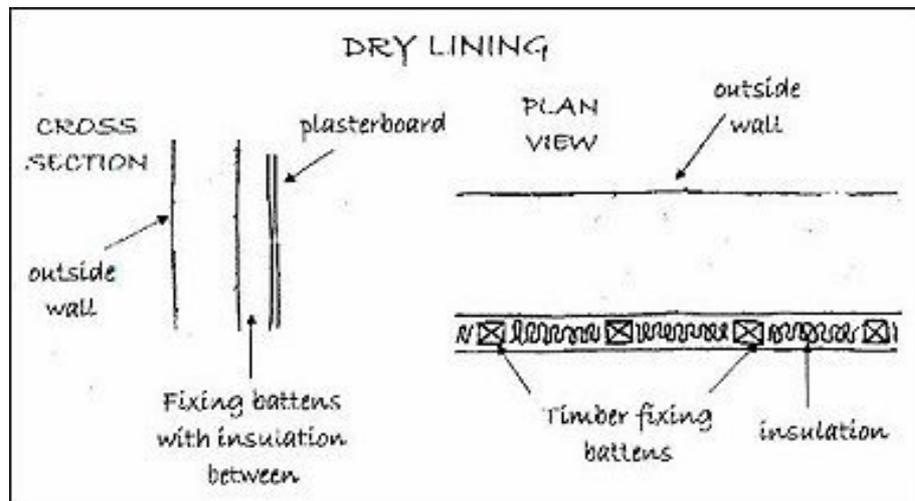
False walling, commonly known as dry lining, has been used predominantly to the front and sides of the property. This is often used in older properties to hide / prevent dampness coming through. From our personal experience we have found that dampness can often be hidden behind these walls causing deterioration.

ACTION REQUIRED: Ideally the dry lining should be opened up and checked for defects.

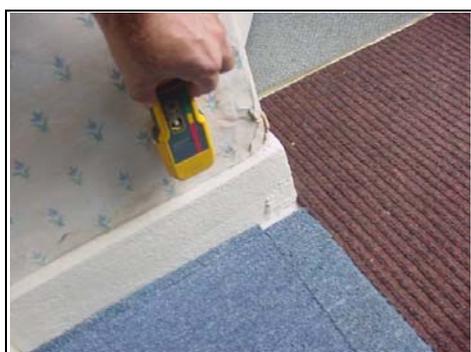
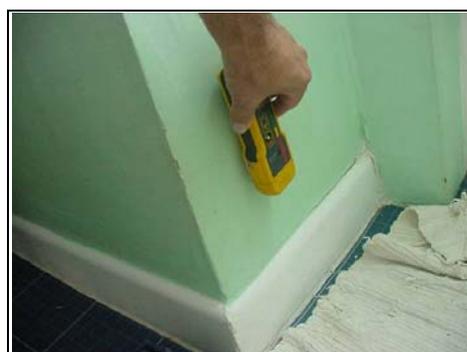
We have carried out tests with an electronic damp meter to a random selection of areas and we found rising damp throughout the property.

Checking for dampness with our electronic damp meter

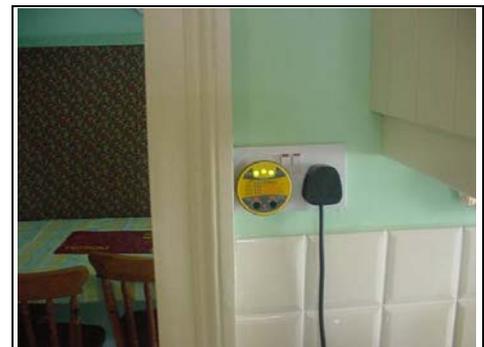
We carried out an earth test in the kitchen area to the socket point that is normally used for the kettle and this proved satisfactory.

ACTION REQUIRED: As the property is changing occupancy an IEE report should be carried out by a NICEIC registered and approved electrical contractor.

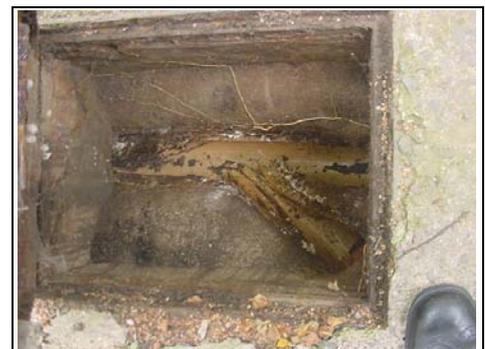
We lifted this manhole cover and found tree roots in the manhole, the source of these needs to be identified and advice taken.

ACTION REQUIRED: A Close Circuit Television Camera Report to be carried out on the drains.

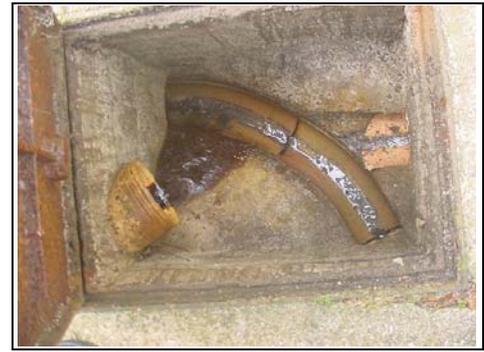
Inspection Chamber / Manhole Two Located to the Rear Right Hand Side

We duly lifted the man hole/ inspection chamber cover and found the drain to be clear, we noted it was finished in brick

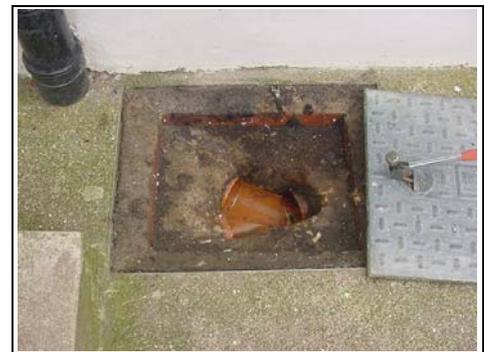
Inspection Chamber / Manhole Three to the Rear

We found this manhole to be shallow; these are typically added at a later date and are certainly not considered good practice. Unfortunately there is usually very little you can do to improve them.

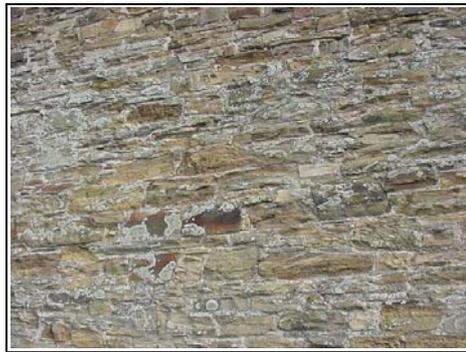
Well restored wall at top of the road
