RESIDENTIAL BUILDING SURVEY

Semi Detached Victorian Property in London

GEM Associates Limited

INDEPENDENT CHARTERED SURVEYORS

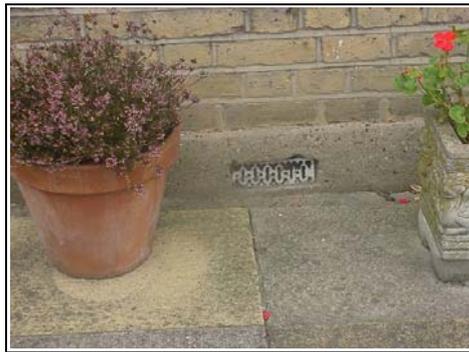
Airbrick to the front of the property

To the rear, if there are any airbricks (which we cannot see) they have been blocked by the decking.

The importance of having airbricks is to enable an air flow underneath the ground floor and limit rot.

We noted airbricks at the front of the property, but there should also be airbricks to the rear of this property to get an air flow. There may be some to the rear covered by the decking.

ACTION REQUIRED: Please see our comments in the Executive Summary.

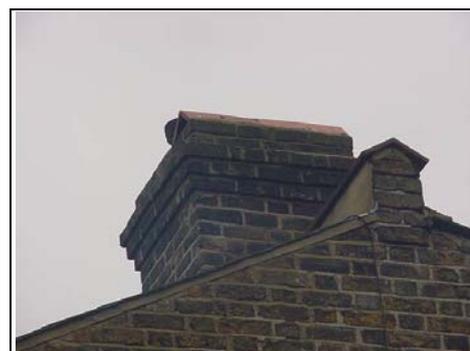
Chimney Two – Located to the Rear Roof

Our view of this chimney was very limited; we could see it was brick built and we know from our further investigations that it has been removed at first floor and ground floor level and is supported. Often we find with alterations to a chimney that there is some dampness coming in around them, which normally raises its head during the winter months.

ACTION REQUIRED: As discussed an option would be to remove the chimney completely although you do need to get Party Wall agreement (more about this at the end of this section).

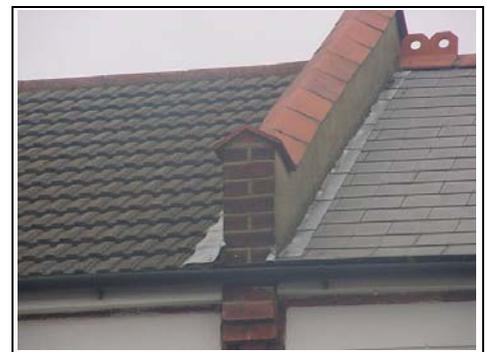
Left Hand Parapet Wall

The parapet walls to this property have been finished in a render with a metal (assumed lead) flashing. To the front we had a good view but to the rear the view was limited.

We could see approximately 50 percent of the parapet walls, which looked in average condition. We have made our best assumptions based upon what we could see. A closer inspection may reveal more.

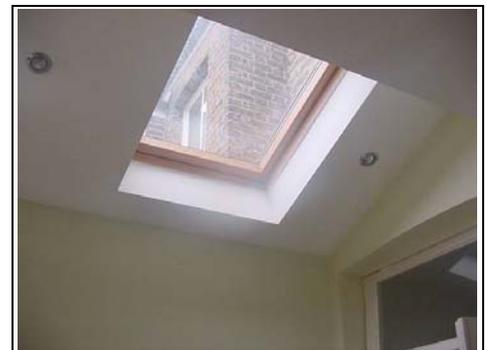
Roof Windows

This is a manufactured purpose made roof window. From our visual inspection outside it looked to have been put in correctly, however we would add that seems inevitable with roof windows that they will sooner or later leak. If this doesn't occur then they seem prone to condensation, particularly in a kitchen environment. Keep a cloth handy!

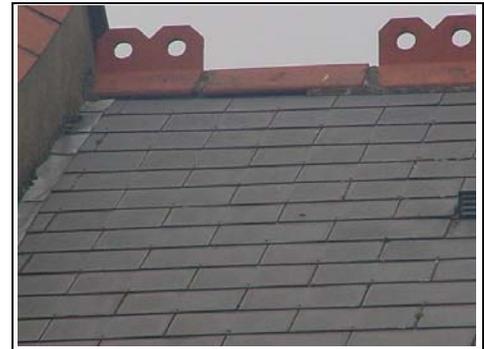
Main Roof

The roof is pitched and clad with manmade quarried slate to the front. The slates sit fairly true and are generally in average condition considering the property's age, type and style.

Manmade slates are thin and light and the wind can catch them, so it's important that the slates are fixed at the perimeter and do sit flat and check from time to time both here and at the perimeter.

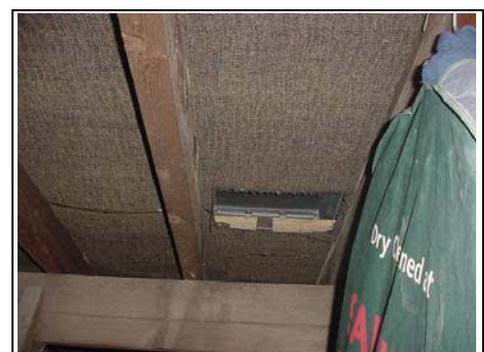
When we inspected the loft space we found a Hessian base Bitumen membrane. This type of membrane has been used since the 1960s. We generally found it to be in average condition, its damaged in a few more places than we normally find.

This photo shows the common rafters (the ones that form the pitch of the roof) and the area between is the underlayer. Note the air vent.

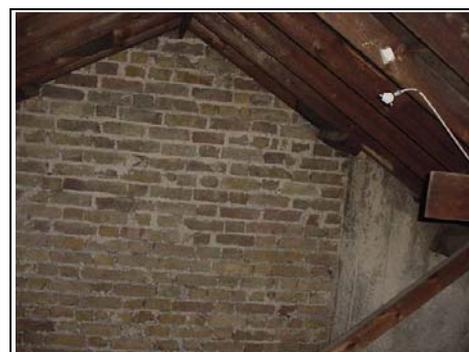
Roof Access

The main roof is accessed via the loft hatch located in the landing. There is a loft ladder, electric light and unfixed floor boarding (so take care). The loft perimeter has been viewed by torchlight, which has limited our viewing slightly. We recommend that the floor boarding is fixed to make the roof safer to use.

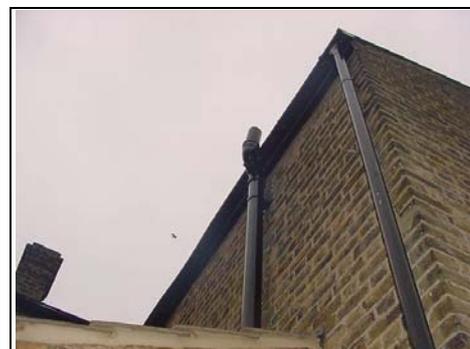
Soil and Vent Pipe

The soil and vent pipes are plastic and looked relatively new. The one to the w.c. we assume is an air inlet valve (although we could not see it) often known by the trade name 'Dergo' valve.

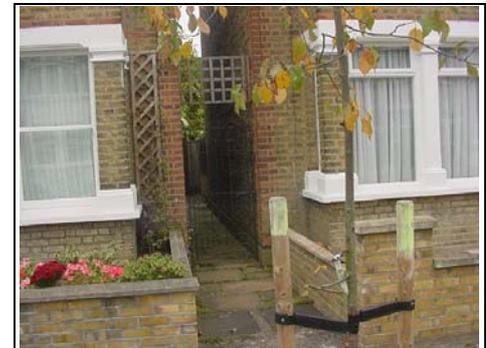
Tree opposite

We would also add that there is a sapling tree to the end of the property which looks to have been newly replaced. There could have been problems relating to this.

The property has a small tree nearby, probably owned by the local authority. It should be remembered that trees need maintenance.

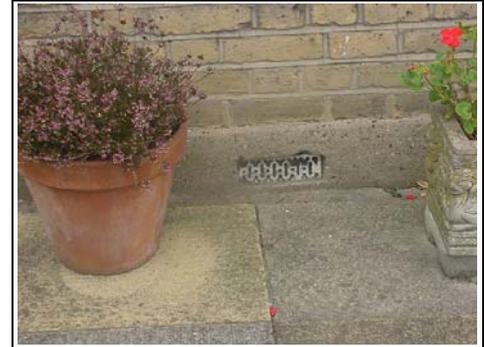
In this case, unfortunately, we could not see a damp proof course because of the render plinth. In this particular property it's probable that there is a slate damp proof course behind the render. With the newer extension there is likely to have been a plastic damp proof course built-in as work proceeded.

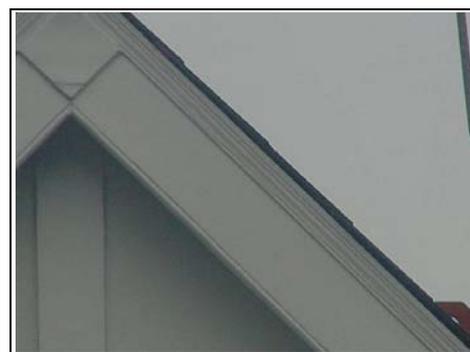
Bargeboard

The property has painted timber fascias, soffits and bargeboards; these are in average condition, although much of the fascia is hidden by the guttering.

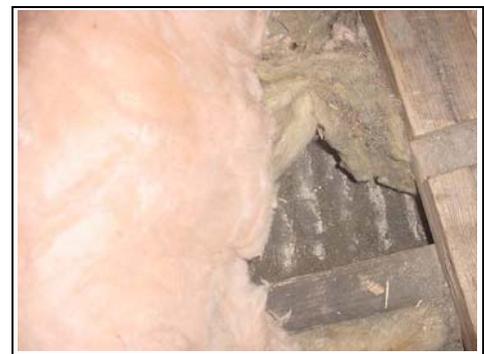
Lath and plaster visible in the roof space

As should be expected with a building of this age, the ceilings have been finished in a variety of ways, from the original lath and plaster to more modern plasterboard in the rear extension. We believe that some of the lath and plaster ceilings may have been tacked over with plasterboard; if you recall we showed you the smoothness of the ceiling in the middle bedroom.

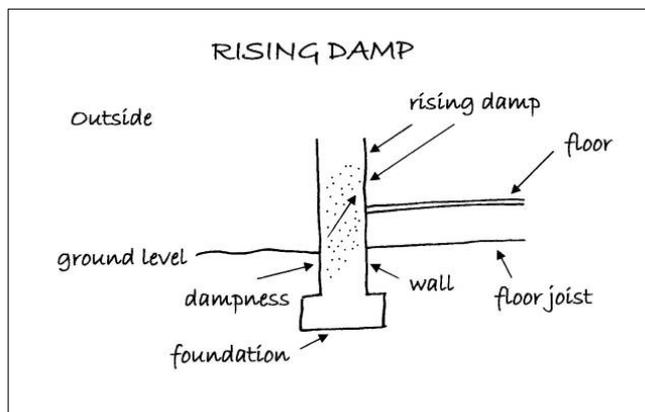
We have carried out tests with an electronic damp meter to a random selection of areas and we found rising damp.

ACTION REQUIRED: Please see our comments in the Executive Summary.

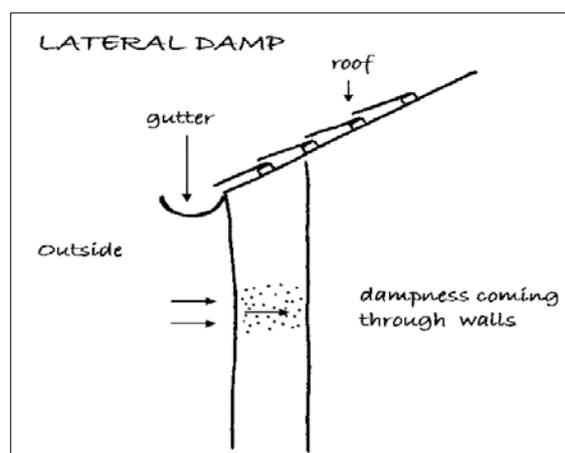
This is where water ingress occurs through the walls. This can be for various reasons such as poor pointing or wall materials or inadequate gutters and downpipes, such as poorly jointed gutters.

ACTION REQUIRED: Please see our comments in the Executive Summary and the Timber Defects Section.

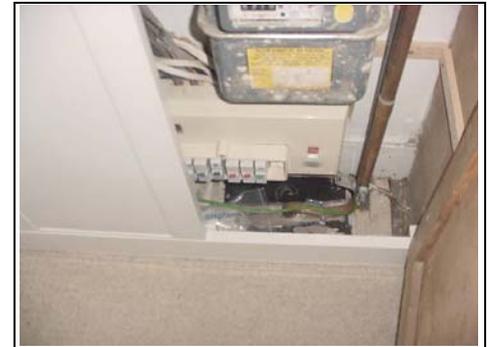
Fuse Board

The electric fuses and consumer units were located in the cupboard to the left hand side. We would date the fuse board as being from the 1980s and, whilst not the best now available, it is reasonable.

ACTION REQUIRED: As the property is changing occupancy an IEE report should be carried out by a NICEIC registered and approved electrical contractor.

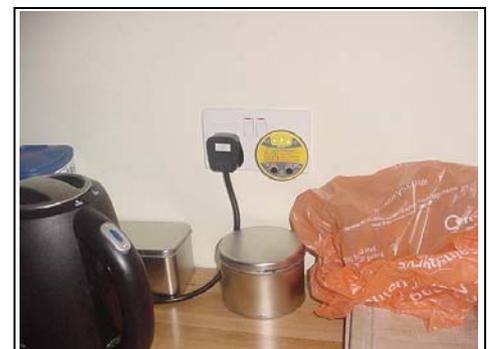
Earth Test

We carried out an earth test in the kitchen area to the socket point that is normally used for the kettle and this proved satisfactory.

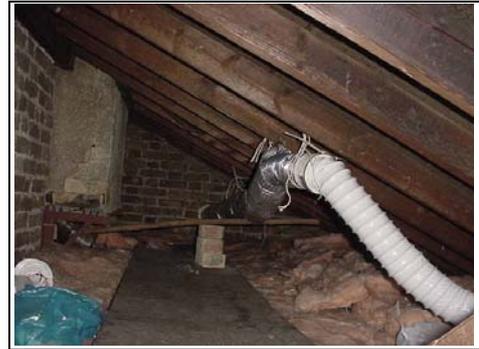
Please see our comments in the Dampness Section of this report regarding condensation being possible in this area. That said, we did note an extract duct which looks to be connected from what we could see in the roof space, although this may not be sufficient.

Extract connected up in the roof space

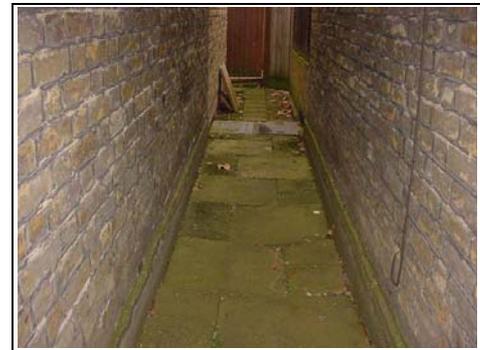
We noted uneven ground over the drainage run.

ACTION REQUIRED: Close circuit TV camera report to check the condition of the drainage run. Please see our comments in the Executive Summary.

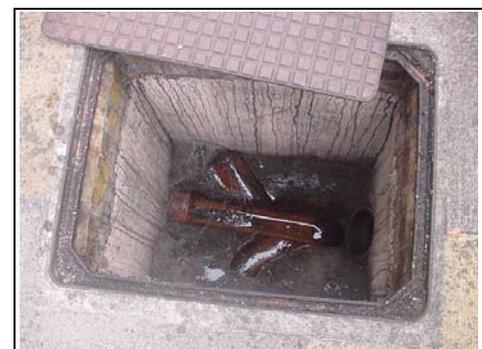
We duly lifted the cover and found it to be free flowing at the time of our inspection.

From what we could see it is concrete built.

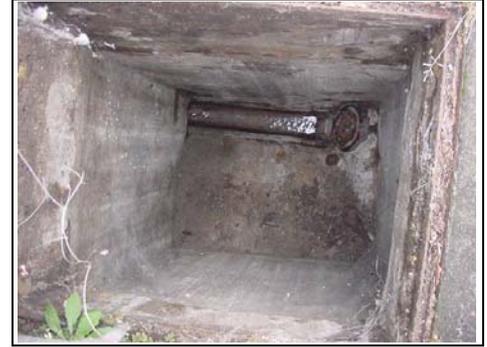
Inspection Chamber / Manhole Two - Pathway

Again, we duly lifted the cover and found it to be free flowing. From what we could see it is concrete built.

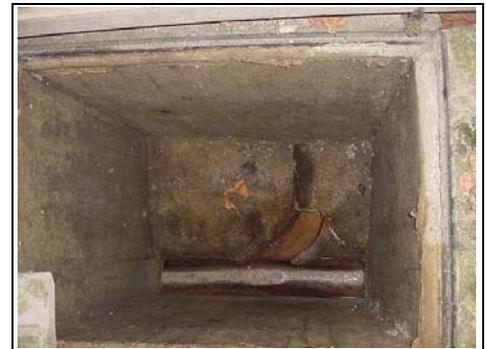
Inspection Chamber / Manhole Three – Rear Right Hand Side

We lifted this manhole too and also found it to be free flowing. Again, we found it to be concrete built.

The fact that all the manholes are concrete built does indicate that some work has been carried out to them, as originally they would have been brick built.
