SPECIFIC DEFECTS REPORT

Relating to Cracking to the Plasterwork

12 Claremont Grove, Woodford Green, Essex IG8 7HS

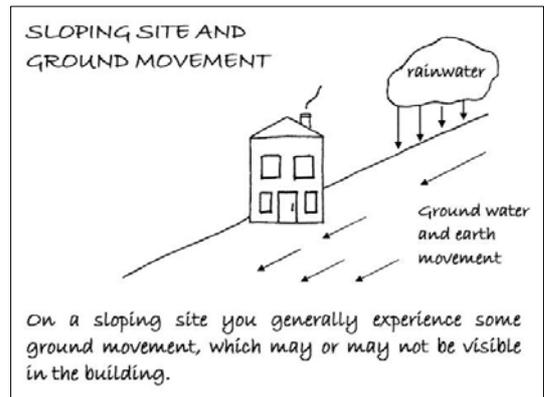
Your home sits on a sloping site. Therefore any rain water will run from the top of your garden to the bottom of your garden. You can however aid how the rainwater travels from the top to the bottom of your garden by adding a French gully (also sometimes knows as a land drain). Presently we can see moss to the rear area of the garden which does indicate that a fair amount of water is sitting in the area.

We would recommend that the next time it rains, you stand out in the rear garden and check exactly how much rain water comes down and passes your property.

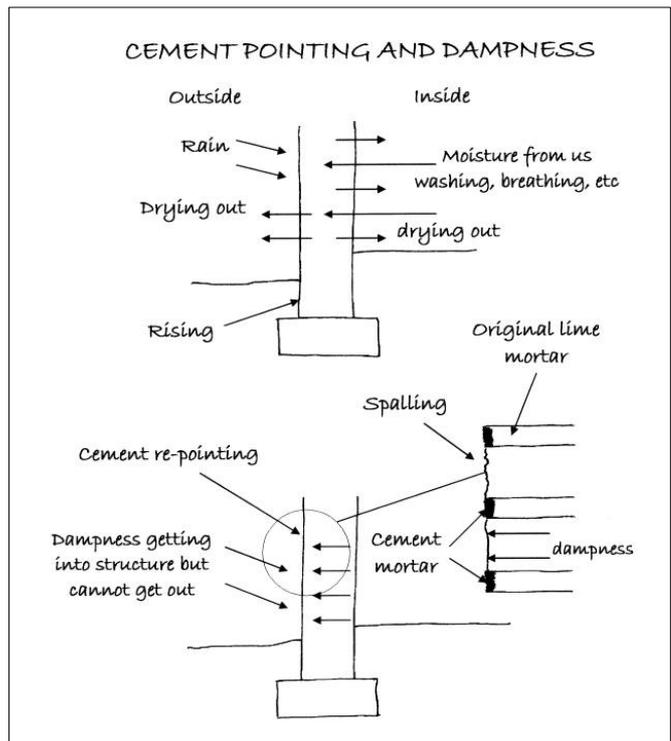
Unfortunately the front of the property has been repointed in a cement mortar. Originally this would have been in a lime mortar which is far softer. The new cement mortar has not only smothered the front of the property (meaning that any rain water which gets into the wall doesn't dissipate that well) but has in turn caused the spalling of the soft red brick.

ACTION REQUIRED: Ideally we would remove all of the cement mortar however this is a difficult job. We would recommend that the cement mortar is removed by hand with a hammer and bolster rather than with a skillsaw as this could cause damage to the relatively soft brick work, particularly on the perp ends (the perpendicular or vertical ends of the brick). The skillsaw simply isn't delicate enough to carry out this work. Unfortunately if left, the spalling of the brickwork will get worse. Some of the bricks are already quite badly spalled and therefore it is usually best considered to take any badly spalled bricks out and replace or use brick dust with a lime mortar mix to match the brick colour, but this is difficult to do and in our opinion doesn't look very good.
