# **SPECIFIC DEFECTS REPORT**

**Relating to Cracking to the Plasterwork Due to Dampness**

**Victorian Terraced Property in London**

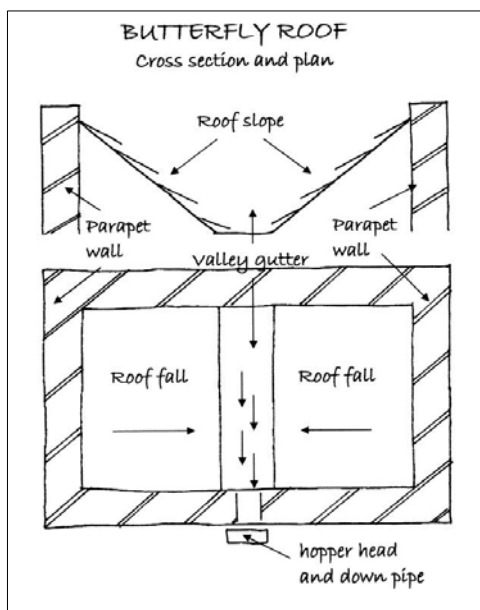
Butterfly Roof Sketch

- Chimneys: Brick chimneys.
- Main Roof: A butterfly roof (sometimes known as a London Roof) clad with a slate adding to the main property on a cut timber roof structure. The rear roof is single pitched and clad in slates with the single storey extension having a flat felt roof. Please see sketch below.
- Gutters and Downpipes: Plastic.
- Soil and Vent Pipe: Cast Iron
- Walls: A mix of a yellow London common brick with some detailing in softer red brick in a flemish bond construction which has been repointed in cement. Please see sketch below.
- External Joinery: There is a mixture of different types and styles of windows.
- Foundations: Not inspected but we would anticipate a step brick foundation in this age of property.

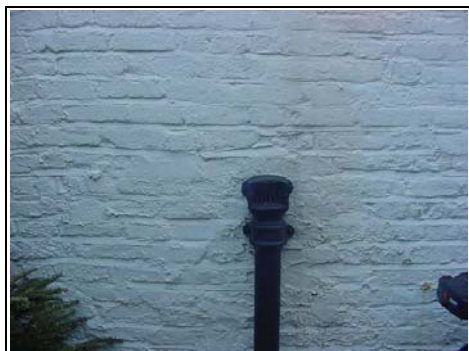
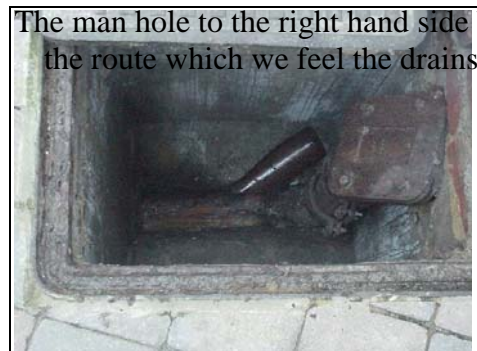
The man hole to the right hand side being along the route which we feel the drains will take

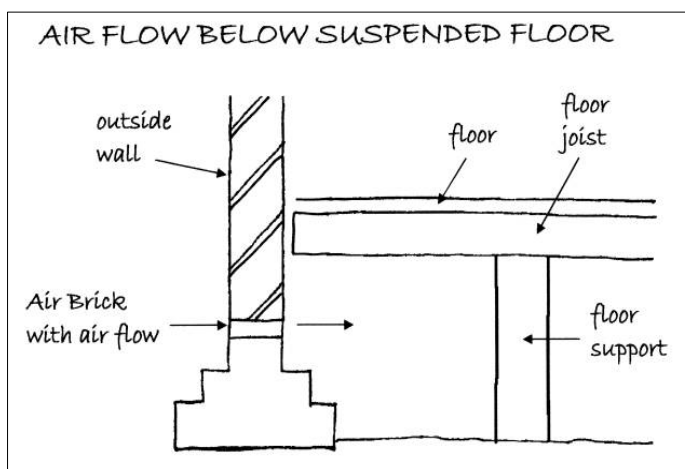
As an aside with a suspended timber floor to the front of the property and a concrete floor to the rear of the property, the concrete floor can affectively be acting as blotting paper, as there is no way that any moisture underneath the floor can escape in this section and this again could be adding to the cracking in the kitchen area.
