Stone Built Example Residential Building Survey

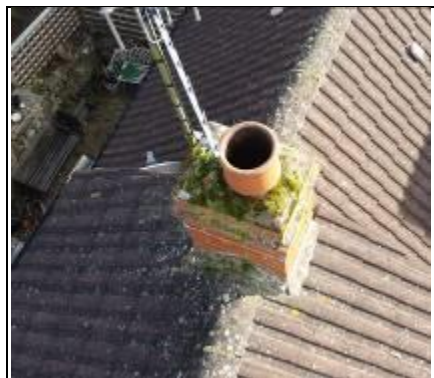
There looks to be moss to the top and general weathering. It has a cement flashing which we would recommend is replaced with a lead flashing. We think the chimney has been removed in part to the left side as we could not see it in the main bedroom which could be causing the cracking that we discuss later on. Equally, it could be concealed.

Left chimney cement flashing
~ Aerial View - 360 Photo ~

ACTION REQUIRED: Replace flashing with lead and check the chimney. Your legal advisor to specifically ask the owner if they have carried out work to the chimney.

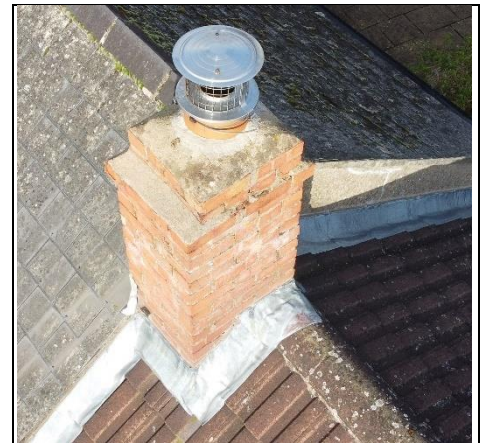
The chimney joints are starting to open up particularly at the top and there is efflorescence visible indicating that dampness is getting in.

Top of right chimney, straight flashing rather than following joints in chimney

ACTION REQUIRED: Whilst work is being carried out to the left chimney we would recommend you also check the right chimney at the same time. This is the chimney to the right bedroom which has been closed up.

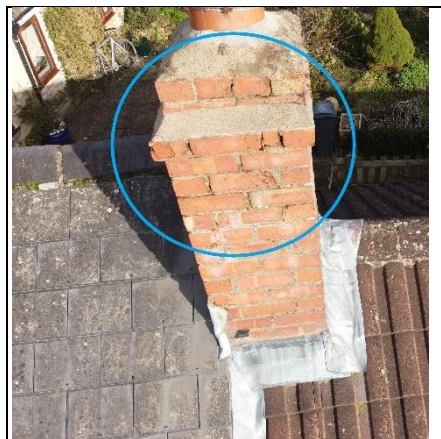
Right chimney joints opening up and efflorescence

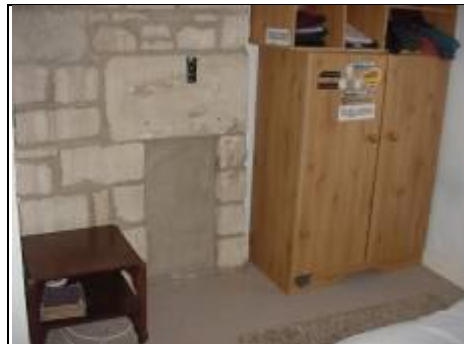
Right chimney closed up

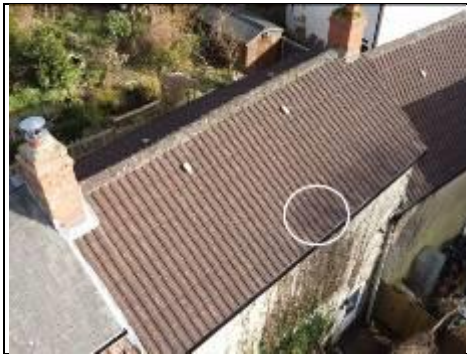
Our sketch below shows a cross section of a chimney through a building. Looking specifically at your chimneys the rear left chimney has been removed externally and is still visible internally to the staircase and also in the top floor left bedroom.

Rear left chimney removed

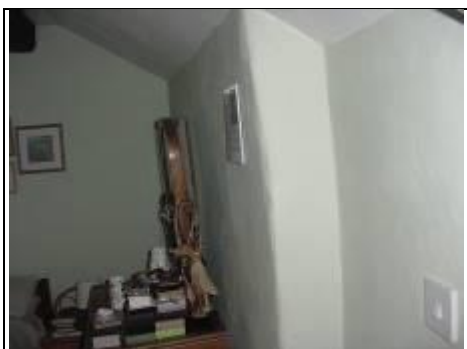
Top floor bedroom chimney visible

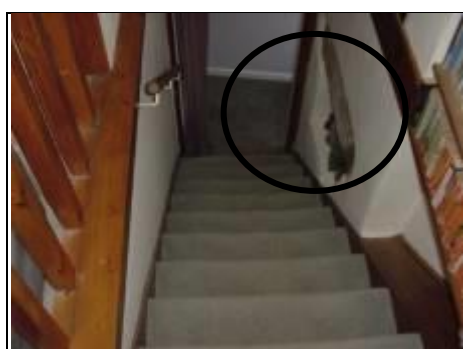
Chimney on stairs from ground floor to first floor stairs

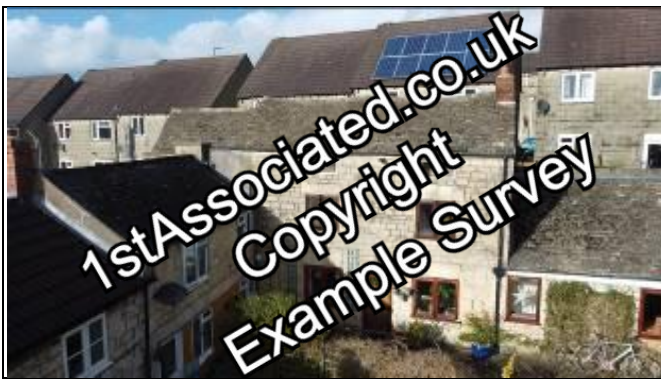
The property has a concrete tile roof however in the listing it describes the roof as a pantile roof. We noted that nearby roofs were both slate and stone. This property has a modern concrete tile roof which were commonly used as replacement roofs in the 1970's to the present day. We could also see the roof has some mushroom vents which we would say dates the roof from about the 1970's-1990's.

Stone roofs to adjoining properties
~ Aerial View - 360 Photo ~

ACTION REQUIRED: Your legal advisor needs to obtain confirmation in writing from the present owners that permission has been obtained for this roof. Also, we would recommend a meeting with the Conservation Officer with regard to this and other modern interventions that we have noted. In a worst case scenario there are fines and prison sentences with regards to unauthorised alterations to listed buildings; please see our article in the Appendices where the owners got a substantial fine plus had to carry out the works.

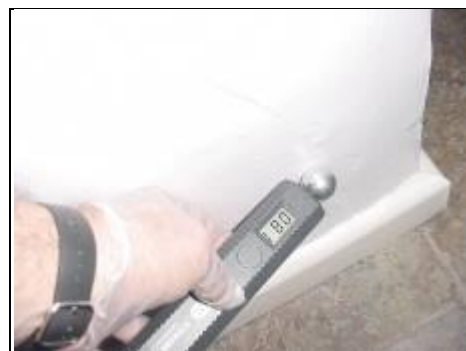
The property has dampness which is due to a combination of issues:

- 1) Inappropriate cement repointing
- 2) Sloping site
- 3) Poor guttering and downpipes, for example the rear gutter discharging onto the wall
- 4) Ivy covering the wall

High damp meter reading

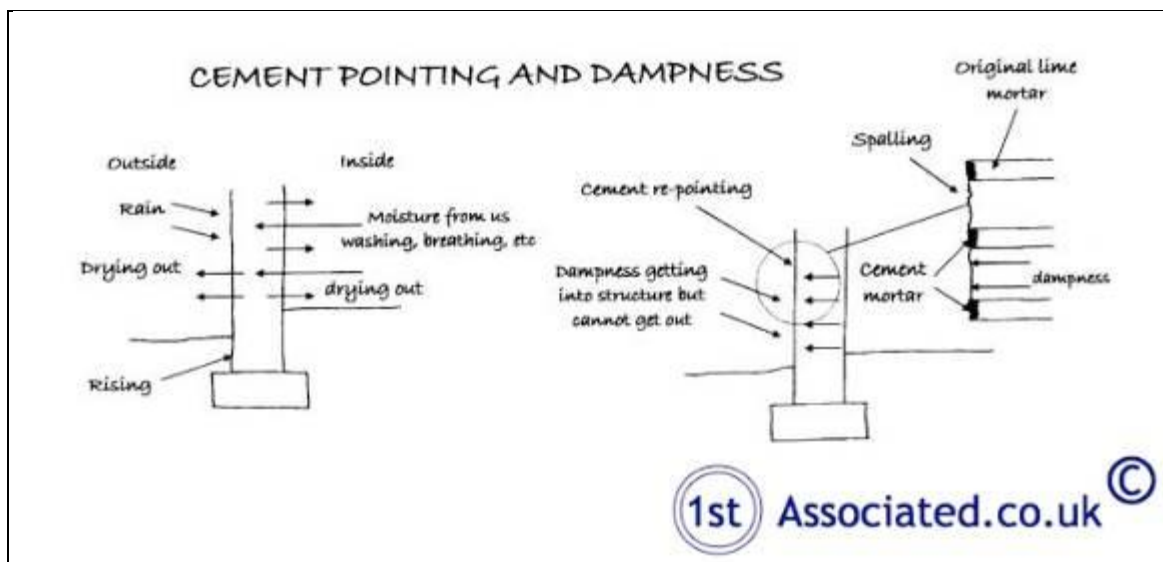
The use of cement mortar causes deterioration to stonework and does lead to the face of the stones deteriorating and also leads to dampness and cracking.

Cement pointing and dampness

ACTION REQUIRED: Find the oldest/most experienced bricklayer/mason you can who is skilled in using lime mortar and ask them to work on your property ideally during warmer days. A programme of work then needs to be carried out on replacing cement repointing with lime. This building needs to be able to ‘breathe’ again. We noted in the roof space that the pointing has gilleting (see sketch); it may be that the Conservation Officer may require this type of repointing.

ANTICIPATED COSTS: £5,000 - £10,000 as we think it will be quite hard/skilled work to repoint to a good standard and will also need scaffolding at the higher levels. Please obtain quotations.

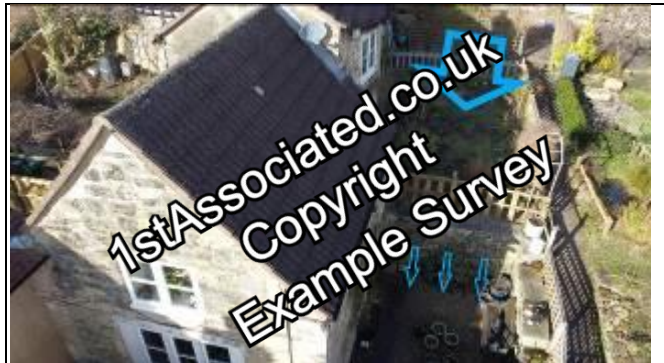
The property sits on a sloping site and because of this rainwater and ground water need to travel from the top of the site to the bottom with the building in the way. Sloping sites are not as good as level sites as they can be affected by dampness which in turn can make them unstable. You need to understand this is a characteristic of any building sitting on a sloping site.

Front retaining wall due to slope
~ Aerial View - 360 Photo ~

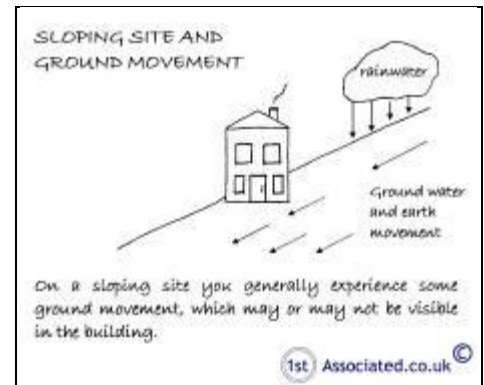
Sloping site

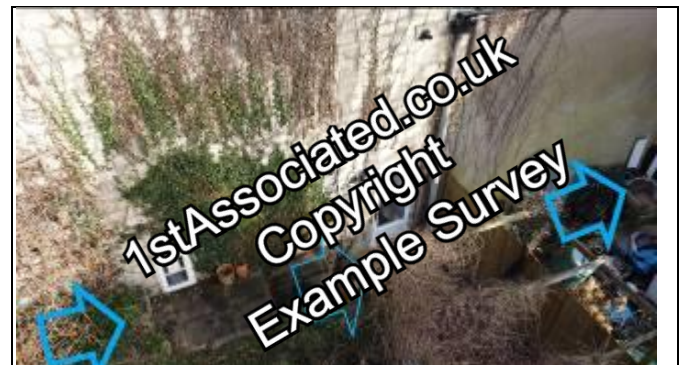
Slope to rear rainwater travel
~ Aerial View - 360 Photo ~

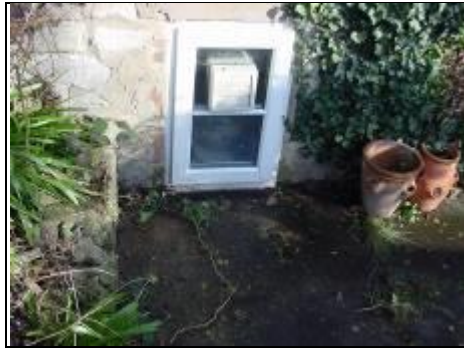
Part of the building is built into the ground, for example the bathroom.

Bathroom built below ground level

ACTION REQUIRED: Often a French drain can help manage the water around the property. We would however live in the building first of all to see just how much water is sitting and running around the property before you add a French drain.

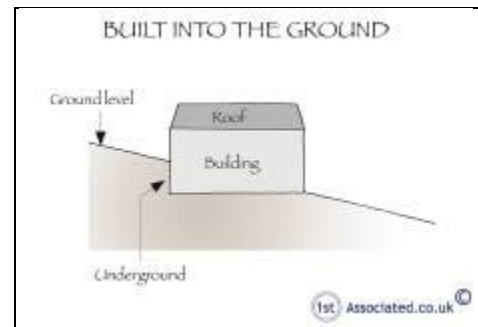
Built into ground

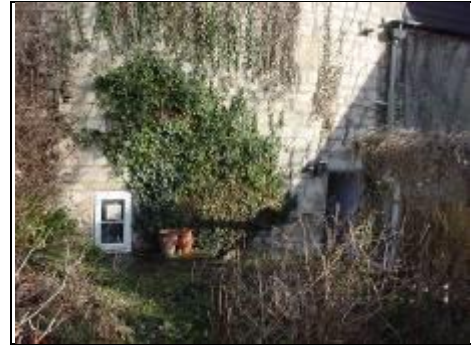
To the rear there looks to have been a covering of ivy which has now been cut back but nevertheless it needs cutting back further and we would recommend removing completely as the ivy limits sunlight and drying out of the building and air movement in the area. It can also hold water and snow.

Close up of ivy

ACTION REQUIRED: Remove ivy.

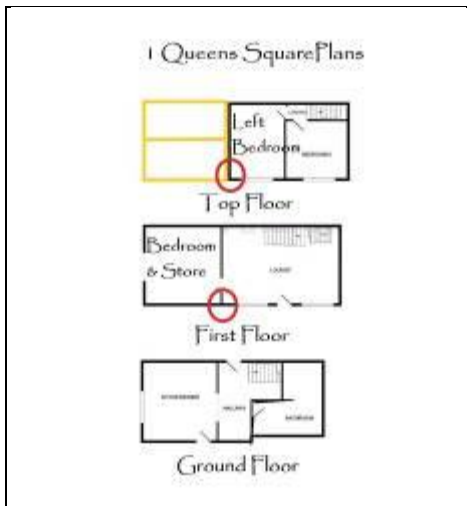
We can see some movement occurring in the property. It is very difficult to assess as we have had a limited view in the roof area due to the amount of insulation and a narrow loft hatch. However, we can see some cracks and repairs to cracks. In our vendor's questionnaire we are advised that the property was decorated throughout in XXX so cracks should not really be visible this soon.

Location of cracks

ACTION REQUIRED: We believe the safest way forward is for the existing owners to take out an insurance claim, advising that the cracking has been noted by a structural surveyor (this should cost them nothing other than time to write the letter/email). This usually means that the insurance company will carry out a monitoring exercise (the Building Research Establishment recommend monitoring any cracks for a minimum of one year) to establish if there is any progressive movement. Your future liability should be limited to the cost of the excess on the insurance providing the insurance company is happy for you to take over the insurance claim.

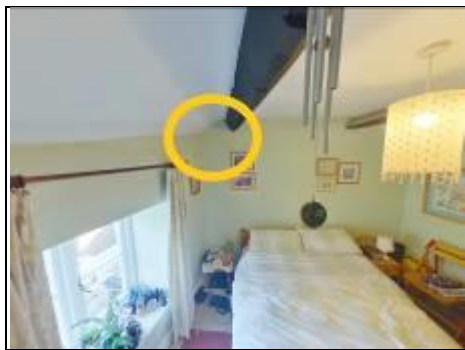
Main bedroom to left on top floor

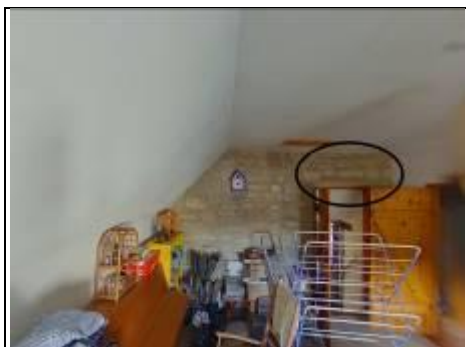
First floor left bedroom crack above door

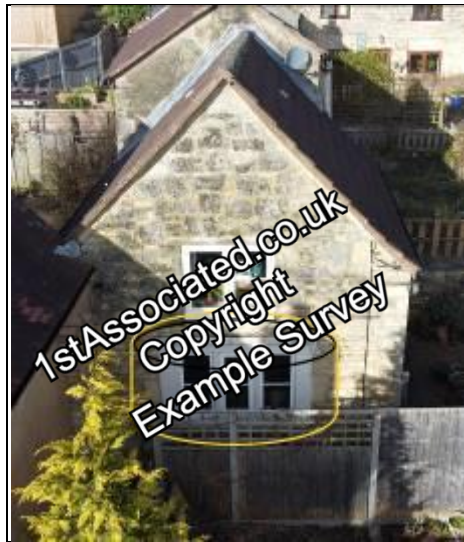
Moulding over window on left side of building

Again, this work should not have been carried out. We rarely come across listed buildings with plastic windows and more regularly see single glazed windows with secondary glazing or a separate double glazing system within but these will normally have had permission and agreement from the Conservation Officer.

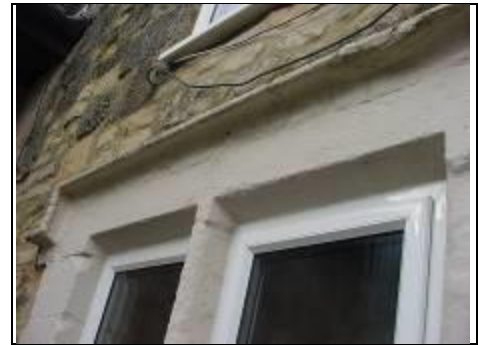
Close up of moulding

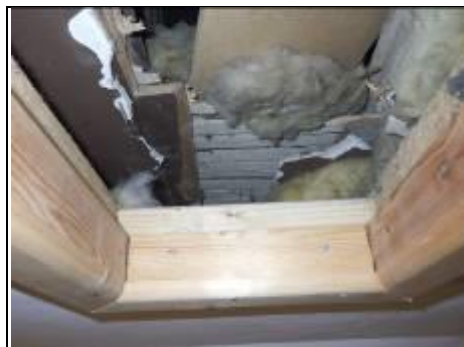
The left side roof has the old lath and plaster and a false roof underneath it. You may be able to improve the thermal efficiency in this area.

Old lath and plaster ceiling with a modern ceiling below

REQUIRED: You could get a better insulation if this false ceiling is removed and replaced with an insulated board subject to discussions with the conservation officer who may prefer to see the older ceiling. This would better ventilate the roof and in our opinion reduces the possibility of woodworm. If it does occur then it makes it easier to deal with.

We would also recommend removing the fibreglass from the roof and replace with a loft board with insulation as this would better ventilate the roof.

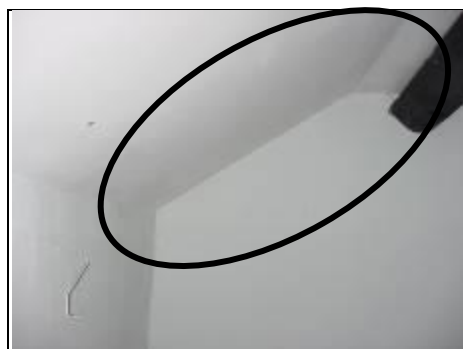
This type of property where the rooms are formed partly in the roof can suffer from thermal bridging and therefore during hotter weather you will get some heat gain unless they are very well insulated and equally in the colder weather you will get heat loss unless they are insulated.

Bedroom ceiling formed within roof

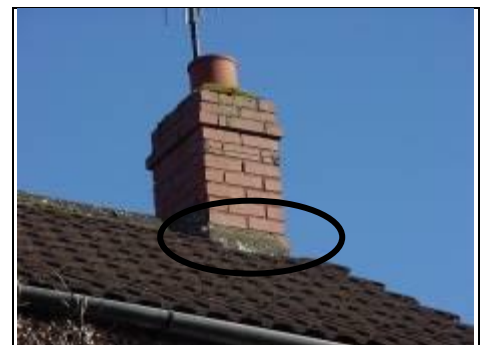
This chimney is brick finished with a cement flashing and one chimney pot. From what we could see from ground level it looked in below average condition considering its age, type and style. We would prefer a lead flashing.

Cement flashing to left chimney

This is where cement has been used to cover up or fill the junctions between two areas, for example between a roof and a wall to help prevent dampness. Cement is a brittle material and prone to cracking which in turn allows dampness into the structure. We would always recommend the use of lead flashings.

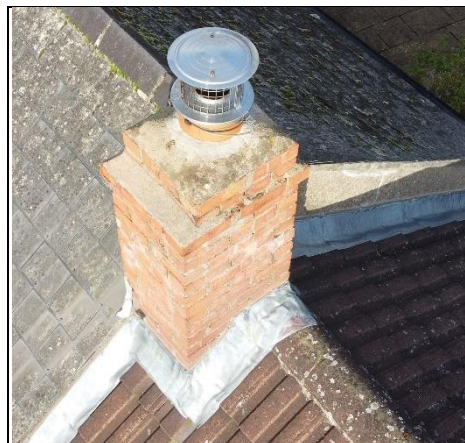
This chimney is brick finished with a lead flashing and one chimney pot. From what we could see from ground level it looked in below average condition considering its age, type and style.

Top of right chimney, straight flashing rather than following joints in chimney

ACTION REQUIRED: Please see our comments in the Executive Summary.

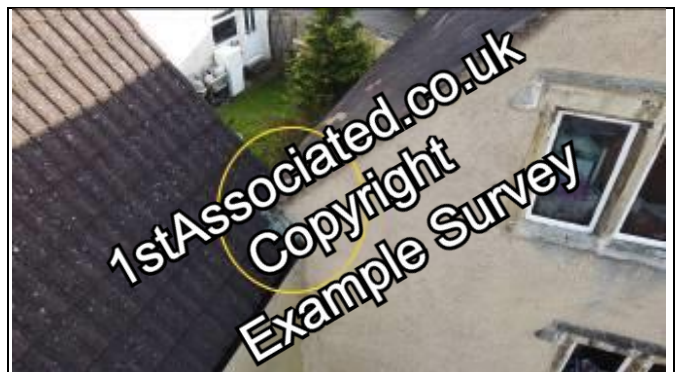
We noted the far left roof overlaps the property on the left side which could be a water trap area and needs to be monitored.

Meeting of your roof with next door's roof to the rear left hand corner
~ Aerial View - 360 Photo ~

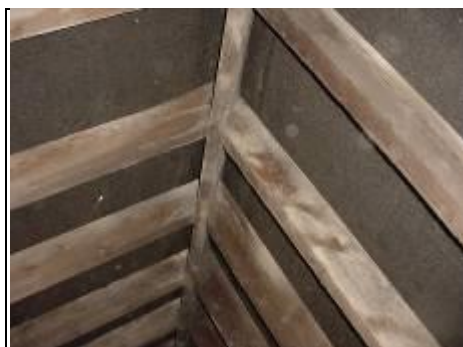
Our view of the left roof was limited to a camera through the hatch on the left side. There is some darkening of some of the timbers indicating that some dampness may be getting in.

Darkening of timbers

ACTION REQUIRED: The only way to be one hundred percent certain is to have the roof cleared and checked. Generally, we recommend in listed buildings that this type of insulation is removed and loft boarding with insulation beneath is added and a throughflow of air.

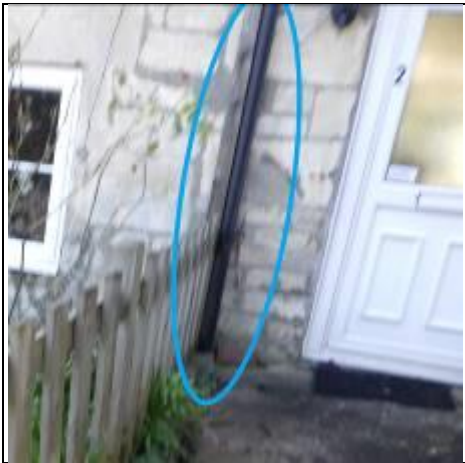
The gutters and downpipes are plastic. They are in below average condition for their age, type and style. By below average condition we mean there are some minor leaks which need resolving relatively quickly. We would recommend you give them your immediate attention.

Front right downpipes feed directly into ground

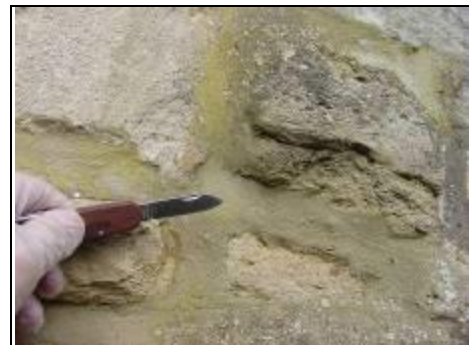
The property is built in rough cut coursed limestone in a cement mortar probably in a rubble wall construction (assumed). The stonework has been wrongly repointed in cement mortar.

Cement repointing

ACTION REQUIRED: Please see our comments in the Executive Summary.

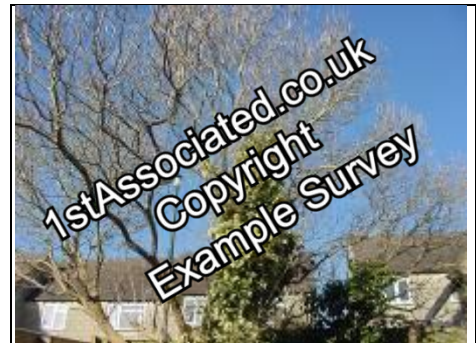
Trees within influencing distance of a property can affect the foundations by affecting the moisture content of the soil.

Tree to rear

ACTION REQUIRED: We would recommend an arboriculturalist (not a tree surgeon) is asked to view the trees and give a ten year plan for maintenance of the trees.

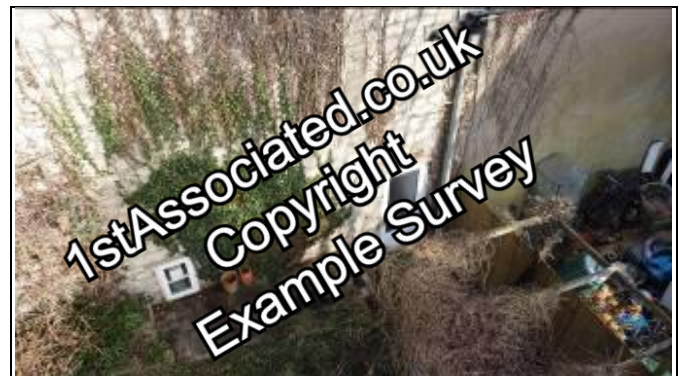
Ivy to the rear of the property
~ Aerial View - 360 Photo ~

Please see our comments in the Executive Summary with regards to clearing the ivy.

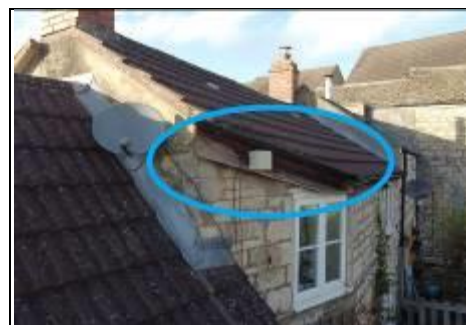
Fascia

The fascias and soffits are timber. They are painted / stained and we would comment they are in average condition for their age, type and style apart from where the guttering is leaking, for example to the front of the property.

ACTION REQUIRED: Make sure gutters and downpipes are watertight before carrying out any work on fascias and soffits.

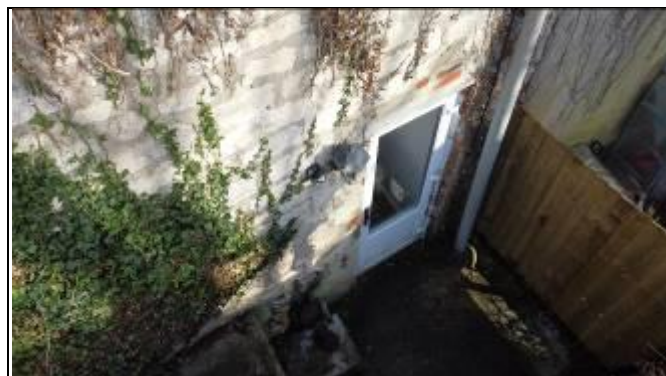
The property has plastic double glazed windows without trickle vents, which generally look to be of an average quality however they are inappropriate for a listed building unless permission has been obtained which in our experience plastic windows are rarely acceptable.

Close up of rear right bathroom window
~ Aerial View - 360 Photo ~

ACTION REQUIRED: We recommend a meeting with the Conservation Officer specifically about the windows, the roof and other features that are identified in the listing that are no longer present.

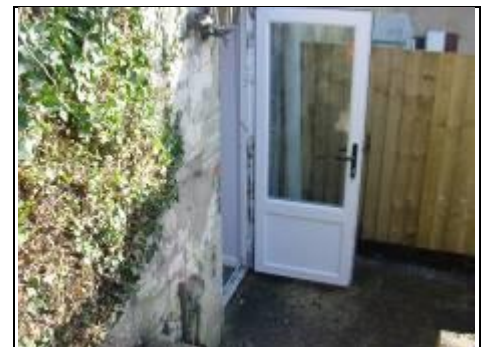
Rear doors

Again, the doors are plastic which are not appropriate for this age, type and style of building.

ACTION REQUIRED: Again, specific advice should be sought from the Conservation Officer with regard to these. You may have to budget for replacement windows and doors. Please see our further comments in the Executive Summary.

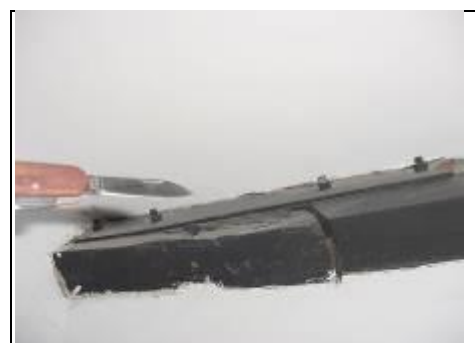
Metal strengthening to beams

ACTION REQUIRED: Your legal advisor to specifically ask the owner if they have carried out the metal strengthening to the timber beams as it looks relatively modern and whether they have any information in relation to this. It may have been caused by the extra weight that is added to the roof when concrete tiles are used rather than traditional lighter weight materials.

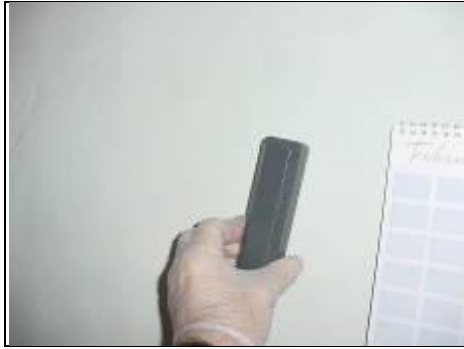
Hollow and blown plaster

ACTION REQUIRED: Please see the Executive Summary.

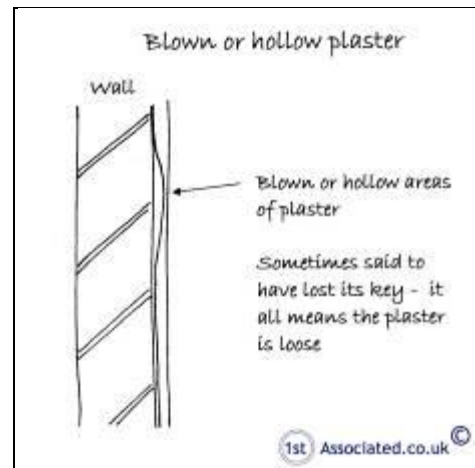
Hollow and blown plaster

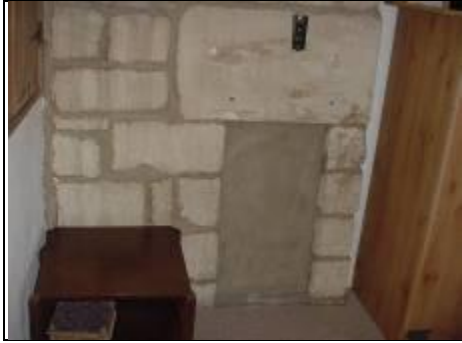
Closed up chimney to right bedroom

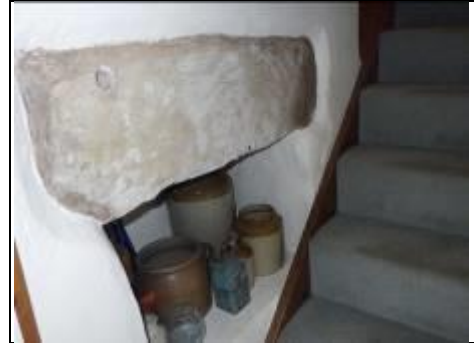
The chimney breasts are located to the left and right hand side (all directions given as you face the front of the property). We think the chimney has been removed in part to the left side as we could not see it in the main bedroom.

Old chimney next to the staircase (chimney removed externally)

ACTION REQUIRED: Please see the Executive Summary.

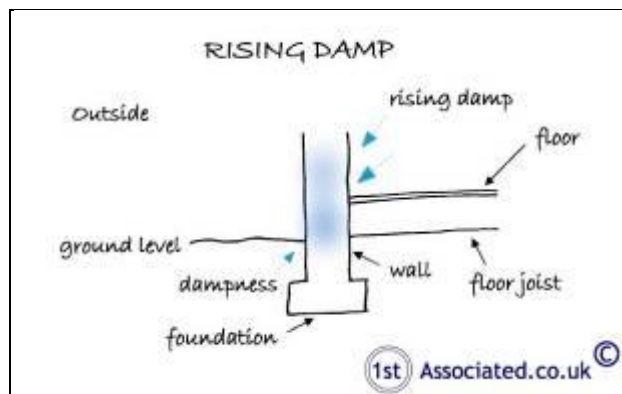
Rising damp

A visual inspection and tests with a moisture meter have been taken to the perimeter walls. In this particular case we have found significant rising damp.

ACTION REQUIRED: Please see the Executive Summary.

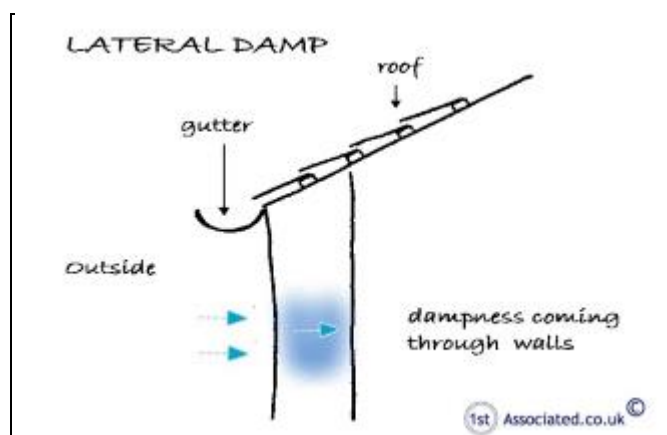
Lateral damp

We used a resistance meter on the external walls.
We have found significant dampness.

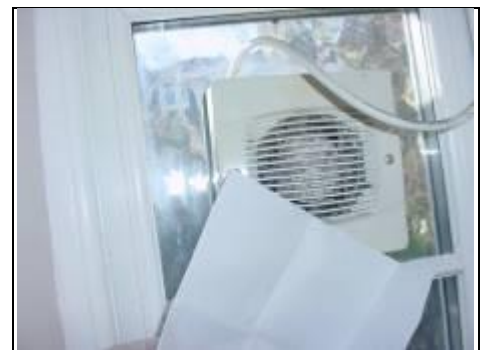
Bathroom extract okay

ACTION REQUIRED: We would recommend large good quality humidity controlled extract fans be added to kitchens, bathrooms and any rooms where you intend to dry clothes.

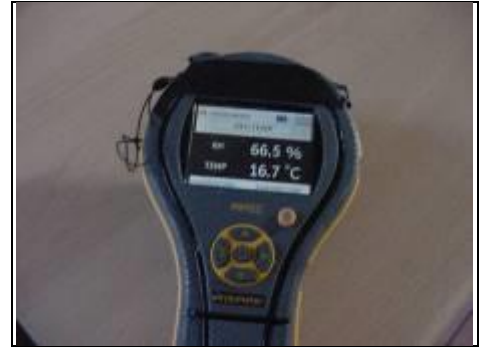
Temperature of 16.6 degrees and relative humidity of 66.5%

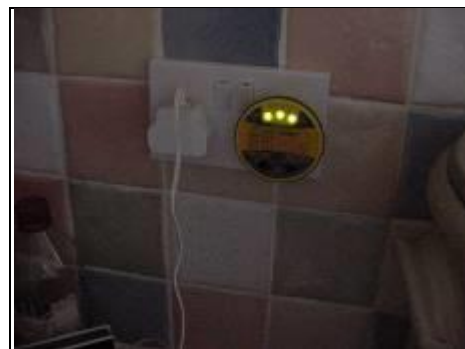
Earth test

We carried out an earth test in the kitchen area to the socket point that is normally used for the kettle, this proved satisfactory.

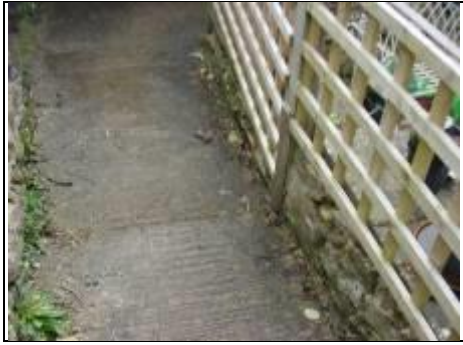
Slightly slippery concrete path
