RESIDENTIAL BUILDING SURVEY

Lincolnshire XXXXXXXX

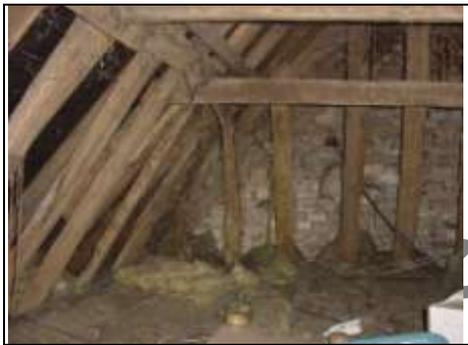
Within this roof we could see old timbers and some peg fixings and also deterioration and woodworm. Rather than replacing the timber it may be better to add additional timber in this way you keep any historic timber and improve the structure. This is the system that has been used over the years and we can see it being used in this roof.

Old roof structure to the left of the property

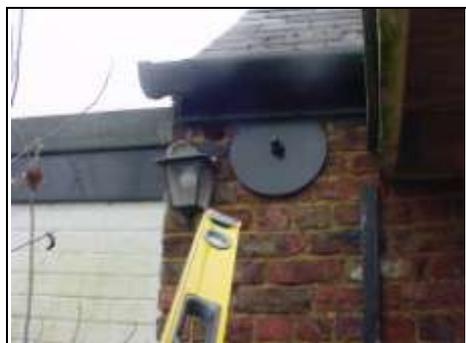
To the left side of the property we can see cracking. Unfortunately, they are very difficult to see in the photos. It does mean that movement is going on to the right side extension as tie bars are added to stabilise walls and offer cross bracing to them.

Tie bar to the function room

ACTION REQUIRED: We would recommend that you open up sections of the wall to see what the wall is constructed from and also to check if the tie bars are giving support to the structure.

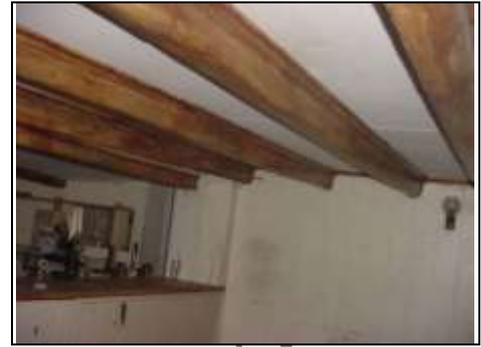
the modern timbers within the right side bar which have been painted with a smoke stain type colour which was popular in pubs years ago (particularly when smoking was allowed).

Timber beams to the right side of the main bar

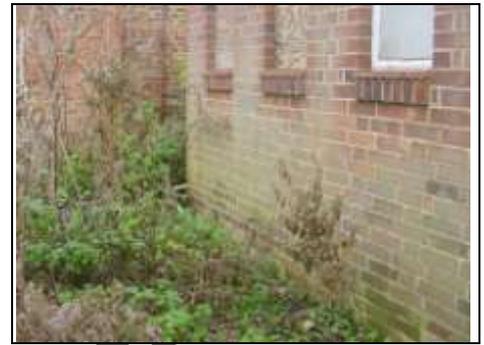
To the rear left side of the property there is what we would describe as an over grown swampy area. We had our best view from the flat roof at the back of the property.

When we were looking down to this area from the flat roof it looked like the ground had been washed away. You advised that you were going to level the ground, you do need to make sure there is not a natural collection of water in this area or even a spring. If there is you need to get the water away from the building

Rear of the ladies' toilets

ACTION REQUIRED: We recommend soak aways are added to the entirety of the rainwater drainage, which will need to discharge as far away from the building as possible.

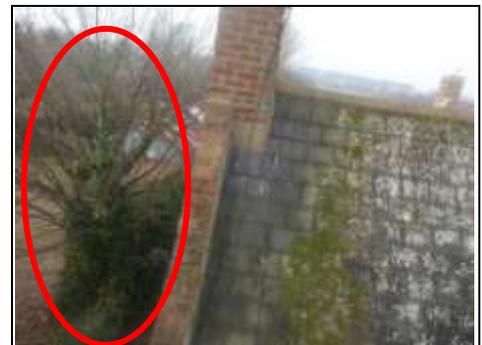
Trees to the left of the property

ACTION REQUIRED: You need to regularly maintain the trees.

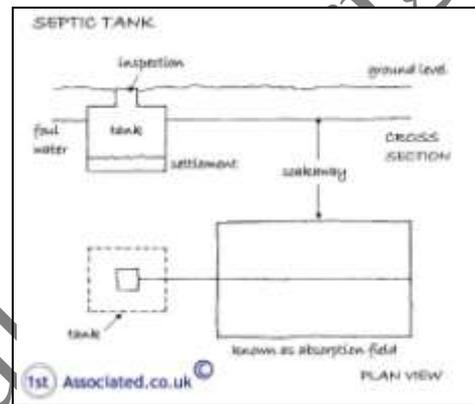
Septic tank

ACTION REQUIRED: We recommend you pump out the well with a sump pump or get a company to drain it to see how it is constructed and put a new septic tank in depending upon the capacity etc.
