**COMMERCIAL BUILDING SURVEY**  
**OF**  
**A Listed 18<sup>th</sup> Century Commercial Property**  
**Restaurant / Bed and Breakfast Establishment**  
**Abingdon, Oxfordshire**

**FOR**  
**Mr C**

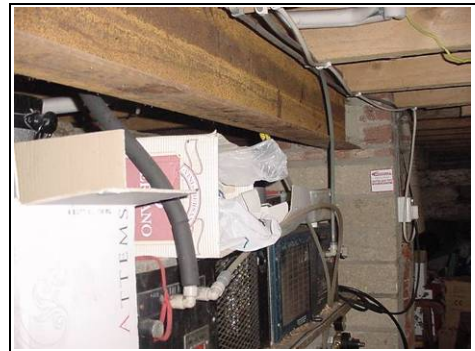
Cellar – note the metal 'I' Beam

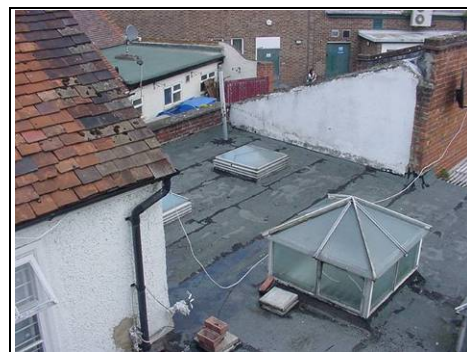
The flat felt roof is blistering and the decking beneath is soft and the flat roof is flat! (It should have a fall of 12° - 15°).

**ACTION REQUIRED:** We recommend that ultimately complete replacement is necessary, including the decking beneath.

We recommend when you do re-roof that you use a high performance felt and insulation cut to falls (to ensure the roof has a fall on it and that you have better insulation) and lead flashings. We would also give consideration to opening up the roof so that it can be accessed and also improving the roof window / roof light. The owner made some comments about the roof windows being too heavy, but we think this is because the roof structure itself is in a poor condition. We would not be surprised if the structural supporting timbers in the roof had to be replaced as well once the roof is opened up.

**ANTICIPATED COST:** We would expect costs to be in the region of £10,000 - £20,000 for the above work. We also believe that you should give consideration to replacing the plastic sheeting. Quotations should be obtained.

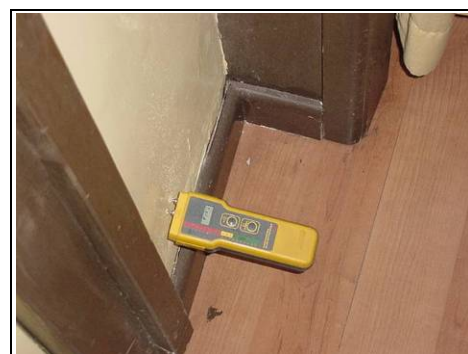
#### 5) **Rising Damp**

Rising damp is in the property throughout. We believe that part of the problem is the external ground level is higher than the internal ground level.

**ACTION REQUIRED:** You need to bring this to the attention of the Freeholder. This is an improvement that needs to be made; dependent upon the Leasehold terms it may or may not be your responsibility.

**ANTICIPATED COST:** To insert a damp proof course would also generally mean replastering internally to a height of approximately one meter and then of course redecoration, which in this case would be disruptive to business. We would expect costs in the region of £5,000 - £10,000 but quotations must be obtained.

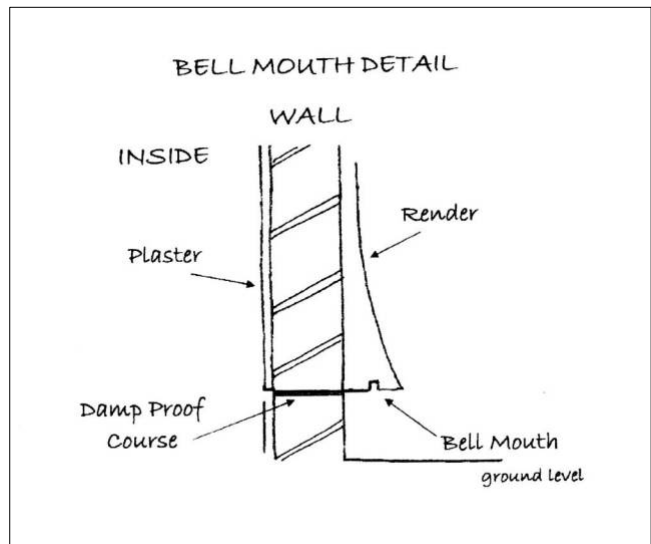
In some areas the external render on the property is not in the best condition. We feel there are weak areas, for example where the flat roof meets the main building, and we feel the render should be bell-mouthed, a lead flashing detail should be provided and generally a redecoration would be beneficial.

**ACTION REQUIRED:**  
Redecoration and repair needed to the render.

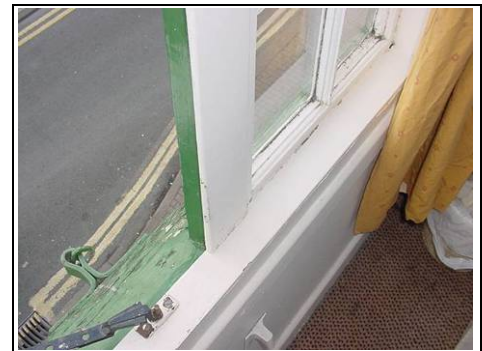
## 11) External Joinery

Please see our comments about the external redecoration above. We would like to reiterate that some windows are likely to need repair; the longer they are left the worse they will get.

**ACTION REQUIRED:** Repair and redecorate; the sooner the better. We would presently term the windows as 'saveable'.

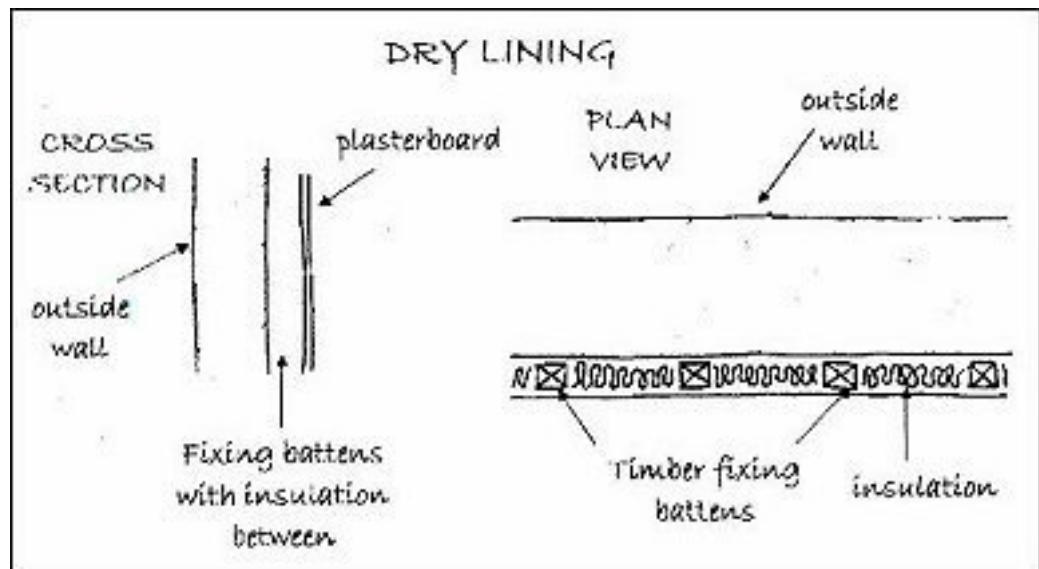
## 12) False Walls

Generally throughout the property there are false walls or what is known as dry lining. This is often used where there is a dampness problem but obviously we cannot see behind this.

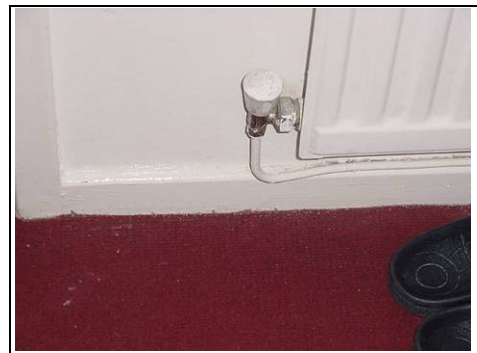
The top floor has its own system; as far as we can see the radiators are on micro-bore pipes that in our opinion are not the best form or way of carrying out central heating, as they can be blocked or ‘flat bent’ (this is where they are bent by and the bends flatten, therefore restricting the water flow).

There are also internal radiators, which are never ideal as they do not allow air circulation as well as radiators positioned under the windows.

**ACTION REQUIRED:** No work but anticipated future repairs.

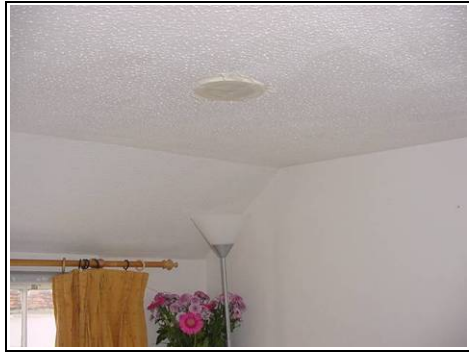
The in-set ceiling lights you have are old style bulb lights.

Inset ceiling light

These must be changed as soon as possible as they are a fire hazard.

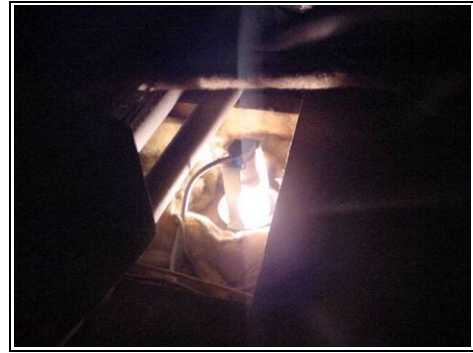
Back of ceiling light

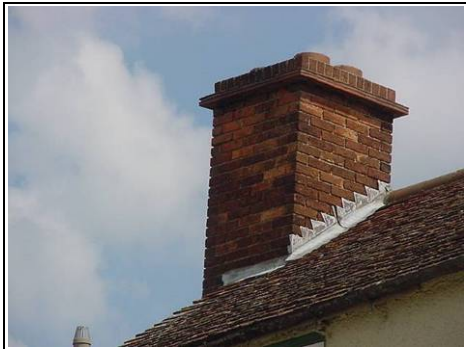
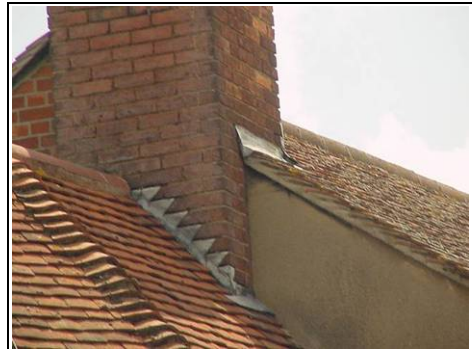
### Chimney One – Left Hand Side Chimney

This chimney is built in brick with a metal flashing that we believe to be lead and what looked to be four small chimney pots, although it was very difficult to see them. Generally the chimney looks in reasonable condition although we believe it needs some repointing and the flashing needs checking. We were unable to see the very top of the chimney know as the flaunching, we therefore cannot comment upon them.

**ACTION REQUIRED:** Check for repointing within the next three years and the lead flashing.

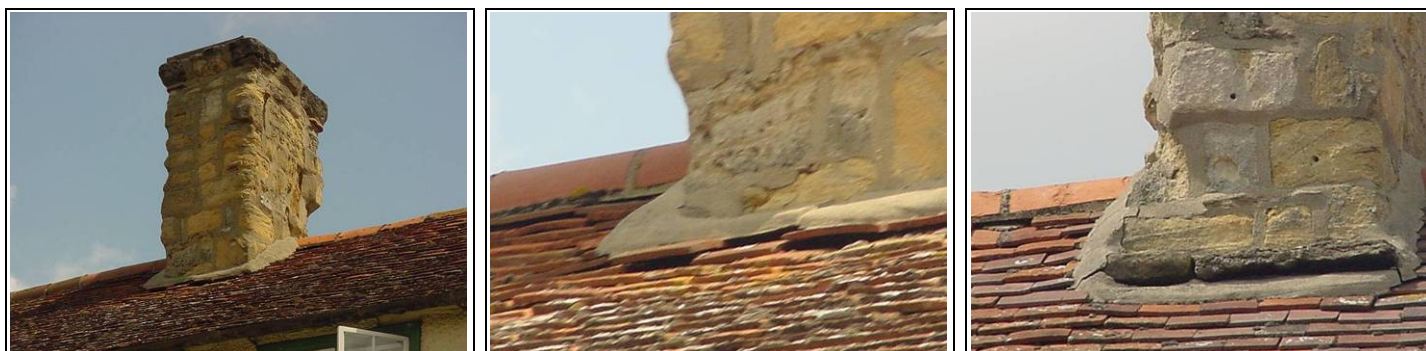
### Chimney Two – Middle Chimney

This chimney is stone finished with no chimney pots as far as we could see. The chimney has a cement flashing, which is never a good thing. Again, we were unable to see the top of the chimney known as the flaunchings and therefore cannot comment upon them.

**ACTION REQUIRED:** Lead flashing required as soon as possible.

**ANTICIPATED COSTS:** As this is high level work you may need scaffolding, so we would recommend a quotation. We would expect the costs to be in the thousands of pounds.

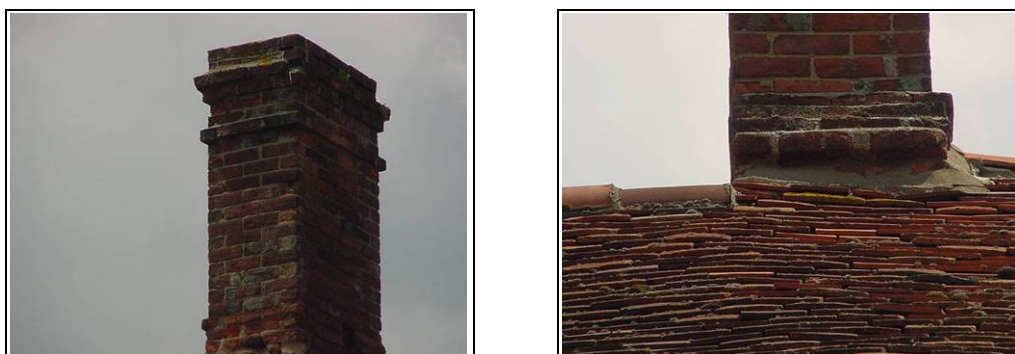
### Chimney Three – Right Hand Side Chimney

This chimney is brick finished and needs a close inspection, as our view is limited, but what we can see indicates that some repointing may be required and the cement flashing needs to be replaced with a lead flashing.

**ACTION REQUIRED:** Carry out minor repairs, ideally within the next two years and replace the flashing.

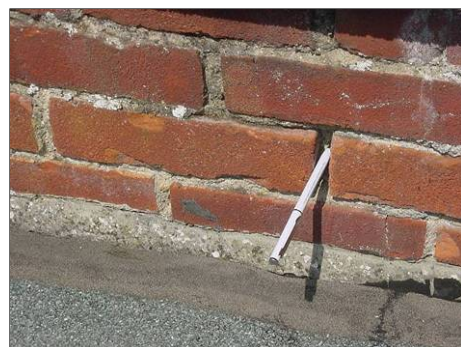
There is a small brick built parapet wall to the rear flat roof.

Pointing required

**ACTION REQUIRED:** Repointing needed.

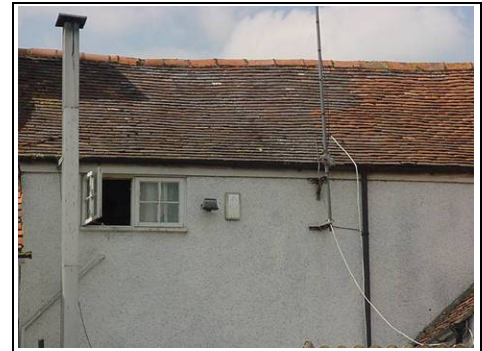
## Main Roof

The roof is pitched and clad with clay tiles and concrete tiles. Both the clay and concrete tiles are likely to be nibbed tiles. Overall we believe the roof to be in slightly below average condition, considering its age, type and style.

We would comment we could see spalling, displaced tiles, wrongly sized tiles and moss; all need repair or replacement.

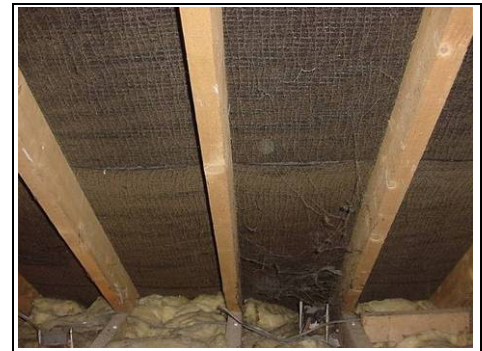
Left Hand Roof

There are three roofs to this property (left, middle and right hand). When we inspected the loft spaces we found a Hessian base Bitumen membrane. This type of membrane has been used since the 1960s. We generally found it to be in average condition, although it is damaged in a few places but this is not unusual considering its age.

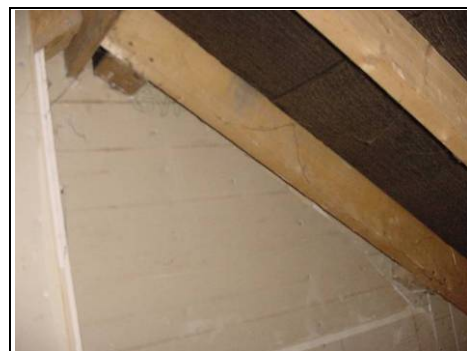
Our examination was limited by the general configuration of the roof, the insulation and stored items. As mentioned what we could see was generally found to be in average condition considering with some minor condensation and damp. It is, however, feasible that there are problems in the roof that are hidden.

**ACTION REQUIRED:** The only way to be 100 per cent certain is to have the roof cleared and checked.

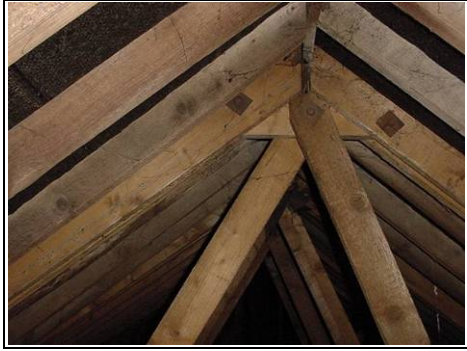
General View

Again, we would make similar comments as above; however, in this case, you have an early pre-fabricated roof, probably from the 1960s, as we could see some bolts in some of the timbers. However, you also have some of the older timbers present and interestingly you can look through into next doors property, which should not be the case. Whilst we again inspected the roof from the loft hatch due to the amount of stored items in the roof space we would comment that we would expect some woodworm to the older timbers.

**ACTION REQUIRED:** You need to add fire break walls into this area. We would also recommend that the roof is boarded out and lit and checked for 'active' woodworm that is causing structurally significant damage. From what we could see from the roof hatch we believe the timbers to be in acceptable condition considering their age.

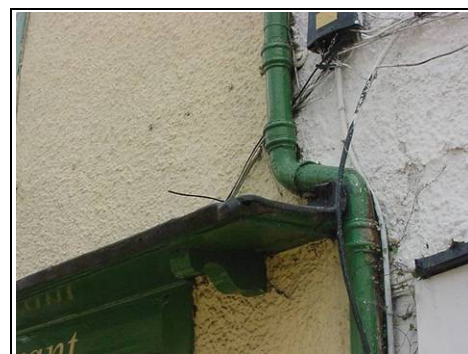
The property has a mixture of the original cast iron gutters and downpipes and the more modern replacement plastic gutters and downpipes. From what we saw of the gutters and downpipes they are in a poor condition and therefore they are causing deterioration to the property.

**ACTION REQUIRED:** Remove the vegetation then repair and replace the gutters and downpipes as soon as possible. We would always recommend that the joints are checked and the alignment checked to ensure that the gutters fall towards the downpipes.

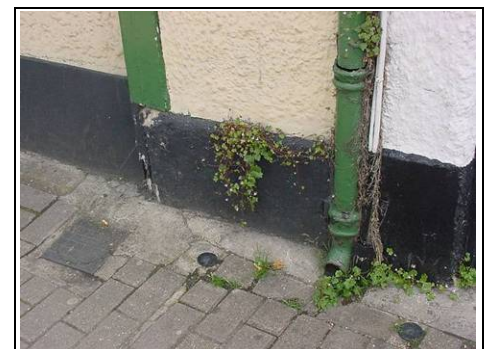
Whilst in theory there should be a bell-mouth detail, in this instance due to the level of the pavement against the property it is possibly best to have the plinth render detailing as you have. The problem of dampness is a difficult one, as not only are the ground levels different between the pathway and internally, you also have downpipes discharging into the area, as can be seen in this photo.

**ACTION REQUIRED:** You need to come to an agreement with the Landlord as to the existing condition of the property and that they will not ask for any improvement. This is very important as improvements could be very costly as it will be difficult to get a satisfactory solution.

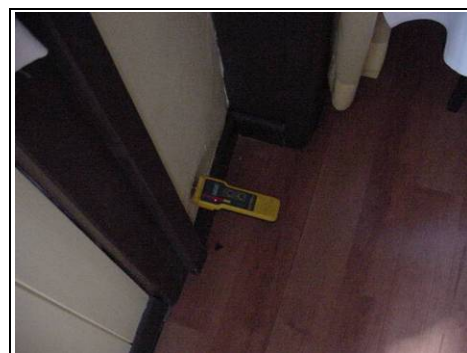
A random visual inspection and tests with a moisture meter have been taken to the perimeter walls and some internal walls. We found rising damp.

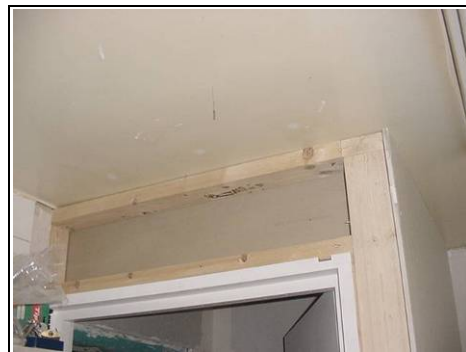
Over the top of the door to the owner's accommodation the studwork needs to be finished to make it fire resistant.

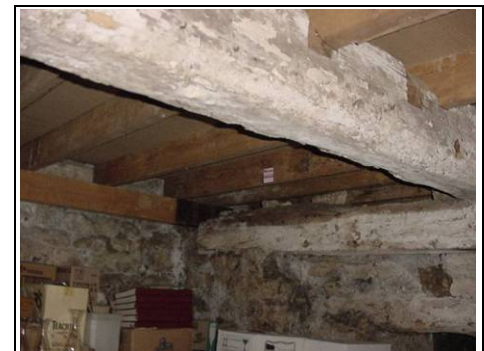
You have the benefit of a cellar, albeit damp and requiring ventilation. We would add that we could not see a sump pump; this is required for when cellars flood (and they always do), you may wish to add one.

Replaced timbers with central spine beam (white timber)

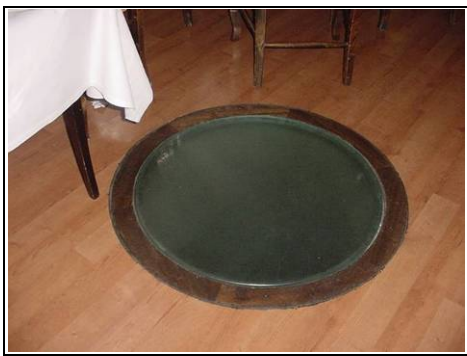
The Well

The well is a nice feature of the property and is an interesting talking point.

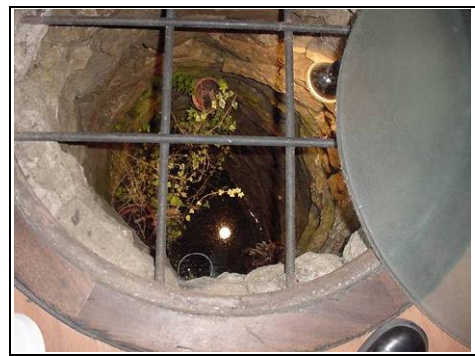
Looking down the well

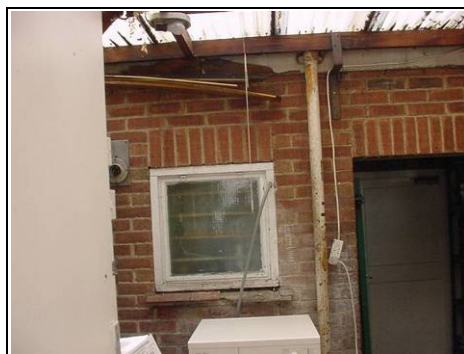
The area on the way to the food store

There are various areas that give us cause for concern; the easiest way to resolve this is to ask for the latest copies of the Environmental Health reports and to meet the Environmental Health Officer at the property. We are particularly concerned about the open area that exists between the kitchen and the store and its condition. Please see our comments in the Executive Summary.

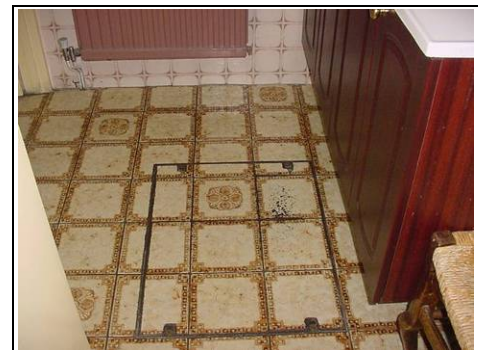
We have noted an air sealed internal man hole which we have not lifted. We are not keen on internal man holes in case they block!

**ACTION REQUIRED:** You need to establish what your responsibilities are within the terms of the Lease; if they are onerous we would recommend a Close Circuit TV camera report of the drains prior to you taking on the Lease.
