COMMERCIAL BUILDING SURVEY

**Barking,
Essex, IG11**

We have been instructed to inspect and prepare a Commercial Building Survey for XXX Barking, Essex, IG11.

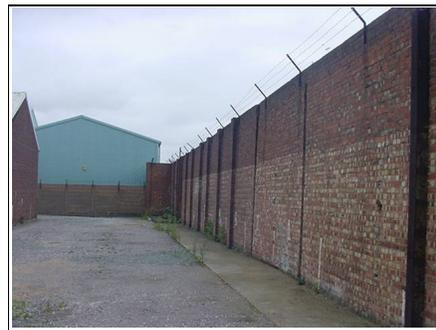
Rear boundary wall

There is a car park surrounding the property and access roads. These are tarmac and concrete areas which are deteriorating. There is no drainage noted which accelerates deterioration. There is a boundary wall with adjoining trees that are damaging the boundary wall and the car park.

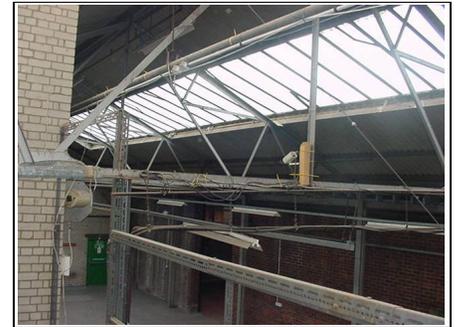
Left hand side with asbestos roof

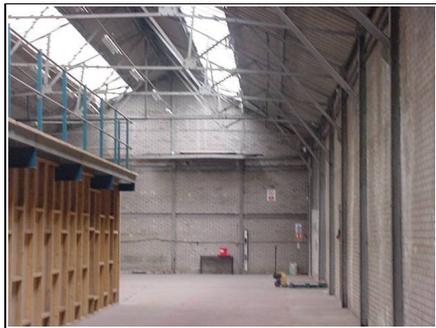
Right hand side

With regards to the warehouse, we can see cracking to the brickwork walls on the right hand side and subsidence to the walls on the left hand side. We have mentioned within this report that we believe this is an area of unstable soil (due in part to the ground stabilising taking place and our general knowledge). Again we cannot recommend that this warehouse is used without further investigation.

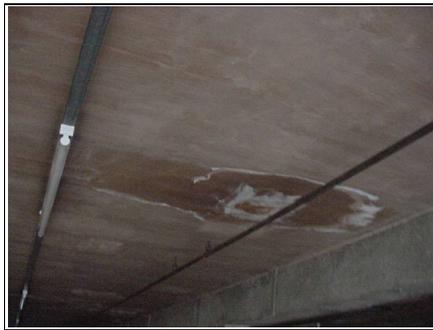
Ponding to flat roof, which is not falling towards outlets and coming through roof.

Water coming through roof.

ACTION REQUIRED: To make the roof 100% watertight we recommend an insulation cut to falls laid over the roof, finished in a high performance felt if you intend to use the building in the medium to long term. In the short term patch repair may be an option, depending upon how you wish to use the building.

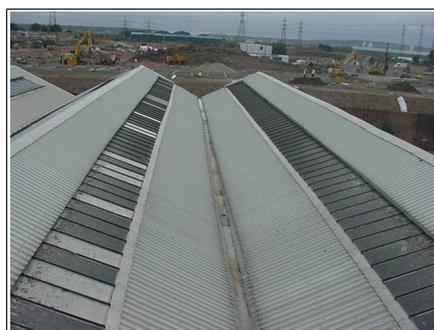
Rainwater/dampness is coming through the valley gutters. This can be seen internally on the dividing walls and also causing deterioration to the metal structural frame and fixtures and fittings.

Right hand valley gutter

ACTION REQUIRED: The rear part of the property needs to be made watertight to stop damage and deterioration being caused to the metal structural frame.

It is likely that the entirety of the valley gutter needs water proofing. There are various ways of carrying out this, from temporary fixes to permanent long term. It needs to be carried out to limit the damage that can be caused to the structural metal frame.

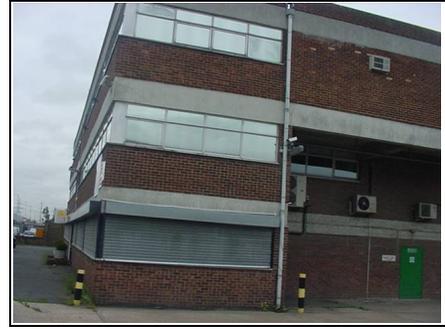
3.1.2. Reinforcement visible and deteriorating.

3.2 Repairs have been carried out on this concrete frame previously, whether these are cosmetic or structural is unknown.

View of front structural concrete frame

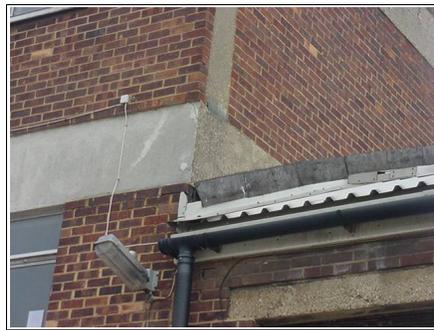
Rear roof of office - concrete the side (left hand) and to the rear no repairs

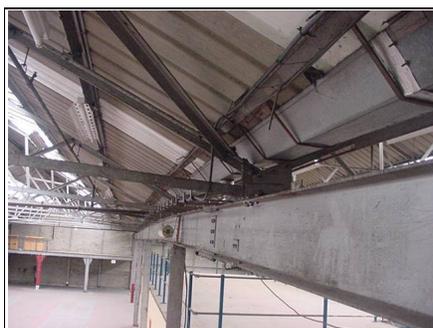
There is twisting and bending and rusting visible to the metal structural frame. We feel this in part is being caused by the dampness coming in via the roof, however we cannot discount problems with the foundations bearing in mind the cracking that we can see throughout parts of the structure.

From a visual inspection this would appear minor, however from our experience if deterioration is occurring to key areas then it could be fatal for the structure as a whole.

Bend and twist in metal frame

ACTION REQUIRED: We recommend that investigations are carried out to establish the original foundation design and also the metalwork capacity, as it appears to have been affected by ground conditions and the dampness. Testing needs to be carried out to ensure the rusting has not affected the integrity of the metal frame, particularly to the bolt fixings, where rusting and corrosion can be seen.

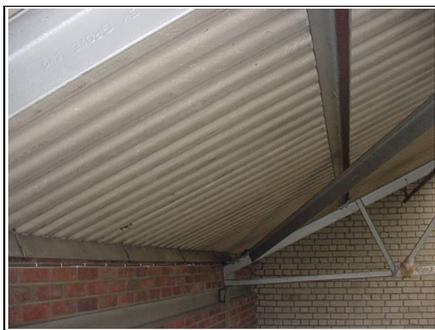
Asbestos roof

ACTION REQUIRED: The selling agent Glennys advised an asbestos report is available. We have not seen this but we are aware that there are different levels and qualities of asbestos reports. You need to obtain a copy of this and understand the report and the cost implications of the recommendations with regard to asbestos.

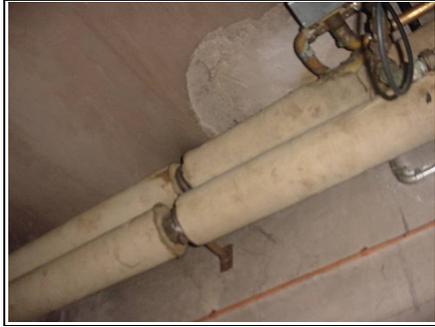
Possible asbestos to service pipes

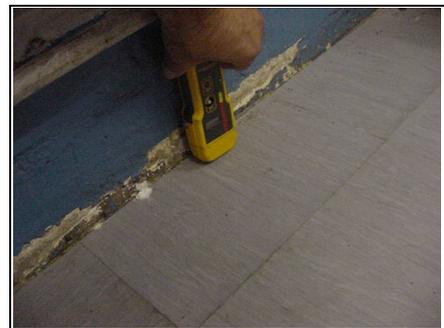
Checking for dampness

ACTION REQUIRED: Lower external ground level; 150mm is normally recommended and/or add a French drain (please see Appendices).

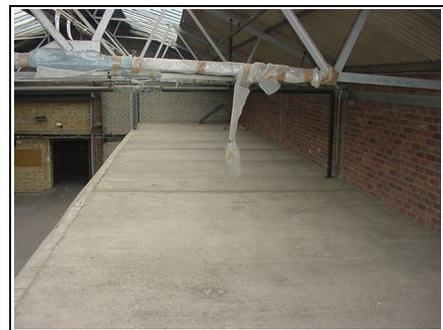
There is an internal concrete roof on the left hand side which is adding weight to the structure below but it could also be adding structural stability. It needs to be understood whether this has been added at a later date to help restrain the structure or has been added as a purely functional requirement of heavy weight storage.

Internal concrete roof

ACTION REQUIRED: This is part of the further investigation needed.

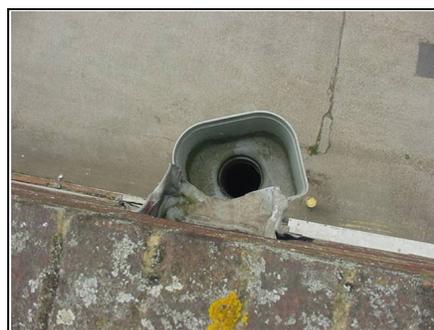
The hopper heads and downpipes are plastic and externally fitted. We do not feel that the hopper heads will be able to take the amount of flow from the roof. We have not had the benefit of seeing the roof when it was raining.

Plastic downpipe

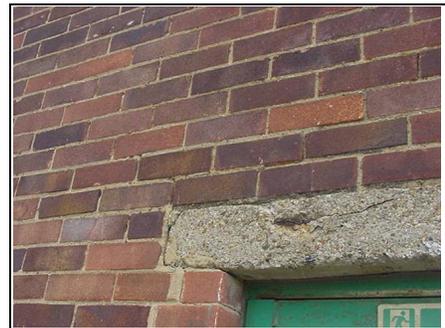
The lintels are deteriorating and reinforcement is visible.

Typical concrete lintel

ACTION REQUIRED: Please see our comments in the Executive Summary.

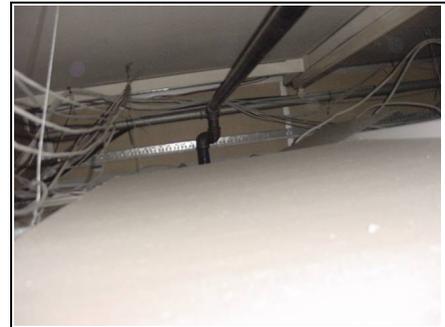
Ceiling on ground floor in office area on front right hand side

We can see that there is dampness coming through to the upper warehouse floors from the flat roof and we believe there is also some dampness coming through around the windows on the front and side elevations, such as staining we can see on the tiles.

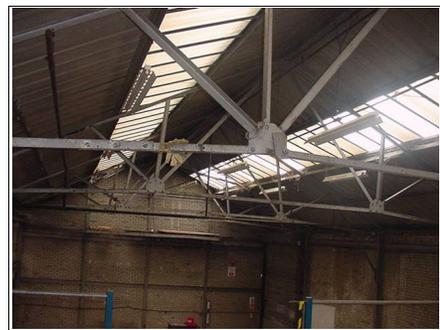
The warehouse has an open ceiling. We can see that the under side of the ceiling has not been lined, as is common in more modern properties, often with an insulation level, and we can in some areas exposed asbestos.

Open ceiling

ACTION REQUIRED: Please see our comments in the Executive Summary.

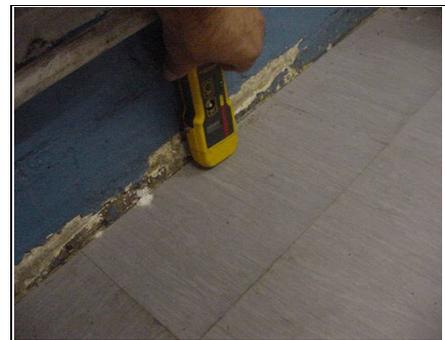
A random visual inspection and tests with a moisture meter have been taken to the perimeter walls and some internal walls and we found minor dampness.

Checking for rising damp

ACTION REQUIRED: It depends how important the areas are to you to have 100% damp free. If this is the case then you will have to lower the ground levels externally. We would recommend a French drain (see Appendices at the end of the report)
