**SCHEDULE OF CONDITION
OF
A Public House
Bedfordshire**

INDEPENDENT CHARTERED SURVEYORS

Address

SCHEDULE OF CONDITION

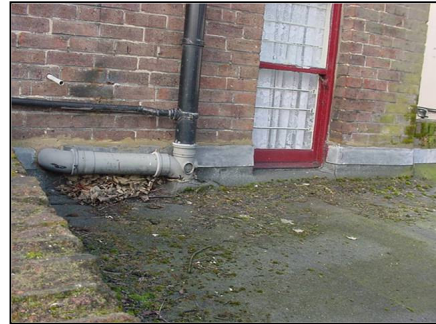
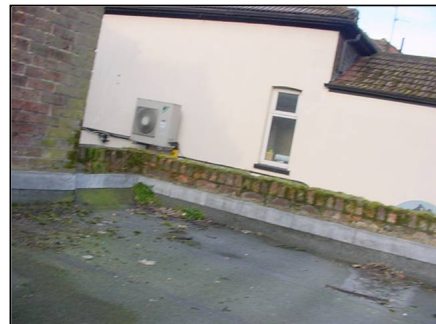
2) Valley Gutter

There is a valley gutter to the rear of the property. These are generally considered to be problem areas. Within the roof space we could see some dampness getting through and the situation can only get worse; although presently, as far as we could see, it does not affect the private living accommodation.

ACTION REQUIRED: We would recommend that a roof light be fitted to the valley slope of the roof to allow inspection of the valley gutter (from the roof space) and access to clear it of leaves and other debris on a periodic basis.

ANTICIPATED COST: We would recommend the sum of £1,000 be set aside. The dampness needs to be resolved as it goes into the cellar area and we do not believe it would meet current Environmental Health Office standards.

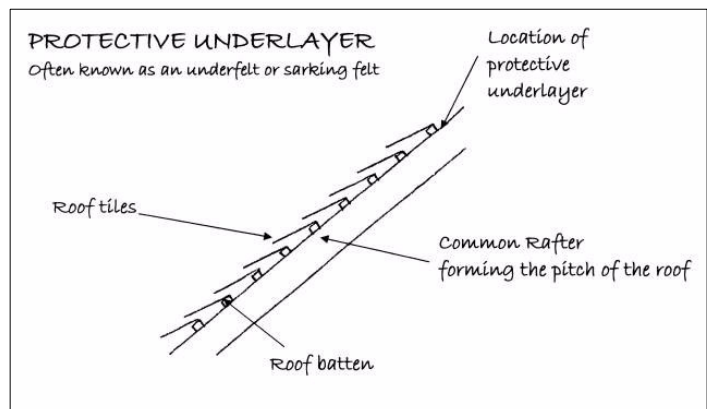
Protective Underlayer (Often known as the sarking felt or underfelt)

We noted a plastic underlayer. This type of underlayer was popular in the 1970s/1980s and does tend to 'sweat' in the warmer months, which can cause condensation. We were pleased to see that it has been vented, which should help to reduce this.

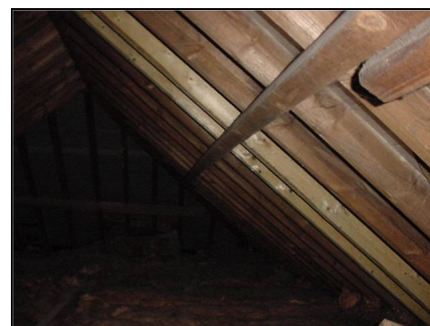
Our main concern with this roof is the condensation that has already been mentioned and the ceiling where the lath and plaster appears to have lost its key in some areas and this can only get worse (for example the front left hand lounge).

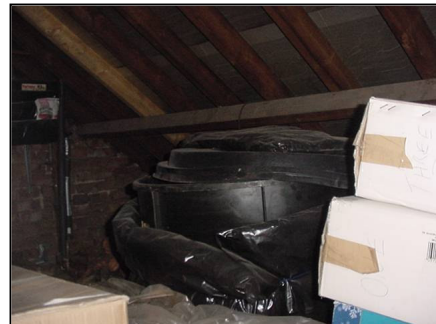
The property has a plastic water tank that is insulated, indicating that it is relatively new (in this case, in surveying terms, we mean in the last 30 years).

We would always recommend that water tanks be drained down and cleared of any debris etc. (we have seen dead birds and other unmentionable things in these tanks). As you are cleaning your teeth with this water it is best that it is as clean as possible!

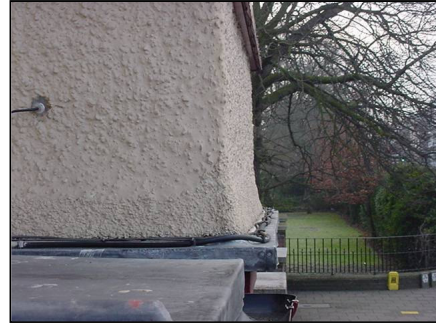
There are areas of painted render to the bays to the front of the property. These can be seen to have been repaired over the years.

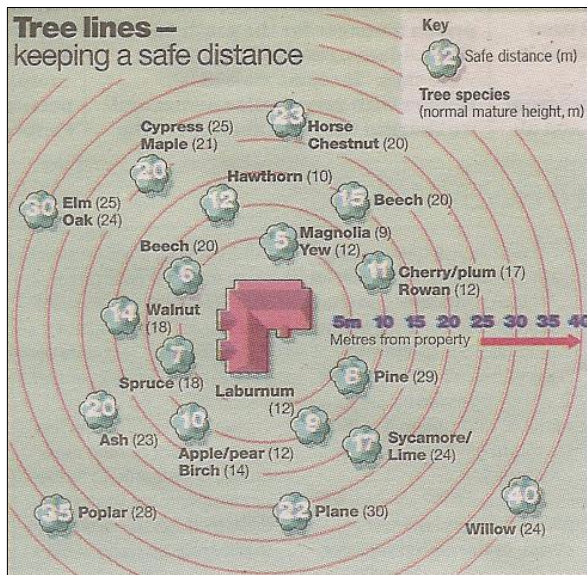
There are various trees to the rear of the property. There is one mature tree to the rear left hand side within five meters of the property (most insurance companies require specifically advising of the tree). It is adjacent to the kitchen, which looks to be a newer extension and it is usual for Building Control to require the foundations to be built to allow for the close proximity of a tree. This usually means them being deeper or a tree root guard being put in place. Without opening up the foundations we cannot comment further.

Tree close to the property. Also note the deterioration to the parapet wall.

ACTION REQUIRED: An arboriculturist (not a tree surgeon) is required to inspect the trees in the next few years and any action recommended should be taken.

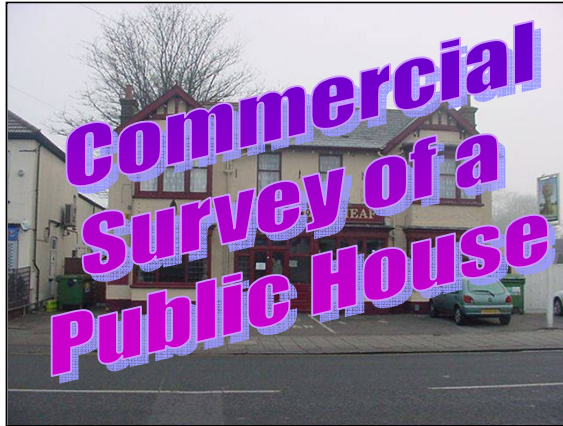
FRONT ELEVATION

Painted timber windows predominantly sliding sash in need of redecoration and repair.

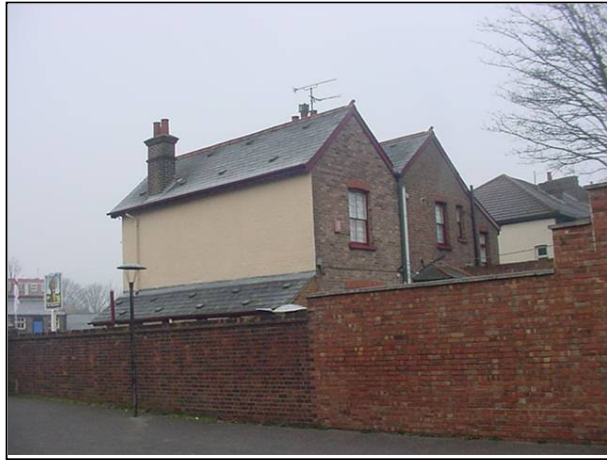
RIGHT HAND SIDE ELEVATION

Painted brickwork in below average condition.

Windows need repair and redecoration.

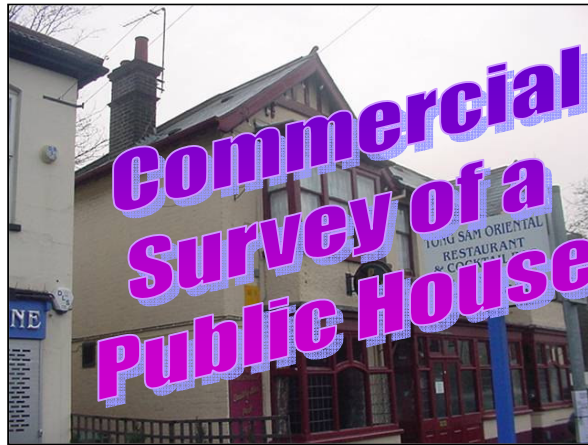
LEFT HAND SIDE ELEVATION

Painted brickwork in below average condition.

Windows require repair and redecoration.

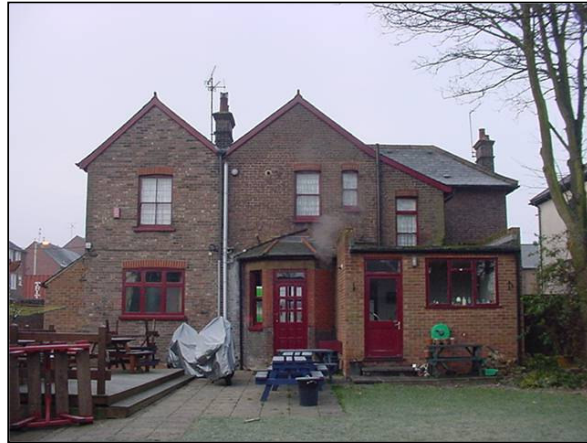
REAR ELEVATION

Windows require repair and redecoration.

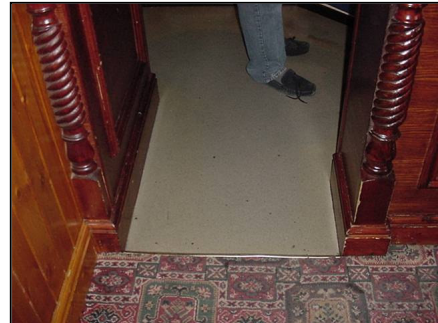
Altro-style floor. Burn marks.

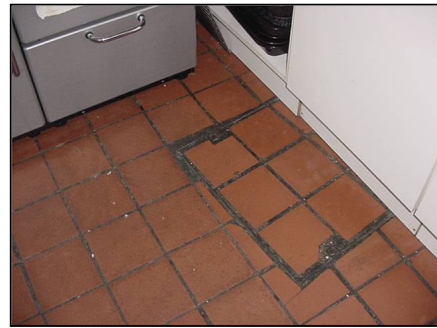
Quarry tiles with ingrained dirt to grout.
Sealed manhole.

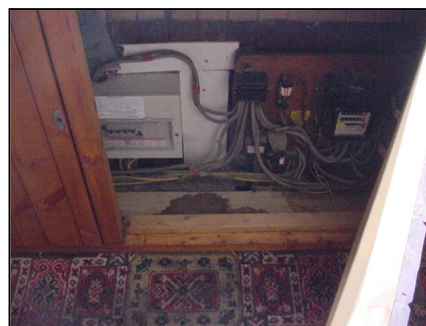
ELECTRICITY

The electrics are located in the main bar in the bay window area. We are advised that tests were carried out in October 2005.

ACTION REQUIRED: If there is no record of an electrical test having been undertaken within the last five years it is recommended that the installation be tested by a competent electrician (NICEIC registered) and all the recommendations be implemented. Thereafter the installation should be re-tested every five years.
