SCHEDULE OF CONDITION

Houghton Conquest,
Bedfordshire.

INDEPENDENT CHARTERED SURVEYORS

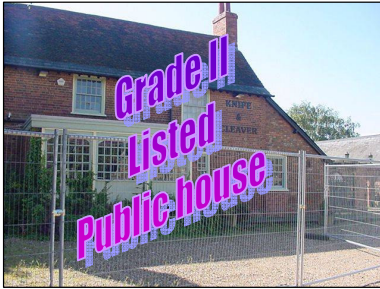
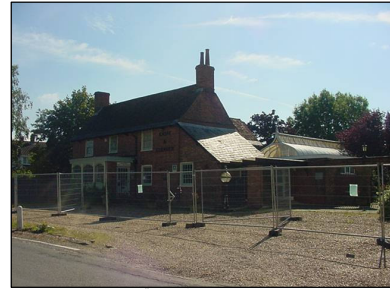
FRONT ELEVATION

DESCRIPTION	CONDITION	ACTION REQUIRED
Chimneys: Two brick chimneys Lead flashings	Weathered	Re-point and make watertight
Roofs: Pitched with a pegged clay tile Three rows of slates to the base Flat felt roof to front porch	Flat, water sitting on it

Ad hoc repairs Amend so that water drains off roof
Gutters and Downpipes: Mixture of cast iron and plastic	Old repairs	Ensure all gutters are watertight and falling towards the downpipe. Repair and secure as necessary, ensure downpipes are clear.
Soil and Vent pipes: Long run of plastic drainage	Likely to block due to lack of fall

<p>Walls: Flemish bond brickwork Pointed weathered</p> <p>Drop to the cellar is on the left hand side</p>	<p>Cracking on left hand side adjacent to the left hand lower window. Airbricks acting as gutters</p>

<p>Repair, prepare and re-point. Landlords to make an insurance claim</p>
<p>Fascias and Soffits: Exposed rafter feet</p> <p>Windows: 10x10 Georgian sliding sash</p>	<p>Some flaking of paintwork</p>	<p>Ease and adjust. Repair, prepare and redecorate.</p>

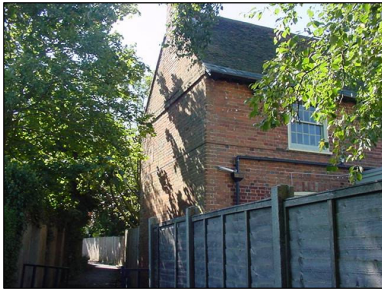
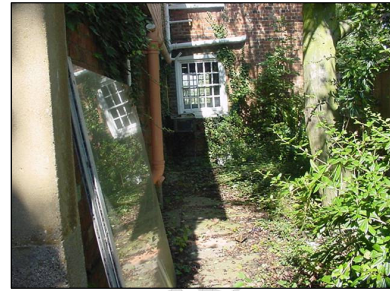
LEFT HAND SIDE ELEVATION

DESCRIPTION	CONDITION	ACTION REQUIRED
Chimneys: One brick chimney		Please see front elevation
Roofs: Clay tiles Three rows of slates to the base Part of rear flat roof visible with extract system		Ad hoc repairs Please see rear elevation
Gutters and Downpipes: Plastic	Looks to be leaking	Clear of leaves. Ensure all gutters are watertight and falling towards the downpipe. Repair and secure as necessary, ensure downpipes are clear.
Soil and Vent pipes: Long run of plastic drainage

<p>Walls:</p> <p>Brickwork walls to main building concrete frame to the rear part brickwork part shiplap boarding part concrete frame</p>	<p>Some deterioration and spalling to the brickwork particularly at low level</p> <p>Newer section to front left hand corner looks to have had impact damage</p> <p>Pile of soil against front left hand corner</p> <p>Shiplap boarding starting to fad</p> <p>Concrete columns deterioration present</p>	<p>Remove earth away from the base to stop dampness and would benefit from adding a French drain. General repair to brickwork and pointing. Would benefit from re-decoration in the summer of 2012</p> <p>Structural integrity report required.</p>
<p>Fascias and Soffits: Exposed rafter feet</p> <p>Windows: 10x10 Georgian sliding sash</p>	<p>Some deterioration, paint flaking</p>	<p>Redecorate in the summer of 2012.</p> <p>Repair and redecorate in the summer of 2012.</p>

<p>Trees and vegetation: Trees and ivy</p>	<p>Overhanging trees and overgrown ivy</p>	<p>Trees and Ivy needs cutting back</p>

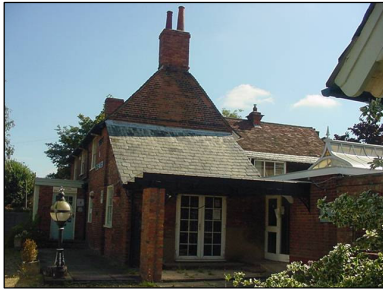
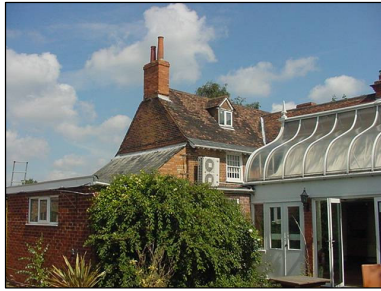
RIGHT HAND SIDE ELEVATION

DESCRIPTION	CONDITION	ACTION REQUIRED
<p>Chimneys:</p> <p>Two brick chimneys visible Chimney one see front elevation Chimney two to the rear</p>

<p>Rear chimney needs re-pointing, cracking visible internally</p>	<p>Re-point and make watertight</p>

<p>Ad hoc repairs</p> <p>Re-roof and re-bed the flashings</p> <p>Recommend insulation cut to fall and re-roofing. Replace felt flashing with a lead flashing</p>
<p>Gutters and Downpipes:</p> <p>Plastic</p>		<p>Ensure all gutters are watertight and falling towards the downpipe. Repair and secure as necessary, ensure downpipes are clear.</p>

<p>Large conservatory advised being redeveloped not included in Schedule of Condition</p>		<p>Ad hoc repointing</p> <p>Re-stain and resecure</p>
<p>Fascias and Soffits: Exposed rafter feet</p> <p>Windows: Timber and metal</p> <p>Doors: Plastic</p>		<p>Redecorate in the summer of 2012.</p> <p>Redecorate</p>

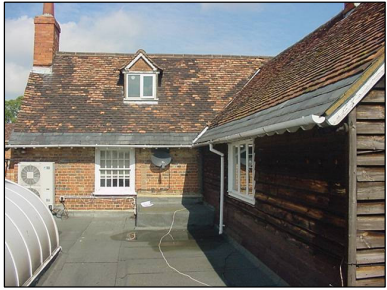
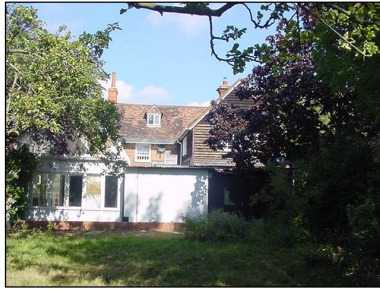
REAR ELEVATION

DESCRIPTION	CONDITION	ACTION REQUIRED
Chimneys: Two chimneys visible		Please see front and right hand side elevations
Roofs: Pitched clay tile Three rows of slates to the base Flat roof Polycarbonate conservatory roof, excluded from Schedule of Condition as advised being demolished as part of redevelopment.	Areas of ponding	Ad hoc repairs Re-roof and re-bed the flashings Recommend insulation cut to fall and re-roofing. Replace felt flashing with a lead flashing
Gutters and Downpipes: Plastic		Ensure all gutters are watertight and falling towards the downpipe. Repair and secure as necessary, ensure downpipes are clear.

Walls: Flemish bond brickwork Shiplap boarding Concrete frame structure	Fading	Ad hoc re-pointing Re-stain Please see comments on the left hand side elevation
Fascias and Soffits: Exposed rafter feet Windows: Timber casement windows, timber sliding sash windows and metal windows Rear dormers plastic windows Timber single glazed panels to conservatory base and also to the rear		Redecorate in the summer of 2012. Require redecoration Plastic windows unlikely to be looked upon favourably as Listed building
Comments: Trees growing within influencing distance close to the property on the right hand side		Arboriculturist report required. Likely to be needed to be cut back.

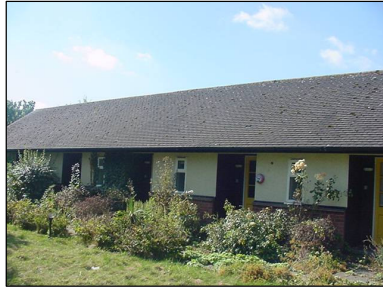
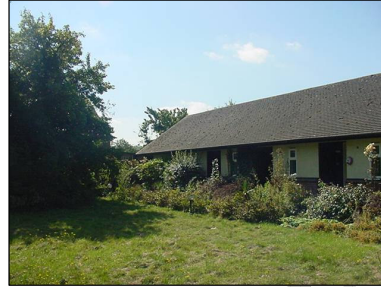
Rooms One to Six

DESCRIPTION	CONDITION	ACTION REQUIRED
Roofs:		
Small concrete tile	Some moss	Remove moss and ensure watertight
Right hand gable	Overgrown with vegetation	Cut back
Rear	Overgrown with blackberry bush	Cut back
Left hand side	Overgrown with vegetation	Cut back
Firebreaks: Number Four firebreak with truss breaks between different rooms either side i.e. room three and room five		Check firebreaks which we assume is part of the redevelopment
Protective Underlayer: visible Approx 150mm fibreglass insulation present not to present thermal efficiency standards		If insulation is added then ventilation is likely to be required.

Gutters and Downpipes: Plastic		Ensure all gutters are watertight and falling towards the downpipe. Repair and secure as necessary, ensure downpipes are clear.
Walls: Render to upper section Stretcher bond brickwork to lower section		Redecorate
Fascias and Soffits: Windows: Plastic, double glazed Trickle vents present Doors: Timber, single glazed	Window sill impregnated with dirt	Redecorate Redecorate

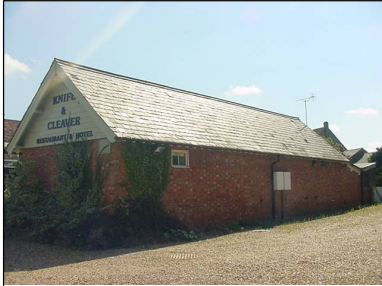
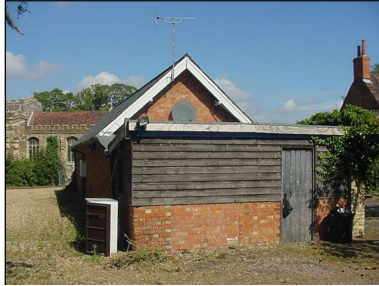
Rooms Seven to Nine

Back of accommodation block

Rear of accommodation block

DESCRIPTION	CONDITION	ACTION REQUIRED
<p>Roofs:</p> <p>Pitched slate tile with tingles</p> <p>Left hand side: Two inward facing hollow pitched flat roofs</p> <p>Centre valley gutter which discharges to the rear of the property</p> <p>Lead flashing and flashband</p> <p>Fire breaks:</p> <p>Room Seven inspected –no fire barrier found</p>	<p>Leak to rear</p>	<p>Repair. Ensure watertight. Repair and re-point.</p>

Gutters and Downpipes: Plastic		Ensure all gutters are watertight and falling towards the downpipe. Repair and secure as necessary, ensure downpipes are clear.
Walls: Flemish bond brickwork Bargeboards Four wall ties approx 1 metre from ground level	In need of redecoration	Redecorate.
Fascias and Soffits: Windows: Plastic double glazed Doors: Timber, single glazed		Clean Redecorate.
Storage Block: Formed out of breeze block to left hand side Brickwork to base and shiplap boarding to top section	Shiplap deteriorating boarding	Re-stain
Comments: We did not have access to Room Eight which is where the tie bars are so we have been unable to comment on these and we did not gain access to the storage block.

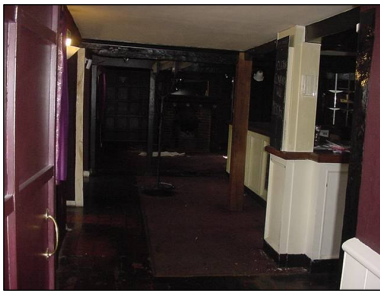
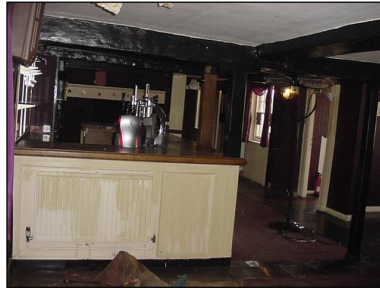
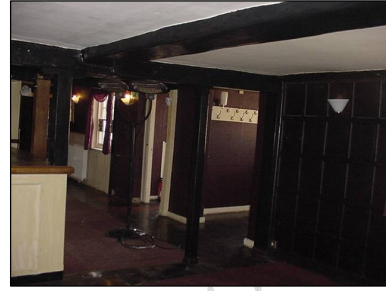
Front Bar server area

DESCRIPTION	CONDITION	ACTION REQUIRED
Ceilings: Painted	Marked	Repair, prepare and redecorate.
Walls: Painted Feature beams of a mixture of ages	Marked	Repair, prepare and redecorate.
Floors: Quarry tiles and Cork tiles	Ingrained dirt	Deep clean quarry tiles and clean cork covering and/or replace.
Detailing: Bar: Mirrored with spirit display Bar top: Timber Bar Front: Painted panels	Marked and worn old drill holes Marked and chipped	Make good, sand, redecorate.
Services: See Services section

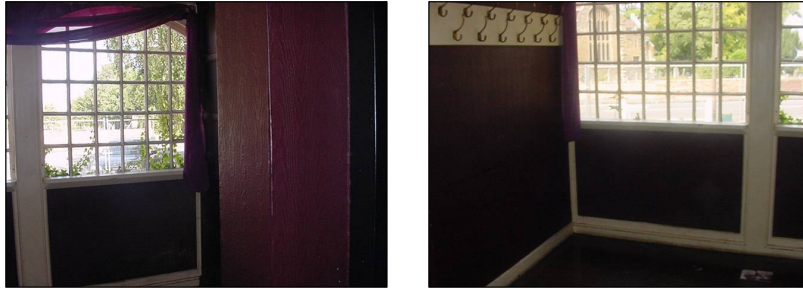
Old cloakroom

DESCRIPTION	CONDITION	ACTION REQUIRED
Ceilings: Painted	Nicotine stained	Repair, prepare and redecorate.
Walls: One panelled the remainder painted Light weight structure	Marked	Repair, prepare and redecorate.
Floors: Cork tiles Solid underfoot assumed concrete		Clean and/or replace
Detailing: Windows: Two Georgian style		Repair, prepare and redecorate.
Services: See Services section

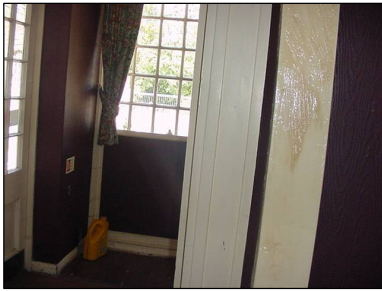
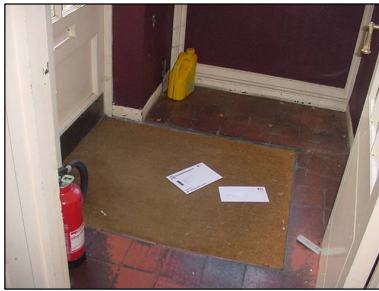
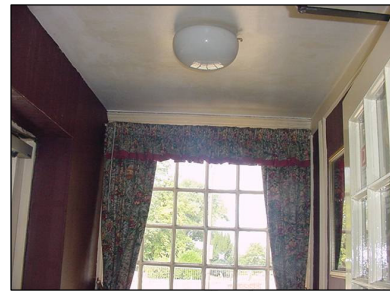
Entrance Lobby

DESCRIPTION	CONDITION	ACTION REQUIRED
Ceilings: Painted	Nicotine stained	Repair, prepare and redecorate.
Walls: Papered	Some paper coming away, marked.	Repair, prepare and redecorate.
Floors: Quarry tile with mat well in centre Light weight construction	Ingrained dirt	Deep clean
Detailing: Windows: Georgian Doors:		Repair, prepare and redecorate. Repair, prepare and redecorate.
Services: See Services section

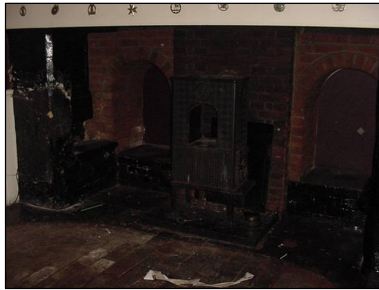
Right hand side

DESCRIPTION	CONDITION	ACTION REQUIRED
Ceilings: Painted One spine beam	Marked	Repair, prepare and redecorate.
Walls: Painted	Marked	Repair, prepare and redecorate.
Floors: Brick tile (probably bedded onto earth)	Ingrained dirt	Deep clean
Detailing: No windows and doors Inglenook fireplace	Damp coming into it

Stop dampness, repair and redecorate.
Services: See Services section

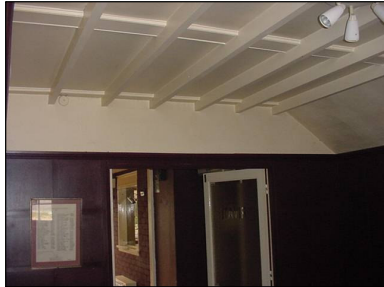
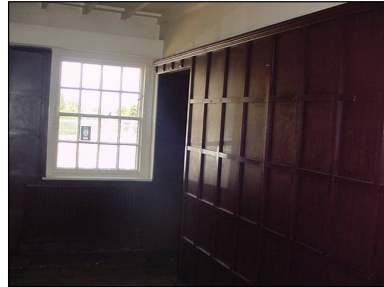
Bar/Private dining
(far right hand side)

DESCRIPTION	CONDITION	ACTION REQUIRED
Ceilings: Exposed joists Painted

Marked	Repair, prepare and redecorate.
Walls: Modern panelled Painted purple	Some marks and old fixings	Repair, prepare and redecorate.
Floors: Veneer	Marked	Clean/replace
Detailing: Windows: Doors: Double doors

Repair, prepare and redecorate. Repair, prepare and redecorate.
Services: See Services section

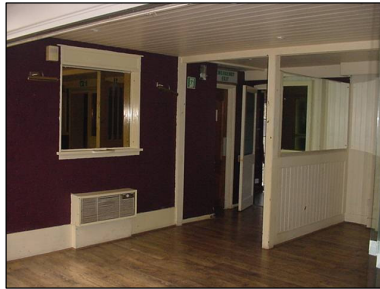
Middle bar area

DESCRIPTION	CONDITION	ACTION REQUIRED
Ceilings: Painted boarded Inset lights	Marked	Repair, prepare and redecorate.
Walls: Painted brick and painted vertical boards	Marked, general rising damp	Resolve rising damp. Repair, prepare and redecorate.
Floors: Laminate	Marked	Clean
Detailing: Skirtings:	Wet rot could become dry rot

Remove wet rot/dry rot. Repair, prepare and redecorate.
Services: See Services section		
Comments: Advised entire section is to be upgraded

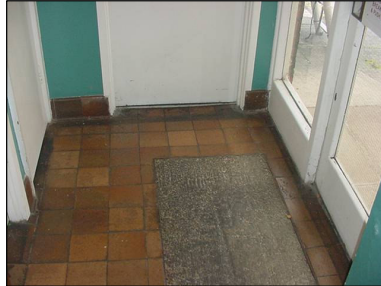
Lobby area to toilets
(with emergency exit)

DESCRIPTION	CONDITION	ACTION REQUIRED
Ceilings: Painted	Marked, hairline cracks	Repair, prepare and redecorate.
Walls: Painted	Marked	Repair, prepare and redecorate.
Floors: Quarry tiles with concrete infill	Ingrained dirt	Deep clean
Detailing: Windows: Doors: Georgian wired panels		Repair, prepare and redecorate. Repair, prepare and redecorate.
Services: See Services section

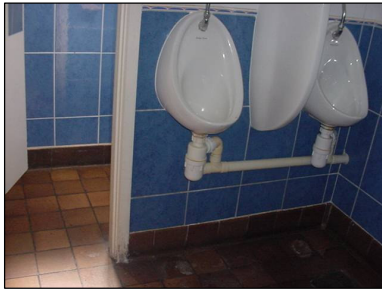
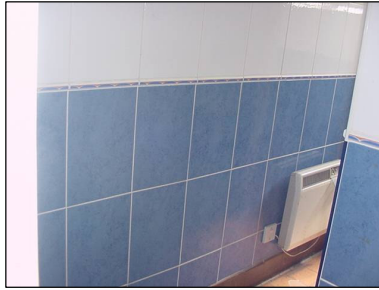
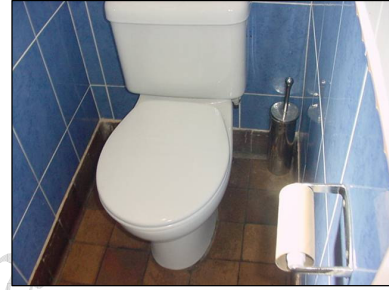
Gentlemen's Toilets

DESCRIPTION	CONDITION	ACTION REQUIRED
Ceilings: Painted	Marked, hairline cracks	Repair, prepare and redecorate.
Walls: Floor to ceiling wall tiles, large blue and white	Ingrained dirt	Deep clean
Floors: Quarry tile	Ingrained dirt	Deep clean
Sanitary Ware Two urinals One WC One corner wash hand basin		Deep clean
Detailing: Windows: Doors: Painted flush door		Repair, prepare and redecorate. Repair, prepare and redecorate.
Services: See Services section Several inset lights some of them literally falling out of the ceiling

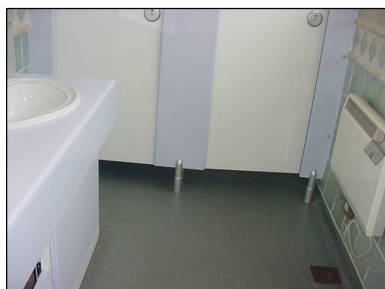
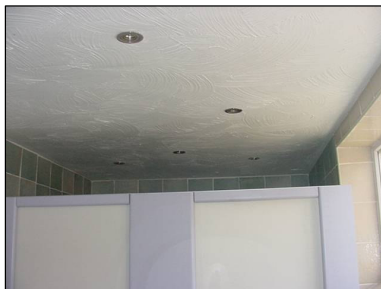
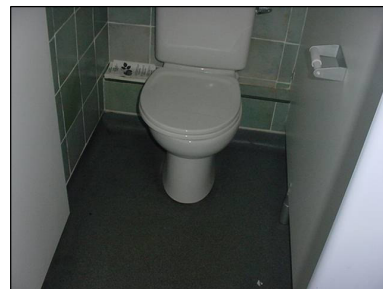
Ladies' Toilets

DESCRIPTION	CONDITION	ACTION REQUIRED
Ceilings: Textured painted Inset lights	Marked	Repair, prepare and redecorate.
Walls: Tiles from floor to ceiling	Ingrained dirt	Deep clean
Floors: Altro style flooring Gully	Ingrained dirt	Deep clean
Sanitary Ware: Lilac Two WC's Vanity unit Two wash hand basin		Deep clean
Detailing: Windows: Doors: Flush painted Entrance door rustic	Marked	Repair, prepare and redecorate. Repair, prepare and redecorate.
Services: See Services section

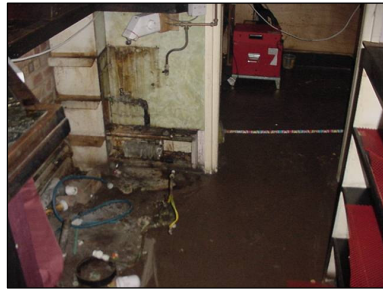
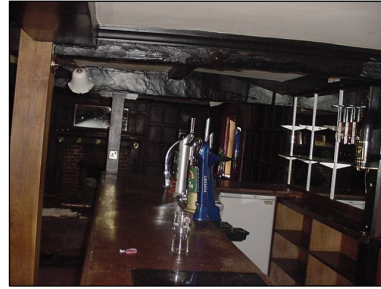
Back Bar Servery area

DESCRIPTION	CONDITION	ACTION REQUIRED
Ceilings: Painted Feature beams	Marked	Repair, prepare and redecorate.
Walls: Painted Mirrored back Wooden shelving system with formica covering	Rising damp

Resolve rising damp. Repair, prepare and redecorate.
Floors: Altro style flooring	Ingrained dirt	Deep clean
Detailing: Timber bar	Marked to top and front	Repair/replace
Services: See Services section		
Comment: Not to Environmental Health Standards

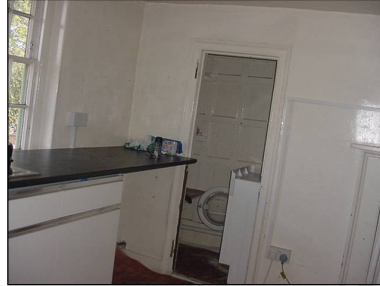
Kitchen

DESCRIPTION	CONDITION	ACTION REQUIRED
Ceilings: Gloss painted	Marked	Benefit from redecoration.
Walls: Gloss painted Part of chimney	Marked	Benefit from redecoration.
Floors: Vinyl covering over timber floor	Deflection falling towards centre of the building	Clean
Detailing: Windows: Georgian style sliding sash Doors: Flush painted	Marked	Ease and adjust. Repair, prepare and redecorate. Repair, prepare and redecorate.
Appliances: The appliances have not been inspected, as we are not expert in this area, you should seek expert advice.

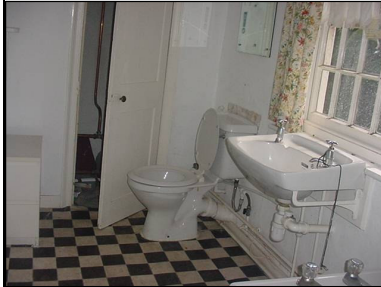
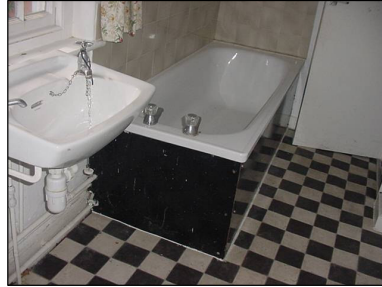
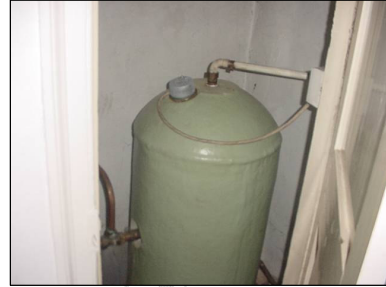
Bathroom
(rear left hand side)
Hot water cupboard adjacent to this

DESCRIPTION	CONDITION	ACTION REQUIRED
Ceilings: Emulsion painted	Dirty	Repair, prepare and redecorate.
Walls: Emulsion painted Part of chimney	Dirty Hairline crack between ceiling and wall to all walls.	Repair, prepare and redecorate.
Floors: Vinyl covering over timber floor	Deflection falling towards centre of the building	Clean
Detailing: Windows: Georgian style sliding sash window Doors: Flush painted	Broken pane of glass. Marked	Replace glass. Repair, prepare and redecorate. Repair, prepare and redecorate.
Sanitary ware: Bath, wash hand basin and WC	Mixture of pipes from plastic to copper flexi pipe	Deep clean

Pipework goes into the chimney pipes currently leaking into the bar below where the ceiling has come down.

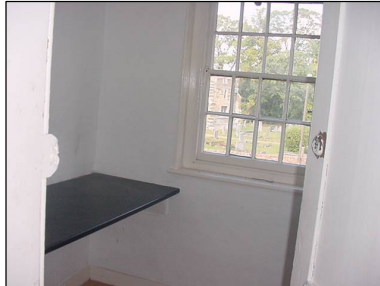
Study/Office

DESCRIPTION	CONDITION	ACTION REQUIRED
Ceilings: Painted	Marked	Benefit from redecoration.
Walls: Painted	Marked	Benefit from redecoration.
Floors: Vinyl	Deflection	Clean
Detailing: Windows: Doors: Painted panelled door	Marked	Repair, prepare and redecorate. Repair, prepare and redecorate.
Services: See Services section

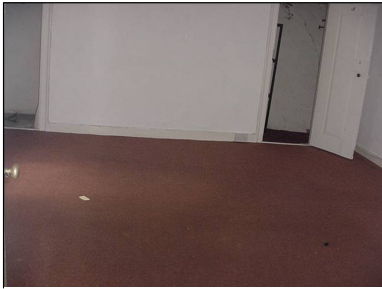
Right hand Room

General view

DESCRIPTION	CONDITION	ACTION REQUIRED
Ceilings: Painted	Marked	Benefit from redecoration.
Walls: Painted Two cupboards around chimney both with panelled doors	Marked Dampness Extensive cracking running for approx two and a half metres from floor to ceiling diagonally to right hand side.	Repair, prepare and redecorate. Resolve dampness Monitor cracking as per BRE recommendations for one year. Place an insurance claim.
Floors: Fixed carpet	Uneven falling to the centre	Clean

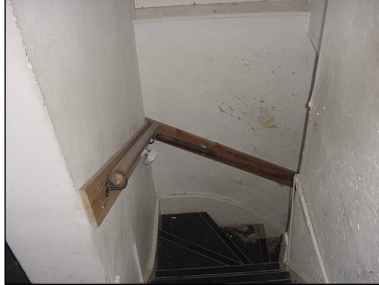
Staircase
(Wrap around central chimney)

DESCRIPTION	CONDITION	ACTION REQUIRED
Ceilings: Painted	Marked	Repair, prepare and redecorate.
Walls: Painted	Impact damage Dampness	Repair, prepare and redecorate. Resolve dampness
Floors: Carpets	General fall towards the centre of the room	Clean or replace
Services: Fire Alarm – battery missing Double panelled radiator

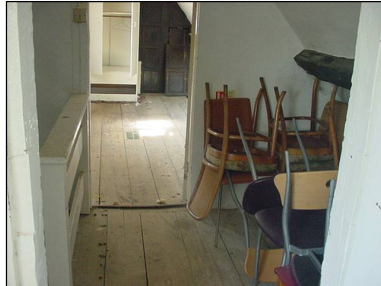
Landing area

DESCRIPTION	CONDITION	ACTION REQUIRED
Ceilings: Lath and plaster Papered and painted	Paper is coming away. Marked.	Repair, prepare and redecorate.
Walls: Papered and painted Timbers	Paper is coming away. Marked. Impact damaged. Woodworm visible to purlins	Repair, prepare and redecorate. Open up walls, check extent of woodworm.
Floors: Timber boarding	Signs of woodworm	Open up floors, check extent of woodworm.
Services: No Heating Electric fittings dated

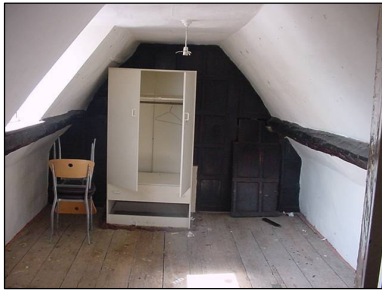
Right hand side Room

General view

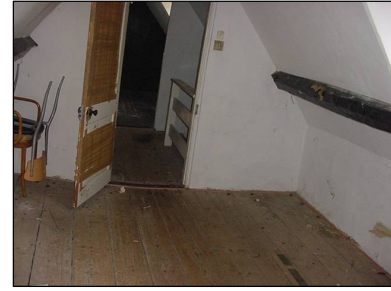
General view

DESCRIPTION	CONDITION	ACTION REQUIRED
Ceilings: Lath and plaster Papered and painted	Partly newly painted assuming that there was a roof leak here recently	Repair, prepare and redecorate.
Walls: Vaulted papered and painted. Timber panel to right hand side Two purlins	Heavily marked Purlin to rear seems to have the worse of the woodworm	Repair, prepare and redecorate.
Floors: Timber	Woodworm found	Open up floors, check extent of woodworm.

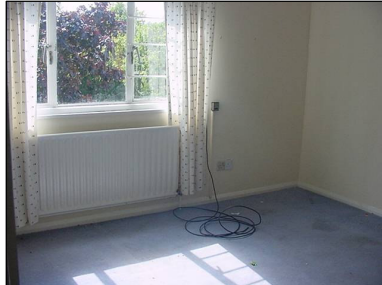
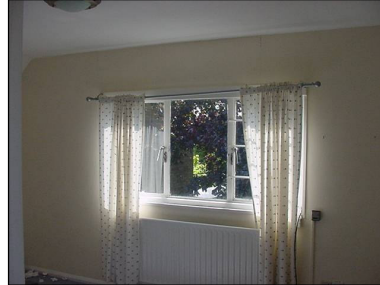
Bedroom with en suite bathroom
(to the rear)

DESCRIPTION	CONDITION	ACTION REQUIRED
Ceilings: Painted	Hairline cracking	Fill holes. Repair, prepare and redecorate.
Walls: Painted	Marked	Repair, prepare and redecorate.
Floors: Carpet	Deflection	Clean or replace
Detailing: Windows: Metal single glazed Doors: Flush veneered 1970s style		Repair, prepare and redecorate. Clean
Services: Single panelled radiator - rusting

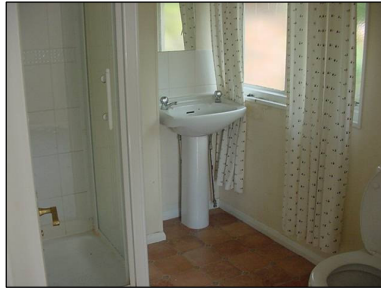
En suite shower room

DESCRIPTION	CONDITION	ACTION REQUIRED
Ceilings: Painted Four lights No extract fan present	Dampness to centre of the ceiling Condensation	Repair, prepare and redecorate.
Walls: Painted	Marked	Repair, prepare and redecorate.
Floors: Vinyl	Falls towards the sink	Clean or replace
Detailing: Windows: Metal crittall single glazed Doors: Flush veneered 1970s style	Damp staining

Sanitary ware: Shower unit, wash hand basin and WC	Sink not plumbed in Tiling within shower is stained and marked WC on a macerator	
Services: Service duct Single pipe for radiator not fitted.

Repair, prepare and redecorate. Clean

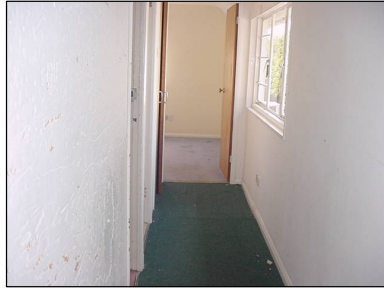
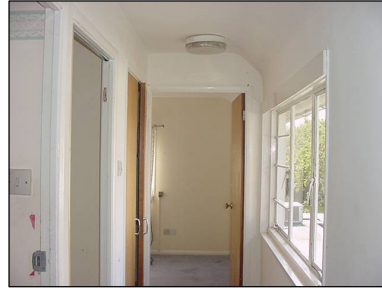
Access corridor

DESCRIPTION	CONDITION	ACTION REQUIRED
Ceilings: Painted	Marked	Repair, prepare and redecorate.
Walls: Painted	Marked heavily near to staircase Dampness around the door Hairline cracking	Repair, prepare and redecorate.
Floors: Carpet	Marked	Clean or replace

<p>Detailing:</p> <p>Windows: One single glazed metal window with security bars</p> <p>Doors: Two veneered doors to cupboards</p> <p>Two Cupboards: One is an airing cupboard</p>

<p>Other cupboard is an open cupboard with sliding folding door</p>	<p>Old style hot water cylinder with insulation jacket. Cracked chimney breast within cupboard.</p>

<p>Repair, prepare and redecorate.</p> <p>Clean</p>
<p>Services: See Services section</p>

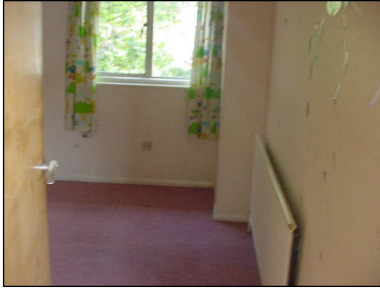
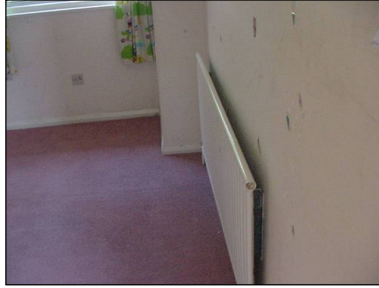
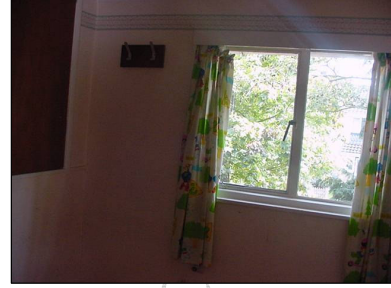
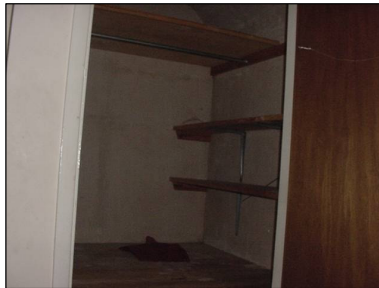
Bedroom

DESCRIPTION	CONDITION	ACTION REQUIRED
Ceilings: Painted 1970s style light	Marked, hairline cracks	Repair, prepare and redecorate. Check light and change
Walls: Painted	Heavily marked	Repair, prepare and redecorate.
Floors: Carpet	Marked	Clean or replace

Detailing: Windows: Double glazed metal Doors: Veneered Cupboard:		Repair, prepare and redecorate. Clean
Services: One internal single panelled radiator
