# PROPERTY REPORT

**Mid Terrace  
Town Centre  
Office Premises**

## **INTRODUCTION**

We have been asked to inspect and prepare a Report and Schedule of Condition on the subject premises.

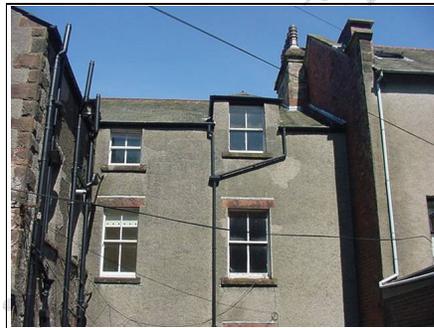
Rear elevation

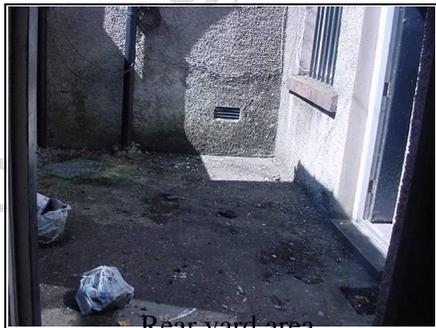
Rear yard area

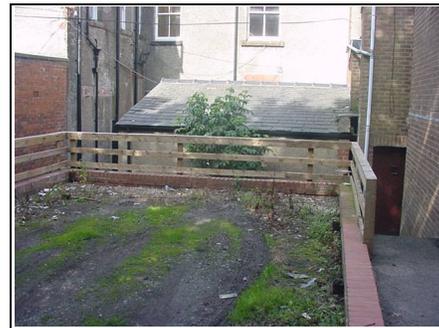
Outbuilding to the rear and parking  
– ownership to be confirmed

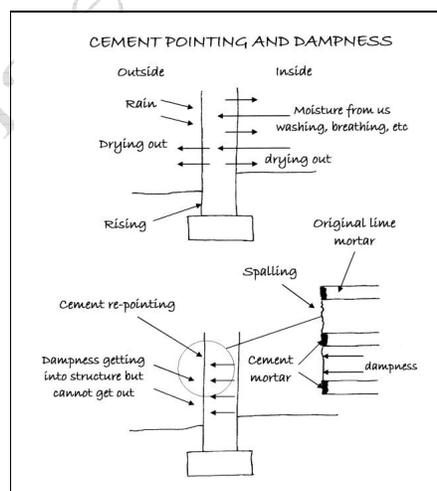
2.1 We can see signs of dampness coming through the walls and also getting damp meter readings. This is known as lateral dampness. We believe this is caused partly by the cracking to the render to the rear and partly by defective gutters and by defective pointing. Unfortunately the re-pointing has been carried out with cement mortar so this stops the building from dissipating the dampness (think Vortex type coat rather than a raincoat with regard to how this building should work when dealing with rainwater).

This type of building therefore should have an open breathable joint in a lime based mortar in our opinion.

Poor quality cement re-pointing to stonework

The work required to reduce the dampness getting into this property is first of all to make the property watertight at high level, i.e. ensuring the gutters and downpipes take water away and then in the case of the stonework we would recommend repointing in a lime based mortar and repairs to the plasterwork internally. Again internally we would recommend a lime based plaster, this puts up with dampness far better in older properties (whatever you do, don't use modern gypsum plaster as this doesn't cope with dampness very well or renovated plasters which locks the dampness into the property). To the rear you will need to seal all the hairline cracking and replace any damaged or deteriorating render.

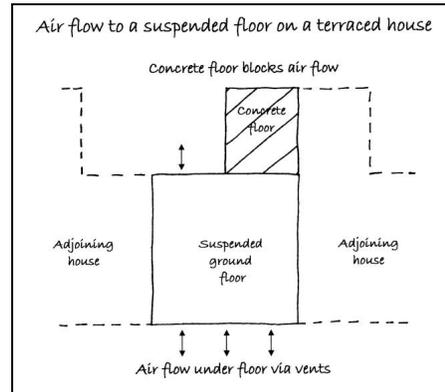
The floor is formed with a suspended timber floor. Unfortunately we have not been able to open this up nevertheless from the damp meter readings we obtained on the ground floor level, the lack of air vents to the rear of the property and the areas of concrete floor to the entrance we believe there is a problem with the floor.

**ACTION REQUIRED:** Before you commit to purchase this property you need to open up a section of the floor, we suggest sections (1) to the front of the property in the front office and (2) to the rear of the property in the rear office and adjacent to the rear exit door. We would be more than happy to return to comment further. You need to have contractors on hand to open up and replace the timbers, ideally the areas that are opened up should be adjacent to airbricks so we can see that these are really working although the airbricks to the rear appear to be at the wrong level unless there are vent trunks through the wall itself.

**ANTICIPATED COST:** To open up and put back the floor we would expect costs in the region of £250 - £500; quotations required. Note that the floor is damp and that new timber may be required. There will be major expense if these timbers need renewing or extensive repair.

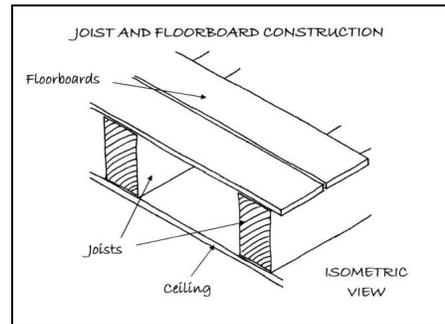
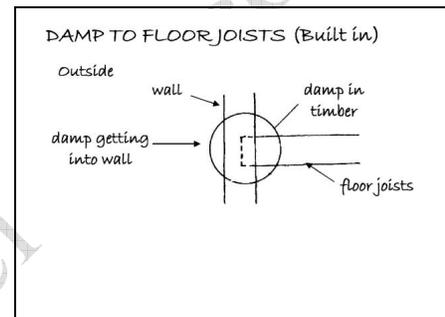
We found excessive deflection in the floors indicating that the joists have problems. This could relate to the joist ends rotting or woodworm throughout the timber. Although we saw no signs of woodworm we didn't take up the carpet area or have good access to the roof (head and shoulders inspection only) which is the other area that problems may be highlighted.

**ACTION REQUIRED:** The floors need to be opened up to check the condition of the timbers, they may have wet rot to the joist ends or they may be suffering from woodworm. We would recommend the opening up is carried out near the front and rear walls as we would also like to see if these are tied in to the joists.

**ANTICIPATED COST:** In the region of £250 - £500; quotations required.

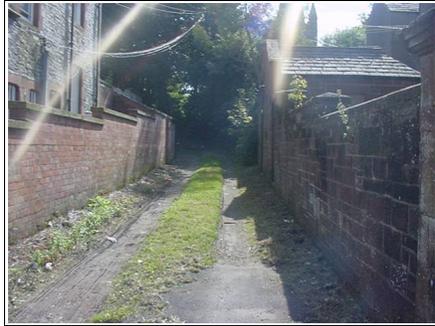
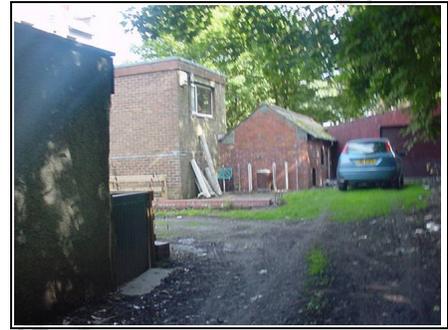
There is a road access on the right hand side, your legal advisor needs to check and confirm that you have a right of way (all directions given as you face the front of the property).

Road access on right hand side

**ACTION REQUIRED:** Your legal advisor to check and confirm if you have rights to use the access to the rear of the property and if so if you have responsibility with regard to the condition of the road, etc.

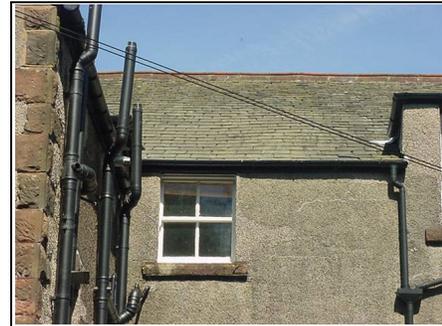
The main roof comprises a pitched roof clad in slates. The slates sit fairly true and we did not note too many slipped or cracked slates considering the property's age, type and style.

Roof slates

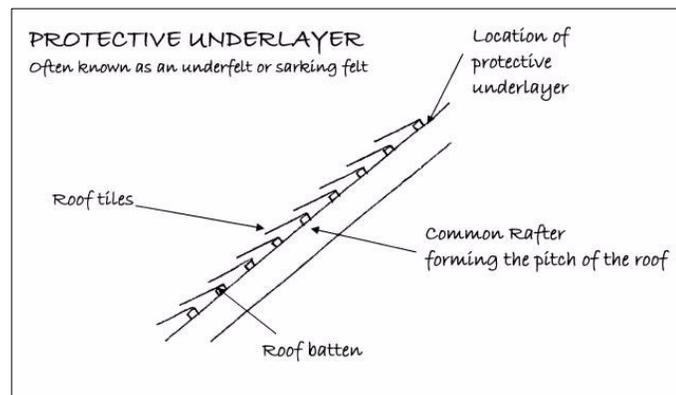
The property has a hessian based protective underlayer indicating that it has been re-roofed post war. Due to an awkward angle to get into the roof (it was over the stairway) and the small access area we have only carried out a head and shoulders inspection, however we would comment that we could see white staining on the timbers (known as batons) indicating that dampness or condensation is occurring in the roof which we were surprised to see. This may indicate problems with the roof therefore a close inspection needs to be carried out when the high level work is taking place.

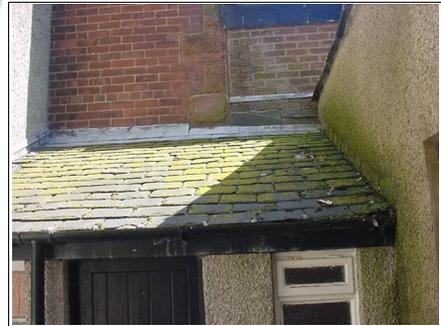
Roof of outbuilding to rear left hand side

This is a shallow pitched slate roof, we can see some lead tingles have been added indicating that the nails may be starting to deteriorate.

**ACTION REQUIRED:** You need to lift a few slates to check the condition of the fixing nails.

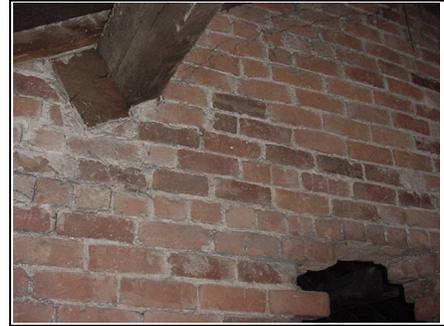
Firewall

We can see brick firewalls on either side, however also please see our comments with regards to you having a stepped division between you and the neighbouring property, possibly a flying freehold.

**ACTION REQUIRED:** Your legal advisor to check and confirm whether or not you have a Flying Freehold.

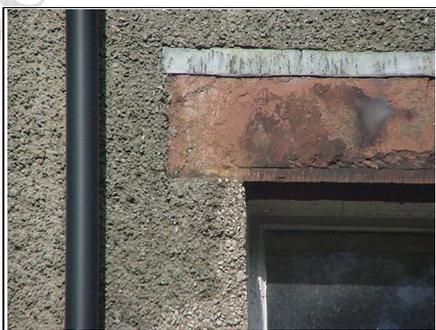
A good indication of the quality of rendering, we have found over the years, is by the quality of detailing above the windows and to the base of the property. In this instance the detailing over the stonework we believe is a good detail. At ground level we would prefer to see a bell mouth detail rather than the render to the floor detail which does tend to allow capillary action which then allows dampness inside which can be seen.

Drip detailing above windows

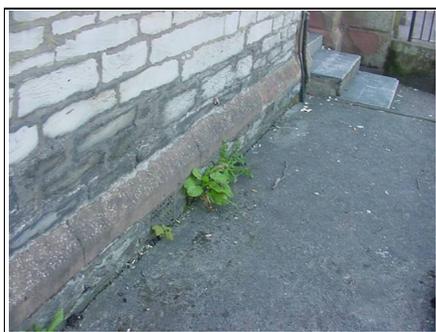
There are airbricks visible to both the front and rear of the property however the airbricks to the rear of the property look too high to be used within the floor. As mentioned elsewhere within the report that unless there is a conduit passing air from the airbrick location through the wall and into the floor you will have to add airbricks to the rear of the property.

Airbrick to front of property – near green vegetation

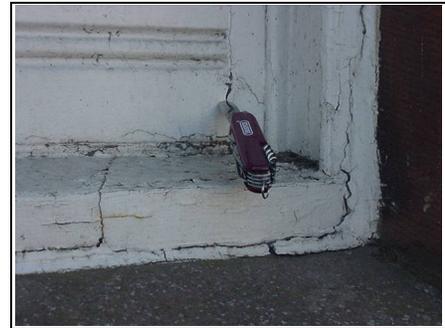
This property predominantly has sliding sash windows. These are single glazed and have a painted timber finish and are in average condition considering their age, type and style. We would specifically comment that our knife test didn't find any major rot in the windows to the ground floor however it is always likely in our experience that rot is at higher levels.

Checking windows

**ACTION REQUIRED:** We would recommend repair, prepare and redecorate.

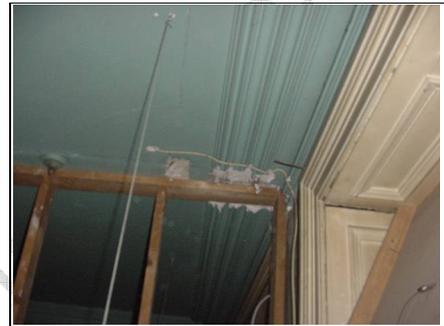
View taken within ceiling space of ground floor office after removing suspended ceiling tile.

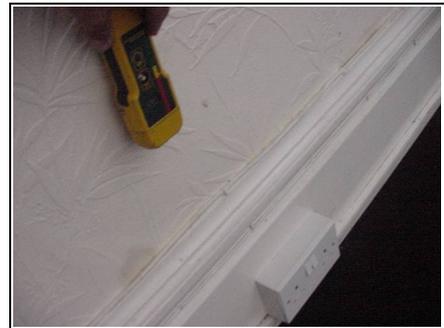
A random visual inspection and tests with a moisture meter have been taken to the perimeter walls and dampness was found throughout the property.

Checking for dampness

**ACTION REQUIRED:** Please see our comments in the Executive Summary.

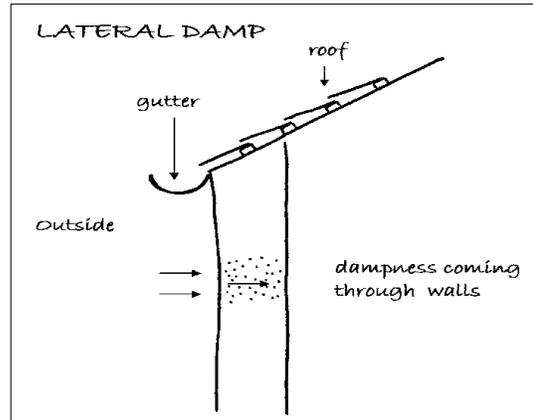
Tests were taken with a moisture meter at random points to external walls. We generally got high dampness readings and/or visually noticed dampness coming through the property in the form of mould.

**ACTION REQUIRED:** Please see our comments in the Executive Summary.

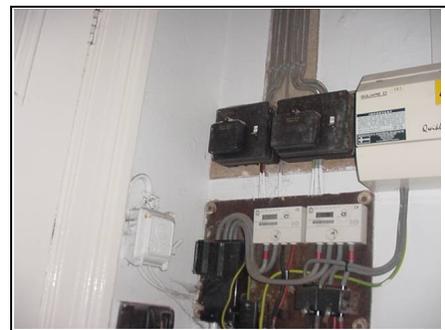
Fuse board

The electrics are likely to require complete renewal however we would recommend in the first instance a test by an NICEIC approved electrician or equivalent to Institute of Electrical Engineers (IEE) standard.

**ACTION REQUIRED:** Re-wire. Please see our comments in the Executive Summary.
