COMMERCIAL BUILDING SURVEY

Basildon

INDEPENDENT CHARTERED SURVEYORS

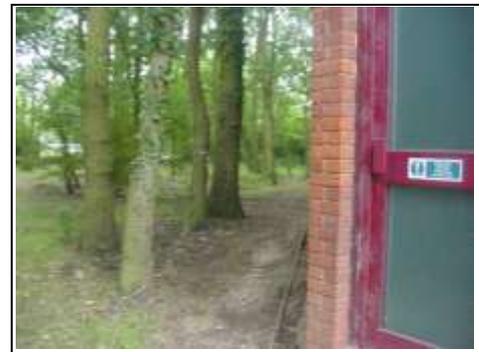
Trees close to property at rear

Logically the developer may have designed the foundations to accommodate the trees or has put a root barrier in place.

ACTION REQUIRED: We feel it is essential that you understand how the foundations are built. This information should be obtainable either from the present owners and/or the managing agent and/or the Local Authority. Your legal advisor needs to carry out investigations on this matter and provide us with a set of drawings for us to comment further upon.

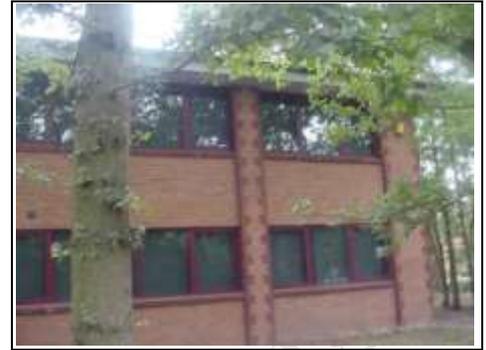
Trees close to property

comment. We would go further than this and say that your legal advisor should be speaking directly with the architects/engineers of the original construction to get a comment upon how they made allowance for/accommodated for the trees that are so close by.

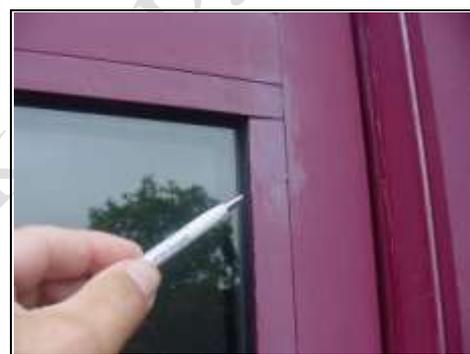
The finish/protective coating on the windows is starting to deteriorate and fade giving a poor quality look.

Close up of front door paintwork fading

ACTION REQUIRED: We would recommend budgeting for replacement windows.

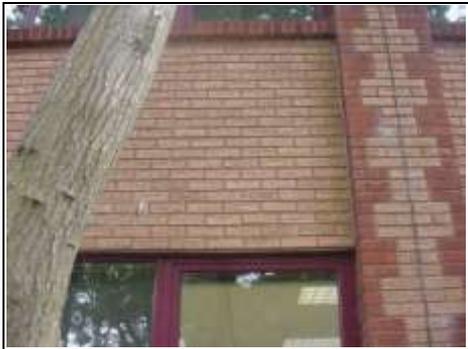
For a property that is so close to the trees we were surprised not to see any cracking damage. We note that there are expansion joints around the plasters and there is what we would term brick panelling between again with mastic joints. It could be that these have been so designed to allow for some movement in the structure which is to be expected with a property so close to trees. We can see that some of the brickwork is not to the best of quality and has what is known as butted up.

Brick panelling around column to right hand side, expansion joint and left brickwork panel close to tree

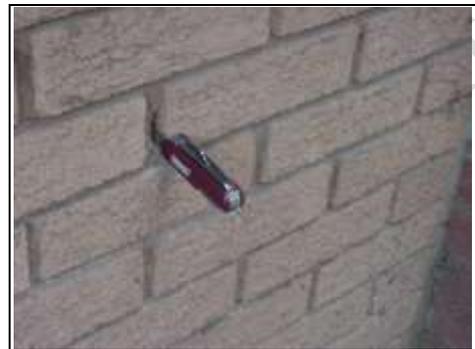
quickly and the ends are just touched with mortar rather than being fully mortared.

This means, as you can see in the photographs, that we can get a pen into the perpendicular ends (known as the perp ends).

Some of the perpendicular ends have not been butted up

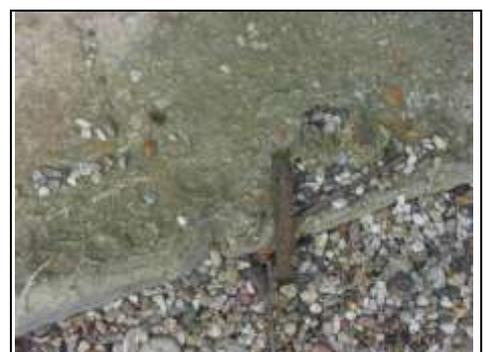
Close up view

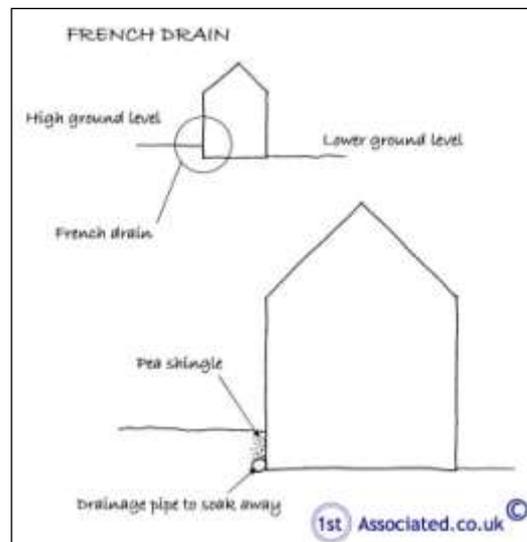
French drain

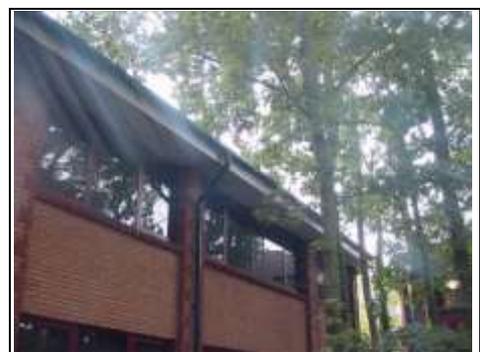
Restricted view on left hand side and rear main roof

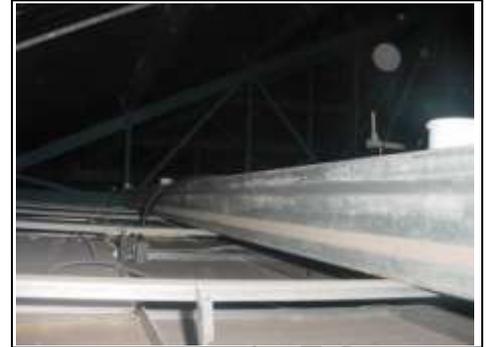
We cannot see the protective underlayer due to the metal cladding beneath the roof. Please see our comments in the Executive Summary with regard to the likelihood of condensation and interstitial condensation in this area and also the large roof void area that you will be heating.

View within the roof void which can be accessed by lifting a suspended ceiling tile.

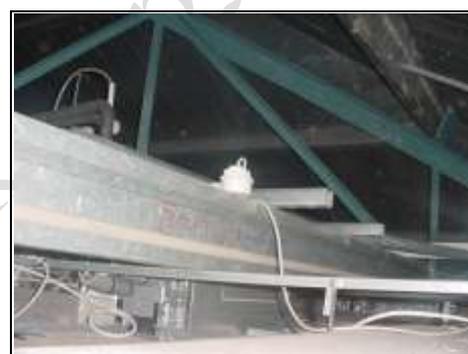
The property, as far as we could see, does not have a safe roof access. The roof space can be viewed by lifting a suspended ceiling tile and here we could see that there is a structural frame with wiring for the lights etc contained in it and also a water tank. Our main concern in this area is as set out in the Executive Summary.

Steel frame forming roof structure

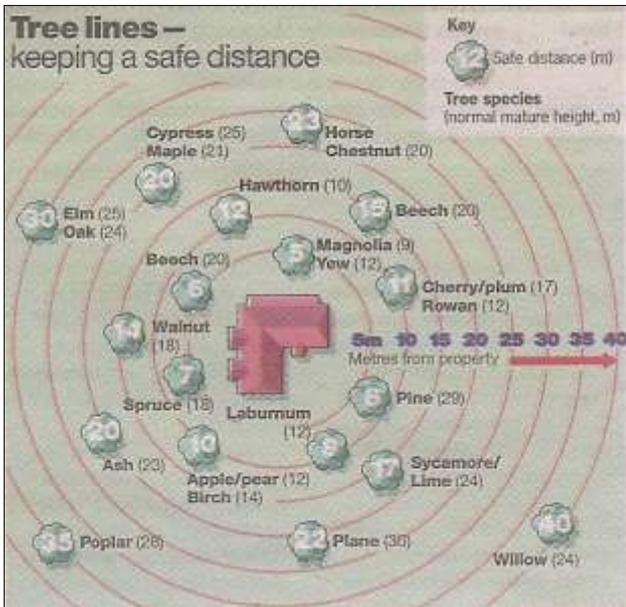
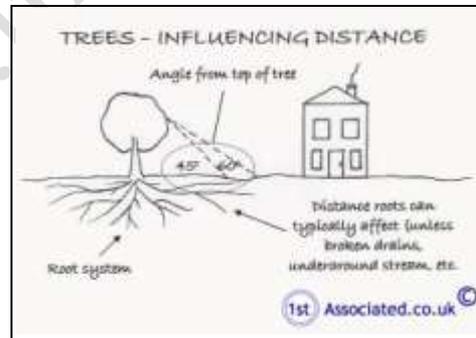
Influencing distance

Trees and vegetation close to property

ACTION REQUIRED: Please see our comments in the Executive Summary.

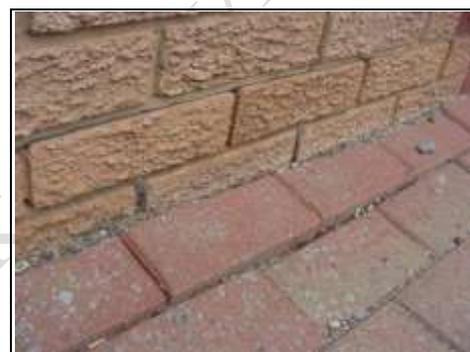
All modern properties should incorporate a damp proof course (DPC) and good building practice dictates that a differential of 150mm (6 inches) should be maintained between the damp proof course and ground levels. In this case, we could see a damp proof course, please see our comments with regard to the brick and mortar deterioration that is being caused by rainwater bouncing up off the brick paves to the front of the property. Your attention is drawn to the section of the report specifically dealing with dampness.

Damp proof course

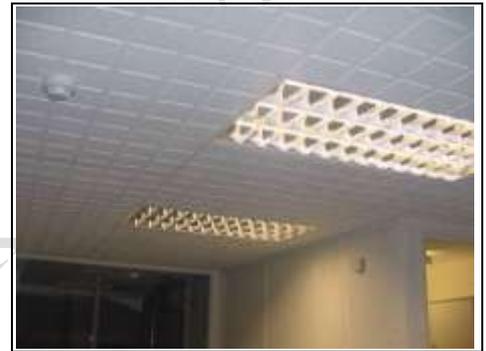
Suspended ceiling system

The ceilings are finished with a suspended ceiling tile. In some areas there are the older rectangular ceiling tiles and in other areas there are more modern square ceiling tiles. We could see damp staining in many areas, both in the ground floor and the first floor. We believe this relates to a combination of pipe leaks and condensation to the pipes and also condensation to the roof.

ACTION REQUIRED: Please see our comments in the Executive Summary.

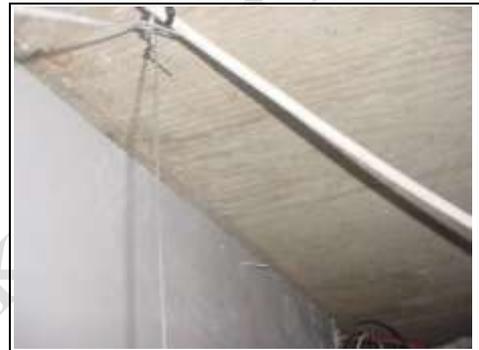
We have assumed that the first floor construction is concrete, as this is typical in this age of property.

Concrete on the first floor

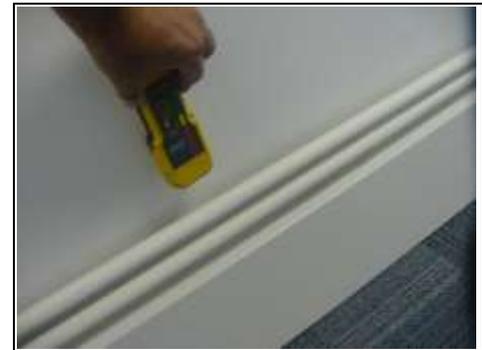
A random visual inspection and tests with a moisture meter have been taken to the perimeter walls and some internal walls. No evidence of any significant rising dampness was detected.

Testing for rising damp

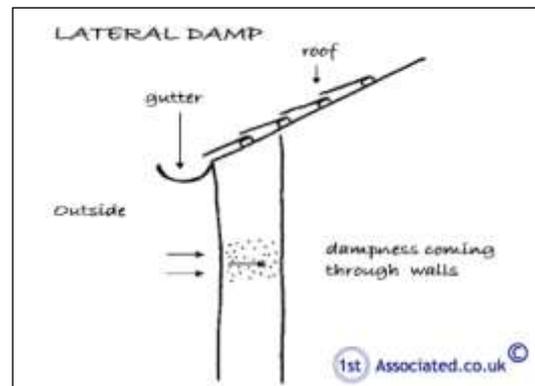
Tests were taken with a moisture meter at random points to internal walls, floors and other surfaces. No evidence of any

Lateral damp
