PROPERTY REPORT
OF
A Commercial Property,
Grove Park, London SE12

FOR
Mrs T

SCHEDULE OF CONDITION
OF
A Commercial Property
Grove Park, London SE12

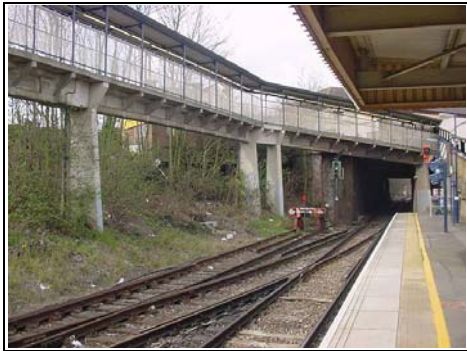
Rear Embankment

To the rear of the property we can see that the building sits on a embankment, which can possibly be partly canterlevered over. Access to the rear of the property is via Railtrack property. Therefore your solicitor needs to confirm whether parking is available with this Lease Agreement and if there are any obligations, limitations or costs associated with it.

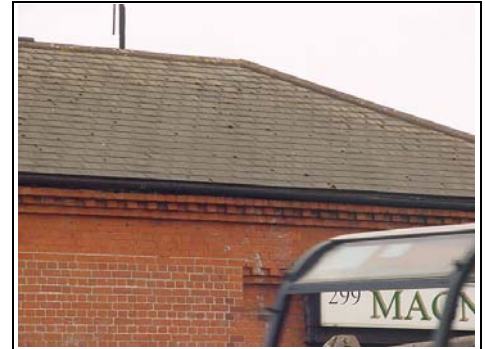
Side Roof

The roof is pitched and clad in a concrete tile. From what we could see the concrete tiles are lying level and true and look in reasonable condition. Sometimes we find that deterioration occurs to the roof abuts and adjoining wall and exposed areas such as the perimeter and so you should periodically check these areas.

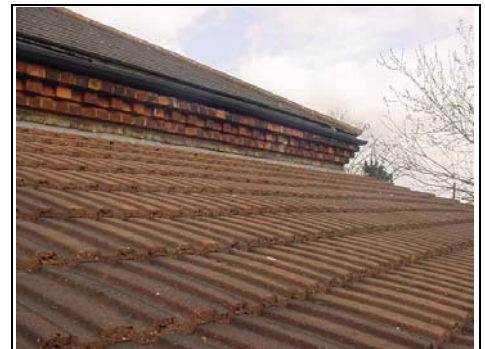
In this case the flashing looks in reasonable condition. Our concern is where the roof abuts the flat roof.

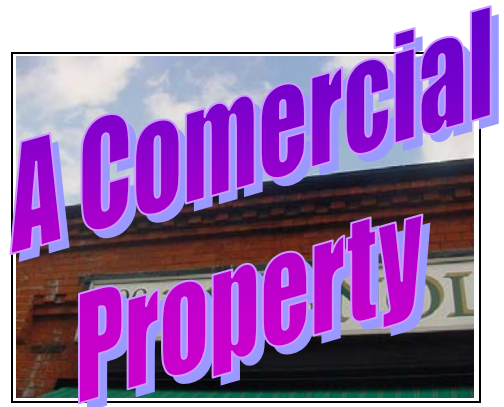
Signage and Lighting

There is dated signage and lighting to the property. You may wish to consider improving/replacing this.

New signage may require Planning Permission.

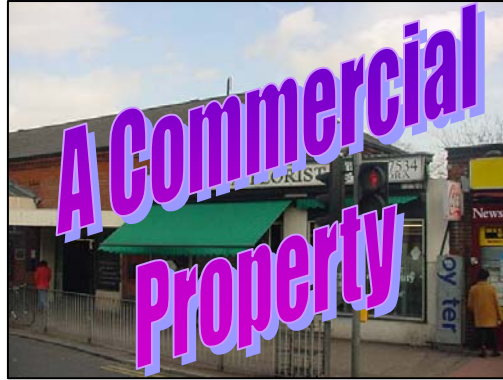
FRONT VIEW

DESCRIPTION	CONDITION	ACTION REQUIRED
<p>Main Roof:</p> <p>Slate</p> <p>Side Roof:</p> <p>Pitched concrete tiles</p>	<p>Average</p> <p>Letting in water</p>	<p>Check condition of tiles, underlayer and common rafters. Add and replace as necessary.</p>
<p>Gutters and Downpipes:</p> <p>Plastic to the high level part of the property and cast iron to the low level part of the property.</p>	<p>Plastic: reasonable, but check.</p> <p>Cast Iron:</p>	<p>Check when next raining.</p> <p>Check and repair.</p>
<p>Walls:</p> <p>Brickwork at high level and painted render around the shop.</p>	<p>Render:</p> <p>Brickwork:</p>	<p>Repair and redecorate.</p> <p>Repair</p>
<p>External Joinery:</p> <p>Windows: Timber boarding to right hand side</p>	<p>Dated frame</p>	<p>Needs re-securing and redecoration.</p>

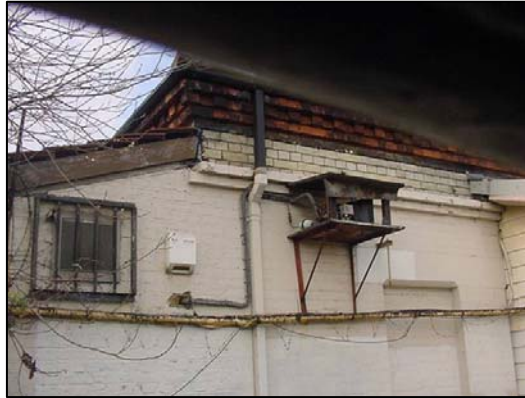
REAR VIEW

DESCRIPTION	CONDITION	ACTION REQUIRED
<p>Main Roof:</p> <p>Slate</p> <p>Side Roof:</p> <p>Pitched concrete tiles</p>	<p>Average</p> <p>Letting in water</p>	<p>Check condition of tiles, underlayer and common rafters and replace as necessary.</p>
<p>Gutters and Downpipes:</p> <p>Plastic to the high level part of the property and cast iron to the low level part of the property.</p>	<p>Plastic: reasonable, but check.</p> <p>Cast Iron:</p>	<p>Check when next raining.</p> <p>Check and repair.</p>
<p>Walls:</p> <p>Painted brickwork to rear of property (accessible via Railtrack)</p>	<p>Average</p>	<p>Redecorate.</p>
<p>External Joinery:</p> <p>Fascias and Soffits</p>		<p>In need of redecoration</p>

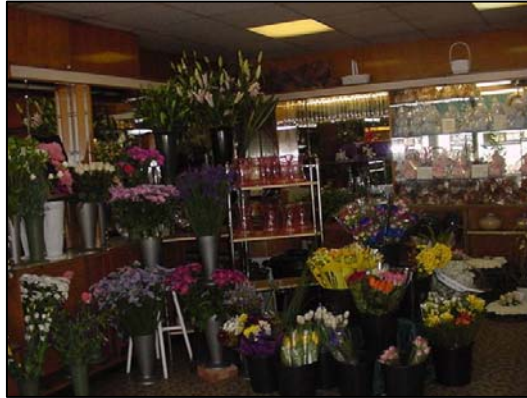
Florist Trading Area (front left hand side of property)

DESCRIPTION	CONDITION	ACTION REQUIRED
<p>Ceilings:</p> <p>Suspended</p>

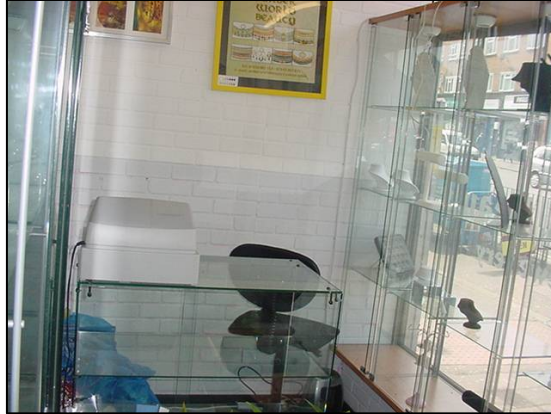
Jewellery Display Area
(front right hand side of property)

DESCRIPTION	CONDITION	ACTION REQUIRED
<p>Ceilings:</p> <p>Suspended</p>

<p>Marked and damaged ceiling</p>	<p>Replace</p>
<p>Walls:</p> <p>White painted with brick effect</p>	<p>Some red coming through white paint.</p>	<p>Redecorate and/or replace.</p>
<p>Floors:</p> <p>Upstand formed in timber with a carpet finish</p>	<p>Average</p>

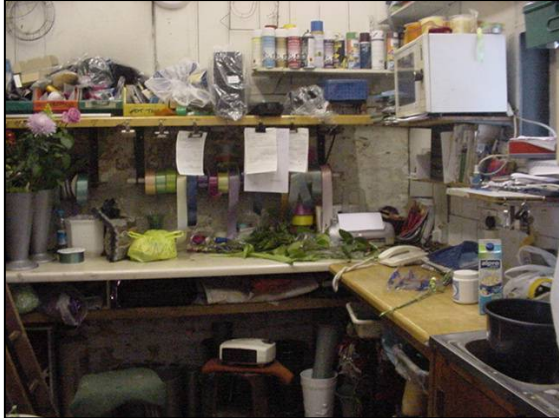
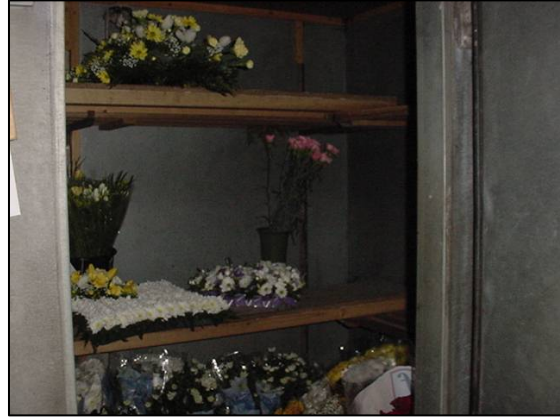
Workshop Area and Cold Store
(at back of property – right hand side)

DESCRIPTION	CONDITION	ACTION REQUIRED
<p>Ceilings:</p> <p>Vaulted</p>

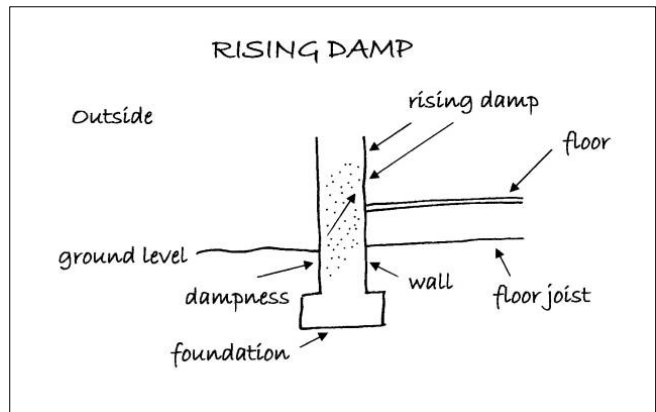
Rising Damp

A random visual inspection and tests with a moisture meter have been taken to the perimeter walls and some internal walls. Minor dampness was found. Please see our comments with regard to the render and adding a bell mouth detail.

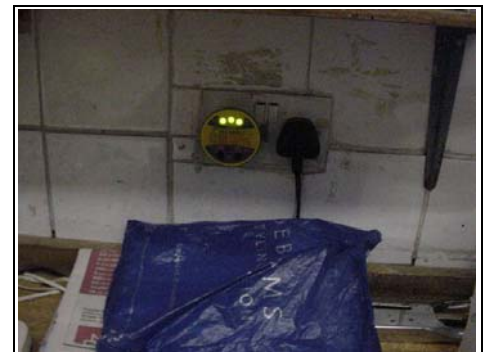
Earth Test

We carried out an earth test in the kitchen area to the socket point that is normally used for the kettle, this proved satisfactory.

ACTION REQUIRED: As the property is changing occupancy an Institute of Electrical Engineers (IEE) inspection, test and report should be carried out by a NICEIC registered and approved electrical contractor. You will also be required to carry out a Portable Appliance Test (PAT) on all portable appliances.
