COMMERCIAL BUILDING SURVEY

Of A Hotel In Norfolk

FOR
Mr C
Property Development Limited

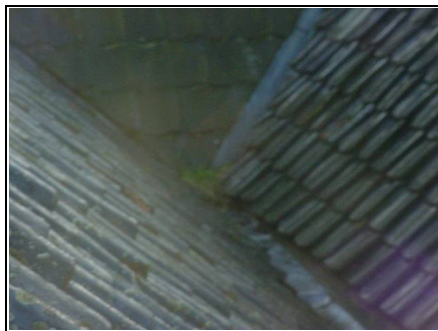
Grass and moss in the valley gutter and also the lead needs checking

ACTION REQUIRED: We recommend that roof lights are added, (accessed via Bernard's Room, formed within the roof space) where there is an access panel to enter the roof void. This will allow viewing of the valley gutter and also access to it. We note at the present there is literally grass growing from both of the valley gutters.

ANTICIPATED COST: To fit roof light and remove grass, etc, in the region of £2,000 to £4,000, depending upon the condition of the valley gutter. We recommend you obtain quotes.

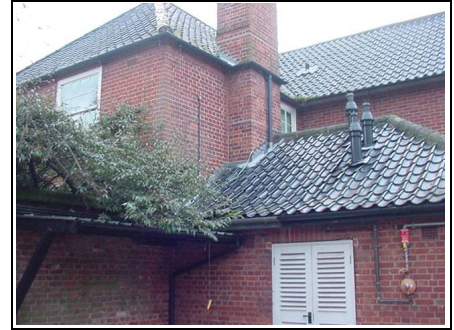
There is also an awkward valley gutter roof to the rear of the property (west side) between the single storey roof over the laundry and boiler room area and the Manager's accommodation area.

Low level valley gutter

ACTION REQUIRED: Requires clearing and checking of the flashing.

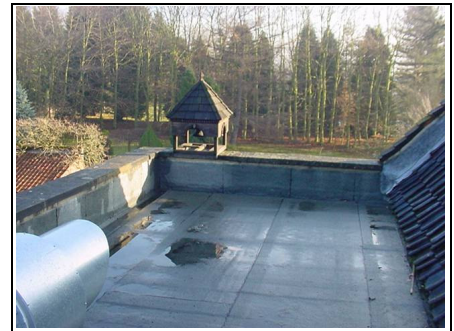
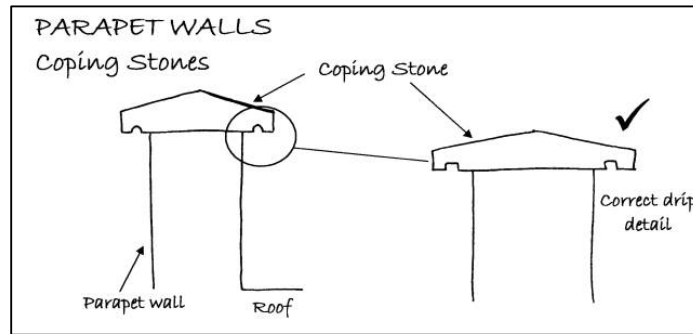
There is a largeish flat roof near the end of this area which is ponding. The felt is relatively new so we would expect the life of this area to continue for some time. However, we did note the coping stone is not large enough and therefore is causing water to come down through the parapet wall.

Flat roof near entrance area

ACTION REQUIRED: Add a larger parapet stone and a lead flashing.

ANTICIPATED COST: In the region of £2,000 to £4,000; please obtain quotations.

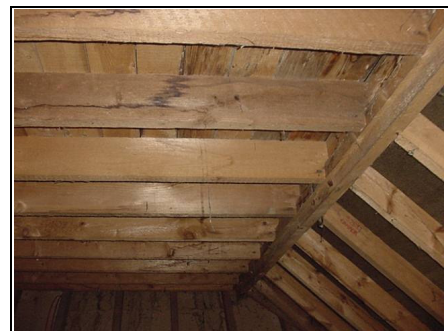
Dampness getting into flat roof near ballroom

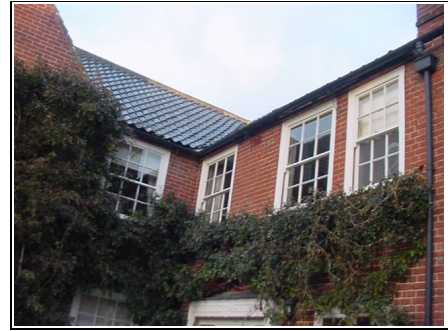
The vegetation to the west side needs cutting back, particularly the ivy to the west side which should ideally be put onto a trellis.

Vegetation needs cutting back

ACTION REQUIRED: Cut back vegetation.

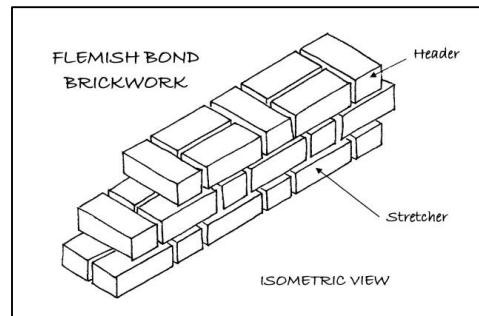
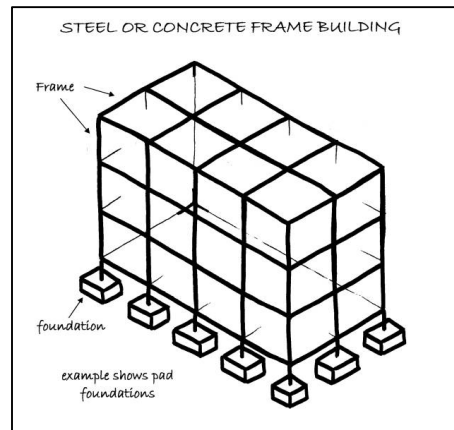
This property has a mixture of different construction techniques that have come about as it has been extended and altered over the years; from the original solid wall construction of the Queen Anne house to the more modern day structural frame construction of the Ballroom. As such, there are different levels of movement occurring within the structure, which has resulted in some visible movement in the property.

This has been exacerbated by the extra moisture that is in the property, as mentioned above.

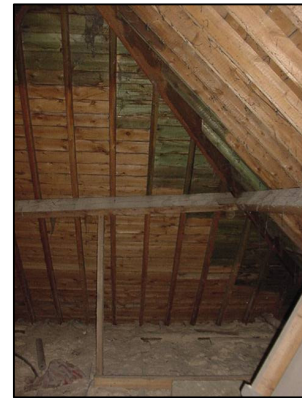
You can see in the purlin that running out in this photo movement has taken place

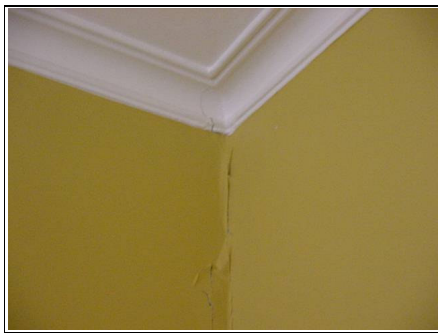
Differential movement in Traffords room between the bedroom and adjoining corridor

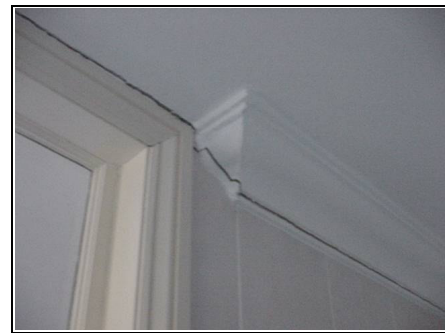
Movement in Andrews room between the bedroom and en-suite

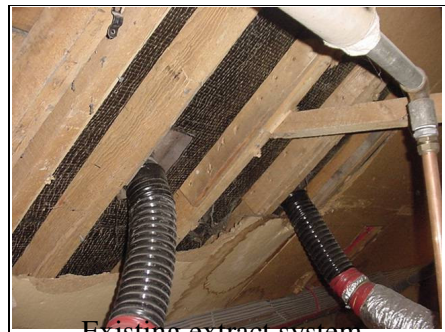
A better balance of heating and ventilation needs to take place in the building

The addition of en-suite rooms throughout the property, whilst essential for the boutique hotel, means that The has a lot more moisture generating areas than it ever had before, particularly when you add the commercial kitchen into the scenario.

ACTION REQUIRED: We recommend a programme of adding additional extract fans throughout the property. These should be controlled by thermostatic controls as you will get interstitial condensation.

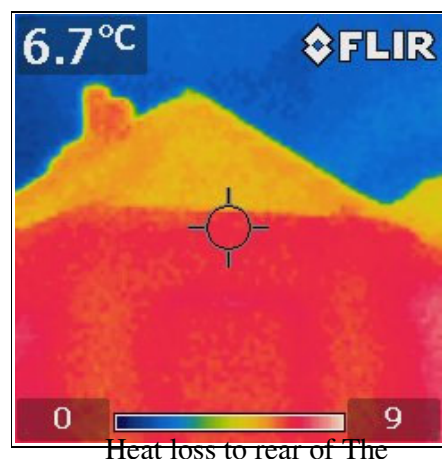
This is not part of the survey but we had a thermal imaging camera to hand and we noted there is quite a lot of heat loss, particularly to the rear section of The Hotel. As mentioned elsewhere within this report there may be the opportunity to use heat exchanges to recycle heat that is being used and lost in the property.

ACTION REQUIRED: We recommend further investigations.

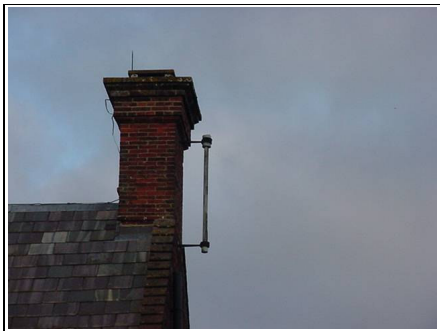
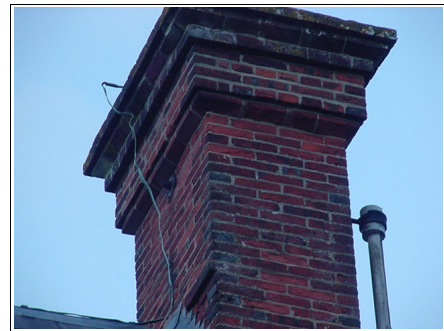
Chimney one

This chimney is brick finished with a lead flashing and no chimney pots. From what we could see the chimney is in average condition. Unfortunately we were unable to see the very top of the chimney, known as the flaunchings, we therefore cannot comment upon it.

ACTION REQUIRED: Re-secure the lighting conductor. Please see our comments in the Executive Summary.

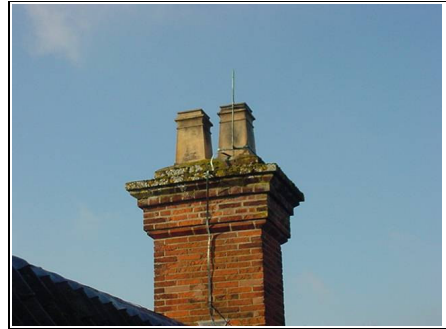
Chimney two

This chimney is brick finished with two chimney pots with lead flashings. From what we could see the chimney looks in average condition. Again, we were unable to see the flashings so we cannot comment upon them, other than to so say that we did notice some moss to the top area, indicating that they may be starting to deteriorate.

ACTION REQUIRED: Close up inspection of this chimney, along with the others in the summer of 2011.

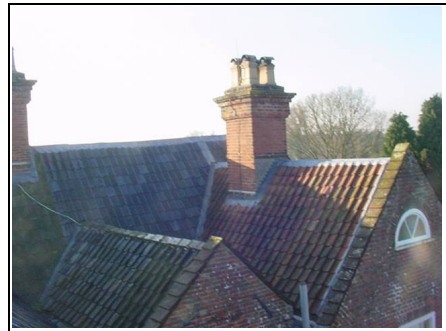
Chimney three

This is a substantial brick built chimney finished with four chimney pots that again we are happy to say is in average condition. It was difficult to view the flashings properly.

ACTION REQUIRED: A close up inspection when access is gained to the valley gutters.

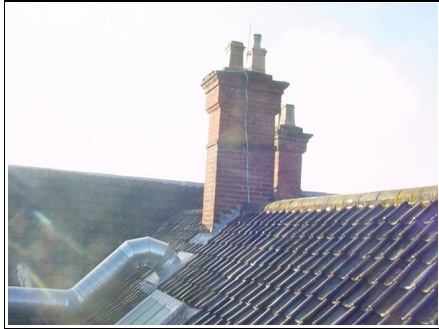
Chimney four

This chimney is brick finished with two chimney pots with a lead flashing. From what we could see the chimney has been partly rebuilt and looks in average condition.

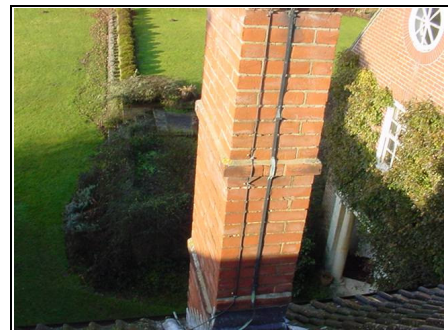
This chimney is brick finished with one chimney pot with lead flashings. It is in slightly below average condition and needs some repointing work.

Base of chimney five

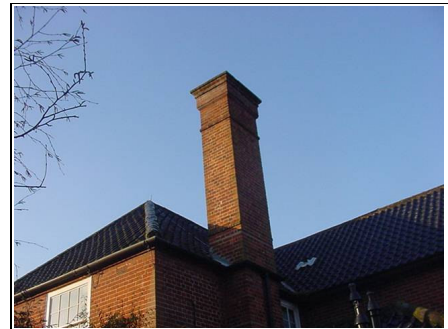
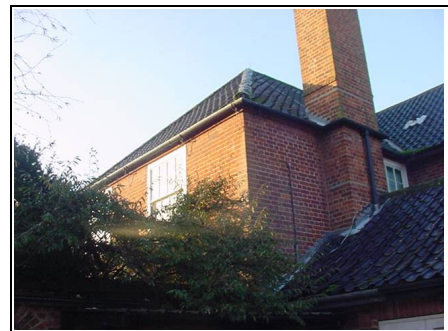
Chimney seven

This is a large substantial brick chimney which was difficult to view.

ACTION REQUIRED: Whilst it looks to have a lead flashing we would suggest you double check the condition of this chimney in the summer of 2011.

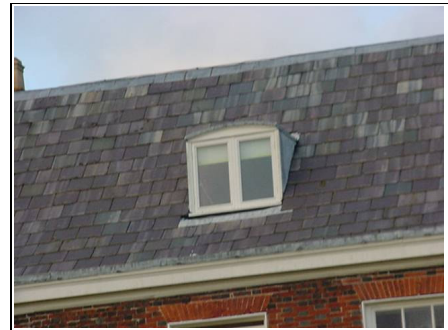
The dormer has a convex roof with lead sides and looks in average condition as viewed from ground level. The windows look to have been upgraded quite recently as they are double glazed. We noticed that the quadrant beads have not been fixed very well and the frame as a whole would benefit from redecoration.

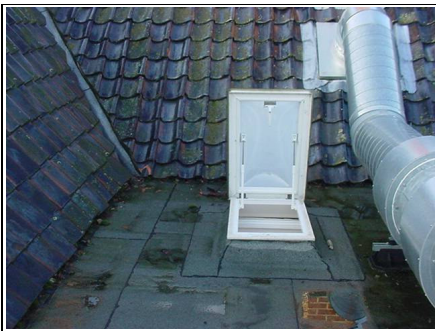
We would make a general comment with regard to roof lights. We generally find it is only a matter of time before they leak. We did notice there was a visible leak on the roof light to the rear stairs end near where access is gained into the rear roof, or this may be condensation. Either way it seems inevitable with roof windows that they will sooner or later leak. If this does not occur then they seem prone to condensation. Keep a cloth handy!

Manufactured roof window from the Traffords Suite

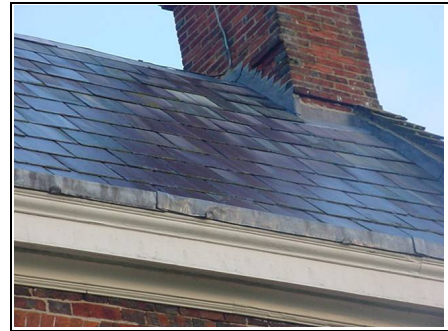
The south roof is pitched and clad with quarried slate. The slates sit fairly true and are generally in average condition considering the property's age, type and style. We can see a few slipped/damaged slates but nothing over and above what we would normally expect to see.

Front south slate roof

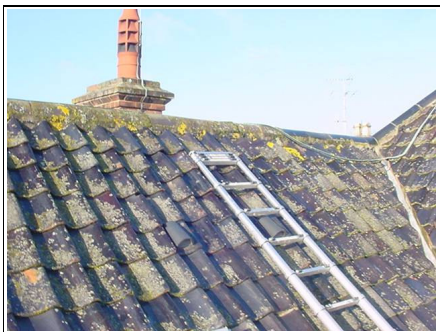
The remaining roofs are pitched and hipped in some areas and clad predominantly with pantiles which are common for the area. We can see some pantiles have slipped and need re-bedding.

Pantile roof

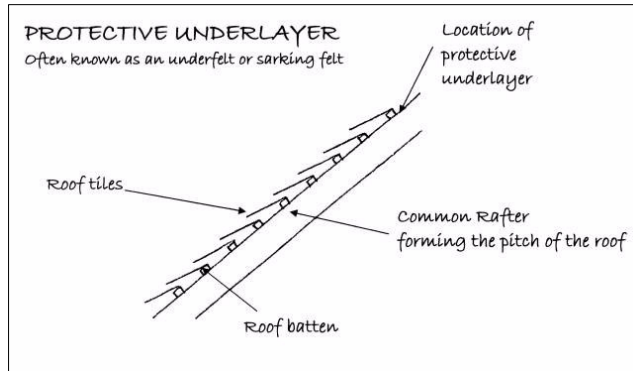
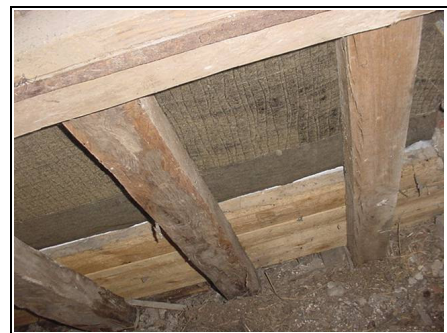
Roof over Lady Betty’s Room

There are two areas where we could view the roof; one was to the staircase next to Lady Betty’s Room on the front left hand side. Here we can see a Hessian based bitumen, which is the sort of underlayer that was used post war. You can also see in the photo some boards to the valley gutter and the darker areas where dampness is getting in. Generally this underlayer is in average condition where we could see it.

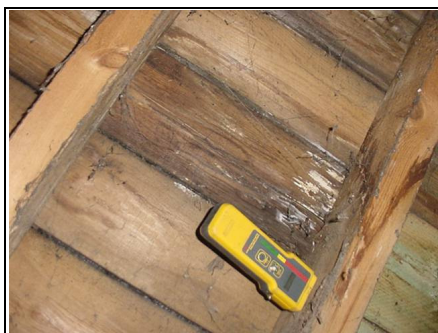
We could also see the roof to the rear northern end of the property where it is accessed near the old rear staircase. Here we could see the roof was close boarded. In most areas some dampness was getting in and we could see the flat roof to the rear Ballroom area was also close boarded and there is some dampness getting in. We can also see some felt has been used, similar to the front roof. Unfortunately we were not able to see the majority of the roofs.

Close boarded roof rear northern end

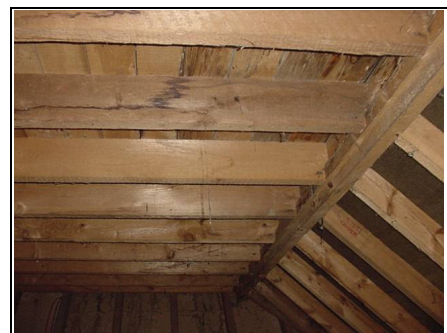
Flat close boarded roof to rear ballroom area

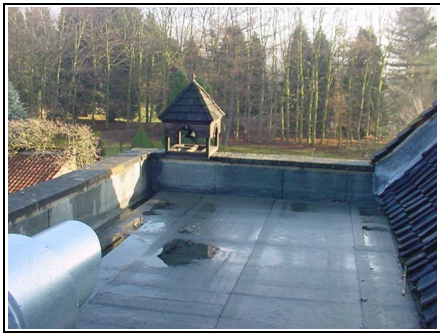
The main flat roof mineral felt covered and has some ponding. Typically this type of roof has a life of between 20 and 30 years, depending upon the quality of workmanship, materials and decking. This roof is approximately five years old.

Flat roof

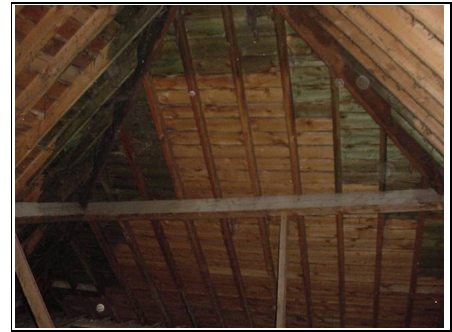
The roof structure is a substantial cut roof, we would normally expect to see double purlins in this size of roof

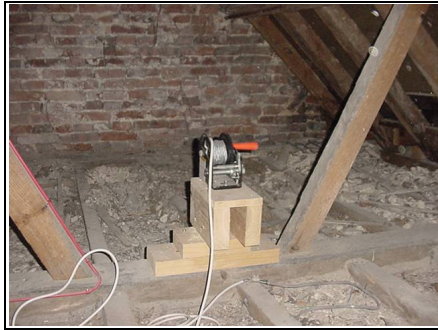
The winch for the chandelier

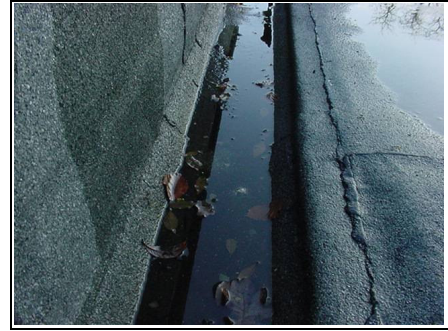
Felt box gutter

Hopper heads, as can be seen in the centre of the adjacent photo, need regular cleaning, particularly where there are surrounding trees, as in this case.

ACTION REQUIRED: We found some dampness getting in via the lead box gutter to the front of the property. We anticipate future problems to the felt box gutter, which is why we would recommend that it is replaced with a lead box gutter. Please see our comments in the Executive Summary.

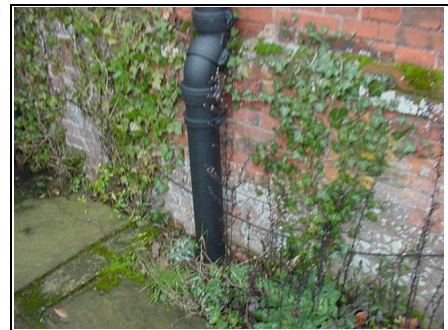
Relatively new soil and vent pipe

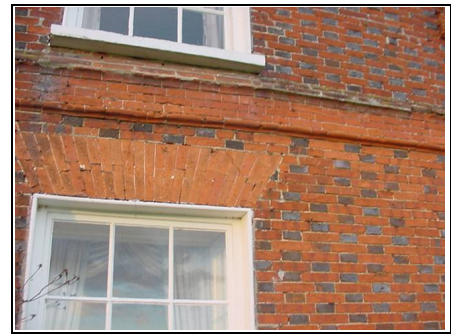
Flemish bond brickwork

Generally Flemish Bond brickwork is liable to penetrating dampness internally, dependent upon the condition of the brickwork and the exposure to the weather.

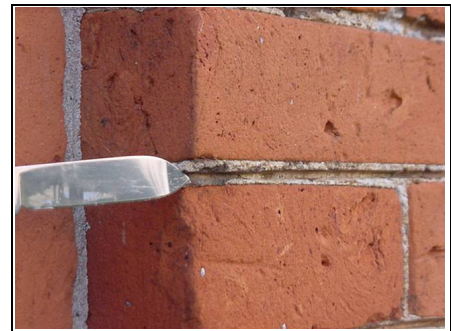
Re-pointing required to pinch pointing

ACTION REQUIRED: Ideally repoint in a like for like style. A skilled bricklayer will be needed.

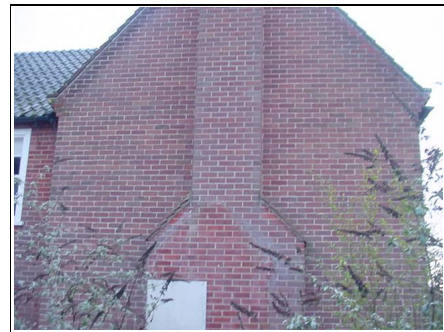
Example of modern brickwork

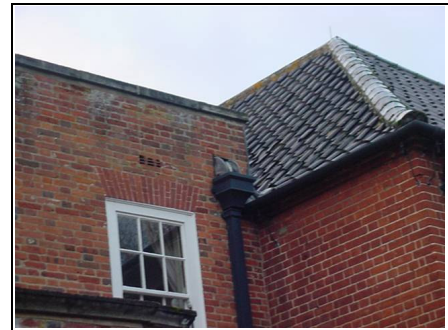
Modern best practice is to vent flat roofs. We were pleased to see that the large flat roof over the front entrance area has vents to the front of it. This should vent right the way through the roof, however it was not possible for us to inspect this area.

Air vent located above window

ACTION REQUIRED: Your maintenance man needs to check that the air flow goes right the way under this flat roof area.

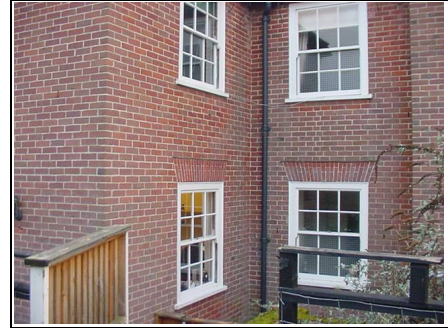
The property has single glazed sliding sash windows; 6 x 6 and 8 x 8, and there are also some double glazed casement windows, for example to the dormer windows on the front of the south face of the property. All the windows need some easing and adjusting, some repair work and some redecoration. We recommend a programme of work starts in the summer of 2011.

Sliding sash windows

ACTION REQUIRED: Please see our comments in the Executive Summary.

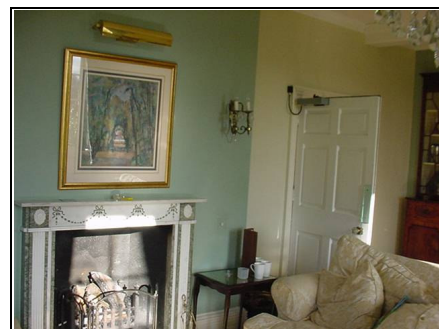
During our question and answer session we were advised that the fire in the lounge had been used in relatively recent times but at the time of our survey no chimneys were in use. Any chimneys that you do not propose to use should be capped and ventilated to prevent dampness.

Chimney in lounge

Finally, it is strongly recommended that flues be cleaned and checked for obstruction prior to use to minimise the risk of hazardous fumes entering the building.

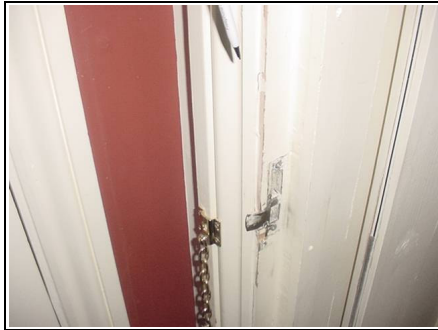
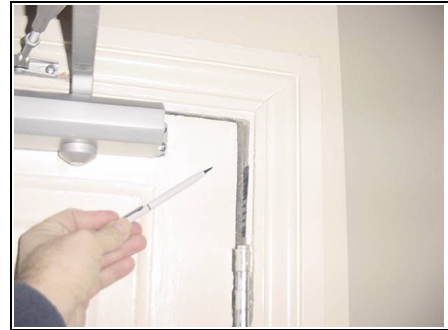
We can see that many of the doors have been amended to make them fire compliant. We can see door closers have been added and we can also see double doors, for example to the Abbot's Suite at the first floor front of property.

We believe from our discussions with Philip Search that this was carried out to ensure that the original doors could remain.

Door closers in Abbots Room

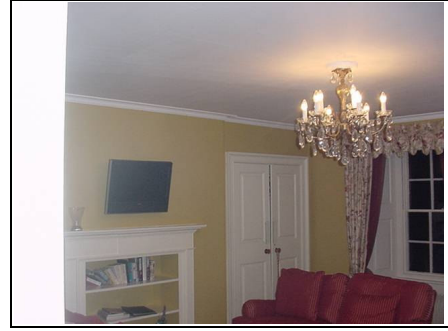
We found that the built in cupboards throughout the rooms are a lovely feature of The and is something that a more corporate hotel does not have. It has various character features such as the bookcases set within the fireplaces.

Fireplace that has become a bookcase and adjoining built in cupboard next to fireplace

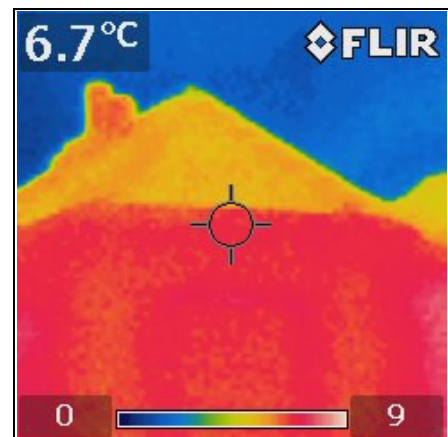
There is a variety of different insulation levels. On older properties this needs to be mixed with ventilation to stop condensation occurring. We noted that there seemed to be a lot of heat escaping from the rear of the property. We carried out some thermal imaging and whilst the property was not prepared for thermal imaging our comments have been made from the general use of the camera.

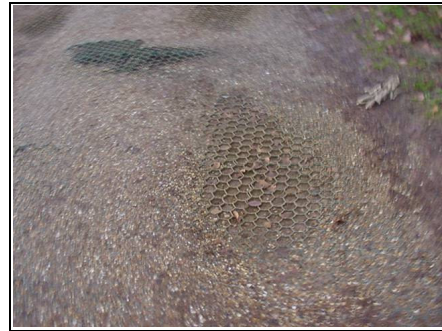
There is a parking area directly in front of The Hotel. There is also a hard standing area, which is in need of some work.

The parking area needs some work
