# COMMERCIAL BUILDING SURVEY

Reading, Berkshire. RG1

We have been asked to inspect and prepare a Report and Schedule of Condition for XXXX Reading, Berkshire. RG1

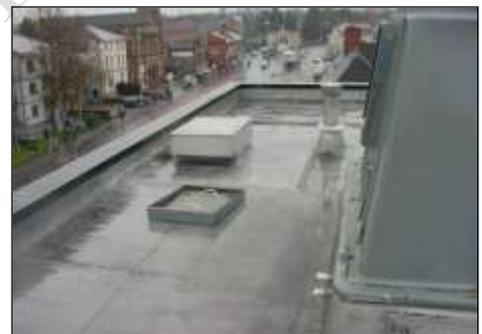
When we opened up the suspended ceiling system we noted that rainwater was getting in via various places for example the drainage outlet point and an internal point.

We noted there had been a replacement of suspended ceiling tiles in the offices indicating that this is likely to have been a long term problem.

Roof general view

**ACTION REQUIRED:** We would recommend the roof is excluded from the Lease. There is a substantial repair liability associated with repairs of this type of roof.

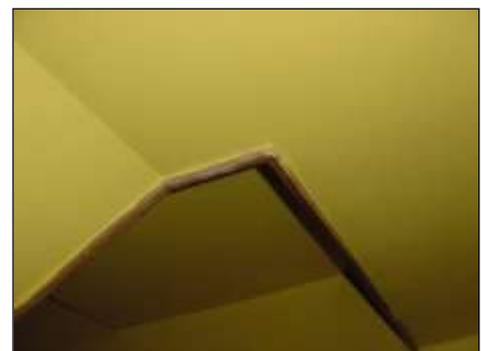
Yellow painted staircase area which would not meet with most Landlord's approval.

**ACTION REQUIRED:** Complete redecoration externally and internally would be a normal Landlord's requirement under a standard Full Repairing and Insuring Lease.

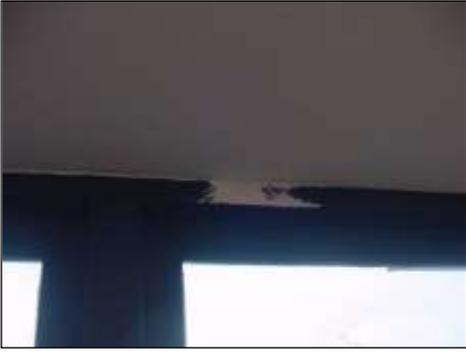
Painting over window frame

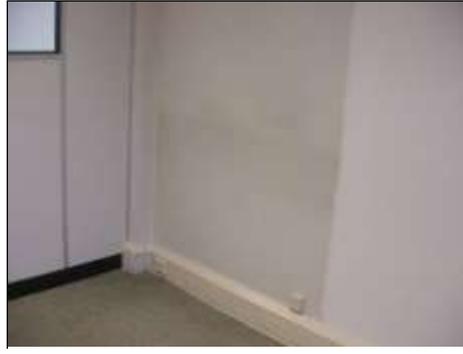
Section of wall that has not been painted

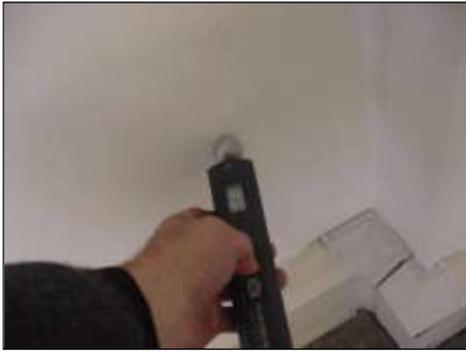
There is a defective box gutter means that rainwater is discharging down the walls as well as into the walls.

This is causing pattern staining externally and dampness to get into the property in some areas, particularly where there is a lack of sunlight which appears to be at the rear of the property. There are spot areas of dampness typically with readings of double what we would normally expect.

Checking and finding dampness in the walls

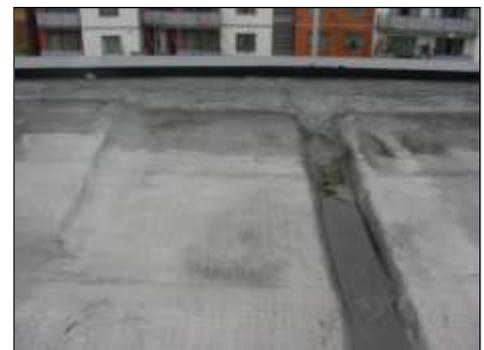
The problem with this flat roof is that it is too flat and there are areas where water is sitting on it known as ponding. We could see that there have been various repairs to the roof over the years yet from our view internally we could see that the roof is still leaking. This roof is a considerable liability.

General view of roof with internal gully

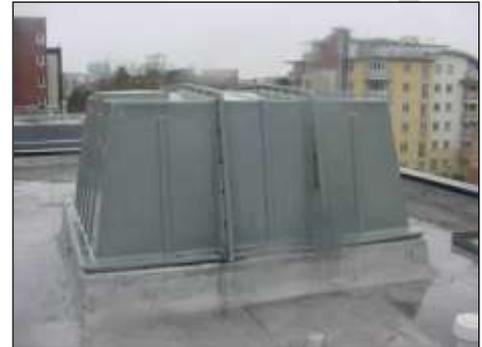
Access to the flat roof is via a ladder concealed in the ceiling then you come up through and into a glass reinforced plastic (GRP) unit which also holds the water tanks. The glass reinforced plastic unit could do with a clean, it is suitably water tight considering its purpose.

Flat roof with GRP structure

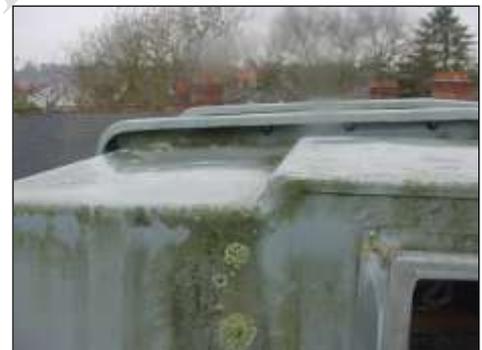
Close up of the GRP structure

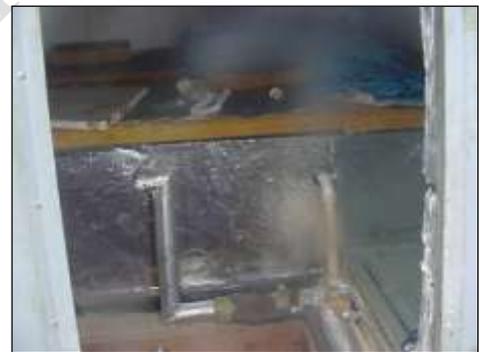
The water tank is located within a GRP preformed box on the roof, which also forms the access to the outside of the roof these can be affected by cold and hot weather

Water tank

We would always recommend that water tanks be drained down and cleared of any debris etc. (we have seen dead birds and other unmentionable things in these tanks). As you are cleaning your teeth with this water it is best that it is as clean as possible!

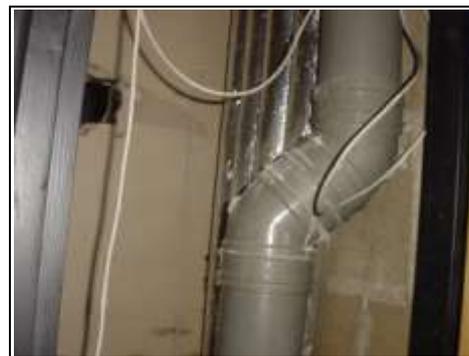
The soil and vent pipes are internal, they are within a service duct adjacent to the lift, access to them is at some areas. We noted a lot of stored items which should be cleared out and removed by the present occupiers or yourself. We have flushed the WC's as we have passed through the building but this is not the same as having an occupied building. The service ducts are visible at roof level and are plastic.

Soil and vent pipe within service duct on the top floor

**ACTION REQUIRED:** We would comment on taking on a property that is not currently occupied with regard to the services. You need to have a full service inspection before you purchase the property or take the risk and have a plumber on standby when you access the property.

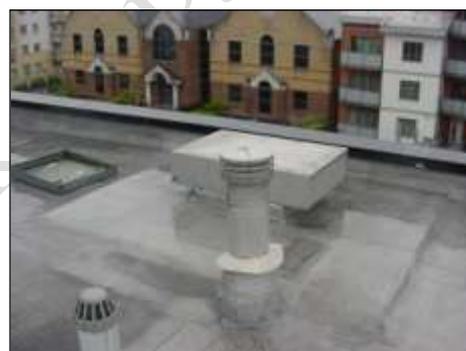
Services terminating at high level

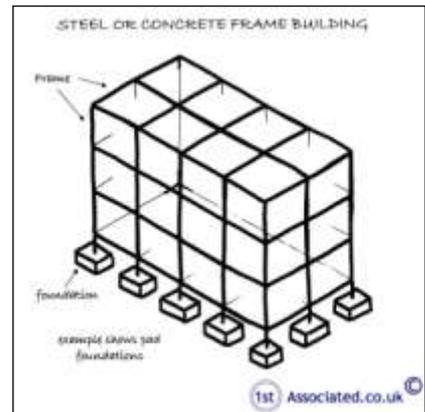
The inner walls are likely to be formed in blockwork and bonded to the brickwork outer walls with wall ties. This gives the impression of a traditional brick built property externally with the concrete structure visible at each floor level

Steel or concrete frame

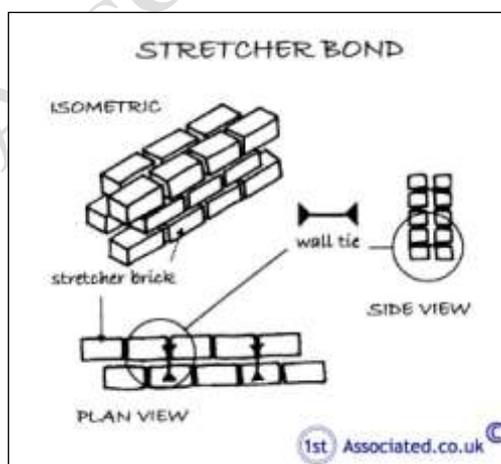
The Stretcher Bond brickwork and pointing is in average condition where we can see it. The brickwork is likely to be cladding on a structural frame.

Stretcher bond brickwork

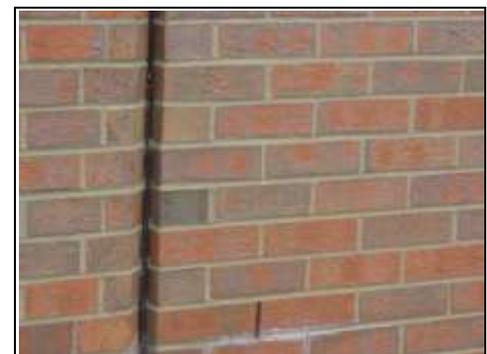
Stretcher Bond Brickwork

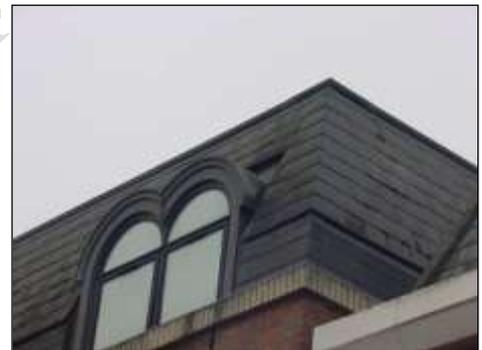
To the top of the building there is vertical tiling to form part of the mansard roof.

The mansard is clad with a man-made slate.

Vertical tiling

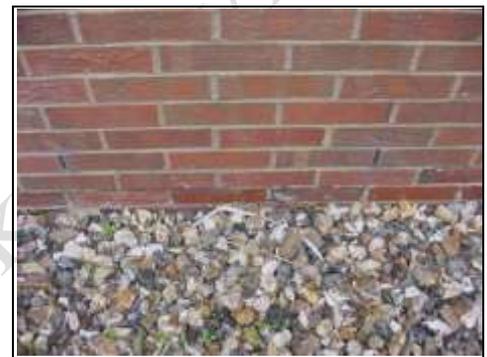
We could not see a damp proof course (DPC) clearly visible around the property but we could however see weep holes which does indicate that there is a cavity tray which allows any dampness in the walls to be transferred at the base of the property. Without opening up the structure we cannot comment further on this.

Weep holes

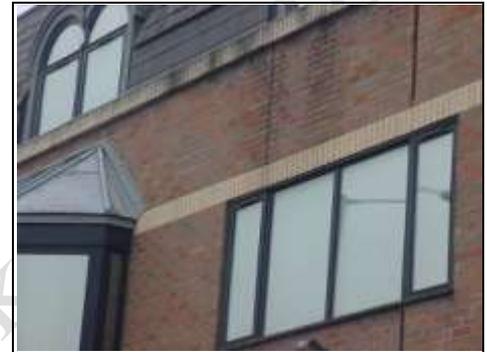
The windows are predominantly casement windows which are painted timber and double glazed with trickle vents. The windows are in below average to average condition.

Timber casement windows with trickle vents

**ACTION REQUIRED:** Please see our comments in the Executive Summary. Repair and redecoration work is required

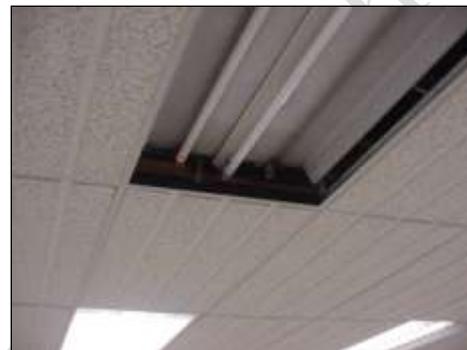
We noted within the suspended ceiling system that there are signs of old leaks and also areas where tiles have been misplaced indicating

Suspended ceiling system with exposed grid

that the roof is leaking. In addition to this there is also impact damage to some of the ceiling tiles.

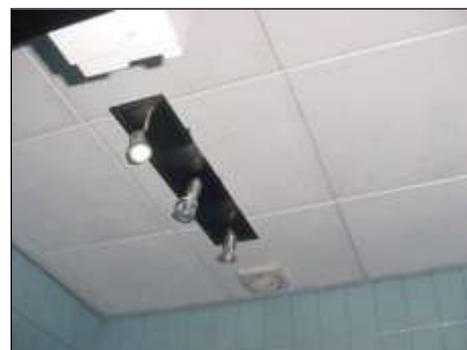
Suspended ceiling system, square tiles

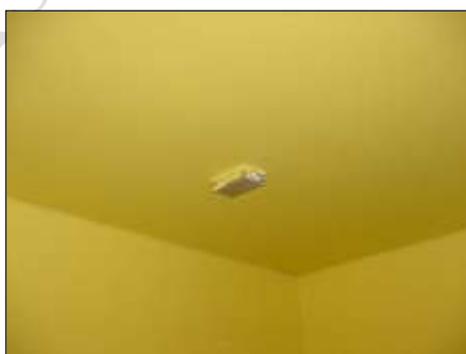
Plasterboard finish

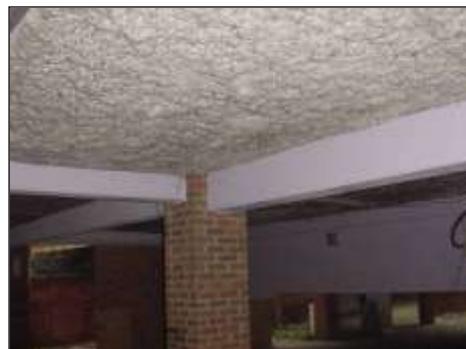
There is a sprayed insulation to the underside of the car area. Sprayed insulation is typically used where there is coldness to the ground floor. We have come across cases where this has been so bad that people have decided to move out of the property due to the wind chill occurs beneath the building.

Car park ceiling

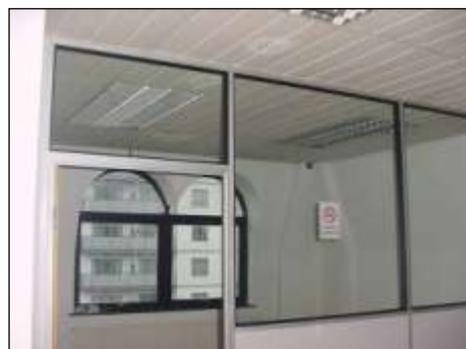
The internal walls have a lightweight studwork which divides the areas into offices. In some areas there is a plastic vision, as far as we can see none of them reach through the ceiling and therefore there are no fire breaks and therefore these partitions are not fire resistant.

Internal partition

The staircase and lift area should be sealed. We noted that there is a hole in the studwork adjacent to the lift on the first floor this needs to be filled and made fire proof. The property needs to be double checked to ensure there are no other such holes as the staircase/lift area can effectively act as a chimney transferring fire from one floor to the next and therefore requires additional fire protection.

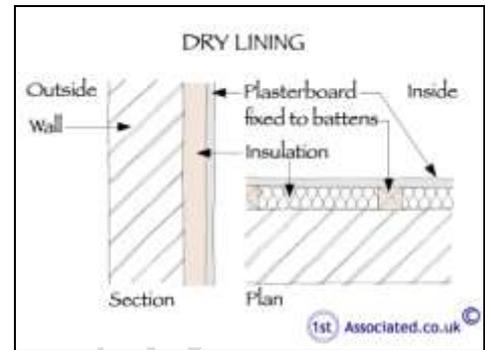
Dry lining

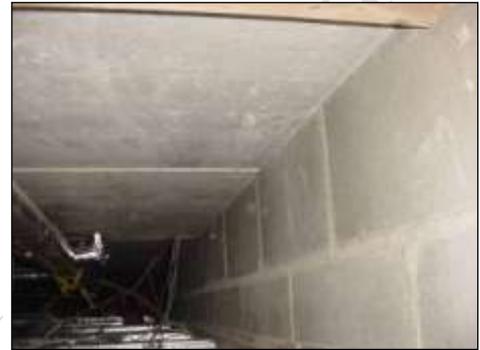
Concrete floor as viewed from the ground floor

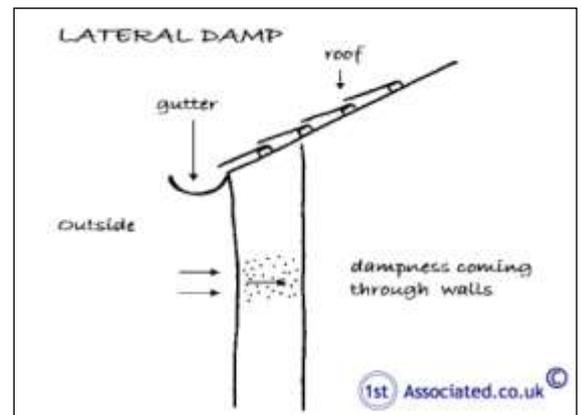
Lateral damp

We noted some areas of lateral dampness, when testing with the electronic damp meter; we believe this relates to pattern staining and the missing tiles.

**ACTION REQUIRED:** Please see the Executive Summary. On a separate note you do need to resolve this matter.

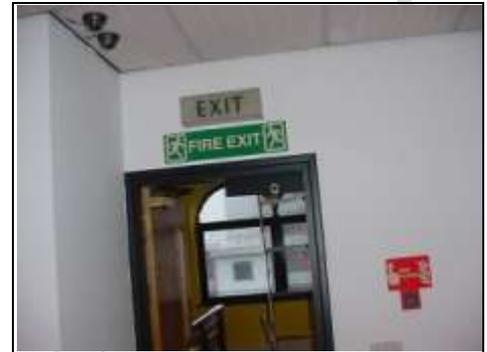
As a general rule a fire door has a door closer and an intumescent strip to help reduce the spread of fire and smoke.

Fire door

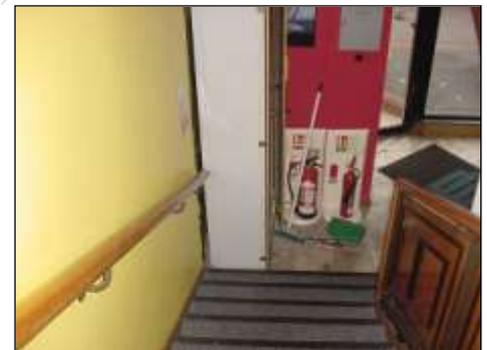
Protection needs to be given to high risk areas and escape areas, such as staircase areas and the lift as these act as chimneys allowing the fire to spread from floor to floor.

Concrete staircase

**ACTION REQUIRED:** We would recommend each stair is individually checked to ensure the carpet is secured and the stair nosing is secure.

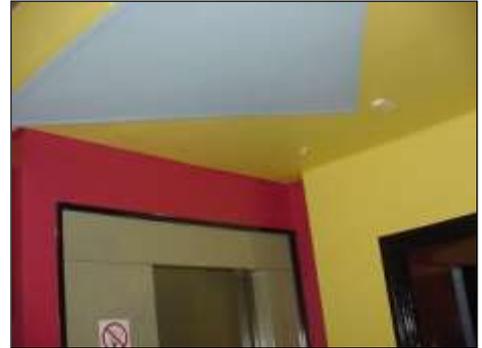
It should be noted that most Landlords only allow magnolia type decoration schemes. If they do allow brightly coloured schemes such in this case they would like it to return back to magnolia as this is generally considered an inoffensive colour which will enable the property to be Let to all parties.

Brightly decorated interior!

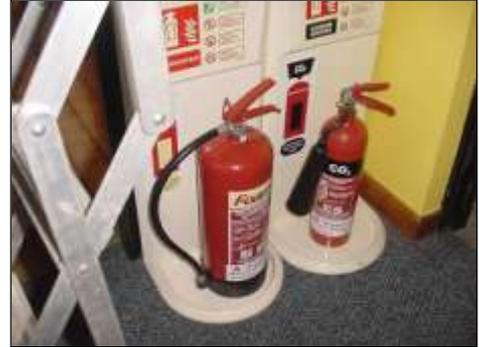
The fire requirements now are for you to prove that you have appropriate fire systems for the use of the building considering its type, age and style. Considering you are changing the use from an office to a college where we would envisage there will be far more people therefore you need to carefully consider this area.

Fire hydrants

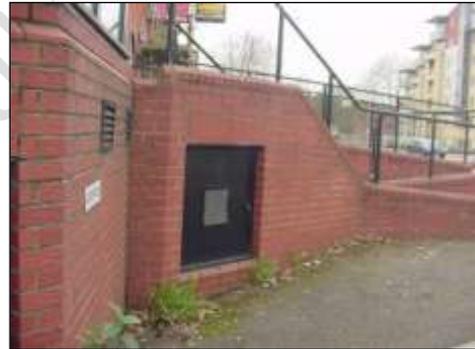
Car parking area at front of property

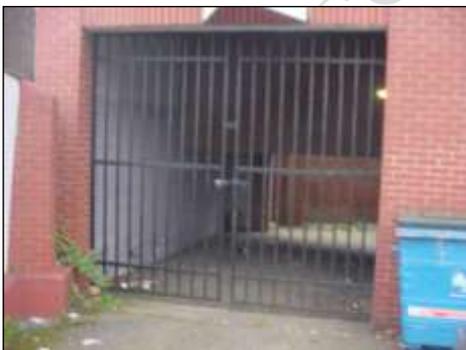
Gate to car park

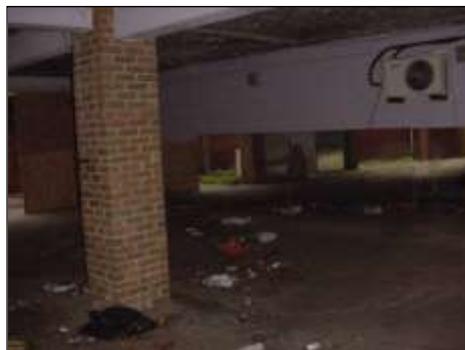
Underground car parking area, lots of mirrors

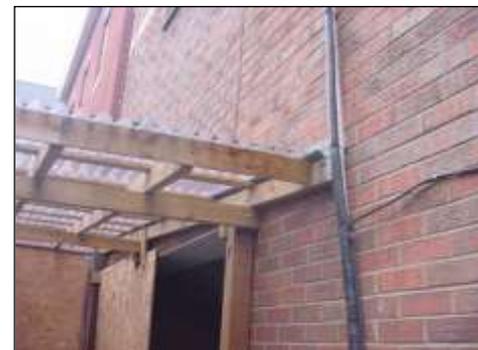
Timber structure

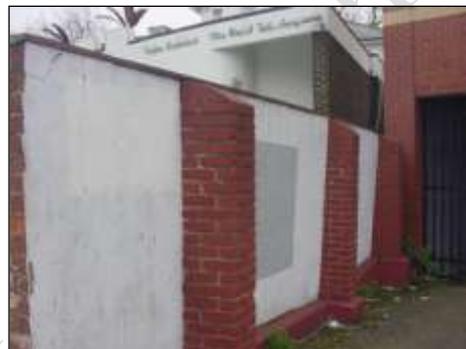
Boundary wall to left hand side
