PROPERTY REPORT

**17th Century Public House in
Shropshire**

We have been asked to inspect and prepare a Report and Schedule of Condition for a 17th Century public house in Shropshire.

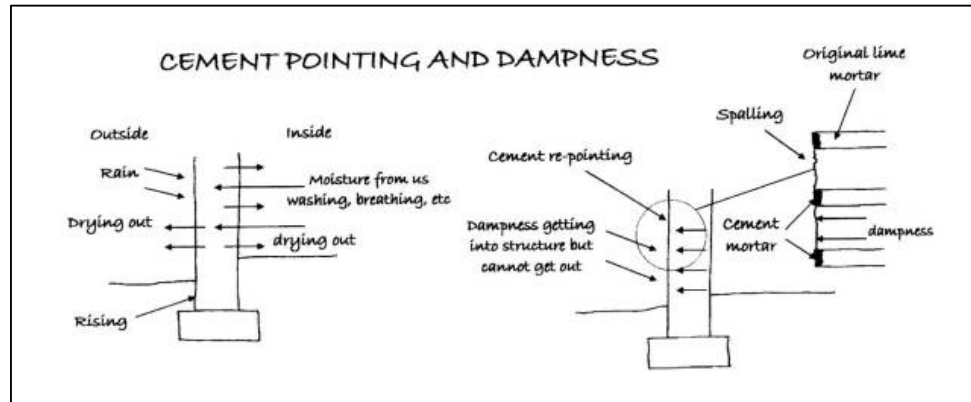
Dampness found internally

You have rising damp. This we believe is being caused by the car park discharging rainwater against the property, together with the ground levels being high and also some of your gutters and downpipes discharging onto the base of the property. There have been various paints added to the property, which unfortunately are plastic based, which means the walls cannot breathe.

We can see the original lime wash beneath the plastic based paint. This is an older style paint and would have allowed the building to breathe had it not been painted over. We also noticed internally that gloss paint has been used and this affectively seals any dampness into the structure meaning it cannot get out. The result will be that the paint will deteriorate and you will have staining. At this point you then need to repaint in an appropriate paint.

ACTION REQUIRED:

French Gully

We would suggest adding a French gully around the property to enable the water to be moved away from the base of the property. In the Appendices within this section we detail how to prepare a French gully properly to make sure it doesn't become a French pond!

Repainting in the correct paint

We would also ultimately re-paint with a breathable paint, such as a lime wash or a microporus paint.
