SCHEDULE OF CONDITION OF

17th Century Public House in Shropshire

FOR

Ms S

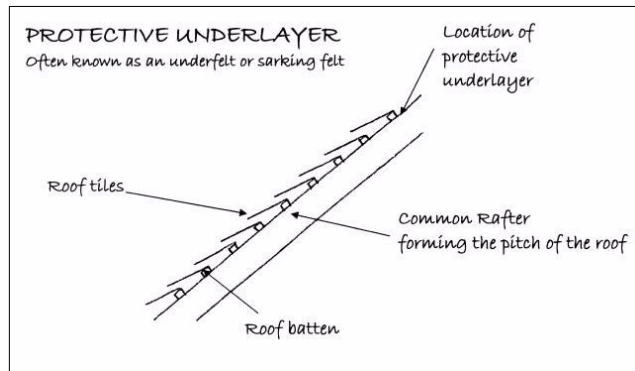
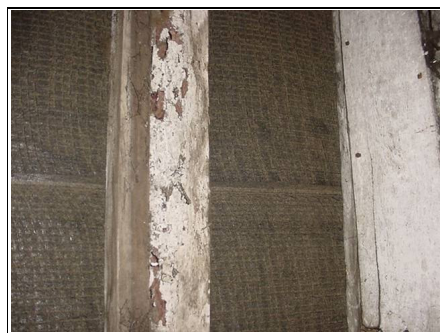
We were only able to inspect a small part of the roof, accessed from a very awkward access hatch, located above the stairway. In this we could see a 1960's based Hessian. The small area we could see, approximately five per cent of the whole roof, was in reasonable condition.

This photo shows the common rafters (the ones that form the pitch of the roof) and the dark area between is the underlayer.

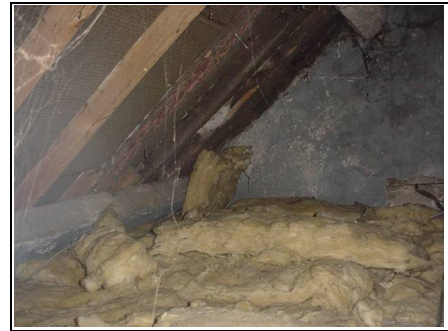
Front Side Roof

Within this roof we could see that there is no sarking felt and we could see the exposed side of the tiles. This means that if any dampness does get in it will come through very quickly. If you note, this is the area where the ridge is deteriorating.

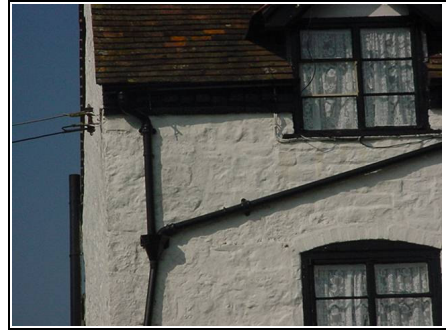
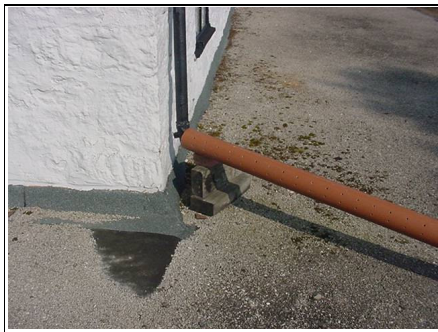
The property has a mixture of the original cast iron gutters and downpipes and the more modern replacement plastic gutters and downpipes. What we found were in typical condition for this mixture of materials. There are some leaks, there is some corrosion of the cast iron, however we feel that most people could live with this, with one possible exception; we have never seen a rainwater arrangement like we have over this flat roof. We think that there may be a problem with getting water away from the main roof and over the flat roof.

The amazing downpipe!

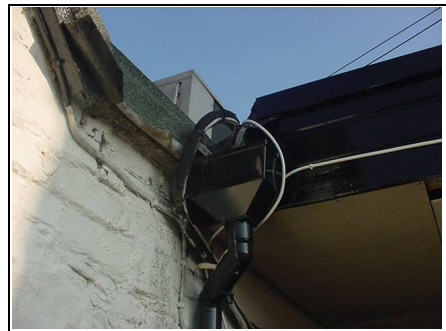
We would draw your attention to the hopper head on the right hand side of the property, next to the flat roof, where we could see water is discharging. This needs to be amended and probably enlarged.

ACTION REQUIRED: We would recommend a look at all of the gutters and downpipes and a re-adjustment of how rainwater is taken away, for example to the rear of the property, rather than taking it to the right hand side (all directions given as you face the property). We would suggest that it is looked at moving it to the opposite side.

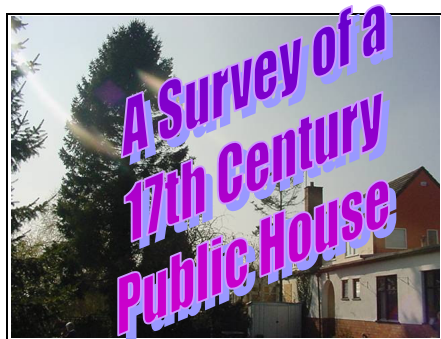
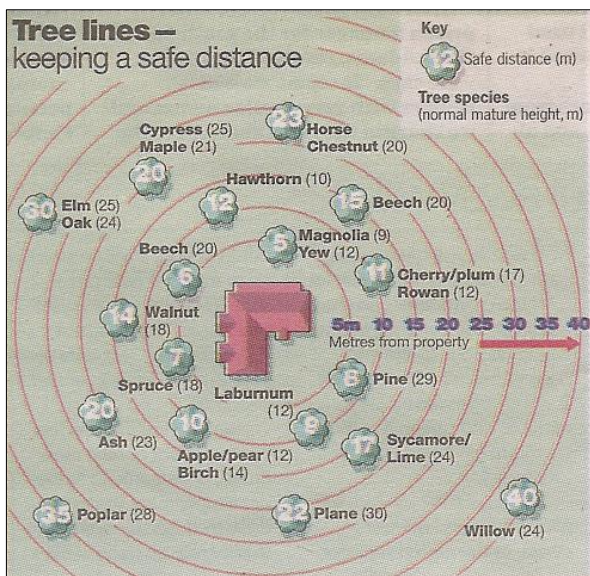
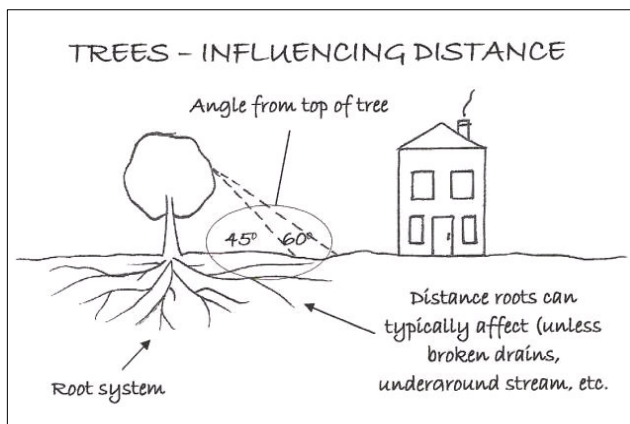
There are trees surrounding the property. They may just be within influencing distance. They will need general maintenance.

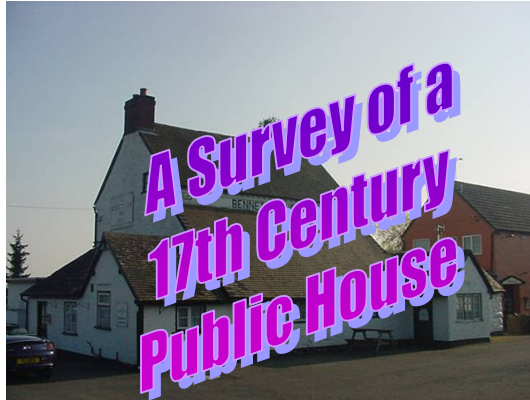
FRONT ELEVATION

DESCRIPTION	CONDITION	ACTION REQUIRED
Chimneys: Two brick chimneys; one to left one to right (all directions as you look at the property from the front), lead flashings. Left hand chimney has two pots, right hand has no pots.	Average	Some dampness is getting in around both these areas, they need to be made watertight.
Main Roof: A pitched high level roof with a concrete tile and various pitched low level roofs with concrete tiles.	To low level roof the ridge needs re-bedding in a cement mortar.	Re-bed in cement mortar Repair

<p>Gutters and Downpipes:</p> <p>Some cast iron, some plastic</p>	<p>Generally, older guttering system needs rechecking, it doesn't appear to be falling towards the downpipes and in many cases the downpipes are simply discharging against the property, which needs to be altered and put into a soakaway.</p> <p>To right hand corner there are signs of dampness to the stonework (assumed from the guttering above).</p>	<p>General overhaul of guttering and altering them so they discharge into a soakaway.</p>
<p>Walls:</p> <p>Painted stonework and painted brickwork</p>	<p>Generally in average condition, with the exception of the paintwork. Please see our earlier comments: dampness has been found.</p>	<p>Please see our comments with regard to redecoration and the changes of the ground level.</p>
<p>Windows and Doors:</p> <p>One timber casement window and four metal casement windows, set within timber frames.</p>	<p>Average to below average</p>	<p>Splice in and replace rotten timber as required and redecorate.</p>

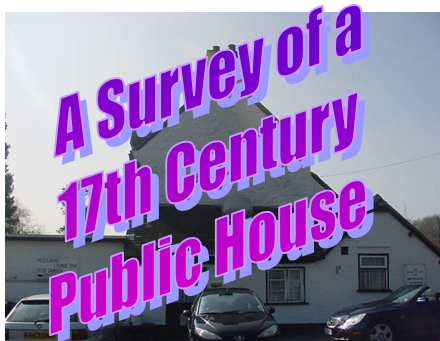
LEFT HAND GABLE SIDE ELEVATION

DESCRIPTION	CONDITION	ACTION REQUIRED
Chimneys: Two brick chimneys; one to left one to right (all directions as you look at the property from the front), lead flashings. Left hand chimney has two pots, right hand has no pots.	Average	Some dampness is getting in around both these areas, they need to be made watertight.
Roof: Single pitched with an air extract system centrally	Cement flashing	Replace cement flashing with a lead flashing
Gutters and Downpipes: A mixture of cast iron and plastic	Generally, older guttering system needs rechecking, it doesn't appear to be falling towards the downpipes and in many cases the downpipes are simply discharging against the property, which needs to be altered and put into a soakaway.	Add to a soakaway.

<p>Walls:</p> <p>Predominantly uncoursed painted stonework</p> <p>White painted brickwork with black to the base at low level</p> <p>One wooden sign and one low level sign</p>	<p>Below average</p> <p>Below average</p>	<p>Redecorate.</p> <p>Lower the ground level and add a French gully to ensure water getting away from base of the walls.</p> <p>Redecorate</p>
<p>Windows and Doors:</p> <p>One high level two pane window</p> <p>One metal casement window in a timber frame and one wooden casement window</p> <p>One timber door</p>	<p>Deteriorating frame</p>

<p>Repair and redecorate</p>

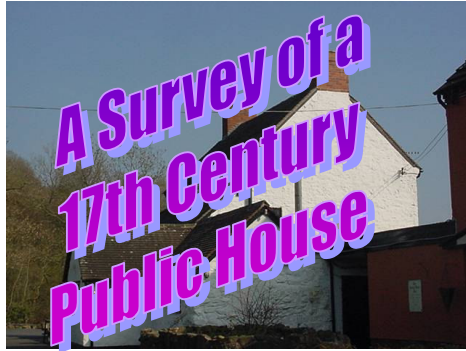
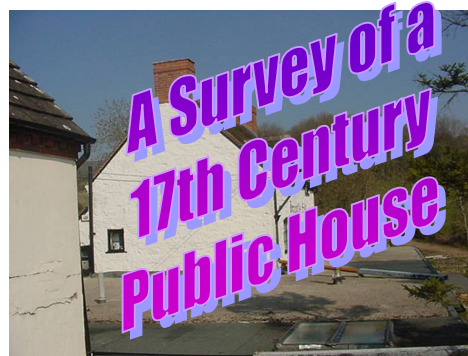
RIGHT HAND SIDE ELEVATION

DESCRIPTION	CONDITION	ACTION REQUIRED
<p>Chimneys:</p> <p>Two brick chimneys; one to left one to right (all directions as you look at the property from the front), lead flashings. Left hand chimney has two pots, right hand has no pots.</p>	<p>Average. Dampness getting into this area.</p>	<p>Make watertight.</p>
<p>Roof:</p> <p>Low level pitched roof (to front bar area)</p> <p>Flat roof (please see flat roof schedule)</p>	<p>Ridge tiles deteriorating, water literally sitting in valley gutter.</p>	<p>Re-bed</p>

<p>Cast iron soil and vent pipe</p>	<p>Discharging onto ground. Patten staining around hopper head.</p>

<p>Lower the ground level and add a French gully to ensure water getting away from base of the walls.</p>
<p>Windows and Doors:</p> <p>Three timber casement windows</p> <p>Two double doors</p>	<p>Slightly below average</p>	<p>General repair and redecoration</p>
<p>Passageway:</p> <p>Fibreboard lined</p> <p>Paved area</p>	<p>Some cracking</p>	<p>Repair and redecorate</p> <p>Repair</p>
<p>Drains:</p> <p>Four manhole covers</p>	<p>Not inspected</p>

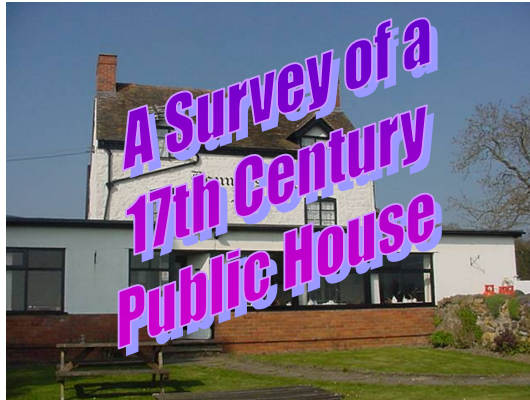
REAR ELEVATION

DESCRIPTION	CONDITION	ACTION REQUIRED
Chimneys: Two brick chimneys; one to left one to right (all directions as you look at the property from the front), lead flashings. Left hand chimney has two pots, right hand has no pots.	Average. Dampness getting into this area.	Make watertight.
Roof: Pitched roof, clad with concrete tiles Large flat roof, 60's style extension	Cement flashing Please see flat roof schedule	Replace cement flashing with a lead flashing

Gutters and Downpipes: A mixture of cast iron and plastic	Generally, older guttering system needs rechecking, it doesn't appear to be falling towards the downpipes and in many cases the downpipes are simply discharging against the property, which needs to be altered and put into a soakaway.	Add to a soakaway.
Walls: Stippled painted render to extension, with brickwork and stretcher bond to the base	Average	
Windows and Doors: Two dormer windows, metal windows into a timber frame at second storey level. Metal windows into timber frame at first floor level Timber casement windows on extension		Repair and redecorate

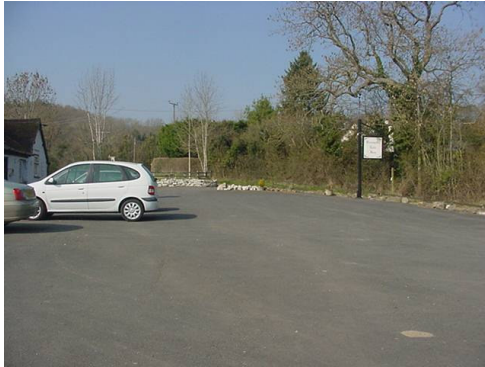
CAR PARK

DESCRIPTION	CONDITION	ACTION REQUIRED
Tarmac	No drainage points, runs towards the front elevation	Add drainage points
Walls: Random rubble stone walling Swing sign

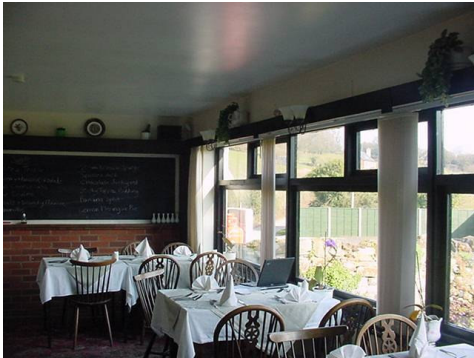
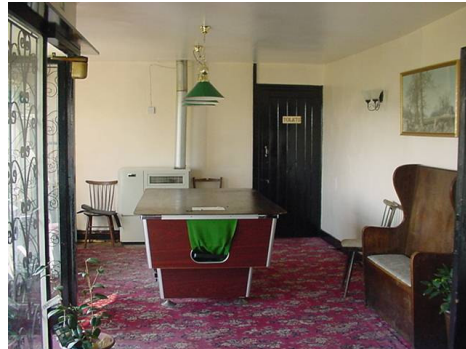
Restaurant Area

DESCRIPTION	CONDITION	ACTION REQUIRED
Ceilings: Painted	Some marks and dated	Repair and redecorate
Walls: Painted finish	Various areas of hairline cracking	Repair and redecorate
Floors: Carpet	Worn	Replace
Windows and Doors: Two internal windows		Repair and redecorate

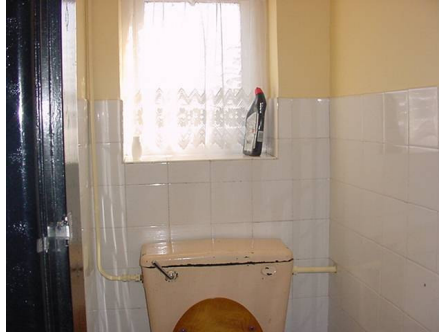
Ladies' Toilets

DESCRIPTION	CONDITION	ACTION REQUIRED
Ceilings: Painted	Some marks, generally dirty	Repair and redecorate
Walls: Tiled to approx 1.5 metres	Some blown tiling. General ingrained dirt and some old fixing points	Clean and repair as necessary, replace if tiling excessive.
Floors: Carpet	Average	
Sanitary Ware Two WC's and one wash hand basin	WC cisterns in poor condition	Replace sanitary ware

Windows and Doors:		
Entrance door	No push plate and handle broken. Some marks	Add push plate and redecorate
Three metal casement windows		Repair and redecorate
Services:		
Background heaters to WC areas

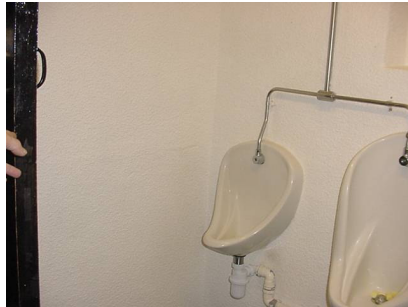
Gentlemens' Toilets

DESCRIPTION	CONDITION	ACTION REQUIRED
Ceilings: Painted	Average	Repair and redecorate
Walls: Painted render	Average	Redecorate within the WC area
Floors: Painted concrete	Below average	Repair and redecorate
Sanitary Ware Two urinals, one WC's and one wash hand basin	Dated	Replace sanitary ware
Windows and Doors: Entrance door Three metal casement windows	No push plate. Some marks	Add push plate and redecorate Repair and redecorate
Services: Background heaters to WC areas

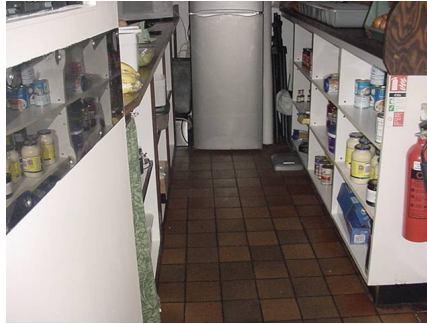
Prep Area

DESCRIPTION	CONDITION	ACTION REQUIRED
Ceilings: Painted	Hairline cracking, some marks	Repair and redecorate
Walls: Shelved and painted		General clean and redecorate
Floors: Quarry tiles

Re-grout and general deep clean
Windows and Doors: Flush finish swinging door with vision panel		Redecorate

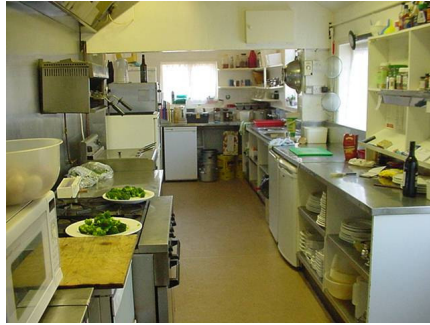
Catering Kitchen

DESCRIPTION	CONDITION	ACTION REQUIRED
Ceilings: Painted vaulted ceiling	Some stains	Repair and redecorate
Walls: Painted Two tile splashback Stainless steel	Some marks Ingrained dirt	Repair and redecorate Clean General clean
Floors: Altro style		Deep clean
Windows and Doors: Three windows	Some rusting to the metal window	Redecorate and check timber window
Catering Equipment: We have assumed that the catering equipment meets Local Authority approval and is appropriate for use. The catering equipment has not been inspected, as we are not expert in this area.		
Services: Extracts		Deep clean

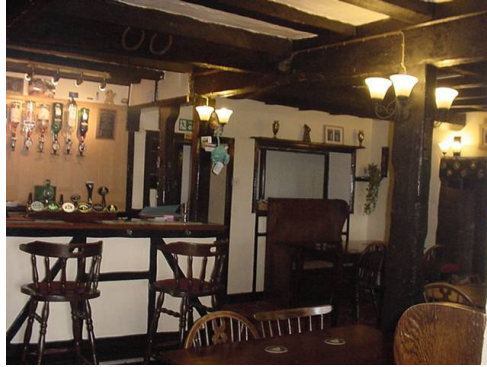
Inner Bar

DESCRIPTION	CONDITION	ACTION REQUIRED
Ceilings: Blackened timber with white painting between	Slightly dated	Repair and redecorate
Walls: Painted	Rising damp found	Repair and redecorate
Floors: Carpet, with timber to bar	Average

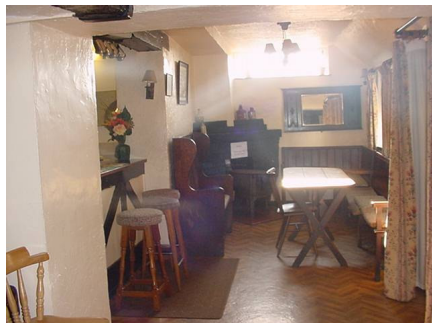
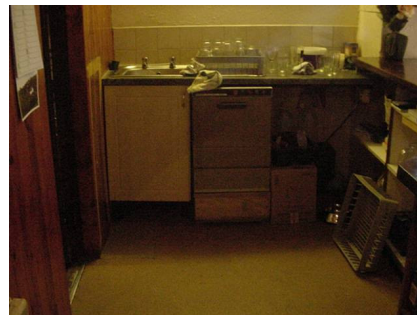
Front Bar

DESCRIPTION	CONDITION	ACTION REQUIRED
Ceilings: Gloss textured paint finish	Average, marks above lights	Repair and redecorate
Walls: Textured paint	Redecorated? Rising damp found.	Repair and redecorate
Floors: Vinyl	Cigarette marks, heel marks, etc.	Replace

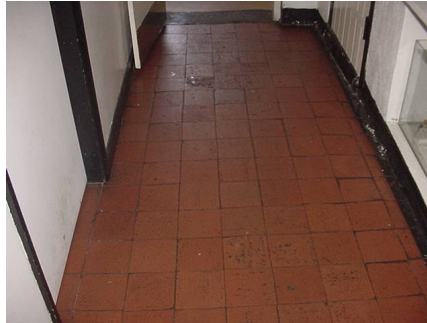
Access Corridor
(between kitchen and bar area)

DESCRIPTION	CONDITION	ACTION REQUIRED
Ceilings: Painted textured	Dated	Repair and redecorate
Walls: Painted	Dated	Repair and redecorate
Floors: Quarry tiles	Ingrained dirt	Deep clean
Doors: Door		Redecorate

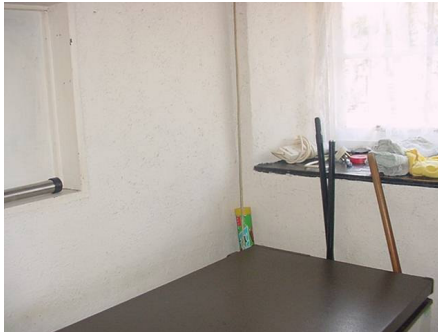
Store

DESCRIPTION	CONDITION	ACTION REQUIRED
Ceilings: Painted artex	Dirty	Repair and redecorate
Walls:	Dirty	Repair and redecorate
Floors:	Ingrained dirt. Rising damp found.	Deep clean
Windows and Doors:

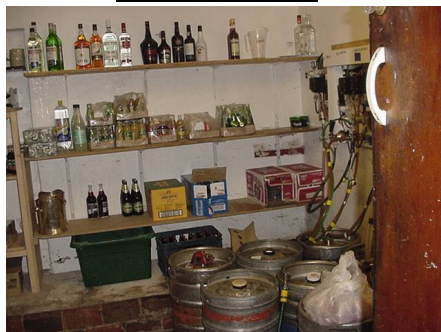
Cellar Area

DESCRIPTION	CONDITION	ACTION REQUIRED
Ceilings:	Marked and dated	Repair and redecorate
Walls:		
Floors:		Repair and redecorate

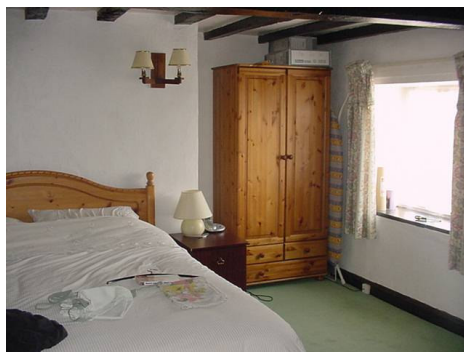
Bedroom

DESCRIPTION	CONDITION	ACTION REQUIRED
Ceilings: Painted ceiling with spine beam and associated blackened timbers	Average/dated	Repair and redecorate
Walls: Painted with signs of old style 1960's artex Built in wardrobe with wooden sliding doors	Average.

Repair and redecorate. Note: likely to have possible asbestos content
Floors: Carpet	Average	
Windows and Doors: Entrance door – metal and timber brace door One window		Repair and redecorate

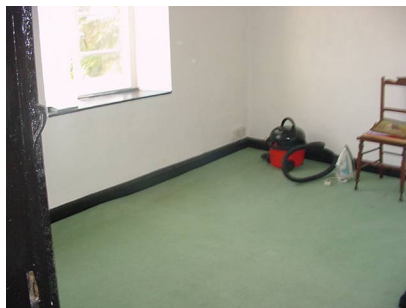
Walk Through Room

DESCRIPTION	CONDITION	ACTION REQUIRED
Ceilings: Painted ceiling with spine beam and associated blackened timbers, some signs of artex	Average	Repair and redecorate
Walls: Painted with signs of old style 1960's artex Built in wardrobe with wooden sliding doors	Average.	Likelihood of having some asbestos contents
Floors: Carpet	Average	
Windows and Doors: One metal casement and timber frame window Two doors: one to bedroom and one timber brace door		Repair and redecorate Repair and redecorate

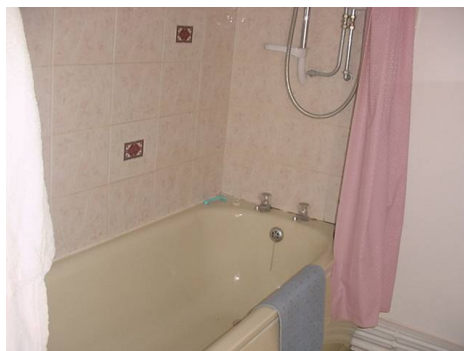
Bathroom

DESCRIPTION	CONDITION	ACTION REQUIRED
Ceilings: Plastered and timbered		Repair and redecorate
Walls: Painted with signs of older style artex	Dampness coming through on external wall

Repair and redecorate
Floors: Carpet	Average	
Windows and Doors: Metal casement window One painted ledge and brace door	Rusting	Repair and redecorate

Sanitary Ware:		
Coloured olive	Dated, with mould around the mastic of bath	Replace
Electric shower		
Services:		
	No mechanical extract fan vent	Add mechanical extract fan vent

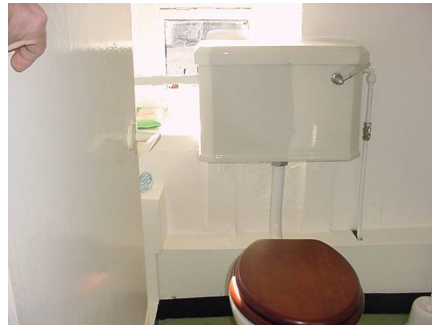
Toilet
(down two steps from bathroom)

DESCRIPTION	CONDITION	ACTION REQUIRED
Ceilings: Painted, part of ceiling is angled	Average	Redecorate
Walls: Painted	Average/slightly dated	Redecorate
Floors: Carpet	Average	
Windows and Doors: Timber window Painted flush door	Average Average	Repair and redecorate

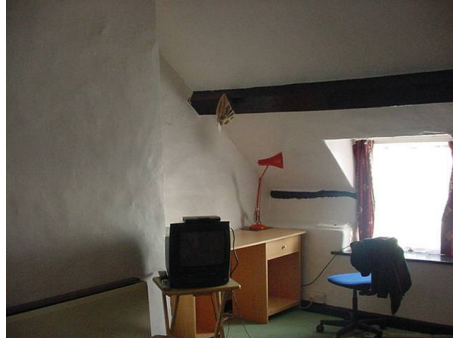
Bedroom Two – Gable End

DESCRIPTION	CONDITION	ACTION REQUIRED
Ceilings: Painted. There are various feature beams and wall/ceiling is vaulted	Average	
Walls: Painted and vaulted	Average, with exception of chimney and gable area, where dampness is coming through. Some cracking to paintwork adjacent to verge, indicating that dampness getting in and the wall plate is soft.

Repair and redecorate The dampness will mean these rooms will need to be redecorated every two to three years. The deterioration associated with the dampness should be excluded from the Lease.

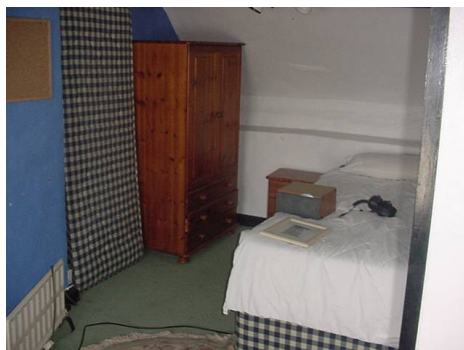
Right Hand Bedroom
(all directions given as you face the property)

DESCRIPTION	CONDITION	ACTION REQUIRED
Ceilings: Vaulted Feature beams, in form of purlins	Older style artex used	Repair and redecorate
Walls: Vaulted

Dampness coming through to gable end. Also looks to have been an older style artex used, which can contain an element of asbestos to walls/ceiling area	Repair and redecorate. The deterioration associated with the dampness should be excluded from the Lease.
Floors: Carpet	Average

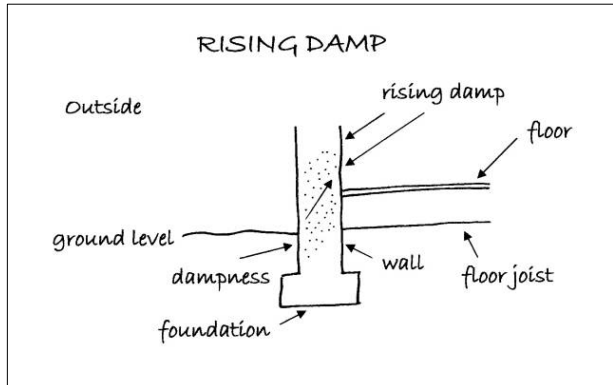
A random visual inspection and tests with a moisture meter have been taken to the perimeter walls and some internal walls. Dampness was found. Also the car park discharges onto the walls and an inappropriate paint has been used.

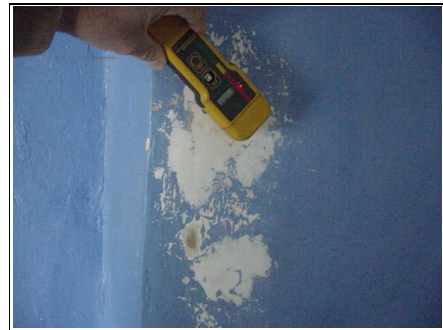
Tests were taken with a moisture meter at random points to internal walls, floors and other surfaces. We get high readings in some areas.

ACTION REQUIRED:
Redecoration required. In some areas we believe a new flashing is needed.

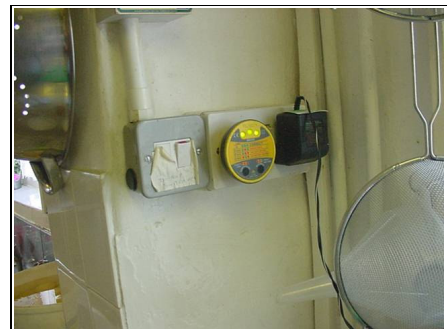
The electric fuses and consumer units range from the 1960's to the 1980's and looked dated. We would recommend they be replaced.

We carried out an earth test in the kitchen area to the socket point that is normally used for the kettle, this proved satisfactory.

ACTION REQUIRED: As the property is changing occupancy an IEE inspection, test and report should be carried out by a NICEIC registered and approved electrical contractor. You will also be required to carry out a Portable Appliance Test (PAT) on all portable appliances.
