**COMMERCIAL BUILDING SURVEY
OF
A Public House in Somerset**

Mr N

Firstly, may we thank you for your instructions; we have now undertaken a Commercial Building Survey (formerly known as a Structural Survey) of the aforementioned property.

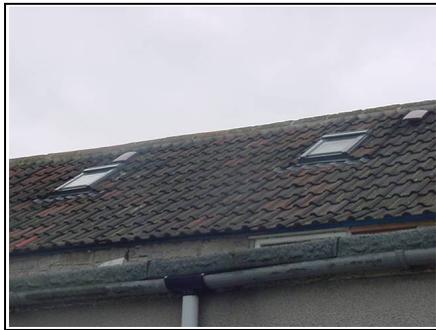
Roof Windows

There are two roof windows (often known as roof lights or Velux windows) to the bed and breakfast accommodation. There were no visible signs of leaks around them internally.

It seems inevitable with roof windows that they will sooner or later leak. If this doesn't occur then they seem prone to condensation. Keep a cloth handy!

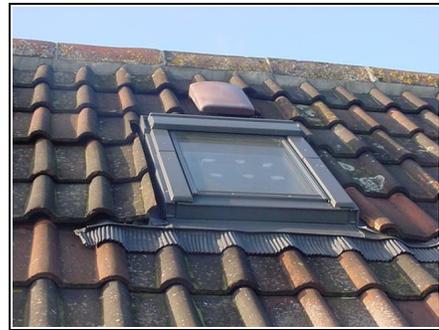
Close up of roof window and vent

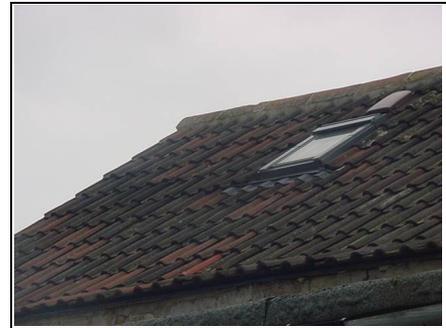
The main roof is pitched and clad in a large interlocking concrete tile (sometimes known as Roman tiles). From what we could see the concrete tiles are lying level and true and look in reasonable condition considering their age. Sometimes we find deterioration to the ridges and the perimeter, so you should periodically check these areas.

We are advised by the owner that the main roof is approximately nine years old and five years to the bed and breakfast area.

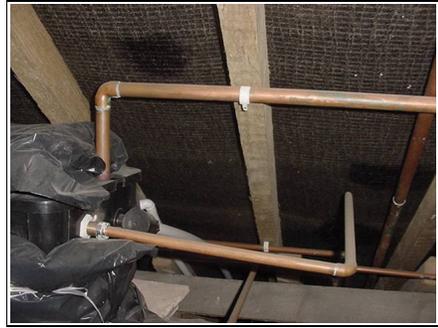
When we inspected the loft space we found a Hessian base Bitumen membrane. This type of membrane has been used since the 1960s. We generally found it to be in average condition, although it is damaged in a few places but this is not unusual considering its age.

This photo shows the common rafters (the ones that form the pitch of the roof) and the dark area between is the underlayer.

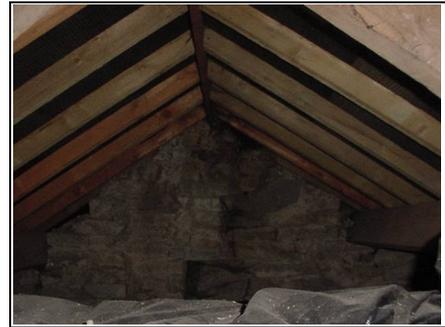
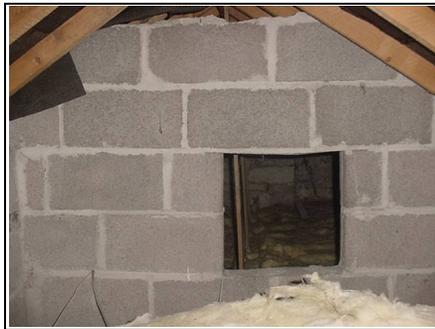
Entrance to right hand side roof.

The main roof is accessed via the loft hatch located on the landing. There is no loft ladder, electric light or secured floorboards. We recommend that these be added, as it will make the loft space safer and easier to use. The loft has been viewed by torchlight, which has limited our viewing slightly.

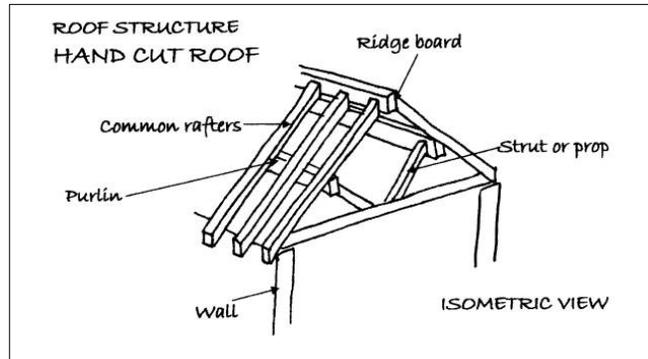
This type of roof structure has what is known as a cut timber roof, with amendments for the new extension roof. This is a roof that is purpose made and hand built on site. Without the original design details we cannot categorically confirm that there are no defects; however it is in line with what we typically see. We do recommend propping to the purlins.

We found the roof timbers generally in average condition considering their age. We have inspected the roof structure for serious active woodworm and for structurally significant defects to the timber together with dry rot and wet rot. Our examination is usually limited by the general configuration of the roof, the insulation and stored items, as mentioned what we could see was generally found to be in an average condition considering its age. It is, however, feasible that there are problems in the roof that are hidden.

ACTION REQUIRED: We recommend propping to the purlins (these are the horizontal timbers that run across the roof) in the older part of the roof.

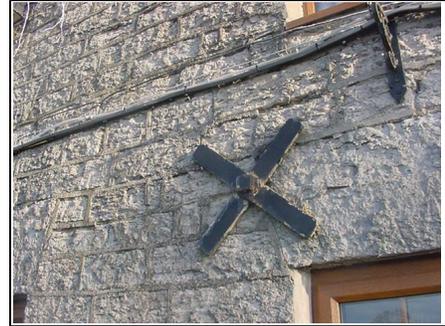
This property has Blue Lias stone, which is relatively soft, and originally it would have been bedded in a soft lime mortar. This lime mortar has been replaced by a hard cement mortar and is causing damage and deterioration to the face of the property, as well as lateral dampness, which is particularly important as the property looks to have timber lintels.

It is notorious for flaky and delaminating appearance if weathered.

Unfortunately the repointing, whilst well meaning, is not appropriate for this type of construction. Cement mortar has been used rather than a lime based mortar. Please see our further comments in the Executive Summary.

ACTION REQUIRED: In summary we recommend that a soft stiff brush (as we don't want to damage the face of the Blue Lias stone any further) is used on the property every six months to remove any loose cement mortar and re-point in a lime mortar. Using lime mortar will limit further damage to the brickwork, which is almost impossible to repair successfully. However, we would add that many, if not most of the properties that we visit that are re-pointed are re-pointed wrongly; it is only in recent years that we have discovered the problems that can occur from it.

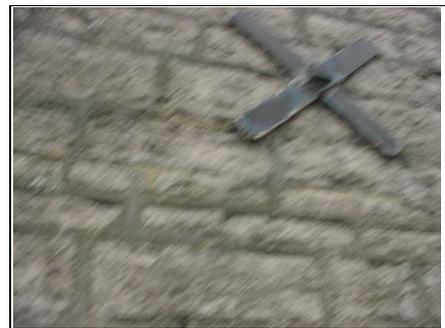
Bracing

Just to explain further the extent of the damage that the lateral dampness can cause, there has in the past been deterioration to the floor timbers at first floor level, which has resulted in tie bars being required. Please telephone us if you wish to discuss this further.

The property has tie bars; these have been added to resist movement in the structure and reinstate it to its original vertical position.

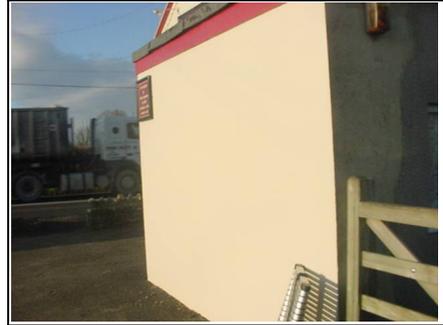
Render to Back

The render to the back of the property is finished in a Tyrolean applied paint finish or similar; this a proprietary paint, which has a plastic base.

Please see our comments in the Executive Summary.

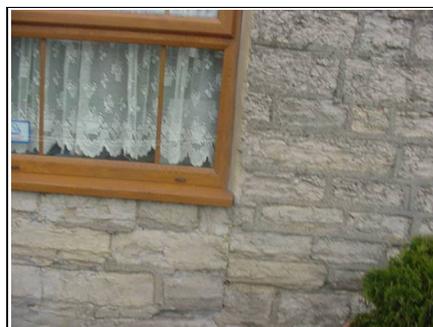
The property has plastic, double glazed windows, which generally look to be of a reasonable quality. We were pleased to see trickle vents.

We would draw your attention to the fact that sealed double glazed units can fail, particularly as a result of poor workmanship during installation. Failure of the seal leads to condensation between the two panes of glass and simply replacing the affected units may not provide a satisfactory long-term solution. In this case they are in average condition.

Double glazed plastic window

Enquiries should be made as to the existence of any transferable guarantees. Generally it is considered that double glazed units have a life of about ten years

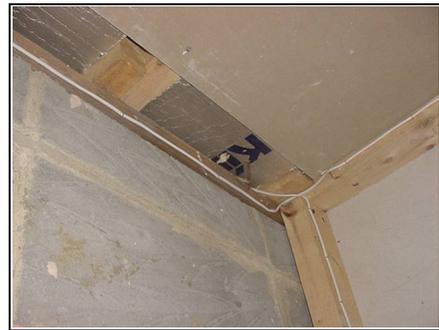
Lath and Plaster ceiling

Kingspan (trade name) insulation has been added between the floorboards where we could see, where the plaster would have been left unfinished.

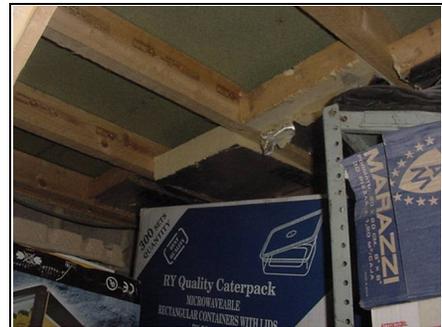
Some Kingspan insulation has been used between the floor joists in the bed and breakfast area.

Exposed floor.

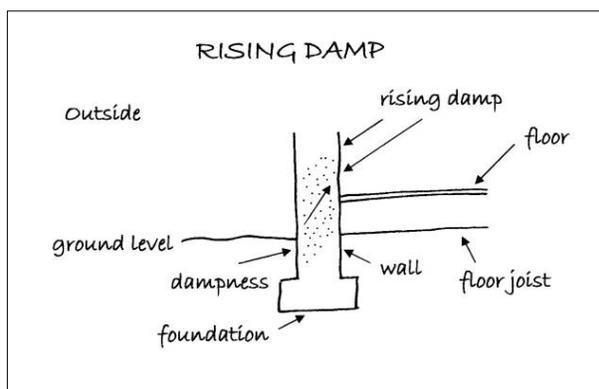
The readings we obtained indicated that there is some dampness in the property. It is located in the dining room area, but we recommend you check the whole property.

ACTION REQUIRED: You should instruct a qualified and experienced contractor, who is a member of the BWPDA (British Wood Preserving and Damp Proofing Association) issuing a long-term insurance backed guarantee, to carry out a quotation on the property, including all necessary remedial works, which should be forwarded to us for comment.

Work should include replacement of all damp affected plaster in accordance with the specifications of the specialist contractor. (Failure to do so may nullify the validity of the guarantee.)

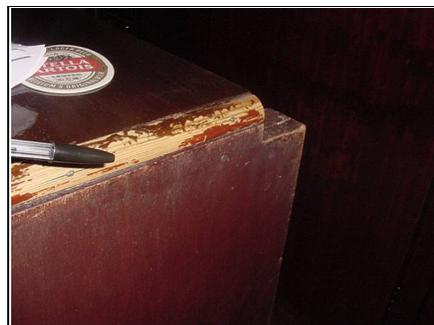
Bar

The bar is stained and worn through in some areas.

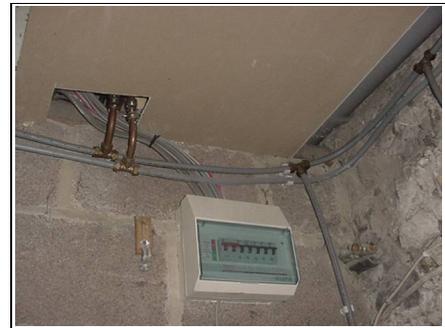
Fuse Board

The electric fuses and consumer units were located to the left hand side of the bar. We would date the fuse board as being from the 1960s. Rewireable fuses are now superseded. Far better fuse boards are now available.

Please see our comments in the Executive Summary.

ACTION REQUIRED: Have an NICEIC registered and approved electrical contractor carry out an inspection to IEE standards. You will also be required to carry out a Portable Appliance Test (PAT) on all portable appliances.

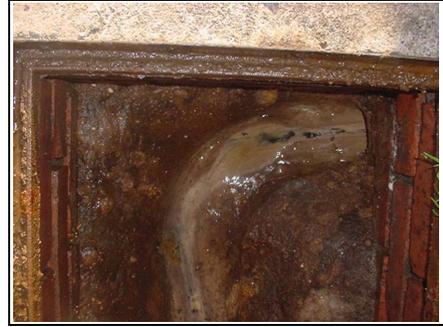
Inspection Chamber / Manhole One – Rear Middle Drain

We duly lifted the man hole/ inspection chamber cover and found the drain to be free flowing, we noted it was finished in brick.

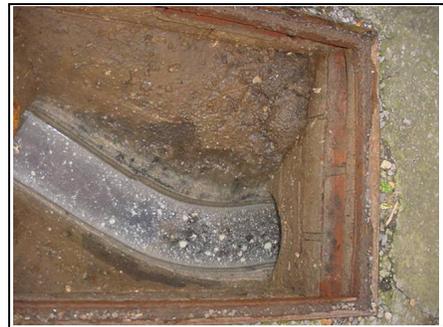
Inspection Chamber / Manhole Two – Rear Left Hand Drain

We duly lifted the cover and found it to be back filling.

Please see our comments in the Executive Summary.
