# PROPERTY REPORT

**XXXX**  
**City of London,**  
**EC3V XXX**

We have been instructed to inspect and prepare a Report and Schedule of Condition for XXXX, City of London, EC3V XXX. We inspected the property on XXXX

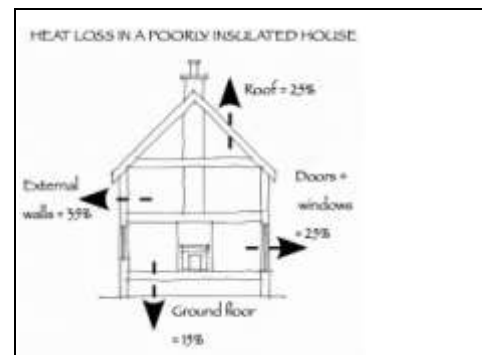
There is no insulation within the roof of this structure and it is difficult to establish if having insulation will be a good idea or not as it may cause both surface condensation and interstitial condensation.

Although this sketch shows a house it shows how heat is lost due to poor insulation
