# PROPERTY REPORT

## Public House in Wandsworth, London SW15

We have been asked to inspect and prepare a Report and Schedule of Condition for a Public House in, Wandsworth, London SW15.

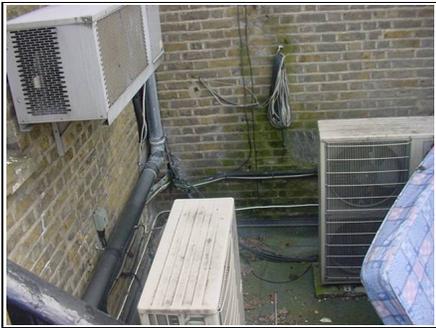
Mould and moss visible to walls

**ACTION REQUIRED:** Make gutters and downpipes watertight and carry out ad hoc repointing and also check lead detailing generally.

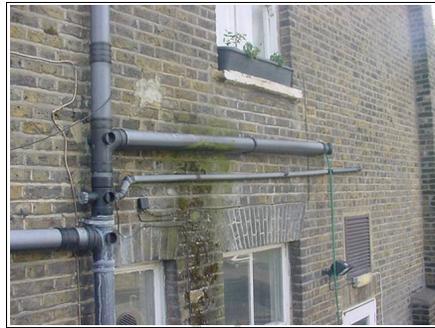
Lateral dampness coming in to kitchen area

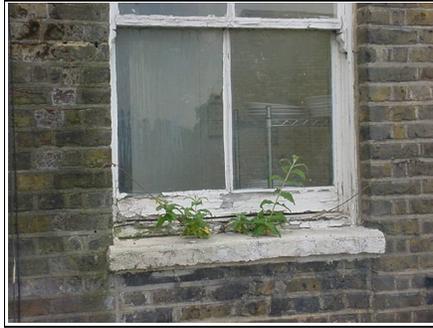
Paint has come off leaving bare timber and window cill literally has plants literally growing out of it

**ACTION REQUIRED:** We recommend repairing the existing windows if at all possible; we would not recommend replacing them as looks to be good quality original timber. We recommend the addition of draught seals for the existing sash units or good quality secondary glazing (assuming that this does not block an option on a fire exit).

You will also need to repair the window cills and there are literally plants growing from some of these.

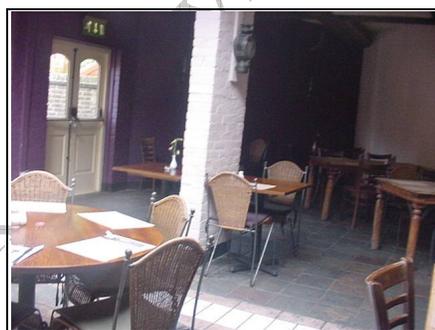
Restaurant area

We are advised that internal painting will be carried out by the new occupiers. However we would refer you to areas of dampness, such as:

This work needs to be carried out prior to repair and redecoration work being carried out to ensure these areas are wind and watertight otherwise the redecoration will just deteriorate rapidly. We would specifically draw your attention to the cellar where we believe it would not meet environmental health standards unless work is carried out and we also would emphasise that some of the rooms being lived in are damp.

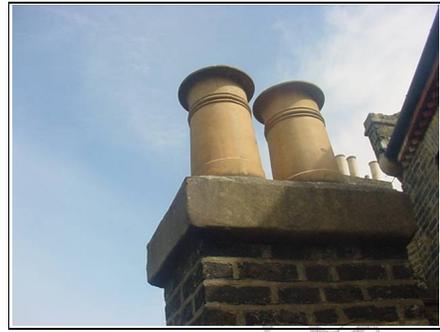
Rear low level chimney

This can be viewed from the rear roofs and looks to be in average condition.

**ACTION REQUIRED:** Close up inspection.

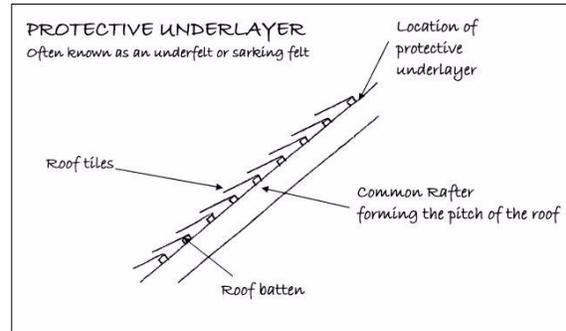
There is no protective underlayer. Our view inside the roof was limited due to an infestation of pigeons.

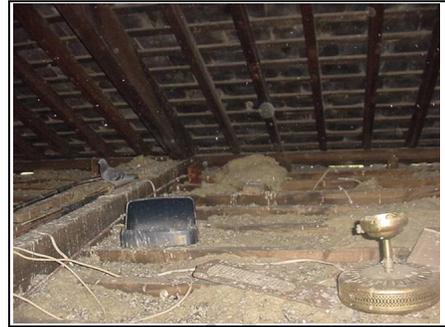
General view of main roof

First of all you should bear in mind that this was a head and shoulders view (by which we mean just our head and shoulders were in the roof space) and therefore our examination was very limited. From what we could see the roof looked in much better condition than we were expecting, though this is often the case in this older style, over engineered roof. We therefore feel that the main problems are likely to be around the parapet walls and the perimeter and chimneys.

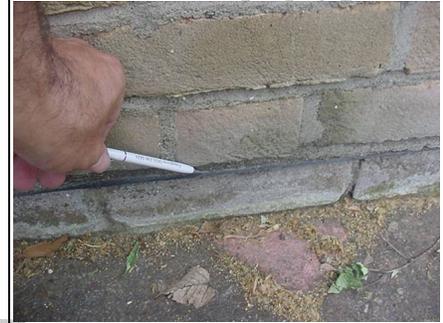
Damp proof course

All modern properties should incorporate a damp proof course (DPC) and good building practice dictates that a differential of 150mm (6 inches) should be maintained between the damp proof course and ground levels. In this case, the majority of the DPC could not be seen because of the render. Where we could see it to the rear extension it was slightly too low; it was one brick above ground level rather than two, which does mean it is susceptible to some dampness.

**ACTION REQUIRED:** Ideally, lower the level of the ground around the extension. We much prefer to see a French drain. Please see Appendices.

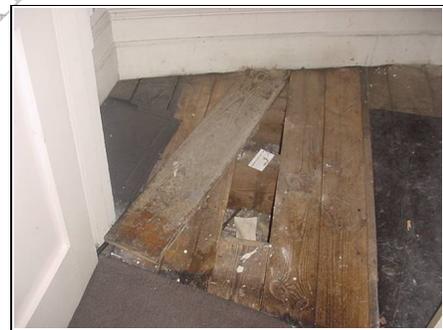
Floor joists

We have been able to see some of the floor construction from within the cellar and also a small area of floor exposed on the first floor. From this we can see that the timbers run from the front to back of the property and this was confirmed within the roof space, where we could see the layout of the timbers.

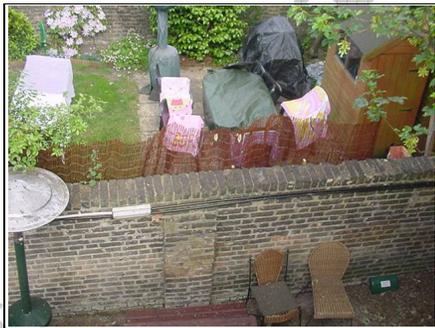
Looking down into your beer garden with close proximity of next door's garden. You will need to have good relations with the neighbours.

**ACTION REQUIRED:** We would suggest you go and speak with your neighbour and take them around to the pub and show them the task that you have in hand and explain to them how you wish to proceed and start off on the right foot.

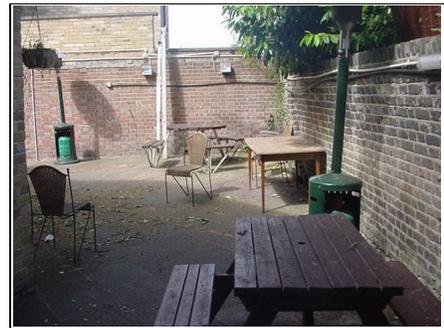
Rear beer garden

The beer garden is very limited and, as discussed, we would draw your attention to how close you are to your neighbours. In our opinion good neighbour relationships are very important.
