PROPERTY REPORT

A Public House In Somerset

We have been asked to inspect and prepare a Report and Schedule of Condition for a public house in Somerset.

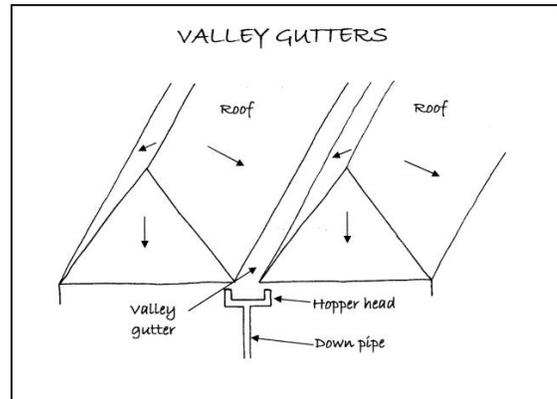
2) Leaking Valley Gutters

We noted that the valley gutter that runs adjacent to the ladies toilets is leaking into the ladies toilets. We also noted (as is pictured previously) that other valley gutters were full of vegetation, etc.

ACTION REQUIRED: You will need a roofer for approximately one day to clear the valley gutters and to carry out some specific work on the valley gutter over the ladies toilets, where it needs to be stripped back and the lead checked and check the adjacent tiles for leaks.

ANTICIPATED COST: To have a roofer for the day plus whatever work is ultimately found in the valley gutters, plus materials, we would expect costs in the region of £500 to £1,500, assuming scaffold access is not required. Please obtain quotations.

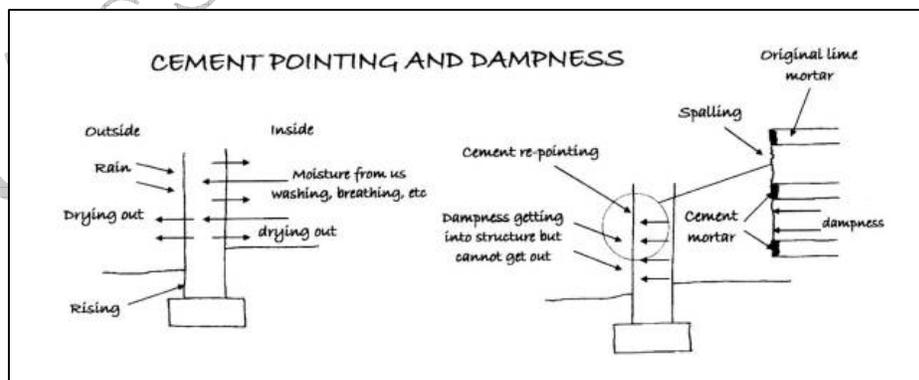
This type of older property would originally have been built using lime mortar and that is what we think should be used on it today as it allows the property to breathe. Unfortunately, the property has been repointed in the majority of places with a hard cement mortar (this is something we often come across), just as the render that has been used is a hard cement based render in other parts of the property. Whilst you find this in the majority of properties we look at, we feel that over the course of the lease this will cause a lot of deterioration. It is, however, hard to appreciate the effects of spalling stonework.

Close up of front of stone spalling

ACTION REQUIRED: We recommend that you find a builder experienced in lime mortar and ask them to return on sunny days with a soft brush to gradually remove the cement mortar and the repoint in a lime mortar; this is a major task.

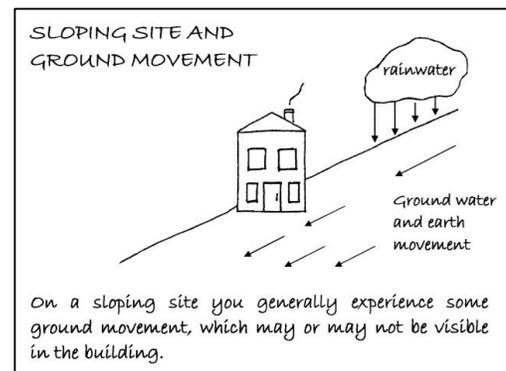
The property sits on a sloping site and as such water needs to move from the top of the slope to the bottom. Currently the water runs from the car park area, past the skittle alley and the pub and then discharges on the road.

General sloping of property towards road from left to right

ACTION REQUIRED: Ideally we would recommend a French gully is placed around the property to give the rainwater a path to follow and to minimise the rainwater getting onto the road, which you have a liability for if there are any accidents.

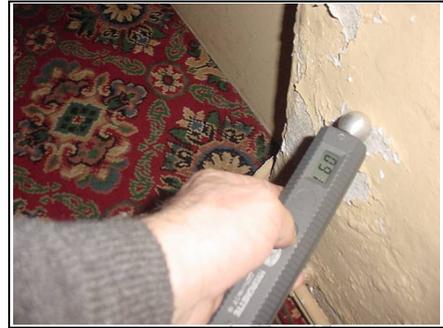
Internally we found dampness to the perimeter walls and interior walls. We believe that the dampness to the perimeter walls relates to the sloping site discharging water against the building and feel that a French drain should reduce this.

We feel the central wall in the restaurant / function room area is due to rising damp that can be best reduced by having a water based paint finish that allows the area to breathe.

Checking for and finding dampness in restaurant area

ACTION REQUIRED: To be on the safe side we recommend that the timber floor joists adjacent to the walls are lifted so you can see the condition of the rafter feet, which are normally embedded into the wall in this age of property and they may need some additional supports.

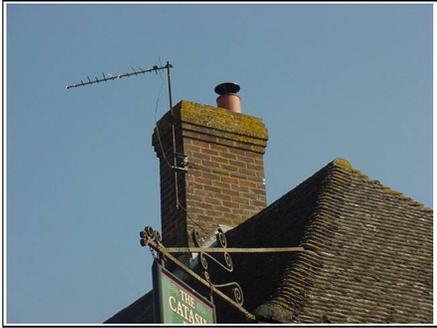
This chimney is brick built with one chimney pot. Again there looks to be a lot of moss to the top of this chimney. We would also comment that there is an aerial on it which is fixed using wire. This can cut into the brickwork and this needs to be checked.

Right hand chimney

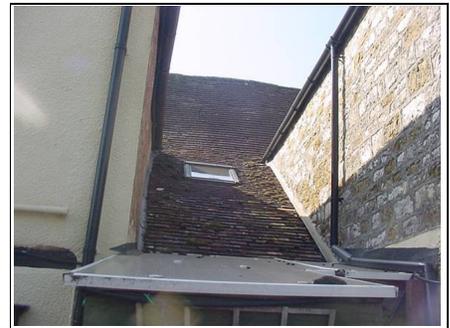
It is always difficult to view roof windows. In this case they are all metal externally with timber internally and purpose made. They look to be relatively modern, i.e. in the past twenty years. Our main concern is the roof window over the stairs area, as it is a relatively shallow pitch and this is the one we think is most likely to leak, although having said that we can see the glass in the ladies toilet is misting over and therefore may have been affected in some way (we often find where misting over of a window occurs it is due to dampness getting into the roof light or movement in the structure causing some movement in the roof window).

Roof window to staircase area

ACTION REQUIRED: It seems inevitable with roof windows that they will sooner or later leak. If this doesn't occur then they seem prone to condensation. Keep a cloth handy!

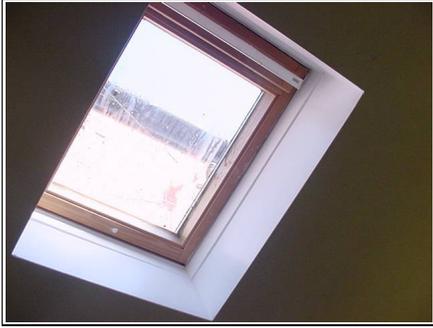
Roof window to ladies toilets – misting over indicating seals have gone

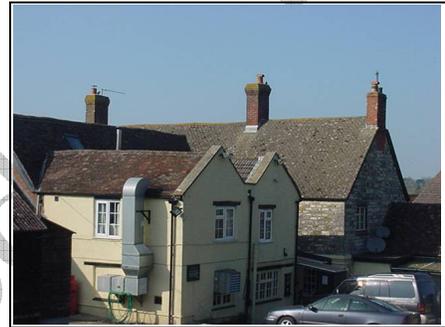
We were able to gain access to the left hand roof from the roof window and walk along the hidden valley on the left hand side. We would comment that the roof is in average condition, although we would expect work during the course of the lease, particularly to the valley gutter area.

Left hand side rear roofs

ACTION REQUIRED: Please see our comments in the Executive Summary about roofs and the awkward valley gutters.

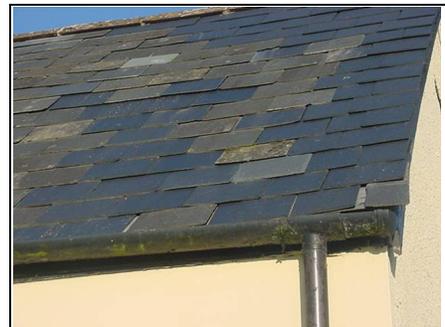
The rear roof has a mix of slates, old and manmade and they look unsettled on the roof. In our experience, where we have seen this type of roof previously, the wind can get underneath it and lift the slates.

Rear slate roof

ACTION REQUIRED: Please see our comments in the Executive Summary.

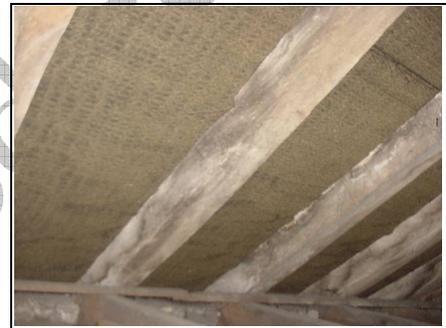
In this instance we found a Hessian based felt. However, our access to the roof was very limited and we were only able to see the roofing felt in the rear section and in the toilet areas. Hessian based bitumen has been used since the 1960s. We generally found it to be in average condition, it is damaged in a few more places than we normally find.

This photo shows the common rafters (the ones that form the pitch of the roof) and the dark area between is the underlayer.

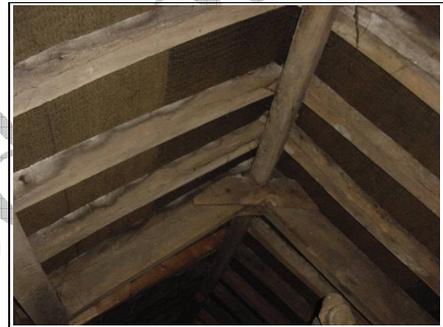
General view of roof

Our examination is limited by the general configuration of the roof, the insulation and stored items, The roof structure is in below average condition in some areas due to us finding woodworm. We believe also there is dampness coming in from the valley gutters in some areas and if you also look at the general view of the roof above you can see dampness is getting in to the roof with staining to the roof timbers. Alternatively, some of this could be caused by condensation in the roof due to over insulation.

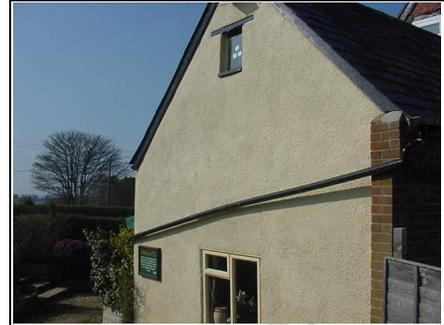
Part of the property has a painted cement render covering it. There is a timber structure beneath, which there may well be in the kitchen area. This is not ideal as it smothers the timber and accelerates the rot in it.

Render

ACTION REQUIRED: Please see our comments in the Executive Summary.

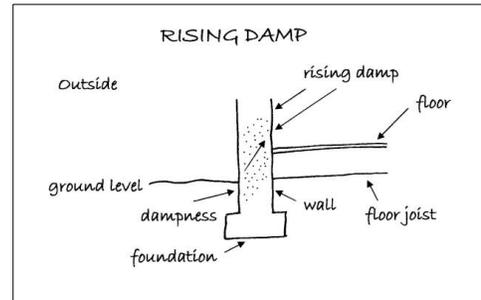
Rising Damp

The readings we obtained indicated that there is dampness in the property, and there is some more likely to be hidden behind the dry lining also known as false walls. To some extent in a property of this age that is a public house, we always find dampness. Work to the outside walls, removing the cement mortar and adding a lime mortar will help the wall breathe and the dampness dissipate.

ACTION REQUIRED: Please see our comments in the Executive Summary.

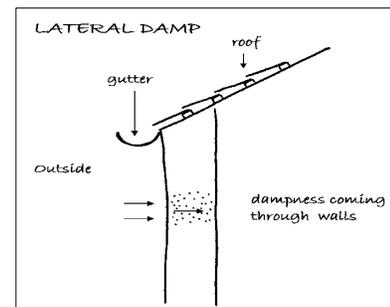
Lateral or Penetrating Dampness

Tests were taken with a moisture meter at points to internal walls, floors and other surfaces. We did not get high readings, but we did note the plaster is coming away from the wall more than we would expect. This generally is a sign dampness is coming through.

ACTION REQUIRED: We would refer you to our earlier comments in the Rising Damp section. There may be a need for some re-plastering when you redecorate.

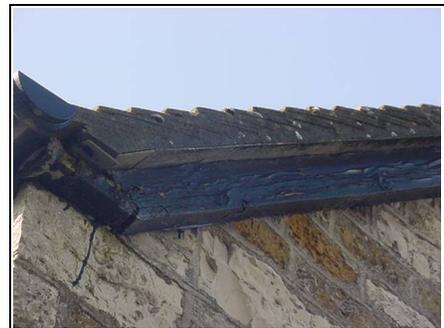
Asbestos has been seen to the skittle alley roof and also, we believe, to the verge of the main roof. Asbestos was commonly used post war until it was banned only in the last ten or so years, although it is rumoured that it was still used after this point in time. We are not asbestos surveyors.

The bargeboard to the gable end also looks to have asbestos forming the seal to the verge. This needs to be checked on your Asbestos Register.

ACTION REQUIRED: If you wish to confirm you are 100 percent free of asbestos you need to have an asbestos survey carried out.
