PROPERTY REPORT

**Public House,
Worcestershire**

We have been asked to inspect and prepare a Report and Schedule of Condition for XXXXX Public House, Worcestershire. We visited the property on XXXXXXXX.

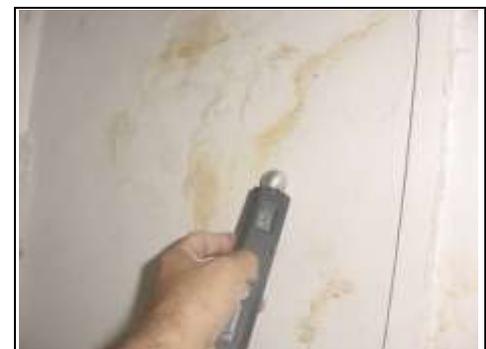
9) Lateral dampness

Within this property there has been a lot of lateral dampness over a considerable number of years. This has caused deterioration in many timber elements within the walls such as the joist ends and also the timber lintels above the windows.

ACTION REQUIRED: We believe that rot has been caused to the joist ends and these need to be exposed and opened up.

ANTICIPATED COST: In the region of £250 - £500 plus cost of works for things discovered; quotations required.
