# PROPERTY REPORT

East Sheen,  
SW14

We have been instructed to inspect and prepare a Report and Schedule of Condition on xxxxxxxxxxxx for xxxxxxxxxxxx.

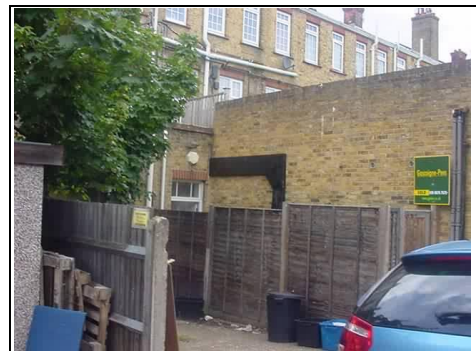
Rear courtyard area

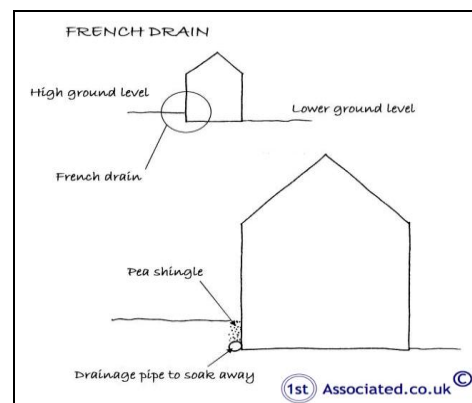
Rising damp is visible to the rear of the property within the W.C. area. We believe this is caused by high ground levels and plant growth around the outside of the property. There is also a pile of materials stacked against the property.

**ACTION REQUIRED:** We would recommend a reduction in the ground level and possibly the adding of a running gulley or a French Drain (please see our French Drain sketch and the article at the end of the report.

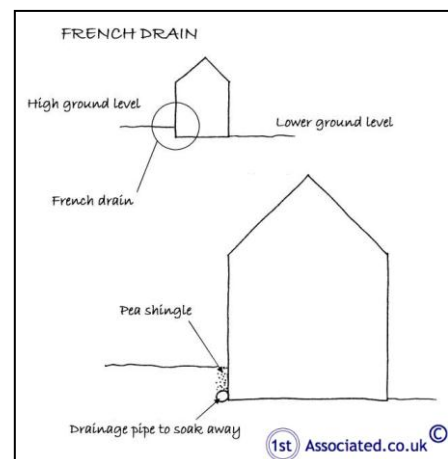
The French drain acts as an area where water soaks away quickly. We often recommend them close to building, but not next to the building, as this helps reduce the ground level and/or take any water that is directed at that area away. For example, where a patio has been put in place which aims any rainwater at part of the wall. As mentioned, whilst a French drain is a D.I.Y. job, it does need some understanding of how it works.
