RESIDENTIAL BUILDING SURVEY

A Modern Detached Property, Abbots Langley, Hertfordshire

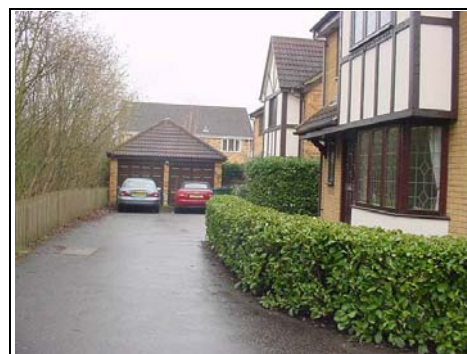
You are situated on a private road which means you will have a shared responsibility for the maintenance of it. Although, as we said in the 'Good' section, as it is a cul-de-sac, maintenance will be limited due to the limited traffic.

ACTION REQUIRED: Your solicitor to confirm that this is a private road.

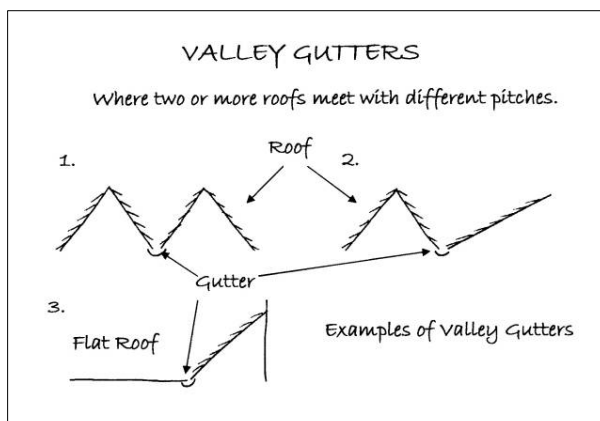
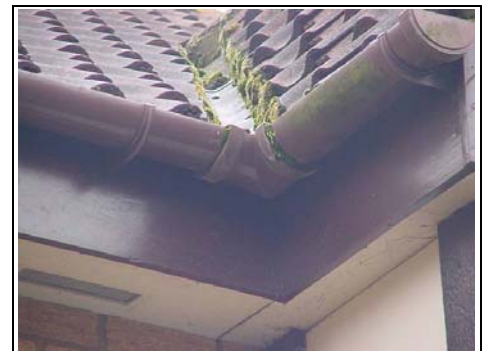
Valley Gutters

This is more something you need to keep an eye on rather than immediate concern. We could see some moss to the sides of the valley gutter. The sides are formed with a concrete edge; we much prefer a lead detail. These do tend to start to deteriorate after 10 – 20 years when the concrete comes away; this in turn leads to blocks in the valley gutters and leaks into the roof.

Valley gutters occur where two roofs join; these are generally considered weak areas. Please see our comments in the Executive Summary about the moss and the deteriorating concrete.

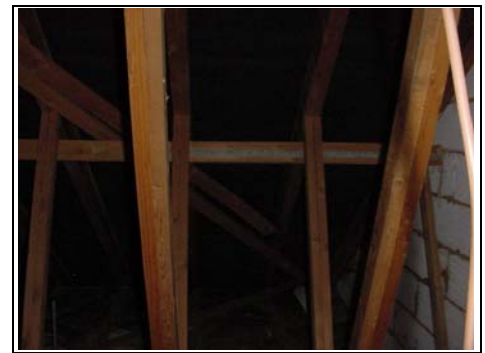
When we inspected the loft space we found a Hessian base Bitumen membrane. This type of membrane has been used since the 1960s. We generally found it to be in average condition, although it is damaged in a few places but this is not unusual considering its age.

This photo shows the common rafters (the ones that form the pitch of the roof) and the dark area between is the underlayer.

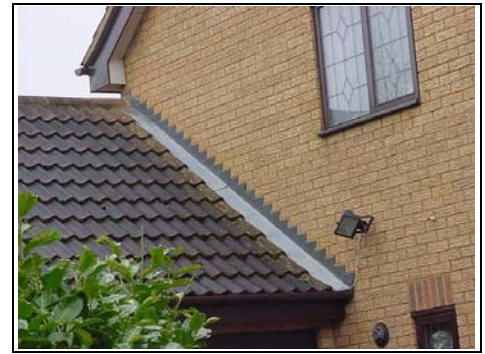
Garage Roof

Again, this roof has a similar tile finish as the main roof and we were pleased to see a lead flashing where it meets the main building. It is in average condition.

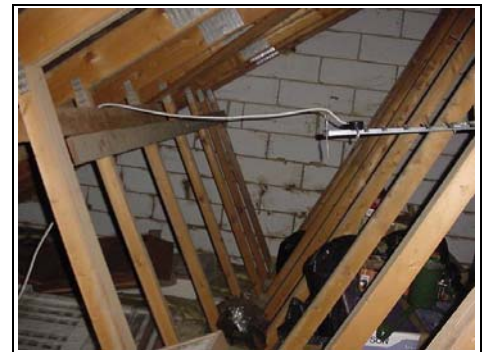
Access

The main roof is accessed via the loft hatch located on the landing. There is no loft ladder, electric light or secured floorboards. We recommend that these be added, as it will make the loft space safer and easier to use. The loft has been viewed by torchlight, which has limited our view, as have the amount of stored items.

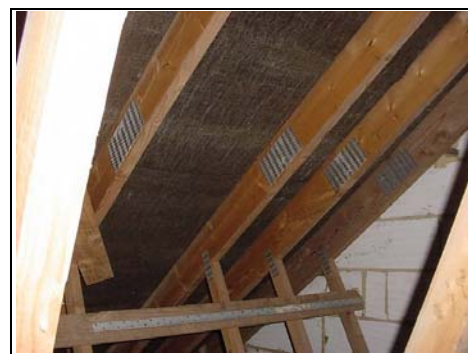
Roof Timbers

We found the roof timbers generally in average condition considering their age. We have inspected the roof structure for:

Our examination was limited by the general configuration of the roof, the insulation and stored items. As mentioned what we could see was generally found to be in an average condition considering its age. It is, however, feasible that there are problems in the roof that are hidden.

ACTION REQUIRED: The only way to be 100 per cent certain is to have the roof cleared and checked.

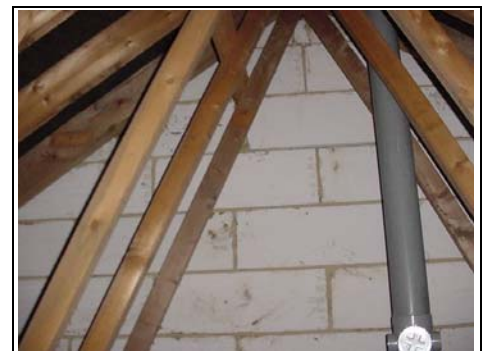
The soil and vent pipe is internal, you can see it in this photo taken within the roof space (the gray pipe).

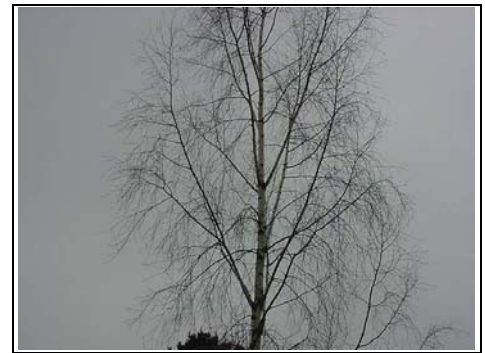
You have a small tree in the garden, it certainly won't be a problem to the house in future years, however it is located fairly close to the drains, so if it does have a sudden spurt of new growth it may be that it has got into the drains.

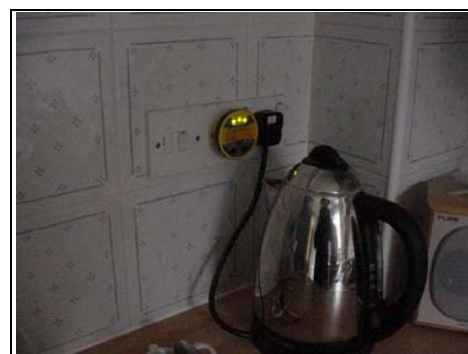
We carried out an earth test in the kitchen area to the socket point that is normally used for the kettle and this proved satisfactory.

ACTION REQUIRED: As the house is changing occupancy an IEE report should be carried out by a NICEIC registered and approved electrical contractor.

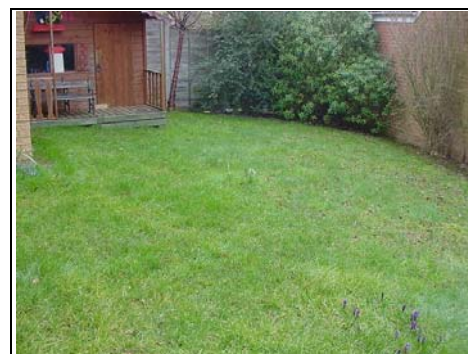
Inspection Chamber / Manhole One and Two in Rear Garden

These manholes are hidden beneath the grass and are approximately two paces to the right at a 45° angle from the back door and two paces to the left.

Manholes are in the middle of this photo under the grass

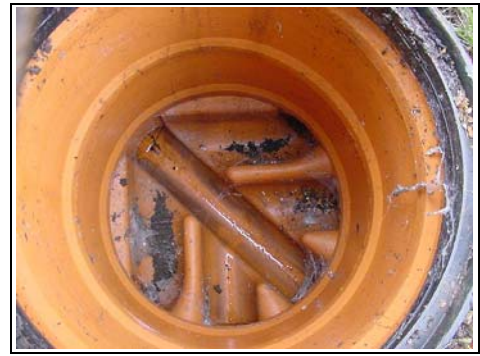
Inspection Chamber / Manhole Three – currently hidden under plant pot

We duly lifted this manhole and it was found to be plastic and free flowing at the time of our inspection.

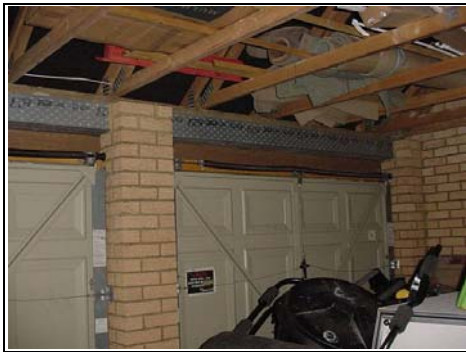
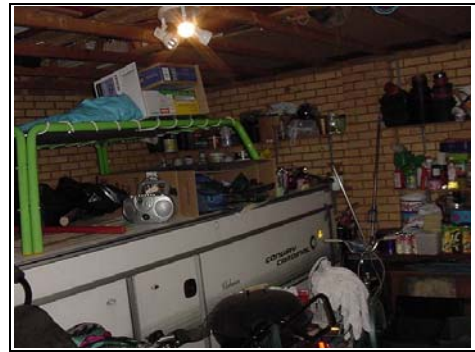
You have a linked double garage built in matching materials to the house. It has a concrete tile roof, brick walls, two separate double doors, metal lintels over the doors, and a trussed rafter roof.

As is common with many garages it is full of stored items, which limited our view slightly. We were pleased to see that the internal walls are brickwork, as opposed to blockwork that does tend to crack.

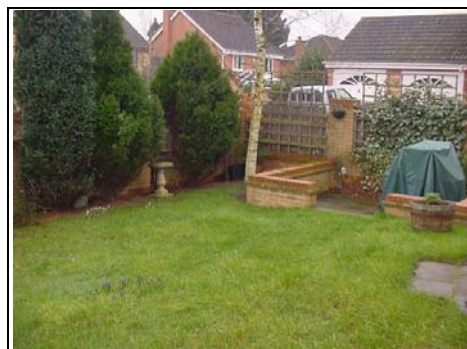
Boundaries: The boundary wall is a mixture of brickwork and timber fencing; it generally looked in reasonable condition although we have not inspected it closely.

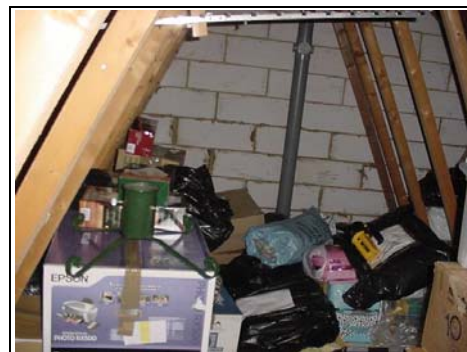
INSPECTION LIMITED

Unfortunately in this instance our inspection has been very limited due to the mass of stored items within the roof and also within the garage. The owner freely admitted that they had not thrown anything away in 13 years and it was all stored within the roof.
