RESIDENTIAL BUILDING SURVEY

OF
Acton, W3

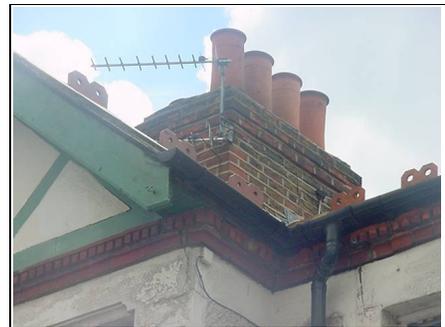
This chimney is brick finished with a metal flashing we believe it to be lead. We had a limited view of the chimney but from what we could see it had a few chimney pots and looks to have been re-pointed. Unfortunately next door doesn't, which can cause a problem. We were unable to see the very top of the chimney known as the flaunchings, therefore cannot comment upon these.

Brick chimney

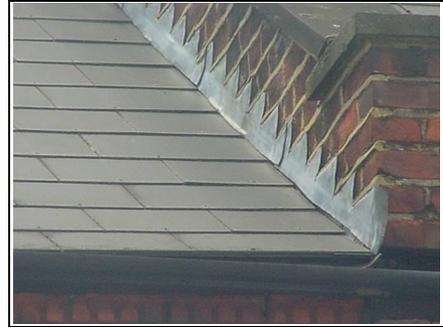
which we are pleased to see is cut to follow the joint and there is also a coping stone on the top. There may be a bit of water getting in via the flashing but it is generally in average condition. We did not see anything unusual for this age of property.

Close-up of parapet wall

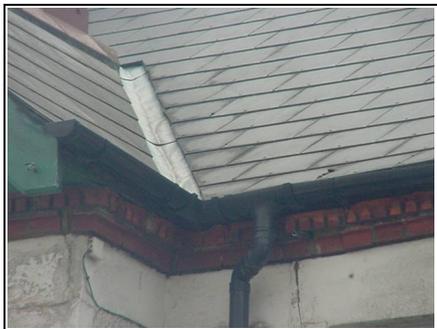
This roof has man-made slates. They are thin and light and the wind can catch them, so it is important that the slates are fixed at the perimeter and do sit flat. Check from time to time both here and at the perimeter.

Main roof to the front and the valley gutter around the front bay window

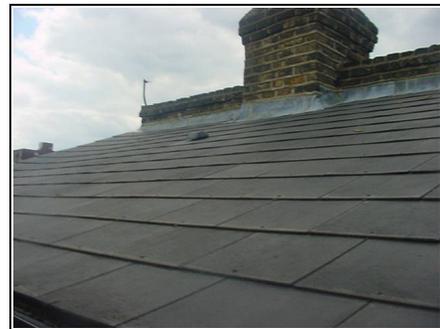
Close-up of the Manmade slates

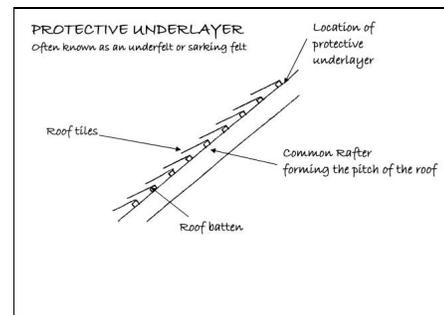
There are two protective underlayers to this property.

To the rear of the property is hessian based bitumen. This type of membrane has been used since the 1960s. We generally found it to be in average condition, although it is damaged in a few places but this is not unusual considering its age.

To the front of the property in the main roof we found a modern breathable underlay indicating this part of the roof is relatively new as breathable underlays have only been used since 2002.

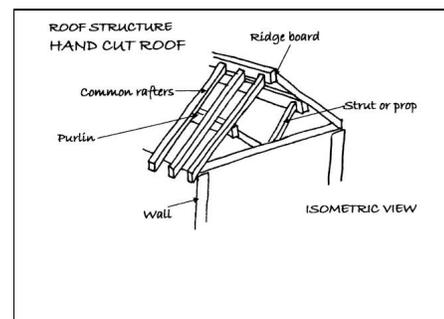
Roof Timbers

This type of roof structure has, what is known as, a cut timber roof, which is a roof that is purpose made and hand built on site. Without the original design details we cannot categorically confirm that there are no defects; however it is in line with what we typically see.

We found the roof timbers generally in average condition considering their age. We have inspected the roof structure for:

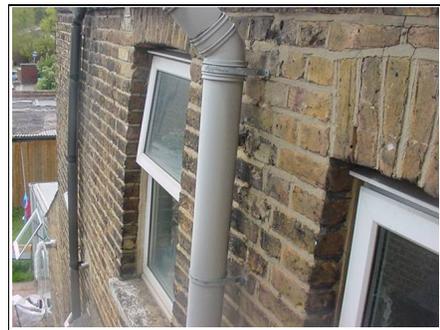
To the rear of the property the walls are formed in brick originally in a lime mortar in what's known as Flemish bond brickwork, which has been repointed in a cement mortar.

Rear brickwork

ACTION REQUIRED: We suggest you set aside a budget with the ground floor flat for ad-hoc re-pointing.

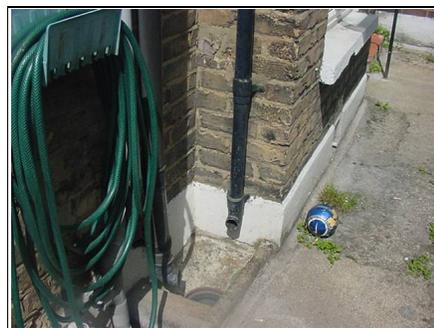
All modern properties should incorporate a damp proof course (DPC) and good building practice dictates that a differential of 150mm (6 inches) should be maintained between the damp proof course and ground levels. Unfortunately in this case it was rendered at the front of the property so we could not see the damp proof course and to the rear there is a rendered plinth.

Rendered plinth

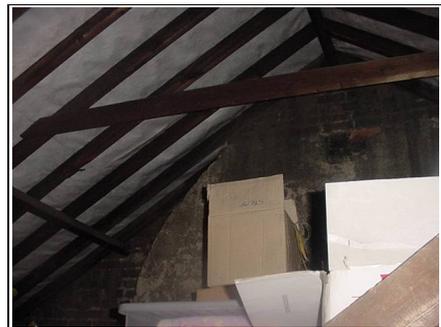
We found chimneys in the roof space had been rendered; this was relatively common as it limited the possibility of fire should the brickwork deteriorate.

Behind the boxes you can just about see the rendered chimneys

At the time of the survey no chimneys were in use. Any chimneys that you do not propose to use should be capped and ventilated to prevent dampness.

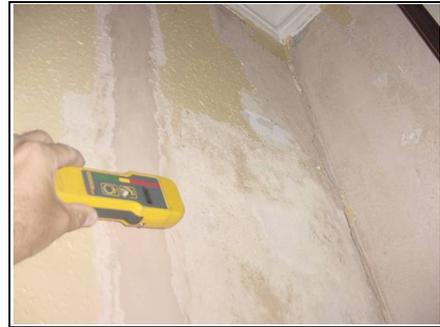
Tests were taken with a moisture meter at points to internal walls, floors and other surfaces. Our readings were in line with what we would expect for this age of property, i.e. minor dampness with no evidence of any significant dampness.

Testing for lateral dampness

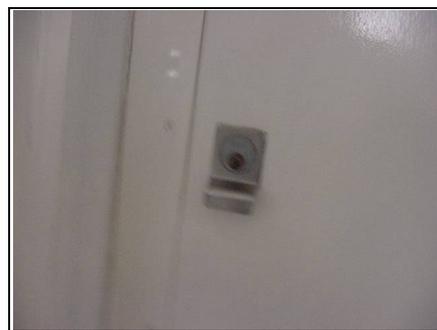
London Bar on entrance door

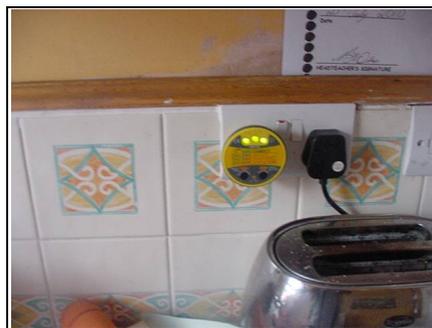
We carried out an earth test in the kitchen area to the socket point that is normally used for the kettle and this proved satisfactory.

Earth test

ACTION REQUIRED: If there is no record of an electrical test having been undertaken within the last five years, it is recommended that the installation be tested by a competent electrician (NICEIC registered) to the latest addition of IEE regulation and all recommendations implemented. Thereafter, the installation should be re-tested every five years.

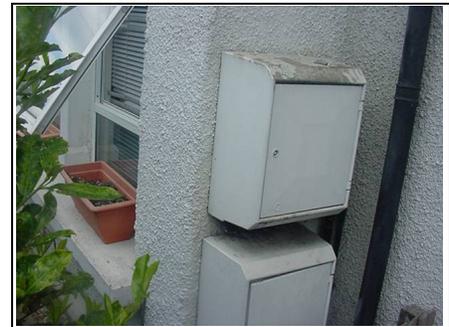
Gas meter cupboard to the front

ACTION REQUIRED: As a matter of course it is recommended that the entire gas installation is inspected and repaired or replaced, as necessary, by a Gas Safe registered contractor. Thereafter the installation should be serviced annually.

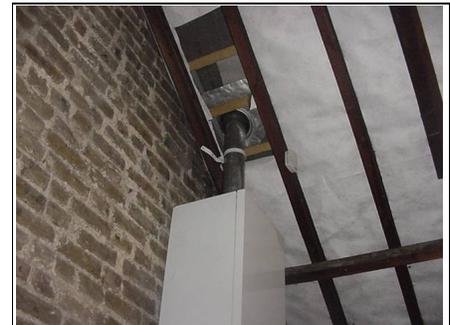
Boiler in roof

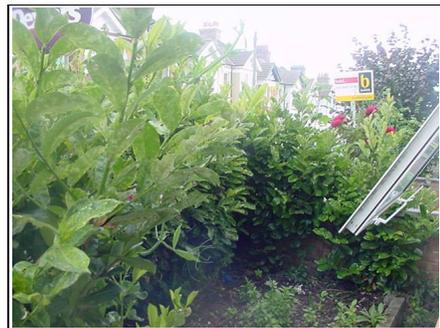
The front garden may or may not be a communal garden. We were advised that there was no communal shared outside space. This is interesting as you will need somewhere to store your rubbish etc.

Overgrown front garden

ACTION REQUIRED: Your Legal Advisor to confirm.

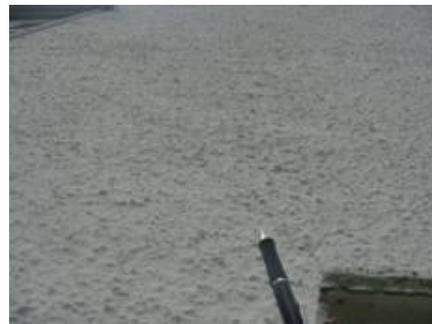
Initially we carried out an external examination of the cracks, photographing the cracks and recording their position and sketching them. Whilst we were carrying out all this work we were thinking about what the problem could be. We carried out the same exercise internally and noted that the cracks were predominantly around the windows. The cracks ranged from hairline cracks to cracks of a few millimetres wide. The action required is that we would recommend anyone with an older property to think carefully before having plastic windows installed.
