RESIDENTIAL BUILDING SURVEY

Anerley, London SE20

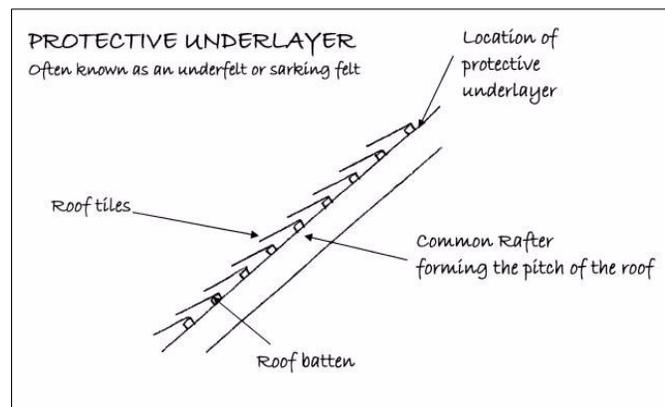
2.0) No protective underlayer in roof

When we were in the roof space we could see that the tiles didn't have any protective underlayer. We could see from the pattern staining that wind driven rain is getting in. Today a modern roof would have a protective underlayer. The main problem with these types of roof is (in harsher weather conditions such as wind driven rain) if the nibs start to deteriorate. Generally we would say that the nibs are in reasonable condition as you can see in the photo below. We are aware that some people would be put off purchasing the property with a roof such as this.

No sarking felt

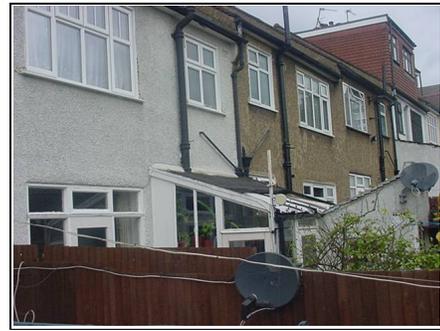
The marks that can be seen to the rear of the property (that we believe you enquired about) are from an old lean-to. There are areas that have been repaired and tend to be weaker than the original render.

We can see in a neighbouring garden the rear lean-to

ANTICIPATED COST: Likely to be in the region of £500-£1000 possibly more if render repairs are required which we feel is more than likely; please obtain quotations.

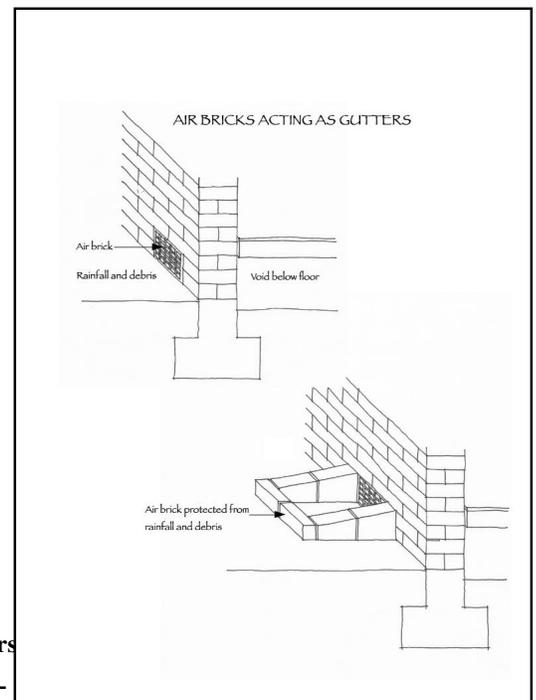
Airbricks acting as gutters

This property has what is known as a suspended timber floor. This means underneath the laminate and tiles that is throughout the ground floor there is a suspended timber floor. We were disappointed that we could not see the floor itself with the exception of under the stairs where we had a very limited view. What we did note is that there are not enough air bricks which are essential in reducing dampness and therefore deterioration. Worse still some of the airbricks are acting as gutters for any rain water that comes in. The photo shows how the air brick is at ground level allowing water to come in. The sketch shows how to remedy this.

opened up at some point to check its condition. We have found in the past that where air bricks act as gutters such as this it can lead to wet rot and woodworm. Unfortunately it is impossible to tell without opening up the floor.

ACTION REQUIRED: Additional air bricks need to be added and existing air bricks need to be amended as per our sketch. We would also comment that the floor needs to be

ANTICIPATED COST: To put extra air bricks and protect them will be a few hundred pounds. To open up the floor will be a small amount of money but it's the damage you could find under the floor that you have to guard against. In a worst case scenario with woodworm etc you may have to replace a large portion of the floor; please obtain quotations.

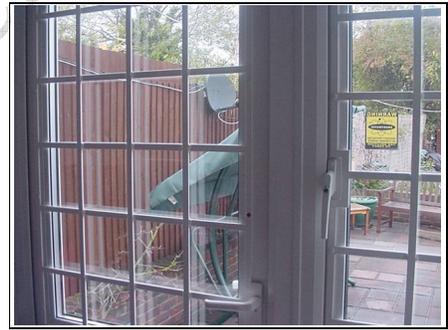
The property has good security and the owner said that he was always concerned about security having known people that had been broken into. You need to double check you are happy to live in this area.

Security bars to rear of property

ACTION REQUIRED: We recommend you revisit the area.

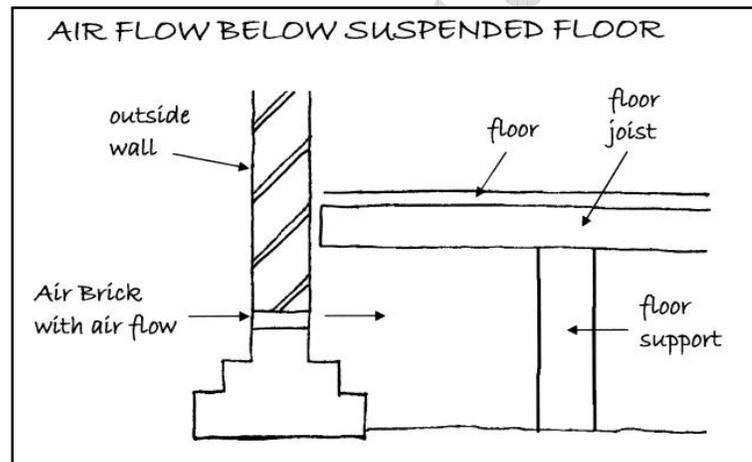
The adjoining sketch shows how the floor needs air vents

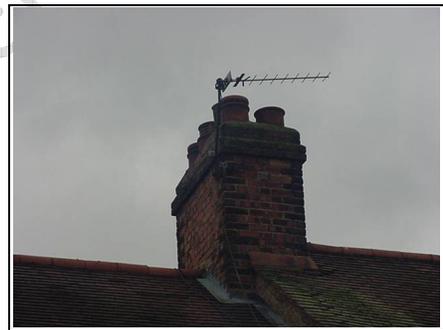
Chimney

This chimney is brick finished with a lead flashing and also tile and edge on your neighbours. There are numerous chimney pots (we think 6). From what we could see from ground level it looked in average condition considering its age, type and style. Unfortunately we were unable to see the top of the chimney underneath the flaunching, we therefore cannot comment upon them.

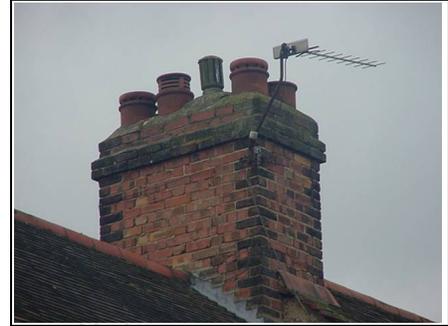
Flue

The property has one flue to the chimney but the actual boiler is located in the bathroom so this may be an old flue relating to a back boiler the property once had. .

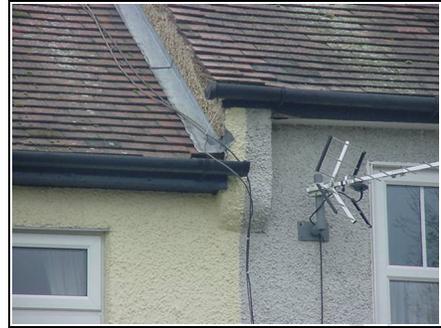
As the property sits on a sloping site there are upstands to the roofs to accommodate the slope. It also means there are exposed areas of render at high level and these areas can be susceptible to dampness getting in and deterioration.

Step in roof to rear of property

ACTION REQUIRED: You need to keep a particularly close eye on the render in these areas

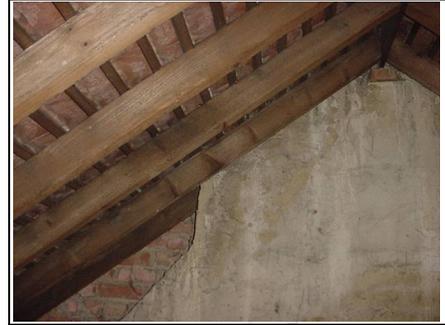
General view of inside of roof

Our examination was limited by the general configuration of the roof, it was hidden by the insulation. What we could see was generally found to be in average condition for its age, type and style except for the lack of protective underlayer. It is, however, feasible that there are problems in the roof that are hidden.

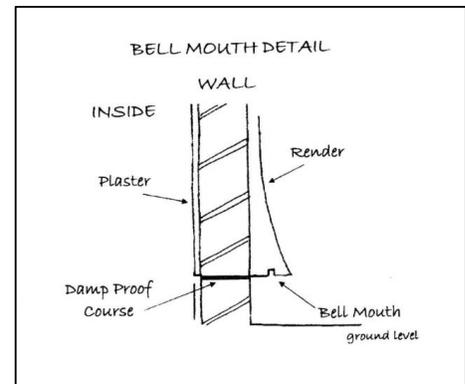
To the front there isn't a rendered bell mouth detail as there are rendered plinths to the front and rear which is quite normal. Our concern is more with the airbricks. Please see our Executive Summary.

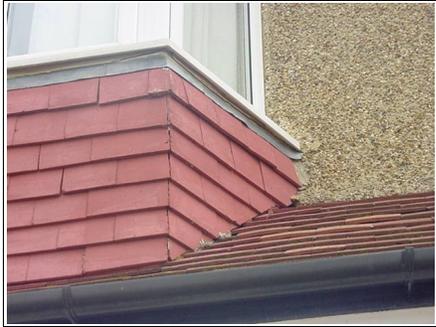
In this particular case we would comment that our concern would be the repairs to the rear where the lean-to has been removed as mentioned in our comments in the Executive Summary and also where the render meets other materials such as the bay window to the front and the tiles.

Where render meets other materials

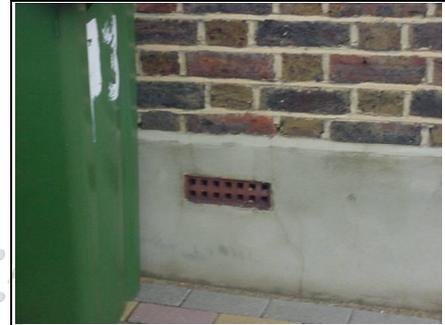
All modern properties should incorporate a damp proof course (DPC) and good building practice dictates that a differential of 150mm (6 inches) should be maintained between the damp proof course and ground levels. In this case, the damp proof course is hidden behind the plinth. We suspect that there was originally a slate damp proof course in there.

Plinth hiding DPC that is likely to be slate.

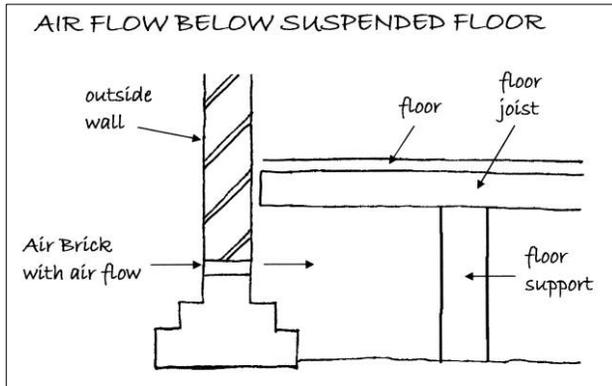
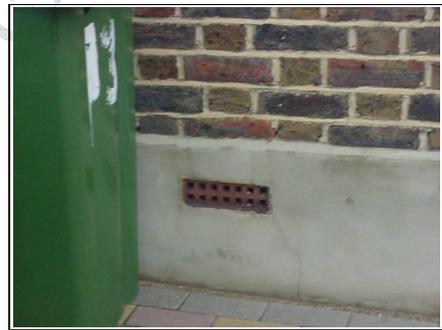
The property has low level air bricks. Our concern is the air bricks to the rear. Please see our comments in the Executive Summary. They are acting as gutters.

Air brick to front suspended timber floor.

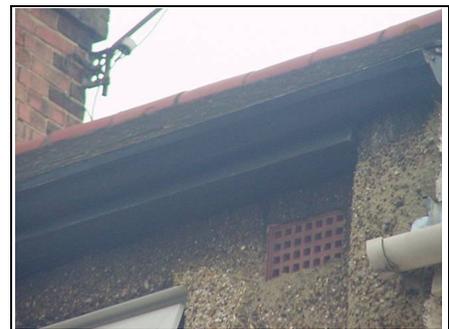
There are vents at high level. These were generally added to allow air flow around the property which would originally have had condensation problems. These are best left in place so that they can vent the room.

High level Air brick

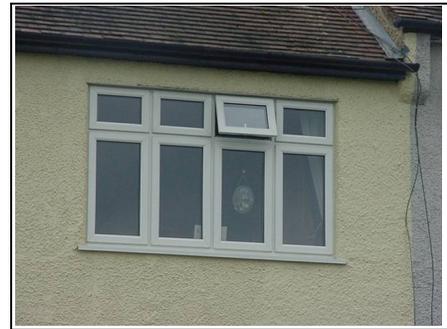
The property has plastic double glazed windows, which generally look to be of a reasonable quality.

We would draw your attention to the fact that sealed double glazed units can fail, particularly as a result of poor workmanship during installation. Failure of the seal leads to condensation between the two panes of glass and simply replacing the affected units may not provide a satisfactory long-term solution.

Plastic windows

Enquiries should be made as to the existence of any transferable guarantees. Generally it is considered that double glazed units have a life of about ten years.

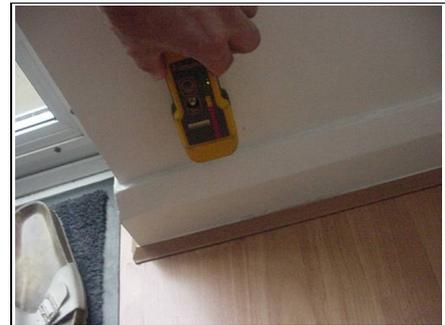
A random visual inspection and tests with a moisture meter have been taken to the perimeter walls and some internal walls. In this particular case we have found no rising damp. Ironically the bricks as acting as gutters can cause dampness in the actual timber floor but we can't see this due to the laminate flooring.

Testing for rising damp

ACTION REQUIRED: Please see the Executive Summary

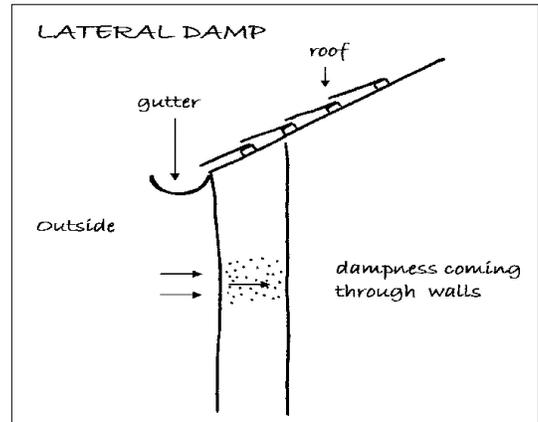
We used a damp meter on the external walls. We have not found dampness. However with older render deteriorating over the years this may become a problem so keep the render in good order. In particular to the rear this means regular decoration.

ACTION REQUIRED: Please see our comments in the Executive Summary.

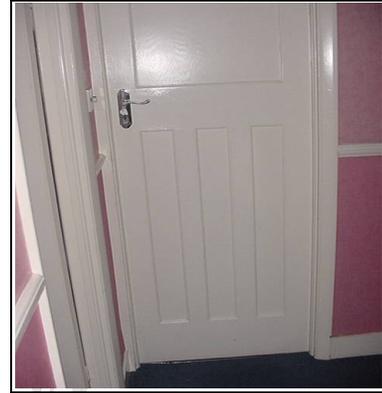
The property has the original 1930's plank style doors. They are painted and are in reasonably good order.

Original 1930's doors

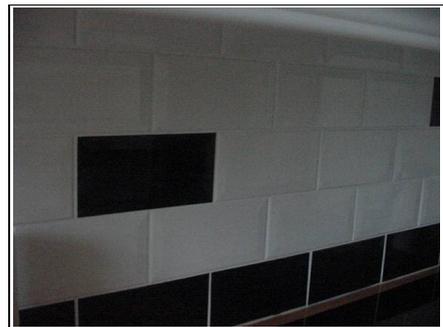
We found the kitchen in above average condition and had been newly refurbished by the owners. We have not tested any of the kitchen appliances.

New wall tiles

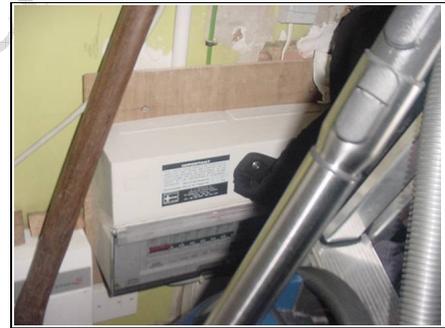
Fuse Board

The electric fuses and consumer units were located under the stairs. The fuse board looked newish.

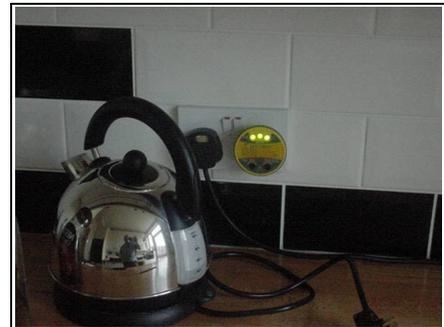
Earth Test

We carried out an earth test in the kitchen area to the socket point that is normally used for the kettle, this proved satisfactory.

ACTION REQUIRED: As the property is changing occupancy an Institute of Electrical Engineers (IEE) report should be carried out by an

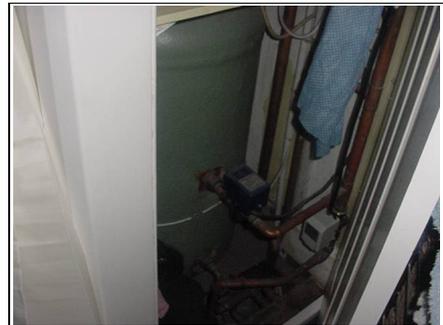
There is a hot water cylinder that is factory insulated this indicates that it is relatively new.

Factory lagged hot water cylinder

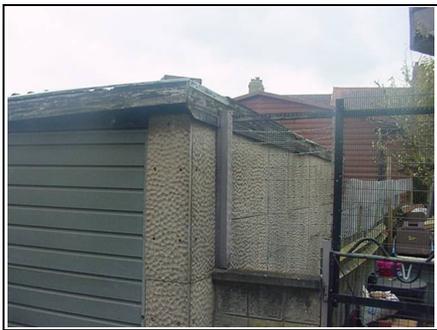
Asbestos car garage

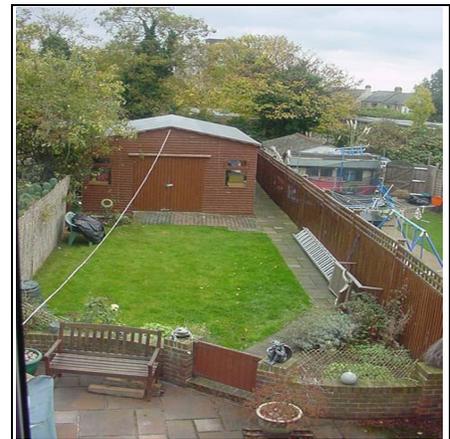
Rear Garden

The rear garden has a patio area, grassed area, a large shed and a car garage. There may well be a man hole hidden under the patio.
