RESIDENTIAL BUILDING SURVEY

xxxxx Ludlow, Shropshire. SY8 X

INDEPENDENT CHARTERED SURVEYORS

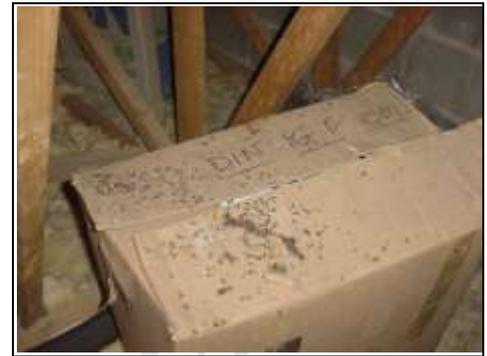
Bat droppings

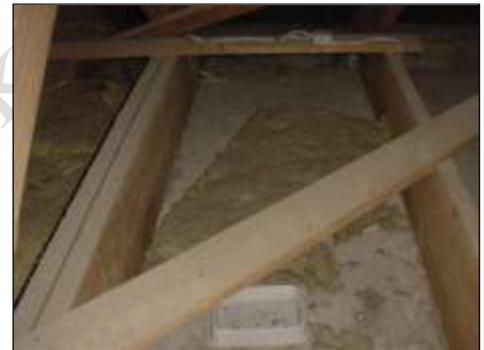
Within roof over garage – tray normally has poison in it.

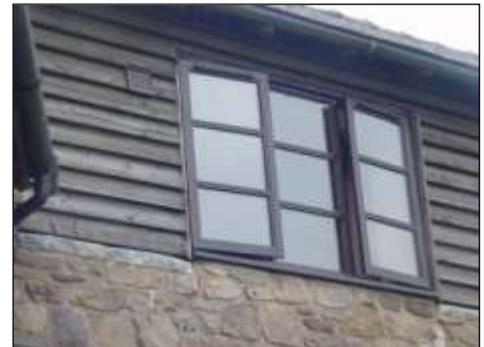
Hardwood window

we noted some of the double glazed units had misted over, this is fairly common in timber windows, particularly poor quality windows where the timber moves and breaks the seal of the double glazing unit.

ACTION REQUIRED: You will need to redecorate within the next few years and also replace the misted up double glazed units if this bothers you.

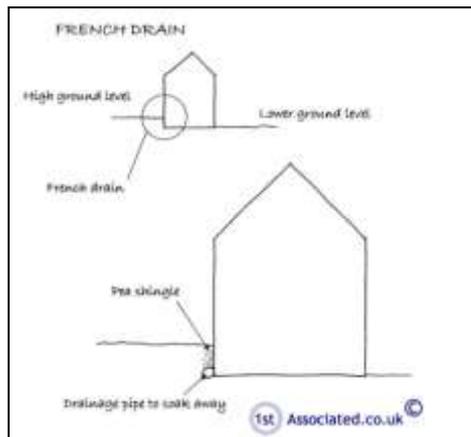
French drain

gully along the front of the property; quotations required.

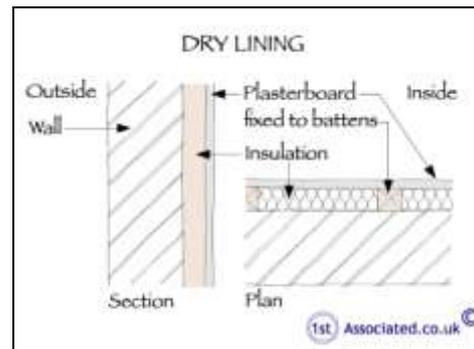
Dry lining

We would expect during heavy periods of rain that some rain may get into the property bringing dampness to the stonework however we would advise that we found the interior of the property to be dry lined (also known as false wall).

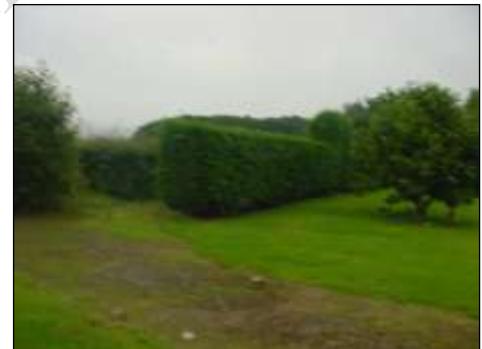
Leylandii trees

You have a fence of Leylandii which do grow very quickly and do not underestimate how quickly they do grow. These need to be regularly maintained otherwise they will block the view although equally they do give some privacy.

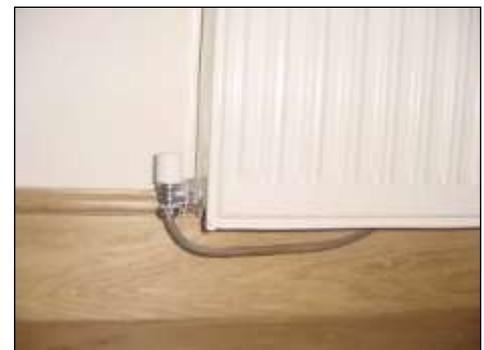
Micro-bored pipe

Micro-bored pipework

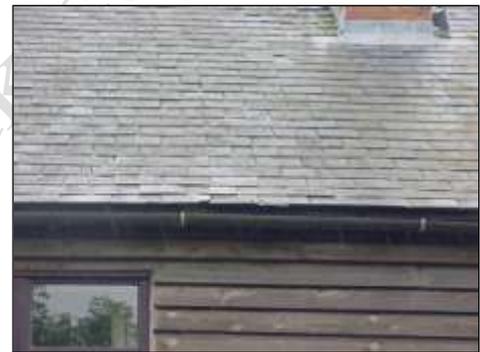
Main roof at front of property

The roof is pitched and clad with quarried slate. The Slates sit fairly true and are generally in average condition considering the property's age, type and style. However please be aware of our comments with regard to this being an exposed location, please see the Executive Summary.

Moss

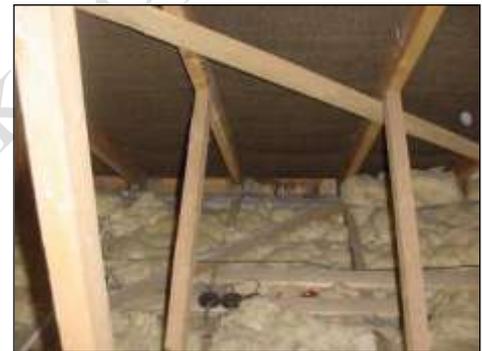
Protective underlayer

When we inspected the loft space we found a Hessian base Bitumen membrane protective underlayer. This type of membrane has been used since the 1960s. Whilst it does have some damage it is generally nothing more than we would expect to find.

This photo shows the common rafters (the ones that form the pitch of the roof) and the dark area between is the underlayer.

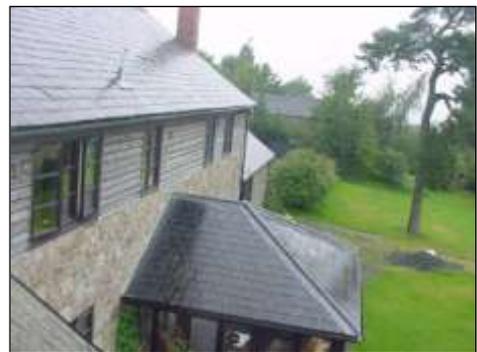
Conservatory/garden room roof

The rear conservatory/garden room roof is as the main roof previously described and where it meets the main building we were pleased to see it has a lead flashing.

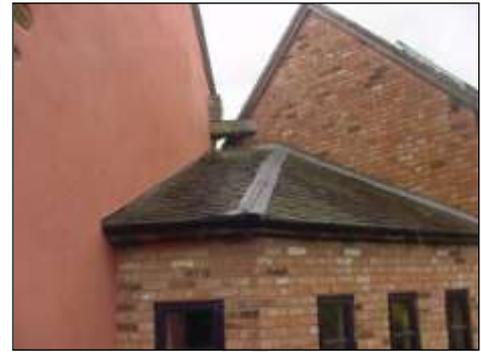
Front link room roof

As previously described clad in slate. Interestingly both roofs have a rolled lead hipped ridge which we only find on the better quality modern constructed properties but in this case it may be due to the exposed location.

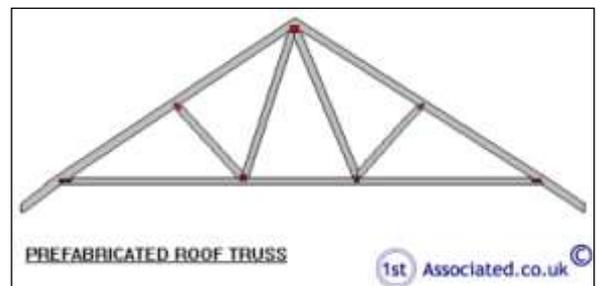
Prefabricated roof truss

The roof structure is a pre-fabricated fan trussed roof rafter which looks like W". These are made in a factory and transported to site and then lifted into place. Without the manufacturer's calculations and installation details we cannot comment categorically on the roof structure.

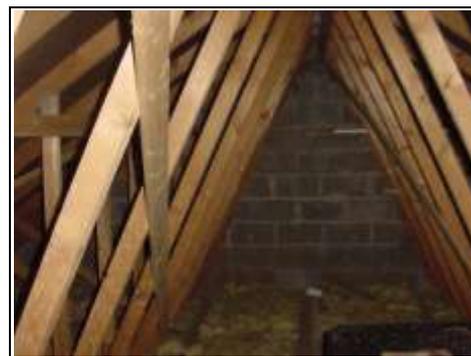
Roof timbers

We found the roof timbers generally in average condition considering their age. We have inspected the roof structure for:

Our examination was limited by the general configuration of the roof, the insulation and stored items. As mentioned what we could see was generally found to be in average condition with some minor condensation and damp.

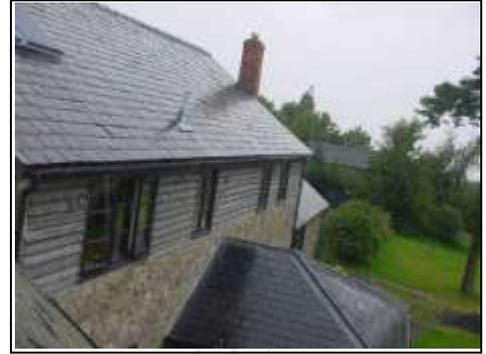
Soil and vent pipe to the centre of the roof

The property has an internal soil and vent pipes, you can see where the flue is at roof level.

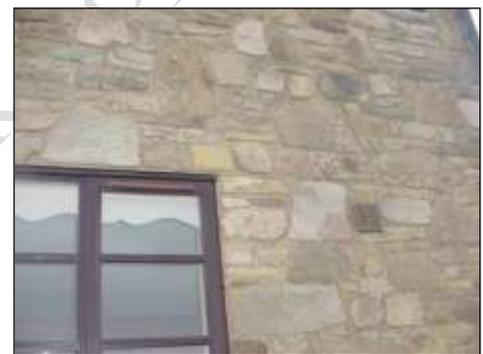
Stonework

Taking into consideration the age, type and style of this property we would say that the stonework and pointing overall is in average condition.

This is a modern stone built building so we would expect there to be a relatively thin stone outer walls compared with older properties with blockwork or dry lining internally. Without opening up the structure it is impossible to advise further.

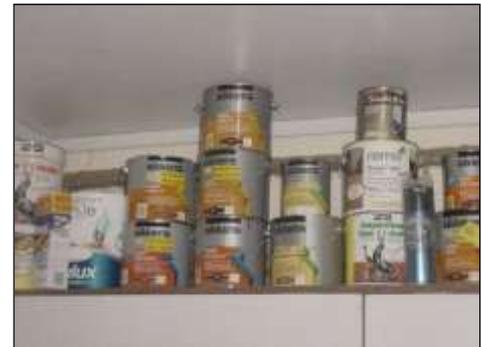
Painting products in stored workshop

With this type of soft wood / location window it will need to redecorate relatively soon the softwood windows, the exposed rafter feet and the cladding, this will no doubt be an ongoing process and do not underestimate the time it will take up and/or expenses. For example in a question and answer session the owner was an expert in Sikken's (we are sure he would not mind us saying this), an expensive but good wood treatment product and he had a good store of it in the workshop!

ACTION REQUIRED: We would recommend external decoration before the winter of 2010.

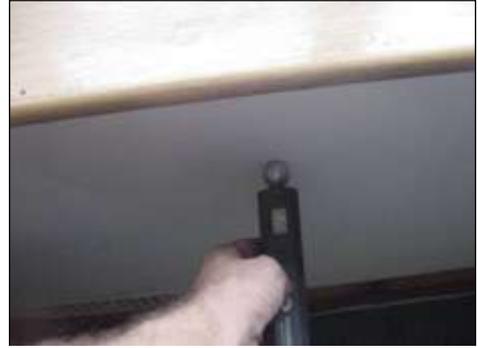
Comments are the same as rising dampness we are limited by the walls being dry lined.

Testing for dampness and showing it is dry lined

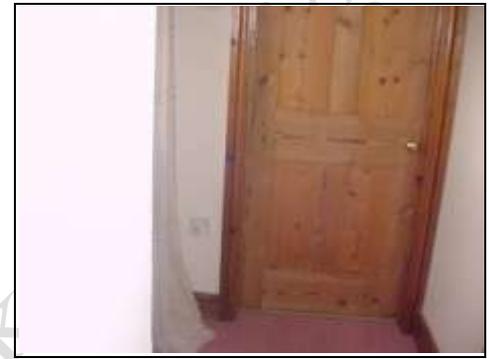
Wood panelled door

The property has stripped wood panelled doors. In the majority of cases they are generally in reasonable condition, although they don't fit perfectly (some of them have been painted in colours that we personally would not choose).

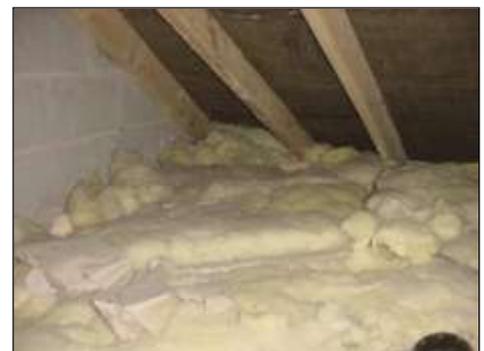
Roof insulation

Various depths of roof insulation were noted. Current Building Regulations requirements are of 270mm of insulations. However if you do insult to this level then you would need to also ventilate.

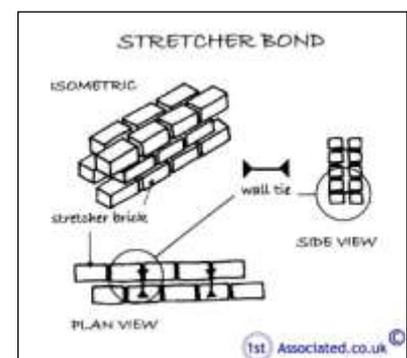
Stretcher bond brickwork

The property has a stretcher bond construction and we can only assume from the age of the property that it is likely that when it was built it included cavity insulation but, without opening up the wall, we cannot be certain. The property was built in the era insulation start to be used.

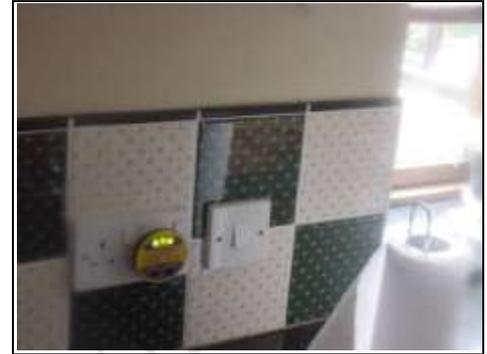
Earth Test

We carried out an earth test in the kitchen area to the socket point that is normally used for the kettle and this proved satisfactory.

ACTION REQUIRED: If there is no record of an electrical test having been undertaken within the last five years, it is recommended that the installation be tested by a competent electrician (NICEIC registered) and all recommendations implemented. Thereafter, the installation should be re-tested every five years.

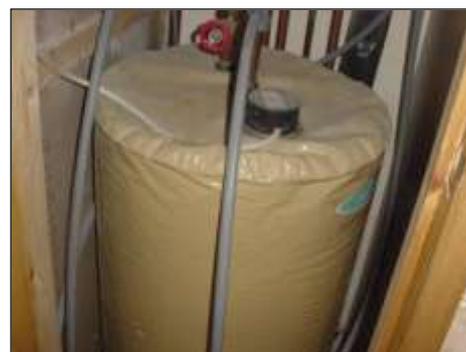
Hot water cylinder

A relatively modern hot water cylinder, we find these relatively efficient and also have the benefit of the solar power.

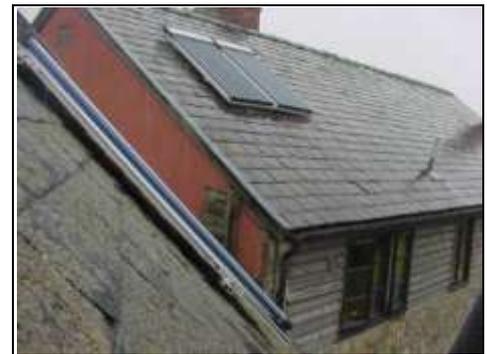
Solar panels to main house

We spoke to the present owner about the solar panels and he advised that it had reduced the amount of oil they consumed (a family of two adults and one child) from four tanks of oil to about two tanks of oil. You must remember this is very subjective as the heat levels different people like in properties can vary enormously, however it is the reduction that we are highlighting. In our experience the modern volatic panels use light as well as sunlight.

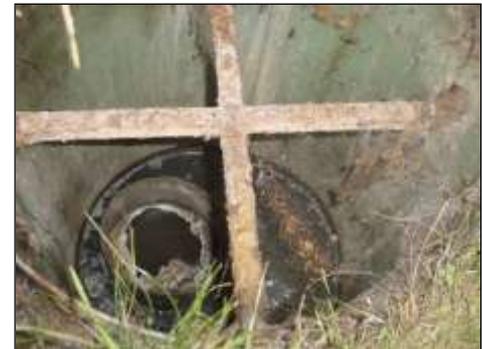
We could not see into the cesspool at the time of our inspection and we have been unable to determine the size, construction or condition of the chamber: obviously the size of the chamber will determine the frequency of the required pumping out, which is, nowadays, a relatively costly operation. In some cases, cesspools have been provided with overflows, or some similar arrangement, designed to reduce the frequency of emptying. This course of action should not be adopted and will result in pollution taking place and the building owner could be liable for prosecution. With regard to the subject property, we have been unable to confirm whether an overflow has been provided or not. We suggest that you make enquiries of the vendor and ask to see invoices for past emptying of the chamber so that a judgment may be made.

Looking down into septic tank

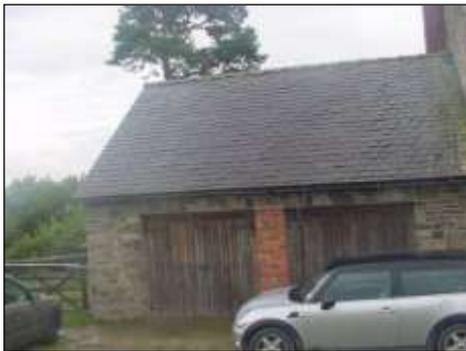
Double garage

The double garage is currently used as a workshop and we did not have access to the single garage. Additionally there is off road parking.
