RESIDENTIAL BUILDING SURVEY
OF
London, N11

Firstly, may we thank you for your instruction; we have now undertaken a Building Survey (formerly known as a Structural Survey) of the aforementioned property.

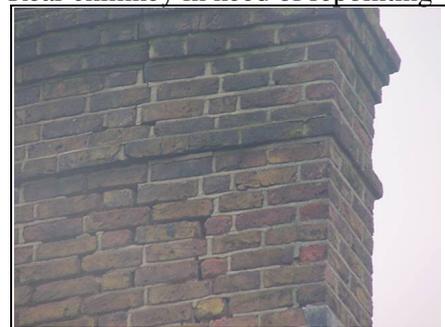
Close up of chimney

ACTION REQUIRED: Repair and repoint.

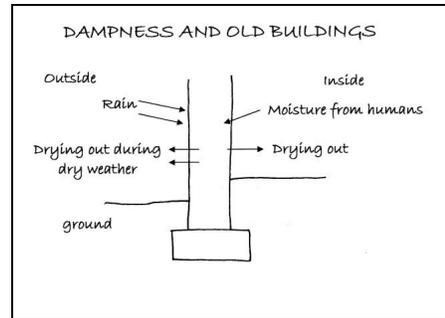
Dampness is coming through the walls in part due to the cement mortar that has been applied.

ACTION REQUIRED: This property needs to be allowed to breath. We recommend the removal of the cement mortar and repointing in a lime mortar. This work needs to be carried out to the front and the rear of the property and the side of the kitchen and the bathroom area as soon as possible.

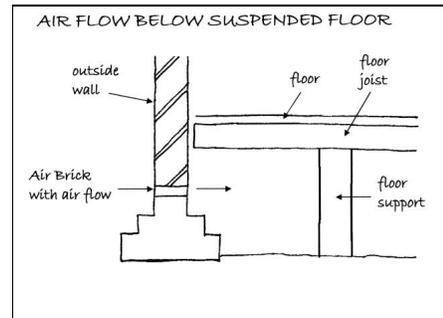
Around the property we can see airbricks which is good to allow an airflow to the suspended timber flooring however they are so low that they effectively act as gutters. A lot of water has entered this property over the years.

Airbrick acting as gutter

ACTION REQUIRED: We have previously mentioned adding a French Drain and this should effectively stop the airbricks acting as gutters.

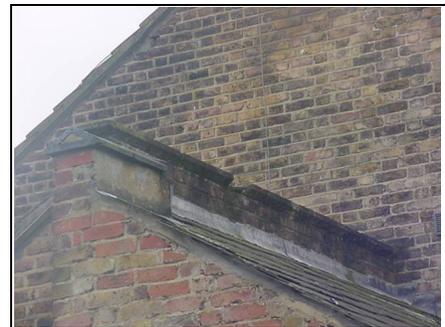
There is a small chimney to the rear of the property which we suspect has been reduced in height as well as being amended internally.

Chimney three

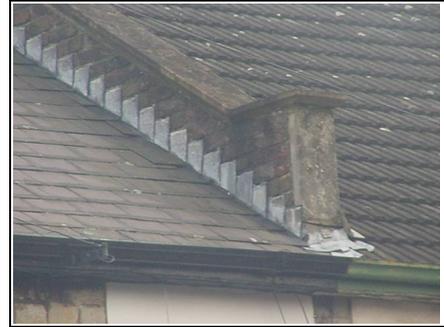
The Parapet walls are built from brick with a coping stone and a lead flashing. Some of the flashing is defective however again unfortunately we haven't been in the main roof so we cannot comment further.

Front right hand parapet wall

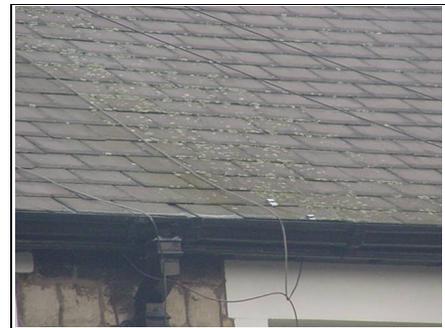
The roof is pitched and clad with slates. The slates sit fairly true and level, considering the roof age type and style, it is in average condition although it should be remembered the roof is old. We did note that it has lead tingles often known as nail sickness, this is where the nails have rusted away and repairs have had to be carried out with a lead tingle (please see the sketch).

ACTION REQUIRED: We believe a sinking fund should be built up for the high level work and areas such as the roof and a general overhaul should be carried out of the roof. Please see our comments in the Executive Summary.

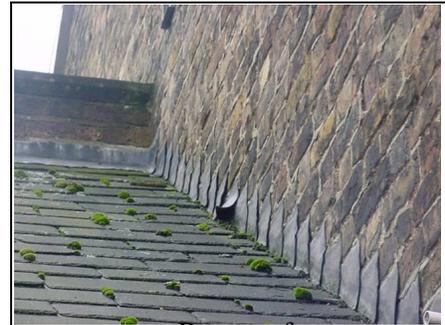
This roof is covered in a quarried slate. What is slightly unusual about it is the amount of moss on it particularly considering the pitch of the roof

Rear roof

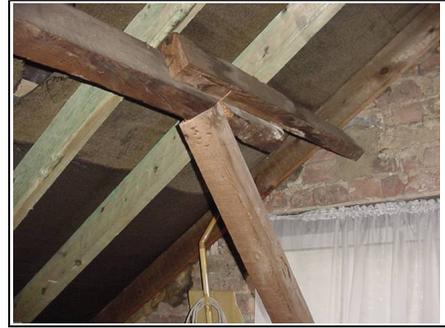
We were able to access the rear roof. Please see our comments in the Executive Summary where we have identified some issues with it.

Rear roof

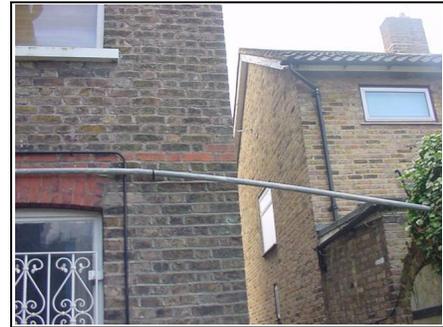
Cast iron soil and vent pipe

Amazing wastepipe!

ACTION REQUIRED: We suggest you have a chat to find a more conventional way of doing this such as running it straight down the wall into several water butts that you share.

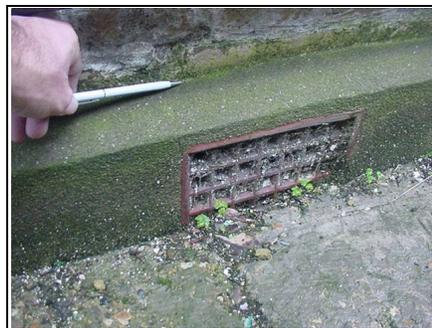
All modern properties should incorporate a damp proof course (DPC) and good building practice dictates that a differential of 150mm (6 inches) should be maintained between the damp proof course and ground levels. In this case, unfortunately we can't see a Damp proof course (DPC) because of the render plinth. In this particular property it's possible it will have a slate Damp proof course hidden behind the render plinth however this picture also shows how the airbrick is acting as a gutter albeit that it was quite blocked it does literally have plants growing out of it.

Cement plinth hiding damp proof course

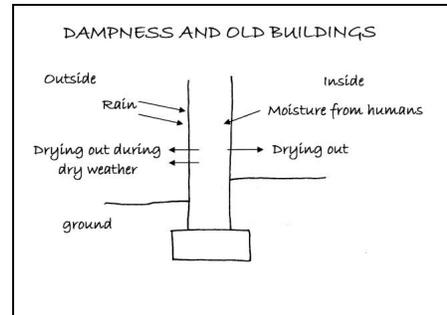
Lateral dampness

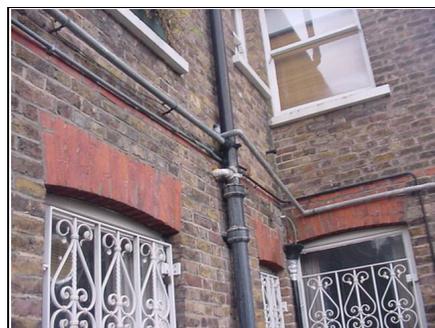
Security on rear windows

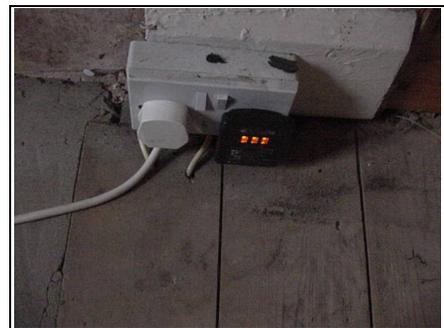
Earth test in front room passed

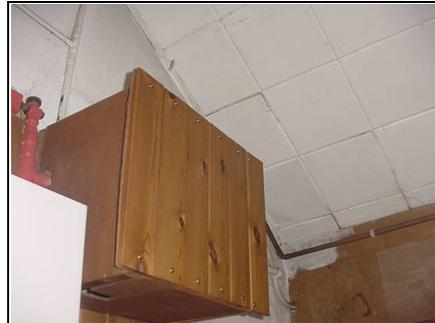
There is a water cylinder within the rear roof space and there is also a water cylinder in the kitchen itself which is quite unusual (we assume it is a water cylinder as it is boxed in but it does have a pipe going to it).

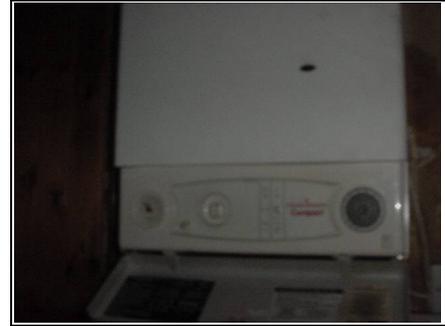
Boiler

A relatively new looking boiler is located in the kitchen. We normally like to turn the heating on but as no-one who owned the property was present we didn't think it was worth risking it in this instance.

We would ask the owners to switch the heating on for ten minutes for you to experience this to see what you think about it or you need to make the decision to replace all the heating. We know that you spoke to us about floor heating but you do need to make sure that that is sufficient.

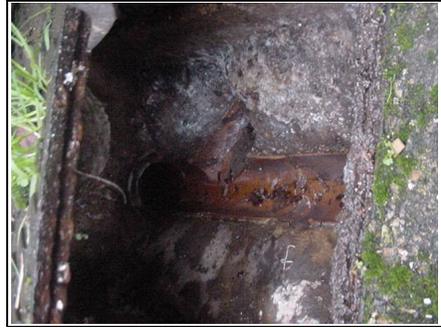
We duly lift the man hole/ inspection chamber cover and we did manage to get water free flowing down it, we noted it was finished in brick.

Manhole 2 – clear drain
