RESIDENTIAL BUILDING SURVEY

Beckenham
BR3

FOR

Mrs S

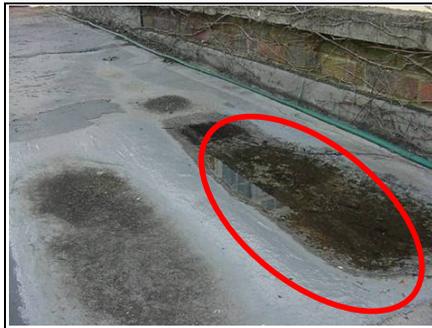
The flat roof is asphalt covered which has been patch repaired and is in need of a proper asphalt repair and a check to the flashings and parapet walls.

Ponding to flat roof

ACTION REQUIRED: Have a roofer for one to three days carry out proper asphalt repairs on the felt roof.

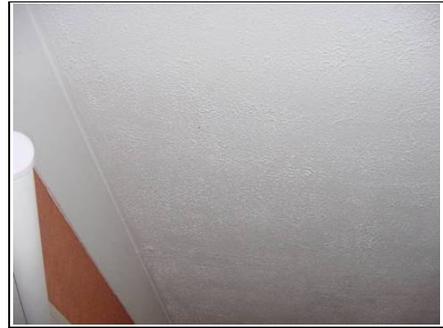
The ceiling looks to be painted in the older style textured paint often known as artex which can have an asbestos content. It is impossible to be 100% certain from a visual check, in fact we have heard it said by asbestos contractors that you have to test for asbestos.

Possible asbestos

Given the age of the building there may be some other areas of asbestos.

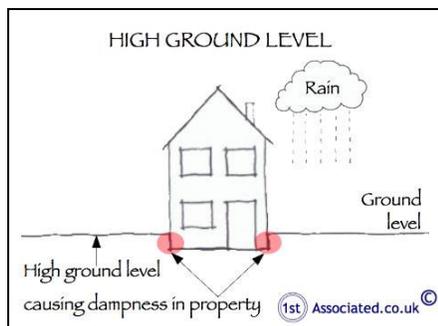
We can see that this property has a suspended floor by the air bricks to the front and rear. We can also see that earth has built up to the front and to the rear over the years and has partially blocked the airflow under the building.

High ground level

ACTION REQUIRED: Reduce the ground level around the property. Ideally an area of the flooring should be opened up to check the condition of the floors beneath.

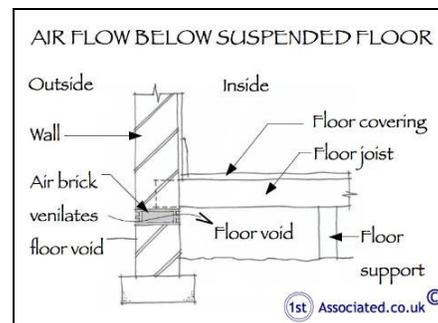
Airflow below suspended floor

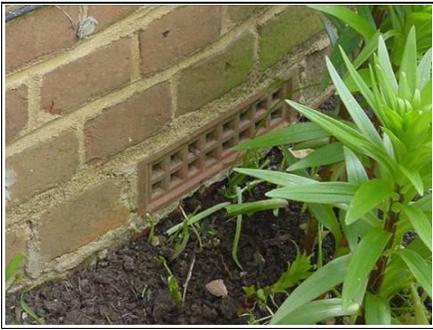
Airbrick to front nearly covered by earth

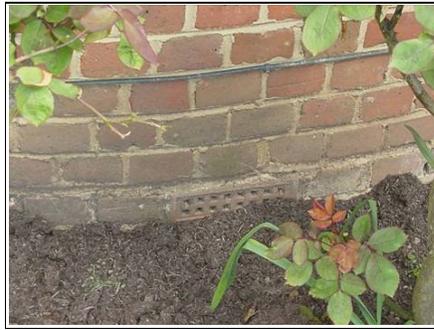
Another with soil partially covering it

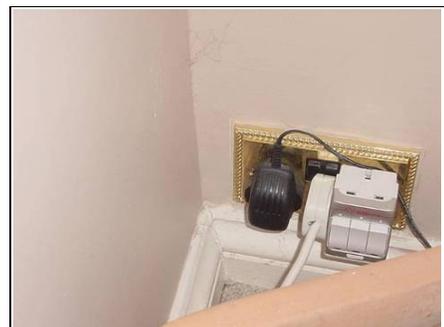
Another reason why we are recommending this is that we noted extension cables and overloaded socket points which normally indicate more electric points are required, as things can possibly start to become unsafe with overloaded points.

More sockets needed

ACTION REQUIRED: Replace fuseboard. We recommend an IEE (Institute of Electrical Engineers) test and report by an NICEIC registered and approved electrical contractor or equivalent.

ANTICIPATED COST: In the region of £2,500 to £4,000 as we feel a complete re-wire will be necessary as we are uncertain how the building has been extended and altered over the years.

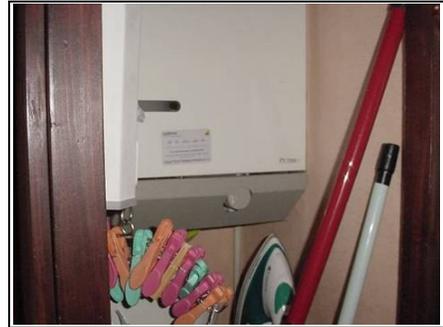
There is an older style boiler that is coming to the end of its life..

Prima boiler

ACTION REQUIRED: We would budget for a new boiler. We consider that you are running on borrowed time with this boiler.

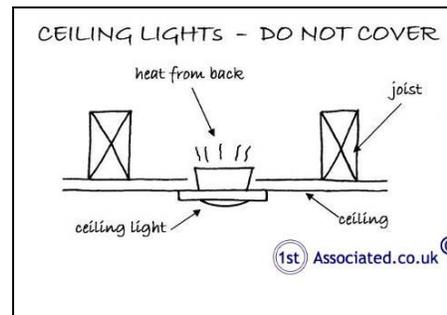
The property has old electric lights to the ceiling. In some instances these can cause problems as the heat given off has in some cases lead to outbreaks of fire; these tend to be in the older type of ceiling lights.

Ceiling lights

ACTION REQUIRED: We recommend replacing this with a low energy bulb.

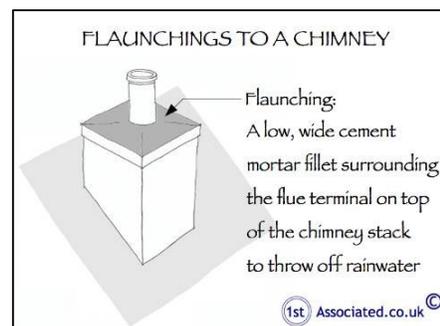
Unfortunately we were unable to see the flaunching, we therefore cannot comment upon them.

Flaunchings

ACTION REQUIRED: Periodically inspect the chimney.

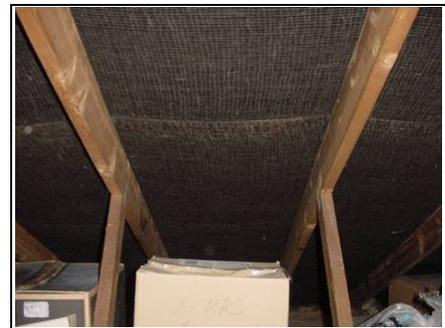
When we inspected the loft space we found a Hessian base Bitumen membrane. This type of membrane has been used since the 1960s/1970s. We generally found it to be in average condition, with damage in some areas which is what we typically find.

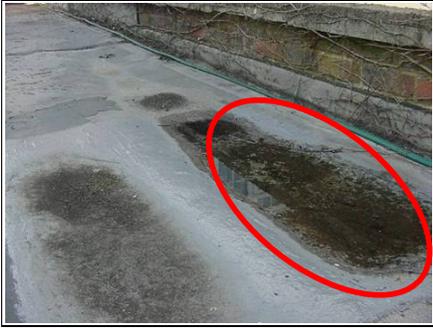
Ponding to flat roof

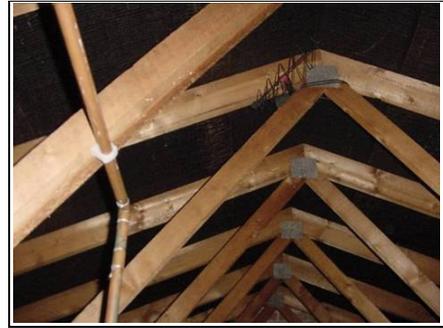
Our examination was limited by the general configuration of the roof, the floorboard sheets that were down and the mass of stored items. What we could see was generally found to be in average condition for its age, type and style. It is, however, feasible that there are problems in the roof that are hidden.

General view of inside of roof

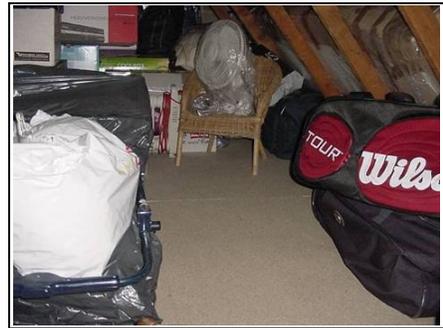
Mass of stored items in roof

ACTION REQUIRED: The only way to be 100 per cent certain is to have the roof cleared and checked.

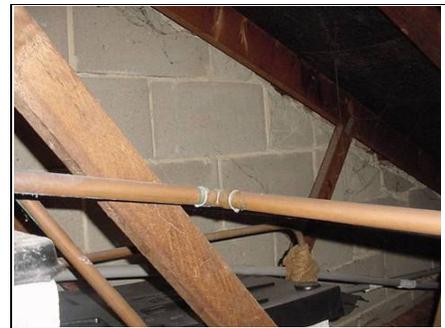
Blockwork firewall and plastic water tank

There is a plastic water tank. We would always recommend that water tanks be drained down and cleared of any debris etc. (we have seen dead birds and other unmentionable things in these tanks). As you are often cleaning your teeth with this water it is best that it is as clean as possible! The original idea behind water tanks was to give an emergency supply of water.

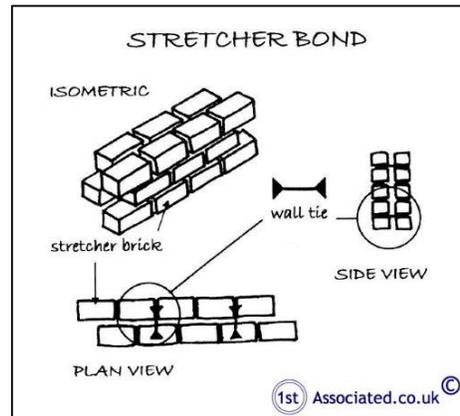
Stretcher bond brickwork

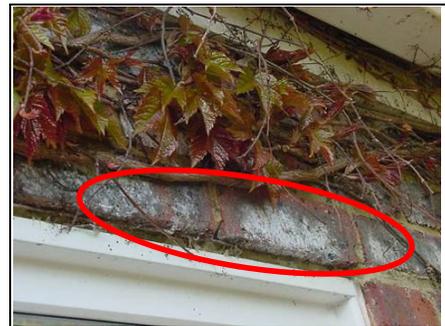
This we believe relates to the ivy holding water against the property when it rains as it does not allow it to dry, which over time causes the efflorescence salts.

Efflorescence

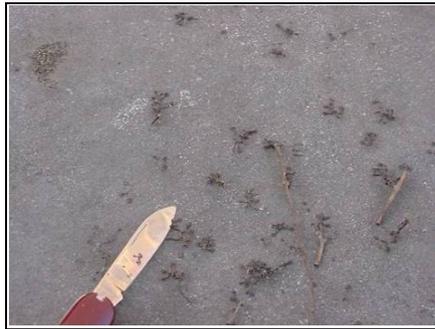
We can see that the ivy looks has been cut back fairly drastically and you can still see where it has caused marks to the brickwork and the flat roof and also the plastic fascias and soffits.

Ivy marks to flat roof

ACTION REQUIRED: We recommend the ivy is regularly maintained, as if left it can cause dampness within a property, so ideally place a trellis between the ivy and the building, but this is easily said than done.

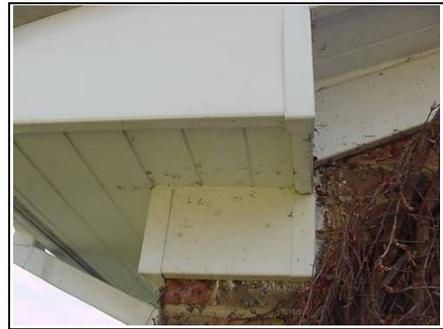
Markings to fascias and soffits

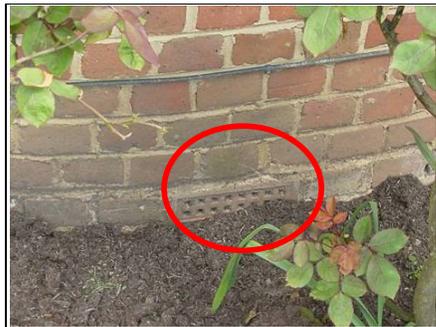
Air bricks are essential to have a through flow of air as this helps to reduce the chances of wet rot, dry rot and woodworm.

Air brick to front covered by earth

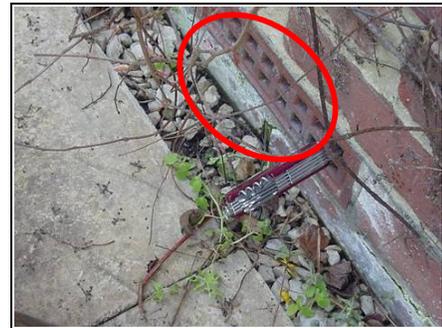
Air brick to rear blocked

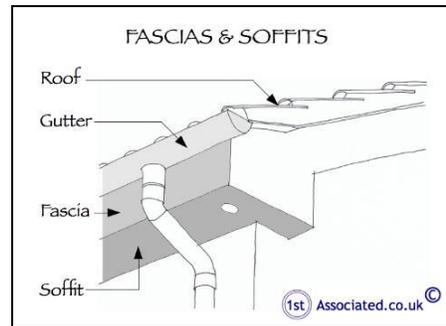
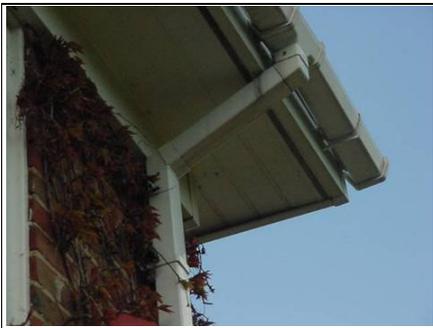
The fascias and soffits are plastic with vents. We would comment they are in average condition for their age, type and style and have suffered damage from the ivy (please see our comments about ivy elsewhere within this report).

Fascias and soffits

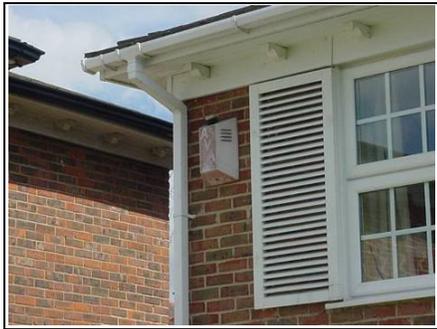
The property has timber shutters and are part of the original style of the property, which would benefit from redecoration.

Timber shutters

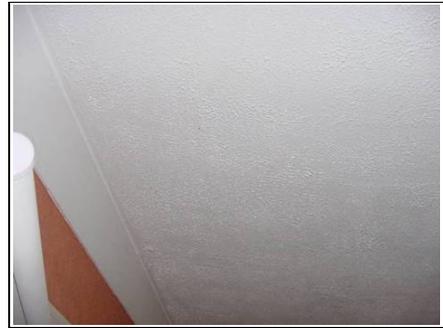
Possible asbestos

As mentioned, the property has some older style textured paint, known as artex, which may contain asbestos.

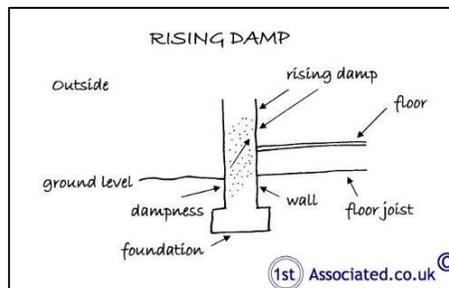
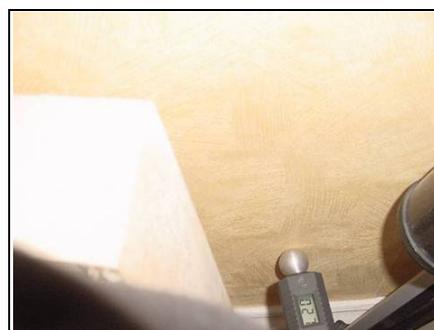
A random visual inspection and tests with a moisture meter have been taken to the perimeter walls. In this particular case we have found no rising damp.

Testing for rising damp

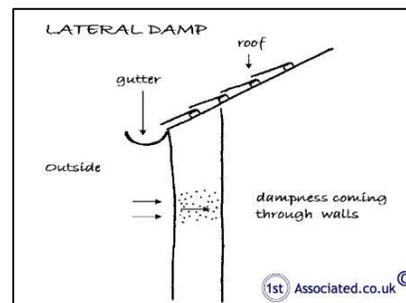
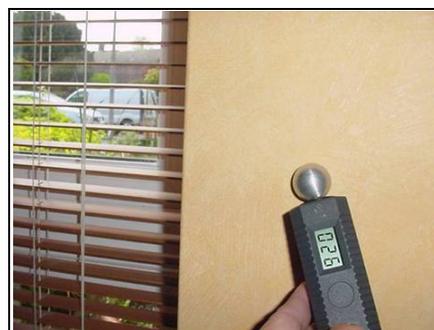
We used a damp meter on the external walls. We have not found dampness.

Testing for lateral dampness

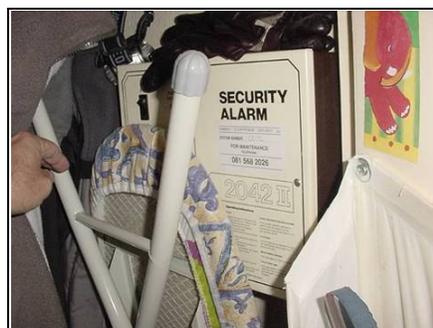
A security system has been installed. A good alarm system should not only help reduce break-ins but also your insurance. We are not experts in this field and therefore cannot comment further.

Security alarm under stairs

ACTION REQUIRED: Further information should be obtained from the vendor and the installer.

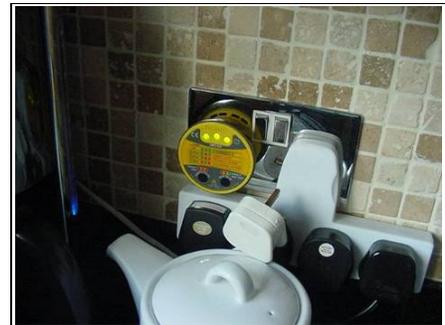
We carried out an earth test in the kitchen area to the socket point that is normally used for the kettle, this proved satisfactory.

Earth Test

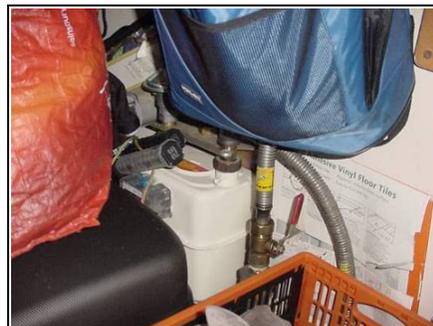
We are advised that the property has mains gas. The consumer unit is located under the stairs

Gas under stairs

ACTION REQUIRED: As a matter of course it is recommended that the entire gas installation is inspected and made good, as necessary, by a Gas Safe registered contractor. Thereafter the installation should be serviced annually.

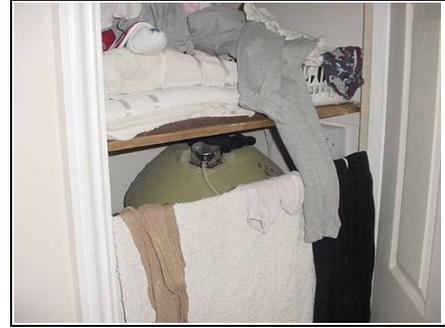
There is a factory insulated hot water cylinder located within the airing cupboard on the first floor. This cylinder will therefore have a good thermal efficiency, although not as good as the more modern hot water cylinders.

Factory insulated cylinder

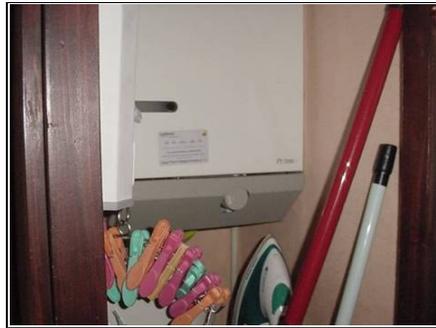
The boiler was located in the dining room, it is manufactured by Prima which is not very common and we consider it is getting towards the end of its working life.

Prima boiler

ACTION REQUIRED: Please see our comments in the Executive Summary.

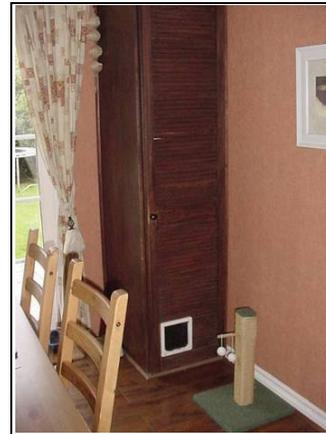
Boiler located within cupboard
in dining room

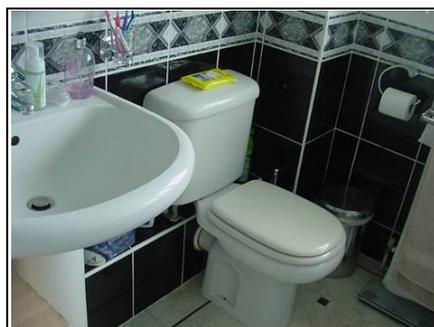
Bathroom

We found it to be particularly humid in the bathroom.

ACTION REQUIRED: We recommend a large humidity controlled extract fan is added.

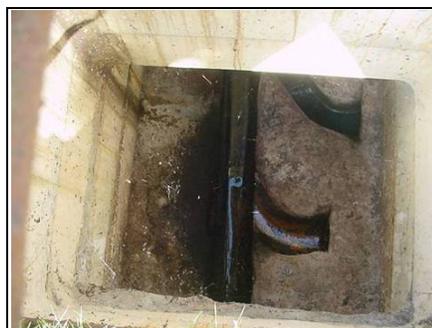
We duly lifted the cover and found it to be free flowing at the time of our inspection.

From what we could see it is concrete built.

Manhole one to front garden

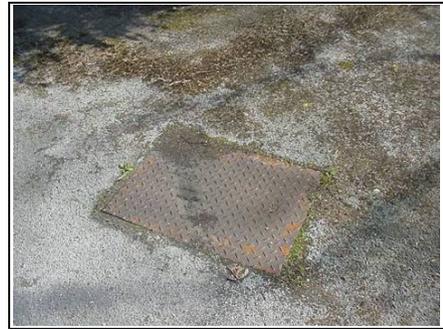
We were unable to open this manhole. You may have a shared responsibility with this manhole due its location being towards the garage block.

Manhole cover not lifted

ACTION REQUIRED: Check whether this manhole has shared responsibility.

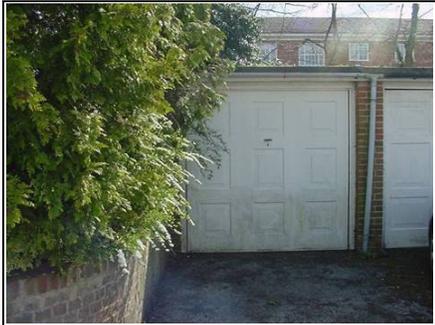
Garage

The property has a garage in an adjacent block of garages (corner garage). The flat roof is not in the best of conditions and will need replacing over the next few years. The garage looks quite small and you need to check you can get your car inside it.

ACTION REQUIRED: Please see our comments in the Executive Summary.

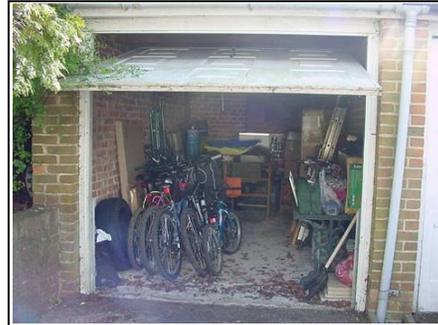
Inside garage – is there room for a car?

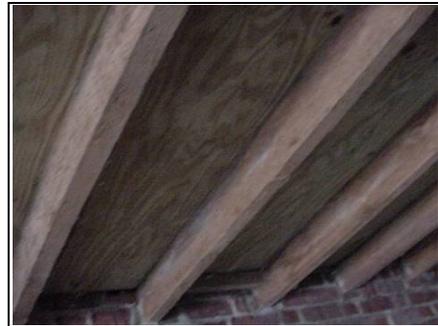
Underside of roof

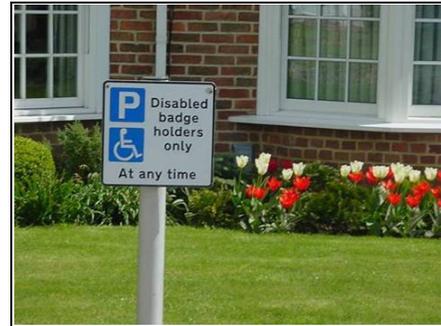
There was no owner present at the time of our inspection so we cannot confirm if there is any allocated parking; your legal advisor to check and confirm. Parking in the area is restricted with a parking limitations notice directly outside the property.

Parking limitations directly outside the house

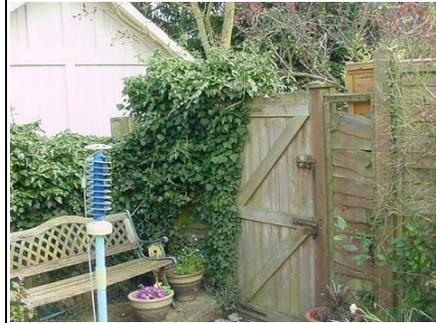
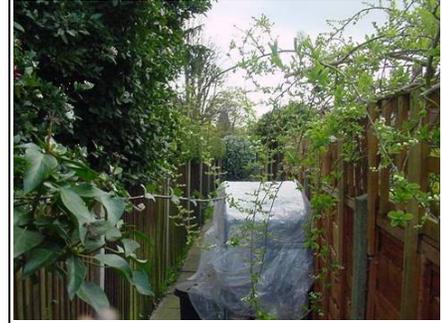
Right of way

There is a right of way passageway to the rear which is accessed through a gate to the rear right hand side of the rear garden.

ACTION REQUIRED: Your legal adviser to check and confirm the right of way to the rear.

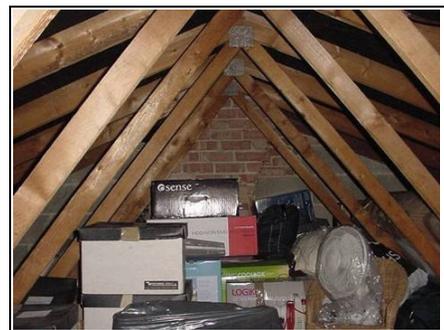
- 1) Due to the amount of stored items in the roof.
- 2) We were not able to open up the ground floor or the first floor.

Stored items in the roof space
limited view
