RESIDENTIAL BUILDING SURVEY
OF
Bedford, MK41

FOR
Mr G
Prepared by:

INDEPENDENT CHARTERED SURVEYORS

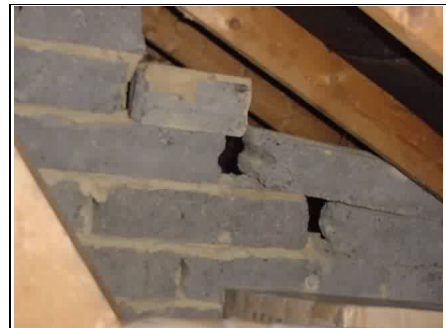
Please see the Roof Section of this Report.

ACTION REQUIRED: Repair hole.

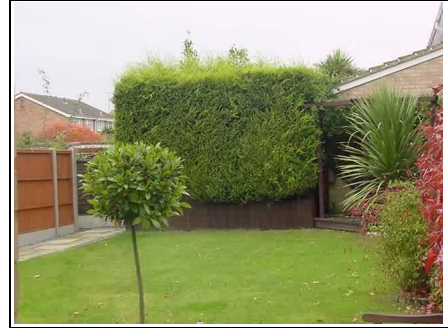
The leylandii trees are a good shield from the neighbouring property and have also been used quite ingeniously as a bin store. However, we would say they do need regular maintenance.

ACTION REQUIRED: Regular maintenance.

ANTICIPATED COST: A few hundred pounds. If you intend to carry the work out make sure you have the right platform for working from.

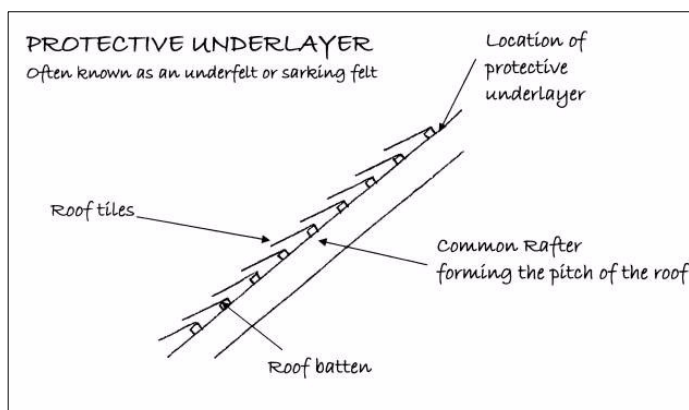
When we inspected the loft space we found a Hessian base Bitumen membrane. This type of membrane has been used since the 1960s. We generally found it to be in average condition, its damaged in a few more places than we normally find.

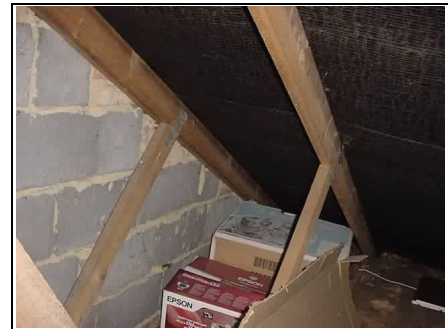
General view of roof

The main roof is accessed via the loft hatch located on the landing. There is no loft ladder, electric light or secured floorboards. We recommend that these be added, as it will make the loft space safer and easier to use. The loft has been viewed by torch light, which has limited our viewing slightly.

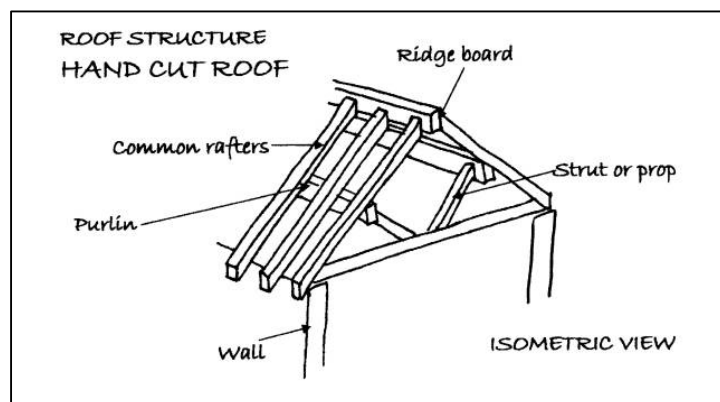
Roof Timbers

We found the timbers in average condition, our examination was restricted by the general configuration of the roof, the insulation and stored items. What we could see we found in generally average condition, with some minor condensation and damp.

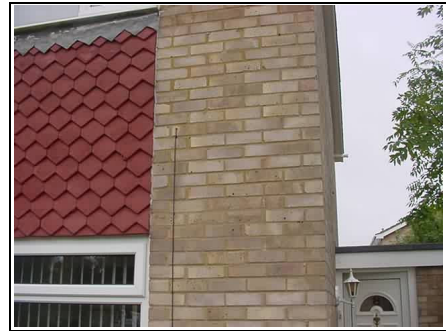
There are also some areas of vertical tiling. This is very common in what is known as cross wall construction, which was a technique used in the 1970's, which is what we think this is.

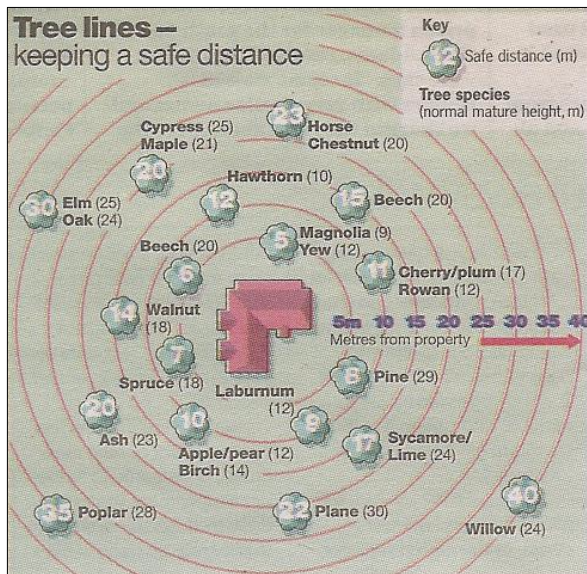
Leylandii are located close to the property at the end of the garden. It has been turned into rather an ingenious way of hiding the dustbin.

ACTION REQUIRED: Ensure regularly maintained.

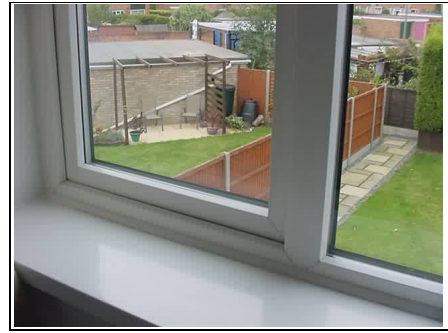
The property has plastic, double glazed windows, which generally look to be of a reasonable quality. We did not see any trickle vents.

We would draw your attention to the fact that sealed double glazed units can fail, particularly as a result of poor workmanship during installation. Failure of the seal leads to condensation between the two panes of glass and simply replacing the affected units may not provide a satisfactory long-term solution. In this case they are in average condition.

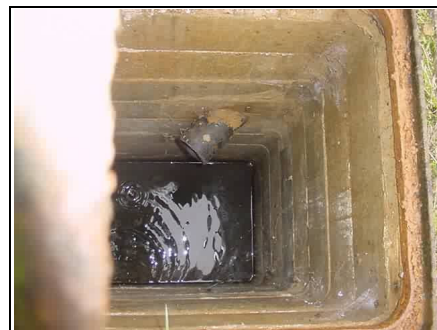
We duly lift the man hole/ inspection chamber cover and found the drain to be clear, we noted it was finished in concrete.

This manhole was located in next door's garden.

Manhole in next door's front garden

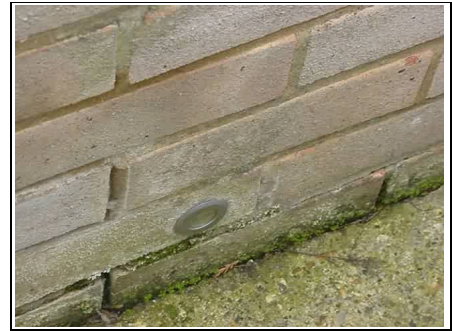
The electric fuseboard is dated. We would recommend that it be replaced. We also noted lighting in the garden to the side of the garage, which although we think is a good idea would not meet current Institute of Electrical Engineers standards from what we could see of it above ground level.

Electric Lights
on side of Garage

ACTION REQUIRED: Replace fuseboard and have NICEIC approved electrician carry out a report and inspection.
