RESIDENTIAL BUILDING SURVEY

Queens Park
Bedford, Bedfordshire MK40

FOR

Mr C

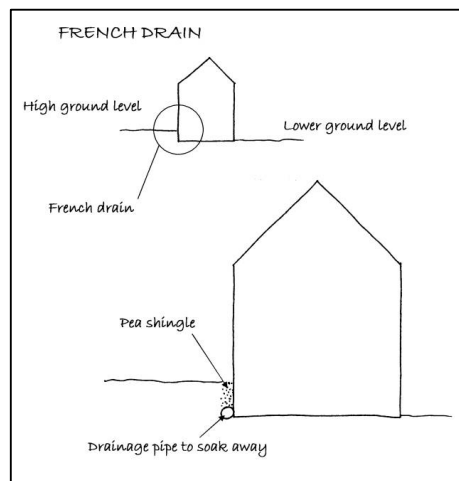
We found rising damp to the front of the property and also to areas at the rear. It is quite complex as to why there are problems: a combination of lack of ventilation under the floor and a cement pointing, together with gypsum plaster internally when previous “damp proofing” work has been carried out.

ACTION REQUIRED: We would recommend, in the first instance, that additional air bricks are added to the bay windows at the front of the property, and that a French gully is put around the property to the front and rear to lower the ground level, as well as moving the water away from the ground level.

ANTICIPATED COST: In the region of £1,000 to £2,000. Please obtain quotations.

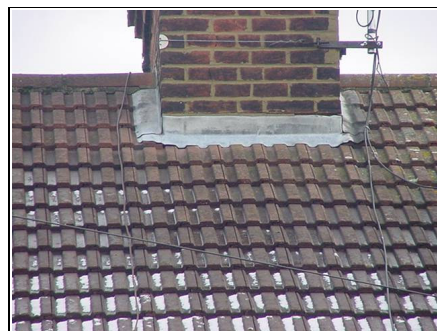
Base of front chimney

This chimney is brick finished with numerous chimney pots with lead flashings. From what we could see the chimney looks in average condition. Unfortunately we were unable to see the top of the chimney known as the flaunchings we therefore cannot comment upon them.

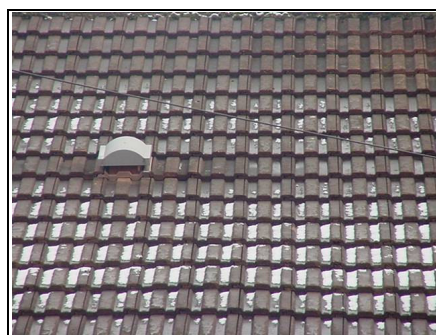
Close up of tiles

The main roof is pitched and clad in a large interlocking concrete tile. From what we could see the concrete tiles are lying level and true and look in reasonable condition considering their age. Sometimes we find that deterioration occurs to the ridges and the perimeter, so you should periodically check these areas.

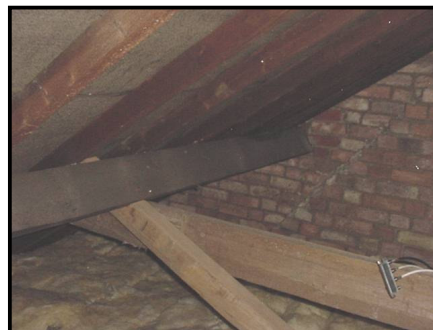
We believe originally the roof was slate. If this is the case and a heavy concrete has been added, then we would expect additional roof support in this case there are additional roof timbers, though they may not be to Building Regulation requirements.

Extra supports in roof.
The lighter timbers on the right hand side are the additional supports

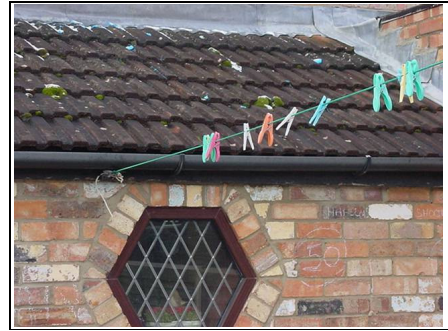
This roof is over the end part of the kitchen. This also had a concrete tile. We were pleased to see there has been a flashing which is, in our opinion, the best method of bringing any areas where the junction meets other buildings.

Lack of tilting fillet to main roof

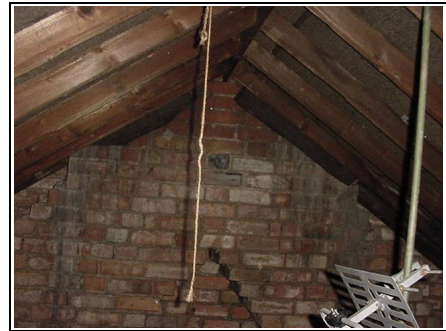
Roof timbers

We found the roof timbers generally in average condition considering their age. We have inspected the roof structure for:

Our examination was limited by the general configuration of the roof, the insulation and stored items. As mentioned what we could see was generally found to be in average condition considering its age. Due to the amount of stored items in the roof, including a mass of insulation, it is feasible there are problems in the roof that are hidden, typically woodworm.

ACTION REQUIRED: The only way to be 100 per cent certain is to have the roof cleared and checked.

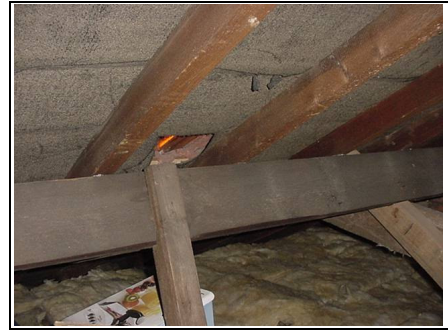
We could see some ventilation in the roof. However, it could be argued, given the amount of insulation in the roof and the lack of ventilation throughout the property, that that is not sufficient.

The roof vent can be seen to the middle of the picture

ACTION REQUIRED: Please see our comments in the Executive Summary.

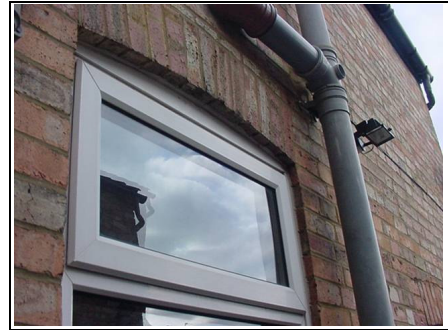
Soil and vent pipe to side of window

We could see a plastic soil and vent pipe. Generally the waste pipes and soil stack appear to be satisfactory where a surface inspection is possible, although for the most part they run in ducts and cannot be inspected.

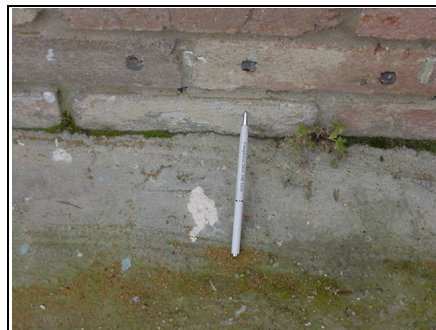
Damp proof course

All modern properties should incorporate a damp proof course (DPC) and good building practice dictates that a differential of 150mm (6 inches) should be maintained between the damp proof course and ground levels. In this case, holes have been noted on the outside of the building, which have been drilled into the wall. This is a typical sign that a chemical injection DPC has been inserted.

From our investigations we have found the DPC to work from not at all to reasonably well.

ACTION REQUIRED: Please see our comments in the Executive Summary, particularly about the run off of water from the rear garden.

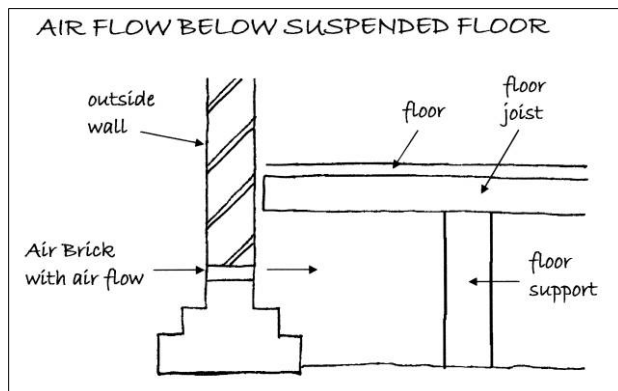
We can see air bricks to the front of the property (but we believe you need to add air bricks to the rear and additional air bricks to the front), which indicates a suspended floor. From what we could see, providing the air bricks are kept clear, you have adequate ventilation.

ACTION REQUIRED: Add air bricks to the front and rear, but mainly note our comments with regard to the adding of a French gully. Please see the Executive Summary.

Open up air bricks to allow free flow of air

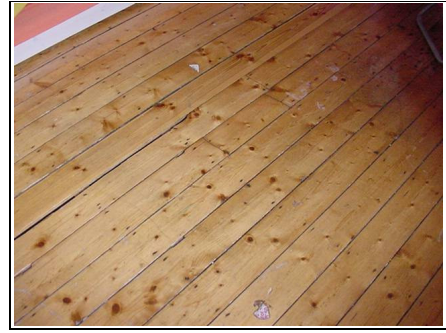
Wooden floor

We have assumed that the first floor construction is joist and floorboards as this is typical in this age of property.

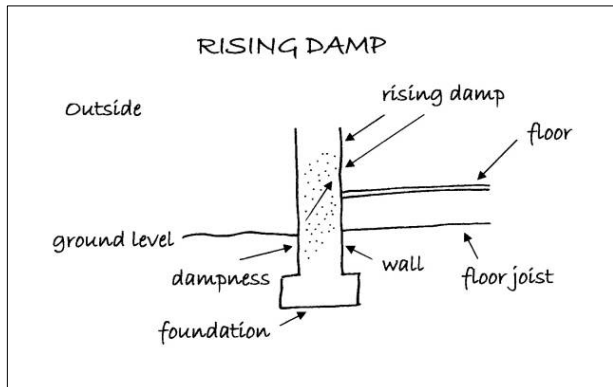
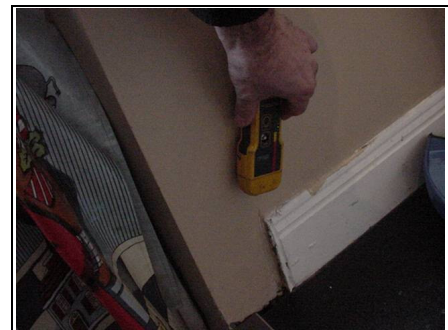
We have carried out tests with an electronic damp meter to a random selection of areas and we found rising damp.

Checking for rising damp

ACTION REQUIRED: Please see our comments in the Executive Summary.

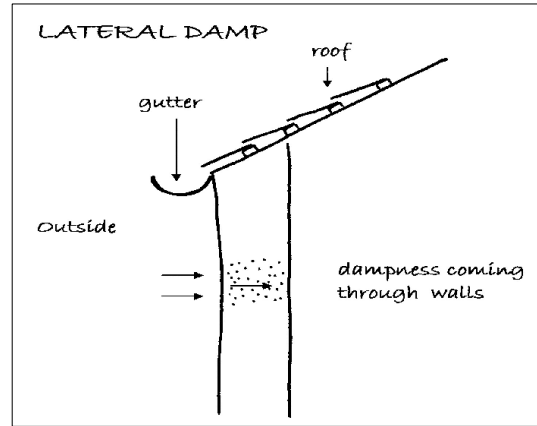
Again, tests were taken with a damp meter. No significant penetrating/lateral dampness was found. We did note areas of blown plaster, usually due to age. This is probably why it has been re-plastered in part.

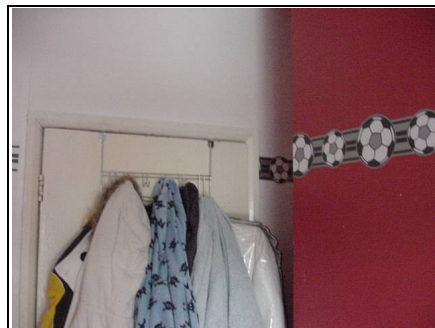
The property has painted panel doors.

Painted panel door

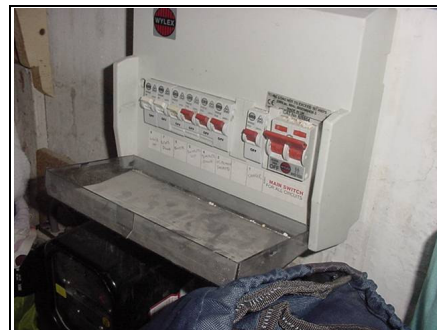
The electric fuses and consumer units were located under the stairs. We would date the fuseboard as being from the 1990s and, whilst not the best now available, it is reasonable.

Fuse board

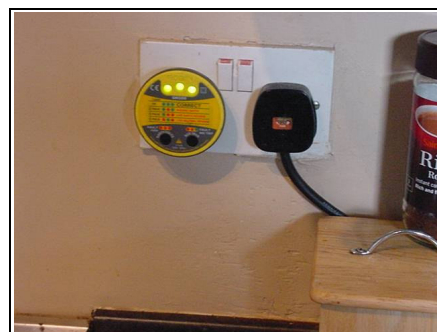
We carried out an earth test in the kitchen area to the socket point that is normally used for the kettle and this did not caused the electrics to trip.

Neither of these indicators can give certainty as to the condition of the rest of the wiring.

Earth Test

ACTION REQUIRED: If there is no record of an electrical test having been undertaken within the last five years, it is recommended that the installation be tested by a competent electrician (NICEIC registered) and all recommendations implemented. Thereafter, the installation should be re-tested every five years.

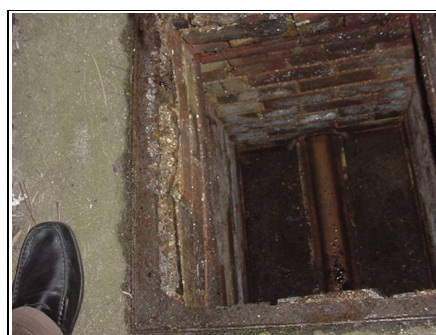
We duly lifted the man hole/ inspection chamber cover and found the drain to be free flowing; we noted it was finished in brick.

Front manhole

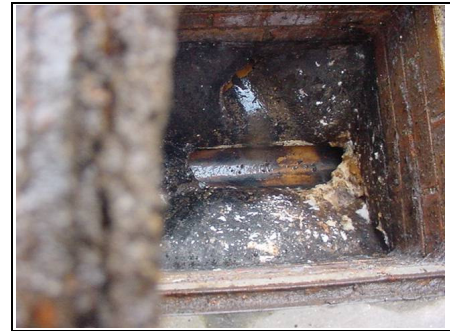
We duly lifted the man hole/ inspection chamber cover and found the drain to be clear; we noted it was finished in brick.

Rear manhole

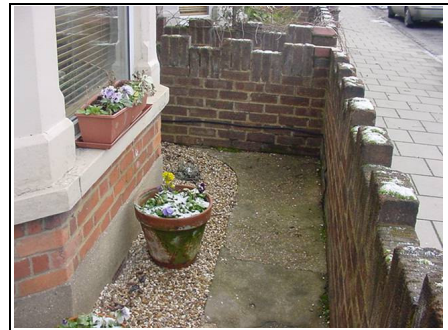
Front Garden

A small paved garden.

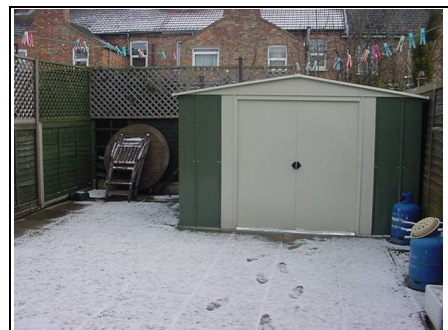
Rear Garden

The rear garden is paved. Please note our earlier comments regarding water run off in this garden.

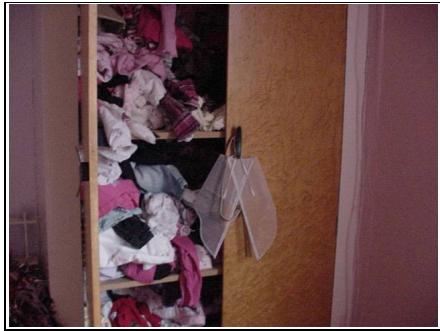
Unfortunately in this instance our inspection has been very limited due to not lifting any floors and the cupboards and the roof were full of stored items and insulation, which limited our view.

Cupboards full of stored items
