RESIDENTIAL BUILDING SURVEY

Bedford, Bedfordshire. MK41

FOR

Mr K

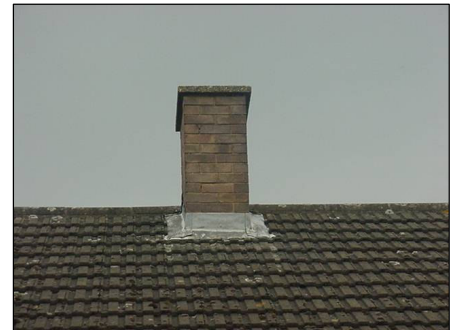
Chimney One

This chimney is brick finished with no chimney pots with lead flashings. From what we could see the chimney looks in average condition. Unfortunately we were unable to see the top of the chimney known as the flaunchings we therefore cannot comment upon them.

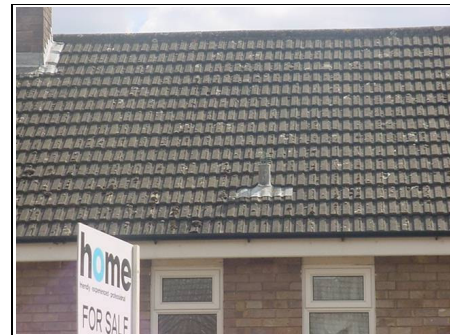
Concrete tile clad roof

The roof is pitched and clad in a concrete tile. From what we could see the concrete tiles are lying level and true and look in reasonable condition. Sometimes we find that deterioration occurs to the ridge and exposed areas such as the perimeter and so you should periodically check these areas.

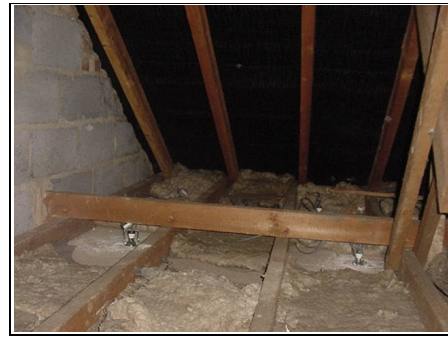
Roof timbers

We found the roof timbers generally in average condition considering their age. We have inspected the roof structure for:

Our examination was limited by the general configuration of the roof, the insulation and stored items. As mentioned what we could see was generally found to be in average condition considering its age. If anything it would benefit from being vented. It is feasible that there are problems in the roof that are hidden.

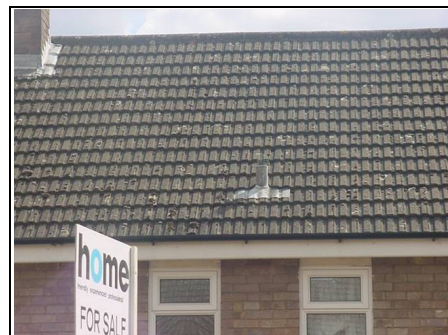
Internal soil and vent pipe

The soil and vent pipes are predominately internal, we can see at the roof level where it emerges and it is finished in lead although a very limited view due to the boxing in etc.

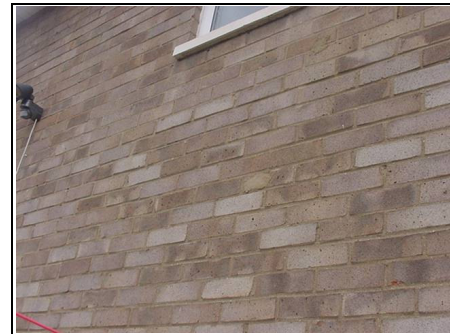
Brickwork

The stretcher bond brickwork and pointing is in average condition where we can see it. The brickwork forms the outer skin and the inner walls are likely to be formed in blockwork and bonded to the brickwork outer walls with wall ties. This has been a common construction method since the 1960s.

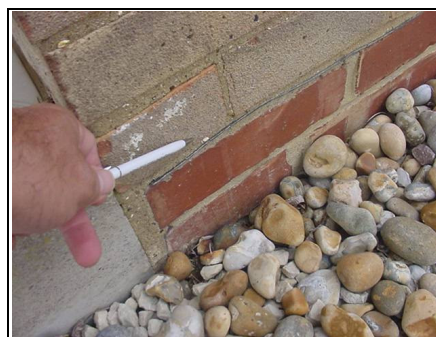
DPC

All modern properties should incorporate a damp proof course (DPC) and good building practice dictates that a differential of 150mm (6 inches) should be maintained between the damp proof course and ground levels. In this case, we could see a damp proof course to the property in some areas.

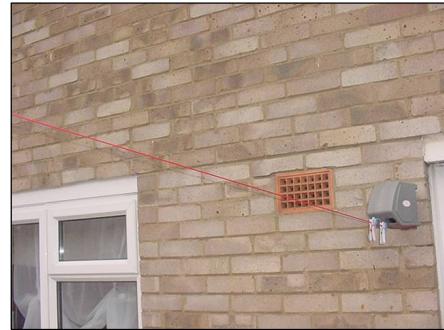
High level Airbrick to rear

There is a low and high airbricks in the kitchen area, these are often used in years gone by to allow air circulation throughout the property.

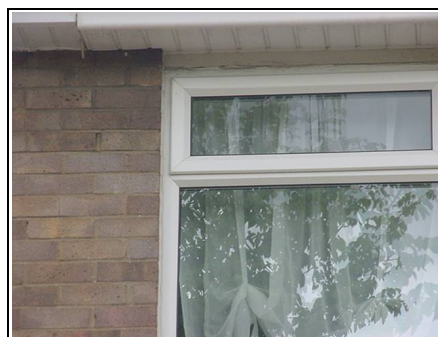
Window

The property has plastic, double glazed windows these are of the older style modern double glazed windows will be more thermally efficient.

We would draw your attention to the fact that sealed double glazed units can fail, particularly as a result of poor workmanship during installation. Failure of the seal leads to condensation between the two panes of glass and simply replacing the affected units may not provide a satisfactory long-term solution. In this case they are in average condition.

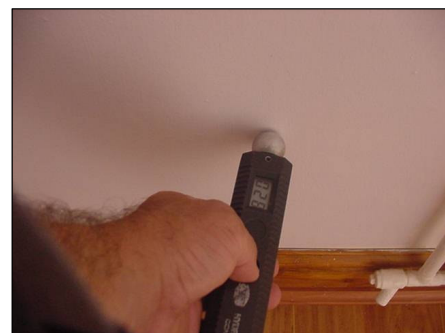
Dampness test

A visual inspection was carried and tests were taken with an electronic conductivity meter at selected points to walls. No significant penetrating/lateral dampness was seen or detected considering the properties age type and style.

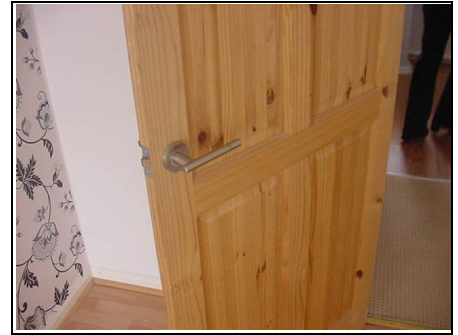
Internal timber door

The property has timber doors they look solid.

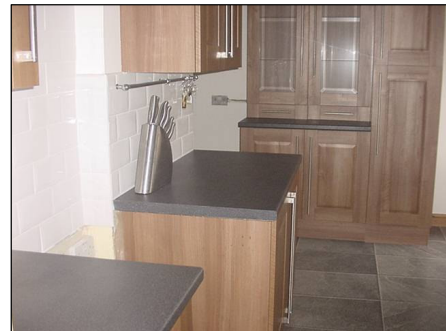
Kitchen

From our cursory visual inspection the kitchen looked in average to good condition. We have not tested any of the kitchen appliances.

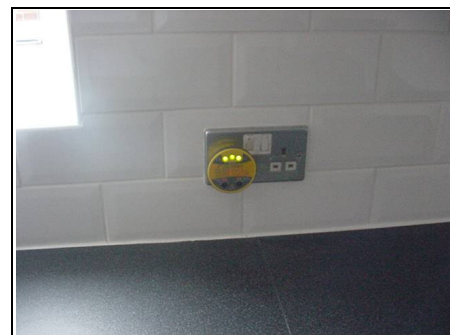
Earth Test

We carried out an earth test in the kitchen area to the socket point that is normally used for the kettle and this proved satisfactory.

ACTION REQUIRED: As the property is changing occupancy an IEE report should be carried out by a NICEIC registered and approved electrical contractor.

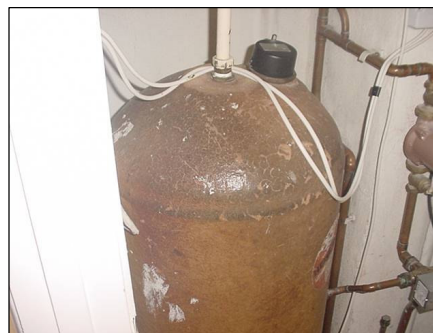
Hot water cylinder

The hot water cylinder is relatively new (in this case we mean in the past 30 years) as it is factory lagged.

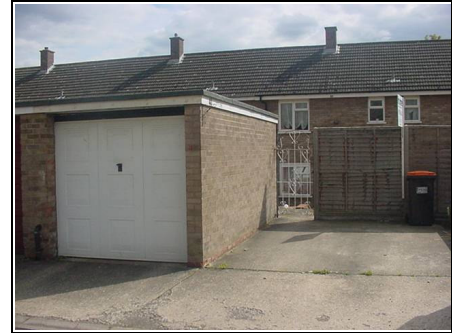
Single garage and off road parking to the rear.
We have not had access to this, you do need to
gain access before you purchase the property.
