RESIDENTIAL BUILDING SURVEY

**Bedford,
Bedfordshire
MK41**

**FOR
Mrs S**

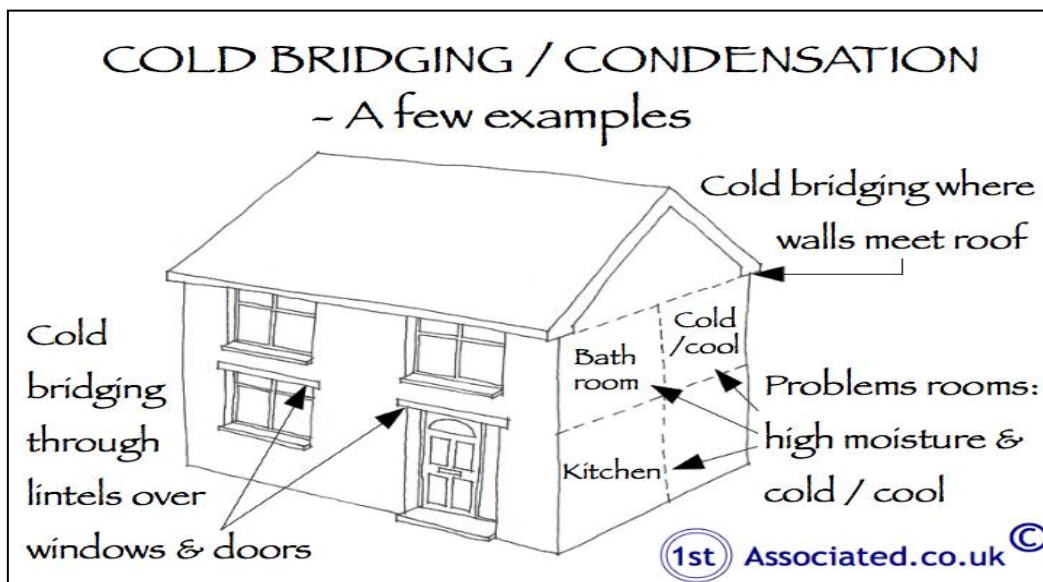
A characteristic of this age of property is cold bridging. This occurs when one material is generally colder than the rest of the materials. For example, this could relate to a concrete lintel.

This combined with other things in the property such as radiators not placed under the windows and no extract fans fitted in the bathroom and kitchen (although there are lots of windows) means condensation is more likely to occur. Whilst these factors can be reduced we find that modern day requirements for a warmer house tend, if anything, to make properties more susceptible to cold bridging.

ACTION REQUIRED: Have good quality humidity controlled extract fans fitted to the kitchen and bathroom. All radiators should be moved under windows. As we know you are looking to replace the existing

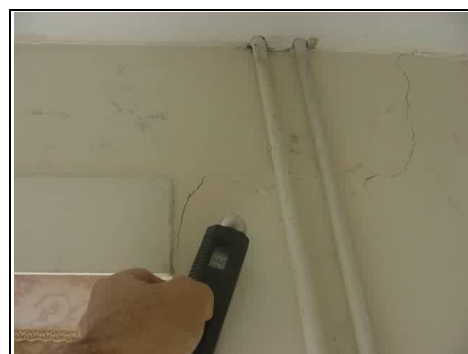
Checking for condensation on flaking paint over kitchen window

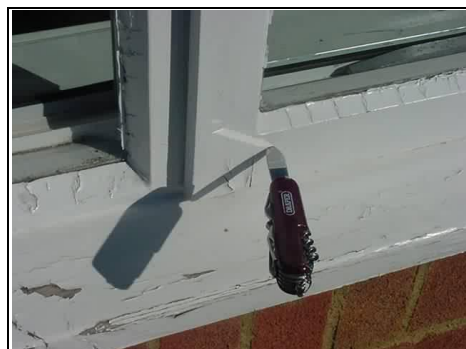
There is flaking to the windows and doors and some areas of rot. There is also some flaking to the fascias and soffits, although this is relatively minor.

Flaking paint to window.

With this you are also more than likely to replace the fascias and soffits.

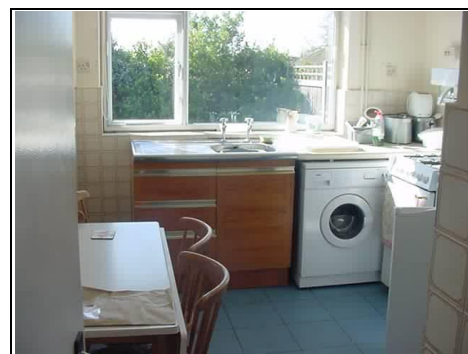
You may wish to upgrade the kitchen and the bathroom in due course. In our experience costs can range from a few thousand pounds to many thousands of pounds dependent upon your taste.

Dated kitchen

ACTION REQUIRED: Upgrade kitchen and bathroom in due course.

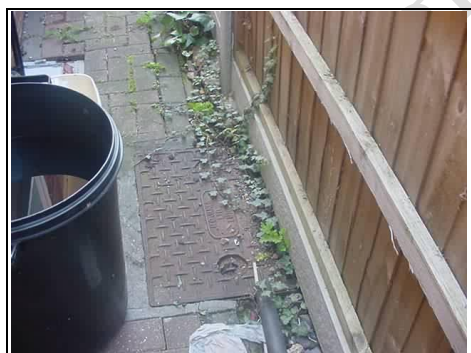
The neighbour on the right hand side has a path that is higher than yours. This means that water will discharge from their garden on the right hand side onto yours.

Your lower pavement.

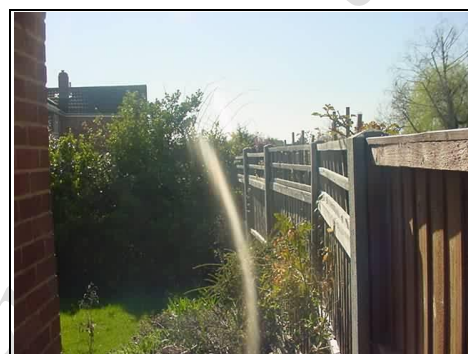
The boundary fence to the right doesn't seem to be that straight. Often older boundaries aren't but you may wish to check this on your deeds. Typically the left hand fence is yours although this may be different in your corner plot position.

The boundary fence does not appear to be in a straight line.

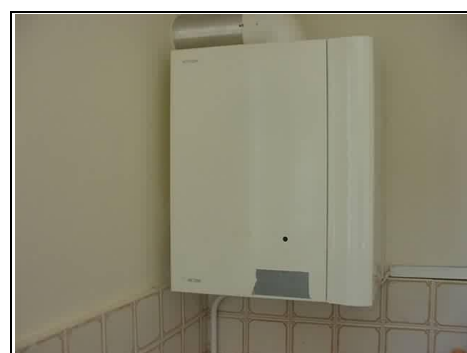
The property had the water turned off at the time of our survey. This meant that we were unable to carry out some of our usual tests or to see if the boiler was working or not.

We could not test the Potterton boiler.

ANTICIPATED COST: If this is not possible then you do need to anticipate a cost of between £4,000 and £6,000 (four thousand and six thousand pounds) to replace the boiler system. This is assuming that the existing radiators can be updated and partly re-used; please obtain quotations.

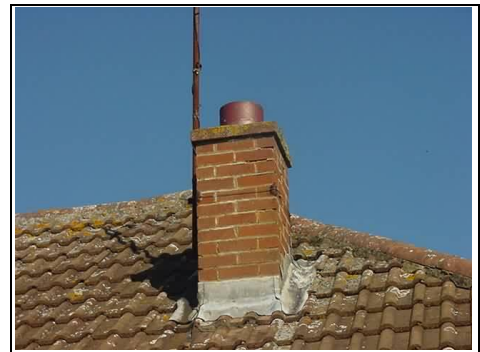
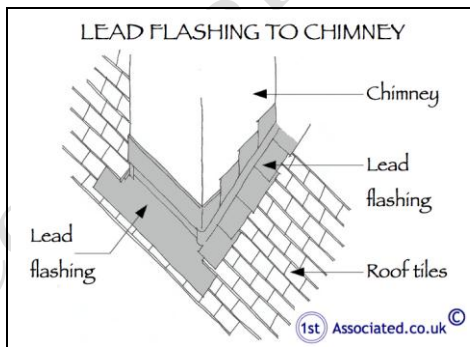
Chimney one

This chimney is brick /finished with a lead flashing and one chimney pot and is in need of some re-pointing. From what we could see from ground level it looked in average condition considering its age, type and style.

Needs re-pointing

ACTION REQUIRED: Ideally this needs some re-pointing in the next few years and also to periodically inspect the chimney.

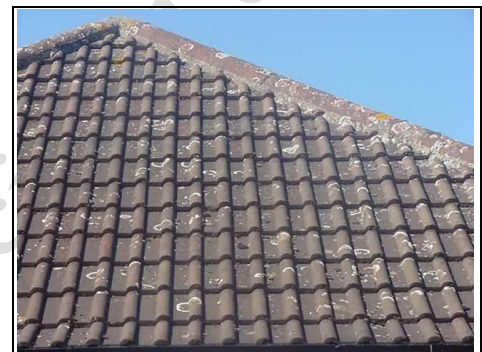
Main roof

The main roof is hipped and pitched and clad with a cement tile, and, from ground level, this looks in average condition considering the roof's age, type and style. There is some minor moss on the roof which may block the gulleys from time to time (you should clear the gulleys regularly in any case).

ACTION REQUIRED: Carry out periodic inspections and maintenance of the roof, as required.

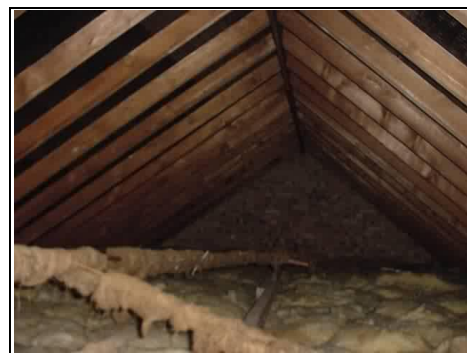
Our examination was limited by the general configuration of the roof, the insulation. What we could see was generally found to be in average condition for its age, type and style. There is some minor dampness visible to the valley gutter. It is, however, feasible that there are problems in the roof that are hidden.

General view of inside of roof

ACTION REQUIRED: The only way to be 100 per cent certain is to have the roof cleared and checked.

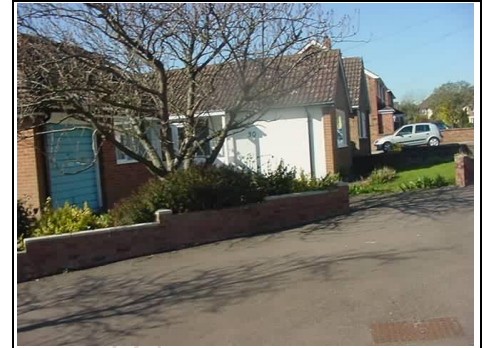
Our concern with removing the tree is that it would upset the balance of water content in the soil. We have already noted a lot of moss in the grass to the left hand side indicating that this is quite a damp area and doesn't get much sun.

The tree is located to the side of the property.

ACTION REQUIRED: You need to telephone your insurer and check what their parameters are in regard to trees.

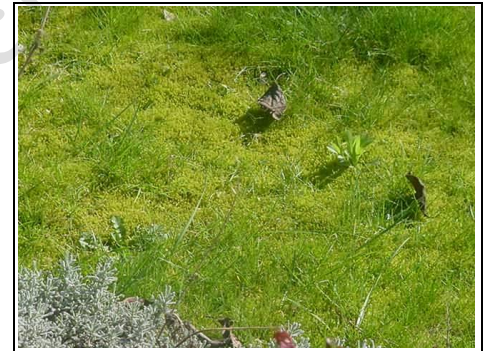
Moss visible in the grass.

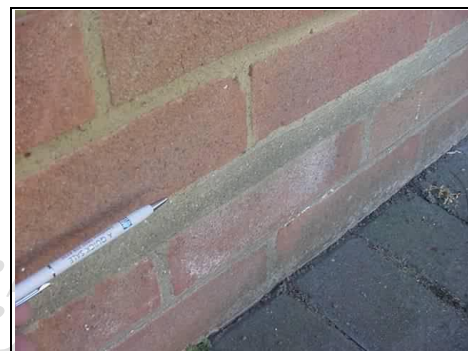
All modern properties should incorporate a damp proof course (DPC) and good building practice dictates that a differential of 150mm (6 inches) should be maintained between the damp proof course and ground levels. In this case, we could see a thickening of the mortar indicating the damp proof course.

Damp proof course

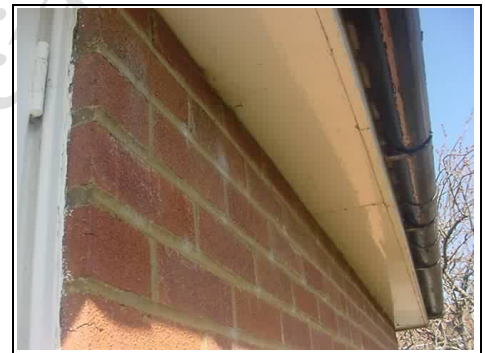
The fascias and soffits are timber. They are painted and we would comment they are in average condition for their age, type and style.

Fascias and soffits

ACTION REQUIRED: Make sure gutters and downpipes are watertight before carrying out any work on fascias and soffits.

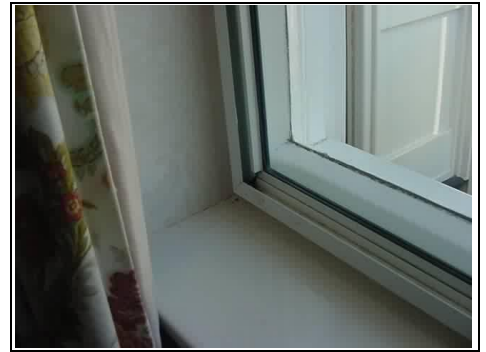
The property has secondary double glazing inside. We discussed that you would be looking to replace this.

Secondary glazing

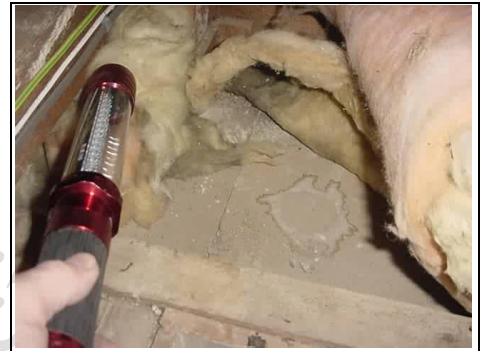
From our visual inspection of the ceilings and our general knowledge of this age and type of construction we believe that the ceilings are likely to be plasterboard or boarding. We have seen some minor staining on some of the plasterboard (we looked in three areas). This staining we assume relates to the water tank leaking as there are no obvious signs of water coming in thorough the roof.

Roof space shows plasterboard ceiling

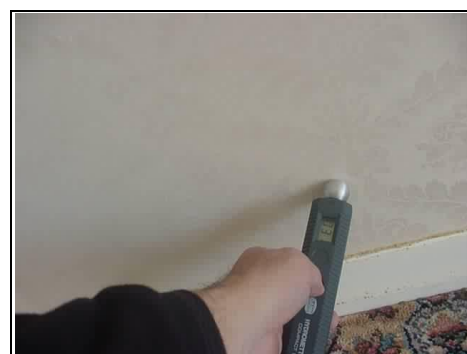
A random visual inspection and tests with a moisture meter have been taken to the perimeter walls. In this particular case we have found no rising damp.

Testing for rising damp

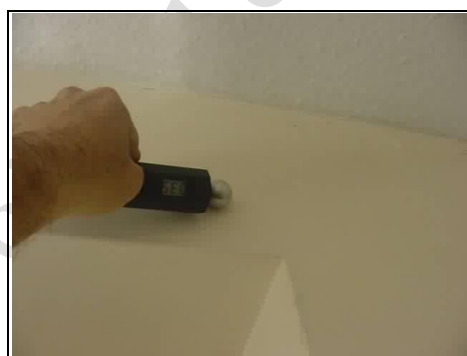
We used a damp meter on the external walls. We have not found dampness.

Testing for lateral dampness

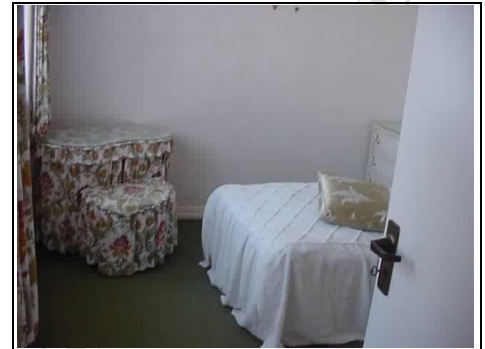
The property has the older style flush doors.

Flush doors

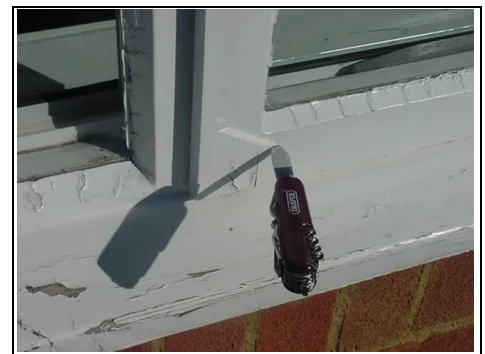
We were surprised at the resilience of the windows, although there is timber visible in some areas.

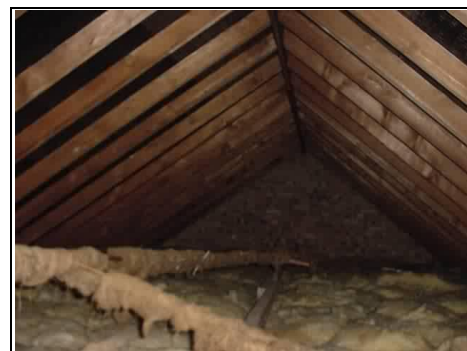
Some roof insulation was present although not to current Building Regulations requirements of 300mm. In this instance there was between 100mm and 200mm. We would not have any more unless you vent the roof as condensation may occur.

Insulation in roof

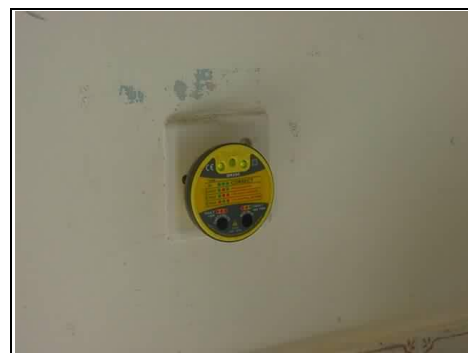
We carried out an earth test in the kitchen area to the socket point that is normally used for the kettle, this proved satisfactory.

Earth Test

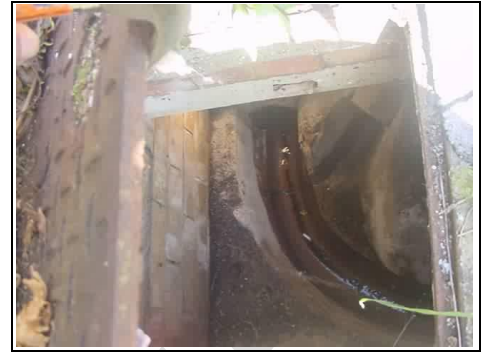
We duly lifted the cover and found it to be free flowing at the time of our inspection.

From what we could see it is brick built.

Manhole to the rear right of the property

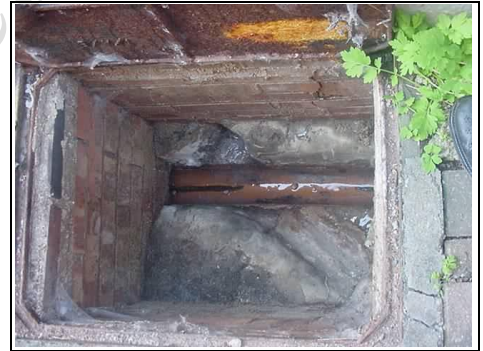
We duly lifted the cover and found it to be free flowing at the time of our inspection.

From what we could see it is brick built.

Communal manhole serving your kitchen and your neighbours

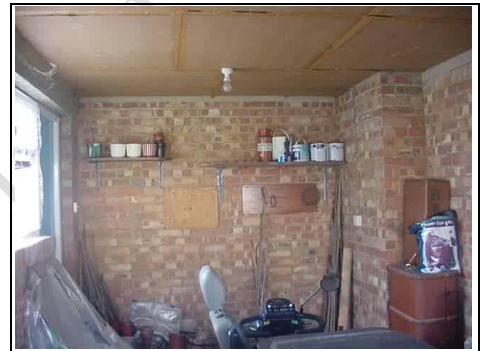
The property has a garage to the left hand side. There is driveway parking. Behind the garage are two garden sheds.

Garage

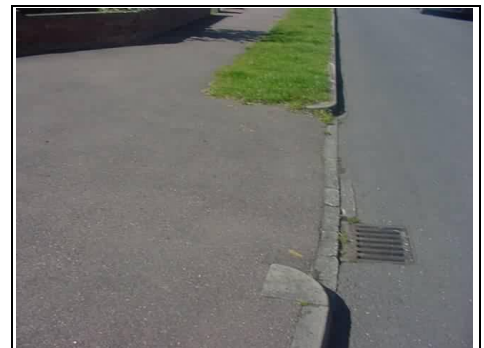
Curb dropped

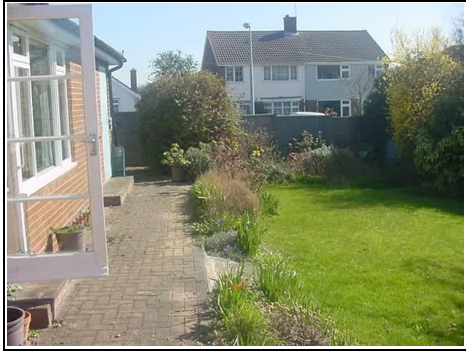
The rear garden is laid to lawn with a paved area and garden sheds. The fence needs some repair work. There is also an electric substation adjacent to the garden.

Rear Garden
