**RESIDENTIAL BUILDING SURVEY
OF
Bexhill-on-Sea, East Sussex, TN39**

**FOR
Mr B**

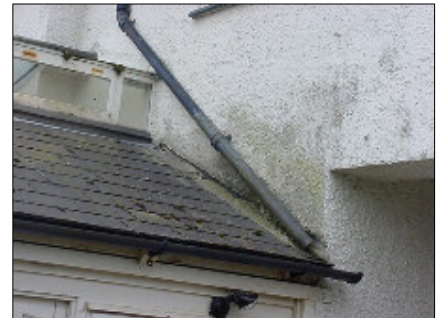
Entrance Porch Roof

This is a pitched tiled roof. Our main concern with this area is that it did not look to have a flashing, although there was some undulations to the render where the roof meets the main wall. If you look at the render there looks like there may even have been another structure in this area, as there is a horizontal band running across it.

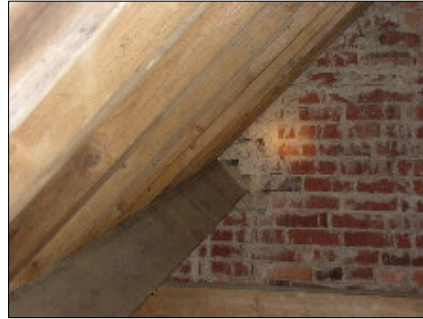
Another general view of the roof.

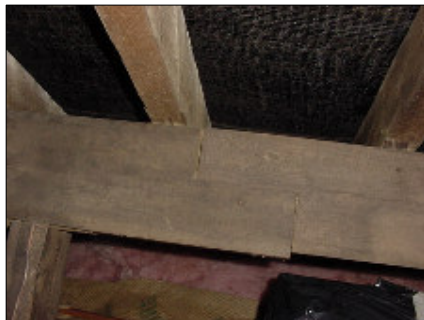
Close up of one of the purlins.

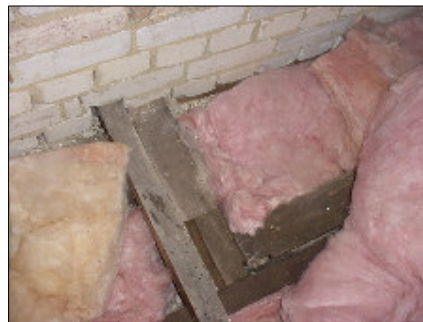
Here we tried to clear some of the insulation to have a look at the timbers, but there was a lot of it and it was not practicable to clear.

ACTION REQUIRED: This is more a suck it and see situation, due to the sheer amount of insulation in the roof we were unable to establish the true condition of the ceilings and unfortunately we were also unable to gain access under the floor area.
