JOB REFERENCE: RBSM2/MH/MB

RESIDENTIAL BUILDING SURVEY

Hertfordshire

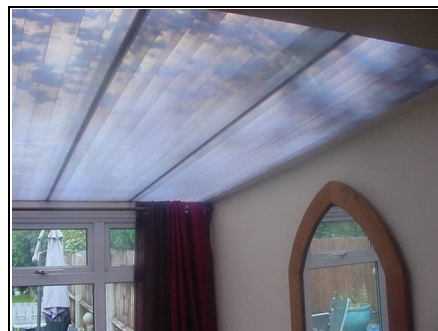
Conservatory gives additional light to rear of property

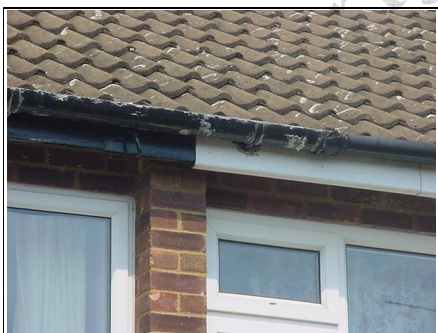
At the time the survey was carried out an asbestos report was also being carried out. We could see that there was what looks to be asbestos gutters, downpipes, water tank, flues, fascias and soffits, (although it is not possible to be 100% certain from a visual check). It is the condition these are in and whether they need removal that the asbestos company should be able to advise you of. The asbestos testing company took samples which they advised they would be analysing within their labs.

Asbestos gutters

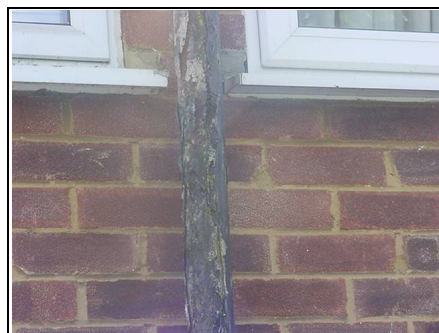
Asbestos downpipe to rear

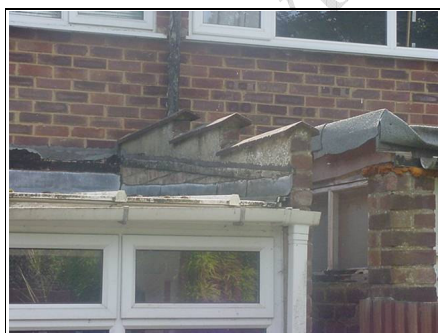
We can see that the right hand side of the rear conservatory (all directions given as you face the front of the property) has part of the flashing missing. Although it has some of the flashing remaining, work is required to renew this flashing to stop water getting in. Rain may also get into the joints and other similar weak areas.

Rear left hand side of conservatory

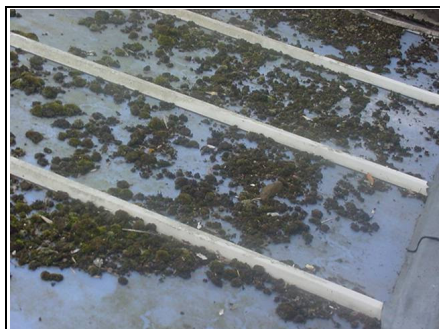
As an aside we would comment that generally we believe that the conservatory roof is too shallow a pitch to work without a clean down occasionally. Given the shallowness of the pitch wind driven rain may well get into it.

Moss to polycarbonate roof over conservatory

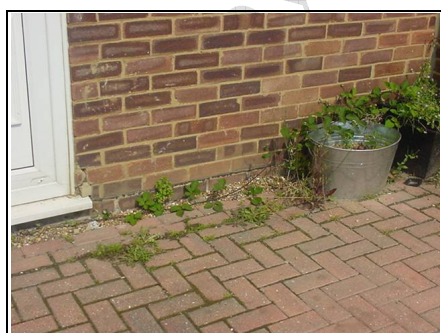
The damp proof course is too low because brick paves have been put on ground level rather than reducing it. There are less than two bricks between the ground and damp proof course.

Damp proof course too low due to brick paves

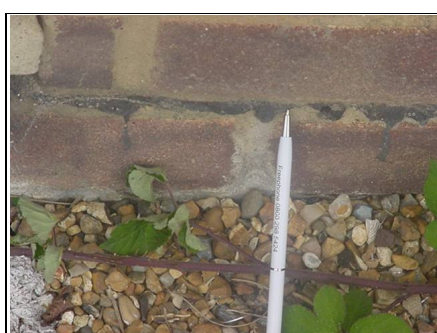
Damp proof course

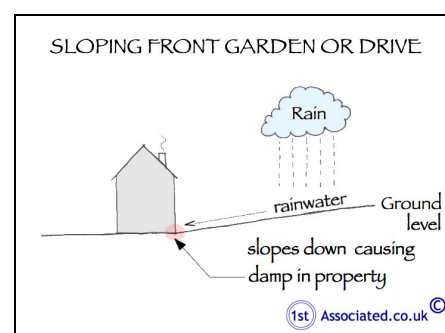
The decking to the rear comes right up to the property and as such can cause dampness by capillary action to the concrete floor.

We have found over the years that decking can be a home for vermin and can also get slippery over time.

ACTION REQUIRED: We would recommend a gap between the decking and the house which may be easier said than done. We would also recommend ensuring that you can lift the panel directly above the drain. Watch out for vermin and for the decking getting slippery.

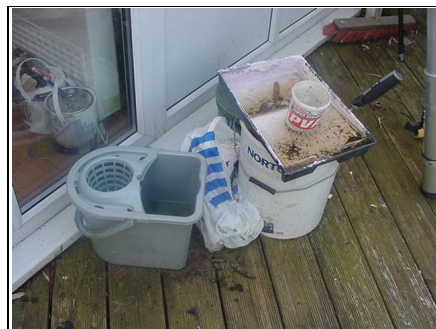
Although this may be a strange thing to say after the last comment, it does look to have been recently painted in some areas which could be hiding latent defects.

The paint was literally sitting outside the back door

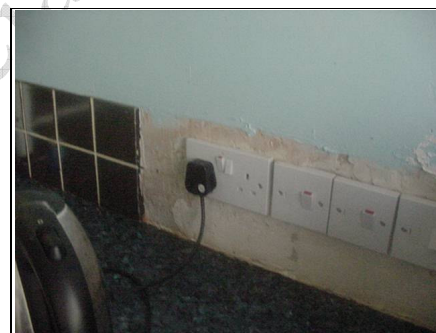
Within the kitchen there was unfinished tiling. There were many electric points which we were unsure what they were for.

Unfinished tiling to kitchen

ACTION REQUIRED: You need to ask the current owner what the electric points are for.

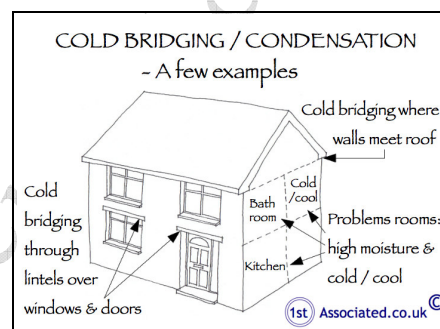
This age of property is susceptible to cold bridging.

ACTION REQUIRED: We would recommend venting of the roof and humidity controlled extract fans to the kitchen and bathrooms (see earlier comment about condensation in bathroom).

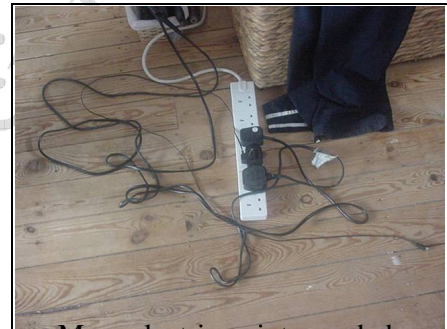
More electric points needed

ACTION REQUIRED: The Institute of Electrical Engineers standards (IEE) recommend a test and report be carried out by an NICEIC registered and approved electrical contractor or equivalent whenever a house changes occupants. We would recommend the same in this instance as there seems to be a lack of socket points and possibly some DIY electrics.

ANTICIPATED COST: A few hundred pounds for the test and then recommendations; please obtain quotations.

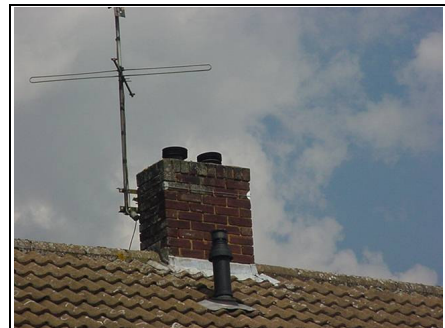
This chimney is brick finished with a lead flashing and two chimney pots. From what we could see from ground level it looked in slightly below average condition as it looks weathered considering its age, type and style.

Chimney one

ACTION REQUIRED: We would recommend repointing in the summer of 2013, by 2014 at the latest otherwise dampness will start to get in. Periodically inspect the chimney.

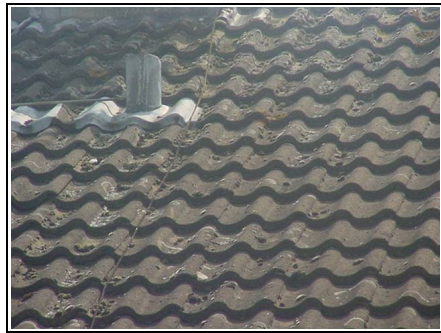
There is an asbestos flue to the rear of the property.

Asbestos flue to rear

ACTION REQUIRED: Please see our comments in the Executive Summary and of course your asbestos report.

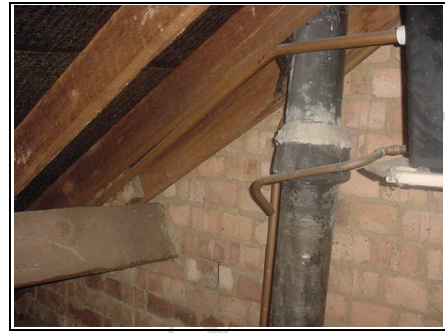
Old asbestos flue within roof space to rear of property

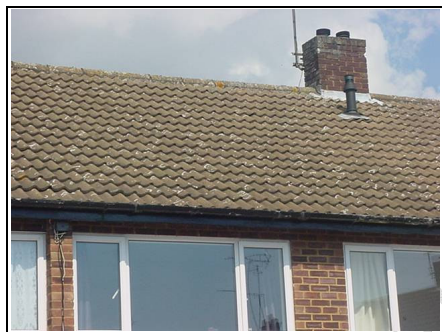
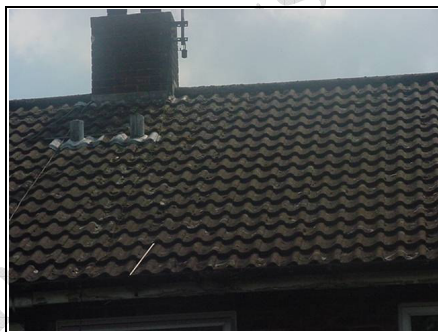
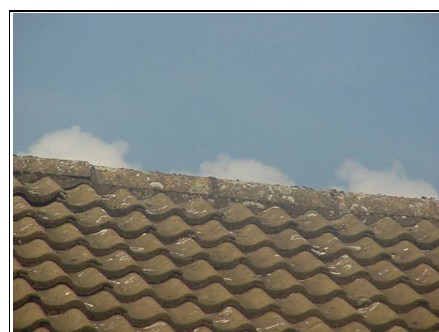
The main roof is pitched and clad with concrete roman tiles and, from ground level, this looks in average condition with minor moss considering the roofs age type and style. Often the ridges weather on this type of roof; the ridge tiles look in average condition at present.

Roman tiles

Rear roof

Close up of roof tiles and ridge tiles

ACTION REQUIRED: Carry out periodic inspections and maintenance of the roof, as required.

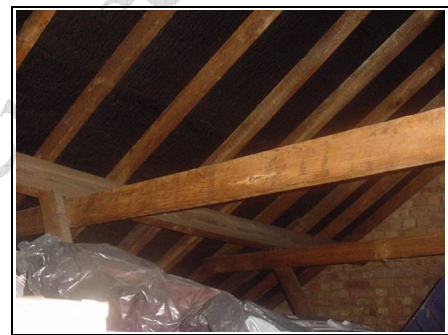
When we inspected the loft space we found a Hessian base Bitumen membrane. This type of membrane has been used since the 1960s. We generally found it to be in average condition, with damage in some areas which is what we typically find.

This photo shows the common rafters (the ones that form the pitch of the roof) and the dark area between is the underlayer

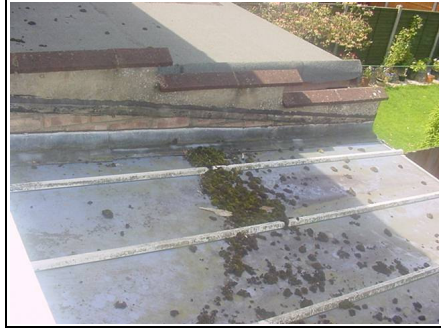
The conservatory has a polycarbonate plastic roof, this is a reinforced plastic roof that is relatively common on the cheaper end of the market conservatories. This has a very shallow pitch; we much prefer good pitches on roofs to get any rainwater away. Due to this, moss sits on the roof. There is also a danger of wind driven rain getting in.

Plastic roof over conservatory

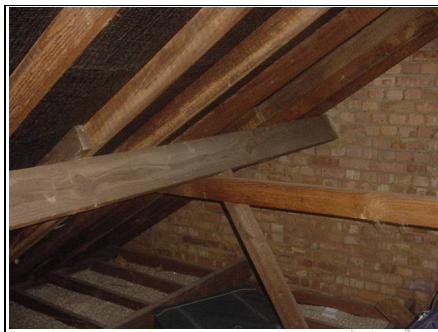
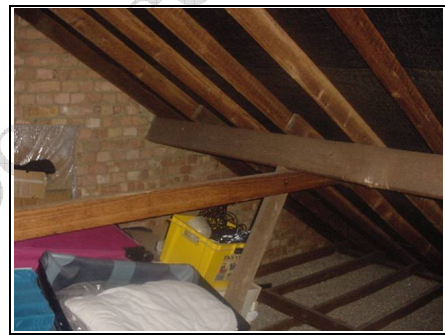
Roof space left

Roof space right

Our examination was limited by the general configuration of the roof, the insulation and stored items. What we could see was generally found to be in average condition for its age, type and style. It is, however, feasible that there are problems in the roof that are hidden.

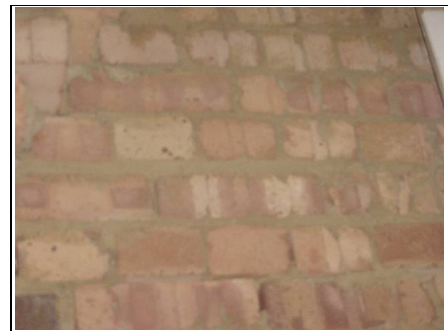
Firewall

The property has two brick firewalls which are located one to the left hand side and one to the right hand side (all directions given as you face the property). The firewalls are also Party Walls.

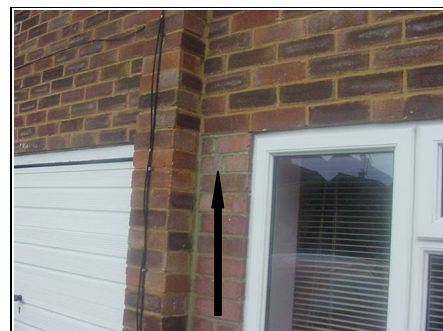
Brickwork infilled to where garage once was

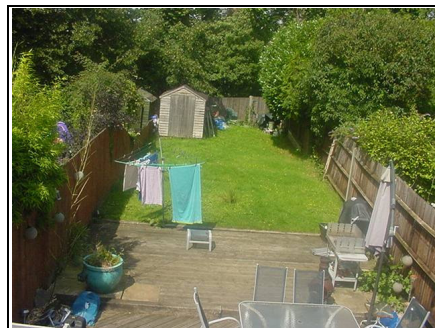
There are trees and bushes that surround the property although not within your garden. Some insurance companies are requiring additional insurance if there is a tree within 5 metres of the property, other companies are 10 or 15 metres so it does depend upon your insurance as to whether you will have a premium with regard to the trees. We cannot see any that we believe are physically affecting the building based upon the height and type of trees in the area.

Trees nearby

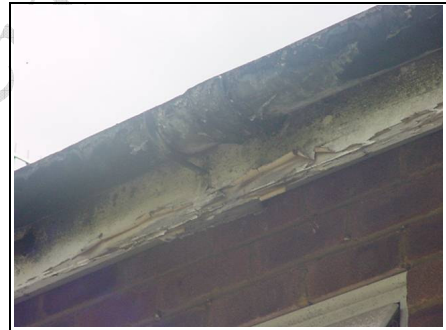
Some of the fascias and soffits look to be asbestos and some look to be timber. The asbestos company should have taken samples to check and confirm. The timber needs redecorating (if they are timber).

Rear timber fascia flaking

Again, we have not visually seen any wet rot during the course of our inspection although there was flaking to the fascia board to the rear. If it is timber it is likely to have rot although we suspect it is asbestos.

ACTION REQUIRED: Repaint timber. Make sure gutters and downpipes are watertight before carrying out any work on fascias and soffits.

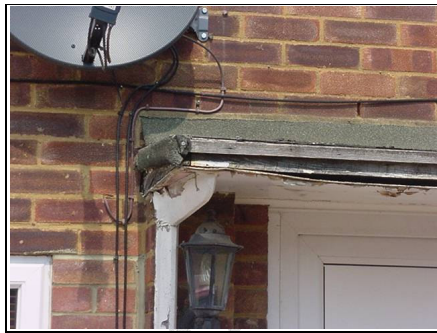
The entrance porch is in need of redecoration and as mentioned the roof would be best re-felted.

Bare timber to entrance porch

ACTION REQUIRED: Redecorate.

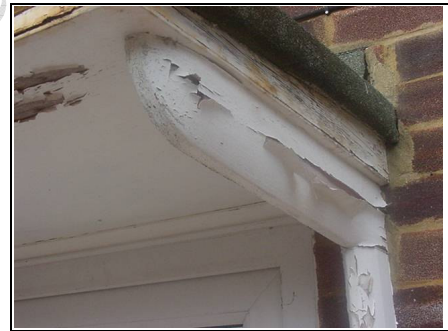
Entrance porch in need of redecoration

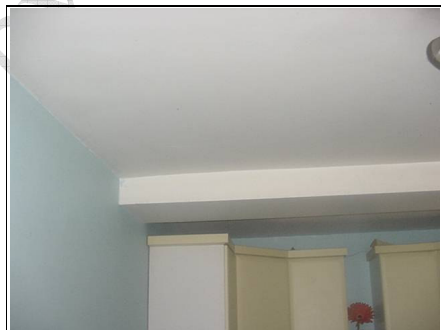
Is this an original design or has a wall been removed?

ACTION REQUIRED: Please see our comments in the Executive Summary.

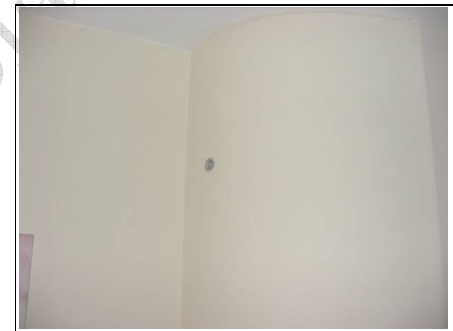
It has what looks to be LED lights which are an unusual feature. We couldn't find the switch to turn these on.

LED lights around chimney

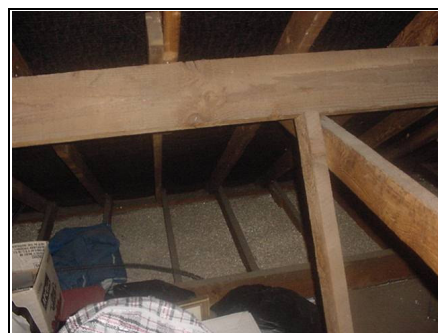
Some roof insulation was present although not to current Building Regulations requirements of 300mm. In this instance there was approximately 200mm.

Older style shingle insulation

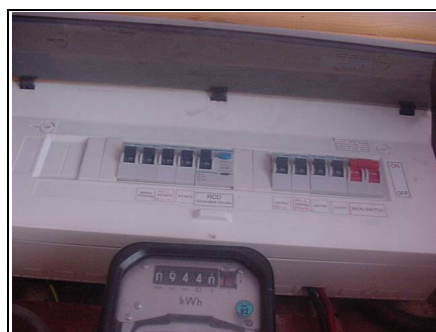
Fuse Board

The electric fuses and consumer units were located in the garage conversion on the right hand wall. The fuse board looked 1980's/1990's and better are now available.

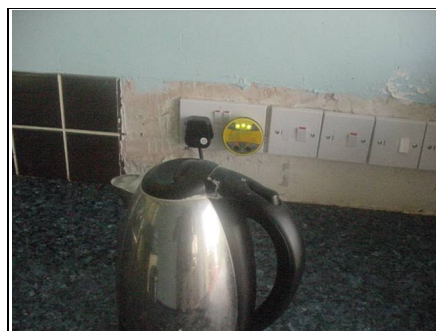
Earth test

We carried out an earth test in the kitchen area to the socket point that is normally used for the kettle, this proved satisfactory.

ACTION REQUIRED: Please see our comments in the Executive Summary. As the property is changing occupancy an Institute of Electrical Engineers (IEE) test and report should be carried out by a

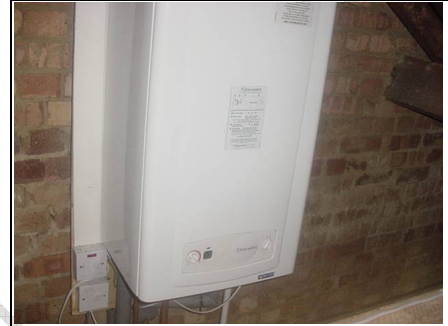
The boiler was located in the roof it is a Glow Worm wall mounted boiler.

Our limited inspection of the hot water and central heating system revealed no evidence to suggest any serious defects but we would nevertheless recommend that the system be tested and overhauled before exchange of contracts and that a regular maintenance contract be placed with an approved heating engineer.

Glow worm boiler in roof

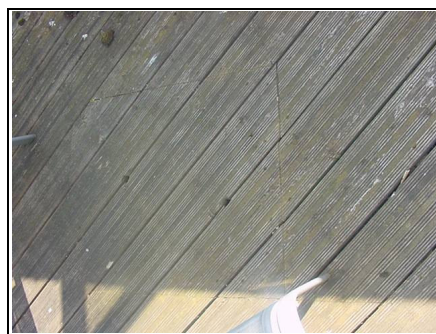
Inspection Chamber / Manhole One located to the rear of the property

We were unable to lift this manhole as it was covered by the decking.

Manhole covered by decking,
you can just about see the
screw fixings.

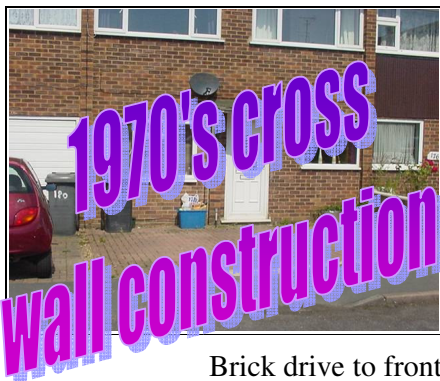
Brick drive to front of property

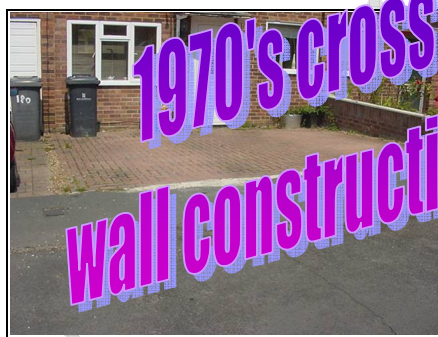
Dropped kerb to driveway

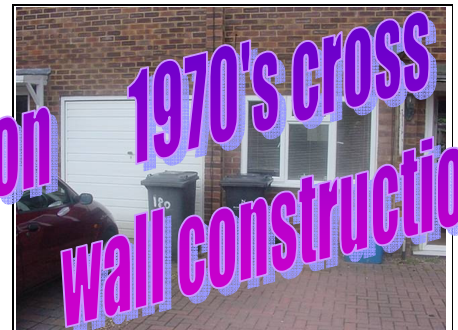
Old garage converted to room

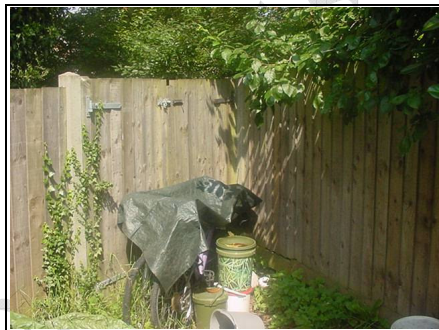
The rear garden is grassed with a decked patio area. To the rear of the garden there is a gate. We have looked over the gate and it drops away to a road. The gate looks to be used for tipping grass cuttings, etc. You need to confirm whose land this is.

Gate from garden doesn't lead anywhere

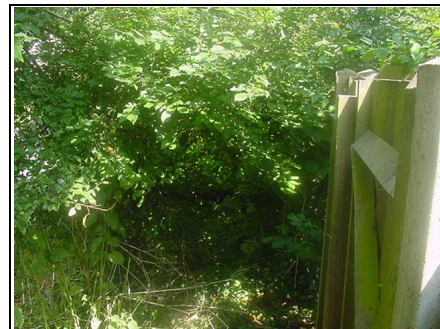
View over gate to rear

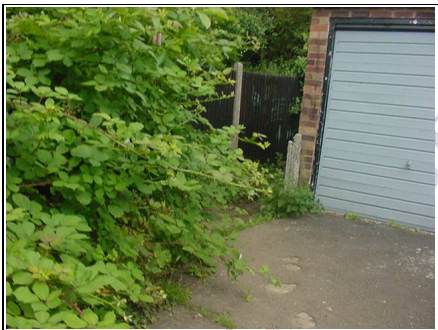
We were surprised by the number of people using the right of way that runs across the front of the property.

Popular right of way

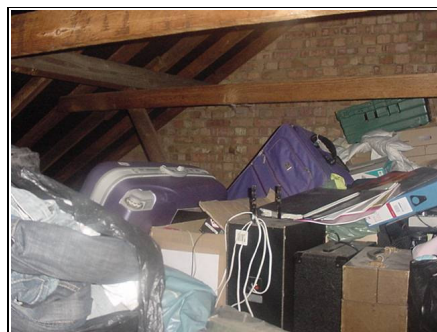
Unfortunately in this instance our inspection has been very limited due to the amount of stored items in the roof. We haven't opened up the first floor or the dry lined walls. We did not have the benefit of talking to the owners or them answering our usual question and answers and we didn't have the benefit of meeting you at the property although we have had a talk on the phone since.

Inspection limited due to amount of stored items
