RESIDENTIAL BUILDING SURVEY

**Bishops Stortford,
Hertfordshire
CM23**

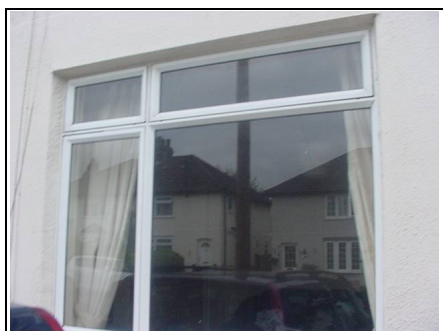
The windows are from the cheaper end of the market. Some of them have missing seals to the windows, etc and we feel they may allow rain in. We also noted there were no trickle vents, meaning that this age of property is more susceptible to condensation.

Window

ACTION REQUIRED: We recommend that you live in the property and see how draughty the windows are. However, we do feel you would be better off with new windows and recommend you look to replace the windows, depending upon how bad the winter of 2012 is, in the summer of 2013.

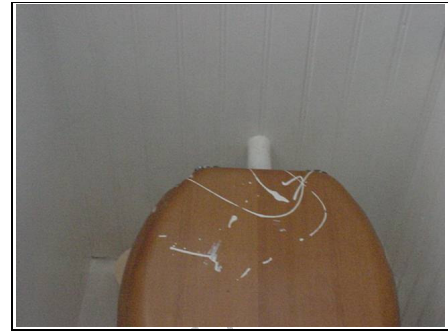
The owner advised that the property had been re-painted only a week or so ago. We are not sure whether you saw it in the re-painted condition or prior to this. The owner explained how she had had the relatives over to paint the house for her.

This may be hiding some latent defects, such as mould from condensation and cold bridging, which is relatively common in this property.

Newly painted, including the toilet seat!

ACTION REQUIRED: Please see our article on cold bridging at the end of the report.

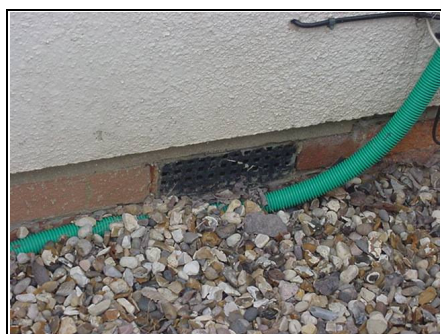
We are slightly concerned with regard to the air bricks to the front of the property as it looks like the driveway has been built high, which could mean that dampness is transferred into the property and into the timber floor.

Air brick to front with shingle up to the air brick

ACTION REQUIRED: Clear back the shingle to give two brick courses below the air brick. This will allow the air bricks to work better and also stop any capillary action taking dampness over the damp proof course (assuming there is one).

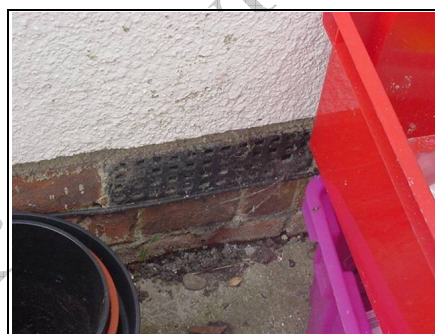
This property has air bricks to the front and to the right hand side (all directions given as you face the property), indicating a suspended timber floor. This type of floor requires an air flow underneath it.

Air brick to side with bricks clear beneath it

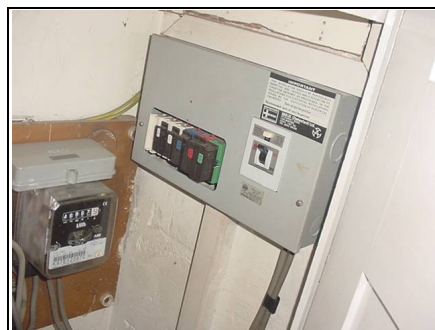
The electrics are located within the cupboard in the front lounge and are dated from the 1960's.

Dated fuse board

ACTION REQUIRED: We recommend replacement and an Institute of Electrical Engineers (IEE) test and report by an NICEIC contractor or equivalent, which is recommended whenever a property changes occupancy.

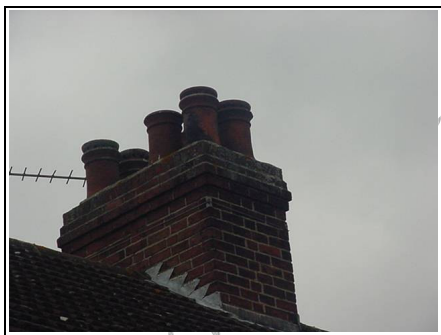
There is one chimney located to the middle of the property. It is made of brick and finished with a lead flashing and numerous chimney pots of which we believe three or four are yours (remember in this era of property every room had a real fire). From what we could see from ground level it looked in average condition considering its age, type and style.

Chimney

ACTION REQUIRED: Periodically inspect the chimney.

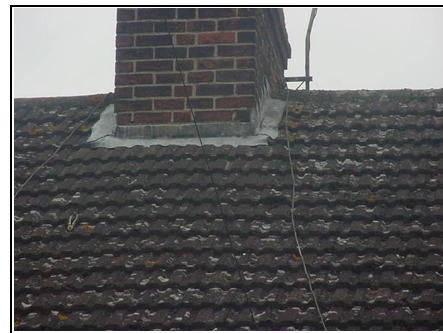
Base of chimney

Unfortunately we were unable to see the top of the chimney known as the flaunching, we therefore cannot comment upon them.

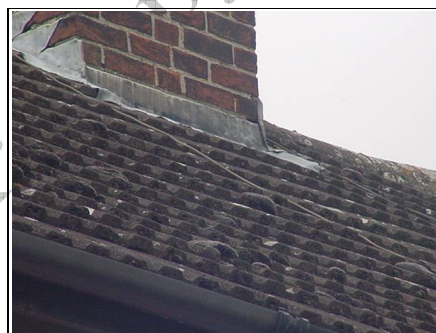
The main roof is hipped and pitched and clad with a concrete tile, and from ground level, this looks in average condition considering the roofs age type and style. It is likely the roof originally had a different roof covering and the concrete tiles were added in during the 1970's. The re-roofing of a clay roof with a concrete tile can lead to problems, a common one being 'roof spread'.

Concrete roof tiles

It is now a requirement where you add a heavier concrete tile to have Building Regulations Approval which normally requires extra timbers within the roof.

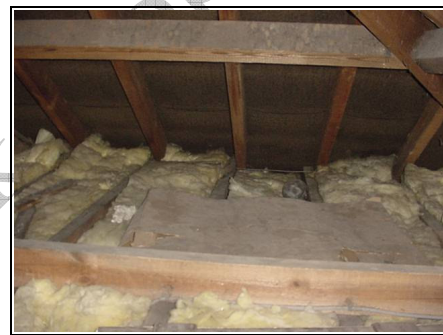
When we inspected the loft space we found a Hessian base Bitumen membrane. This type of membrane has been used since the 1960s. We generally found it to be in average condition, with damage in some areas which is what we typically find.

This photo shows the common rafters (the ones that form the pitch of the roof) and the dark area between is the underlayer.

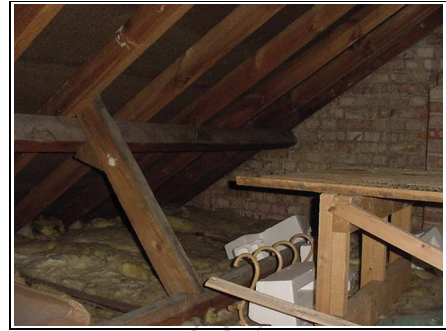
General view of roof

Our examination was limited by the general configuration of the roof, the insulation and stored items. What we could see was generally found to be in average condition for its age, type and style. It is, however, feasible that there are problems in the roof that are hidden.

ACTION REQUIRED: The only way to be 100 per cent certain is to have the roof cleared and checked.

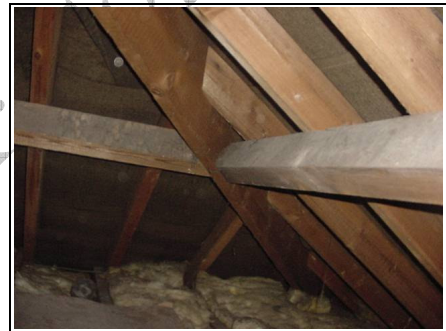
Hipped section of roof

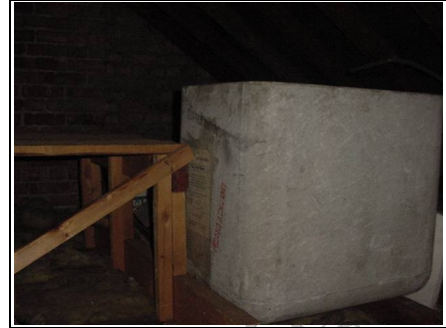
There is an old asbestos water tank which is no longer used. Ideally it should be removed.

Asbestos water tank

ACTION REQUIRED: Please see our comments in the Executive Summary. We are not asbestos surveyors.

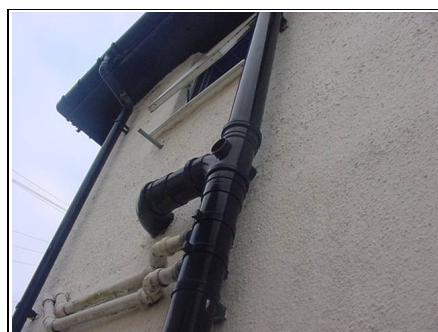
The property has plastic soil and vent pipes. There were no signs of any major leakage.

Soil and vent pipe

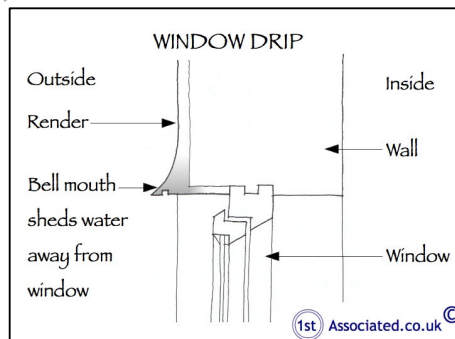
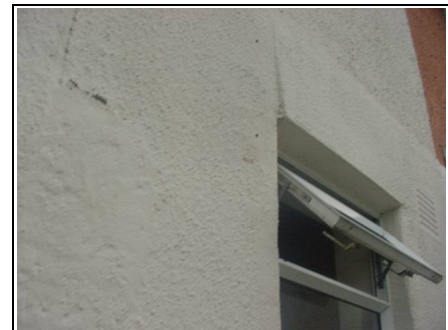
In this case we found a drip detail to the windows.

Drip detail above window

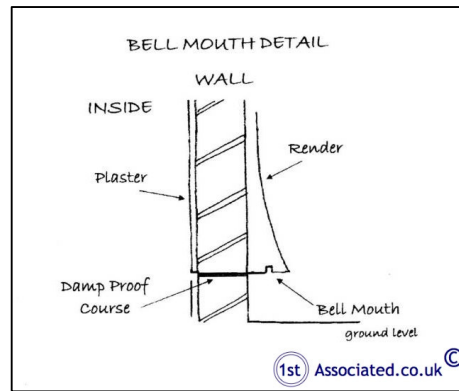
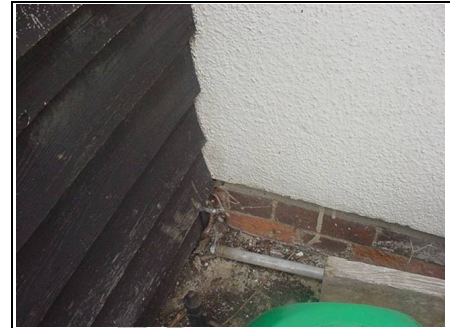
The base of the property finished flush, and as mentioned we much prefer to see a bell mouth detail.

Render finished flush to the base of the property

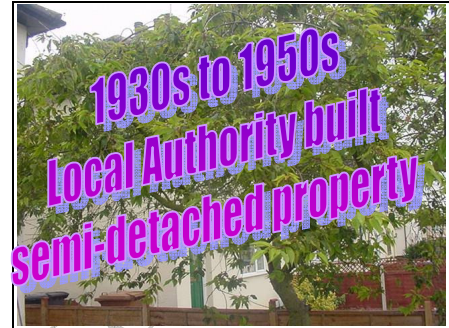
There is a tree within what insurance companies would term as influencing distance of the property.

Tree to front of property

ACTION REQUIRED: You may have to advise your insurers of this tree depending upon the policy requirements of trees within ten or fifteen meters and it may affect your insurance. We do not believe the root system will affect the property unless it has got into the drains or similar.

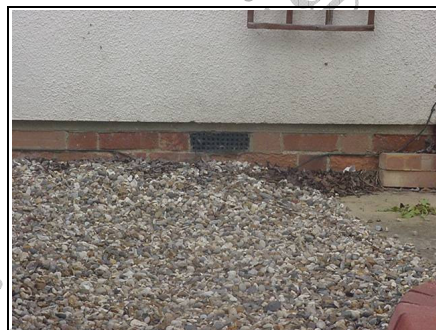
All modern properties should incorporate a damp proof course (DPC) and good building practice dictates that a differential of 150mm (6 inches) should be maintained between the damp proof course and ground levels. In this case we cannot see a DPC but the shingle is high around the property.

Shingle high around property – you can see to the right hand side the correct amount of bricks

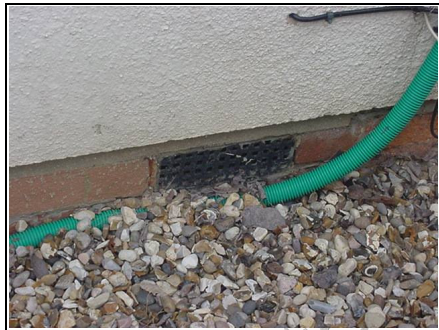
We noted air bricks to the front and side. It is slightly unusual as we did not see any to the rear, unless they have been hidden.

Air brick to front

ACTION REQUIRED: You need to ensure there is a through flow of air. Please see our comments in the Executive Summary.

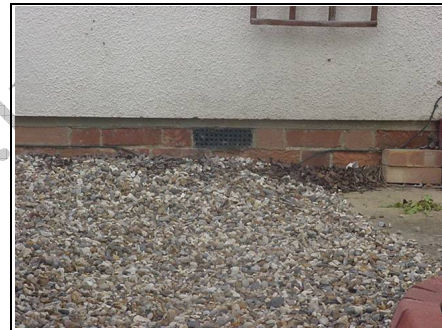
Air brick to front

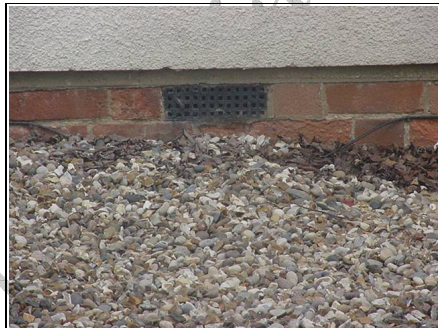
Close up of air brick

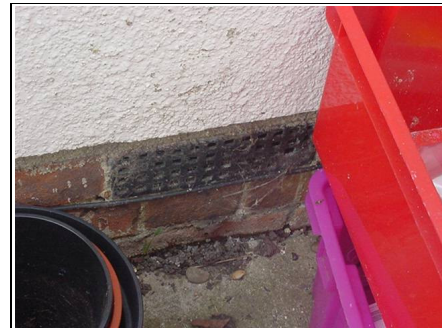
Air brick to side

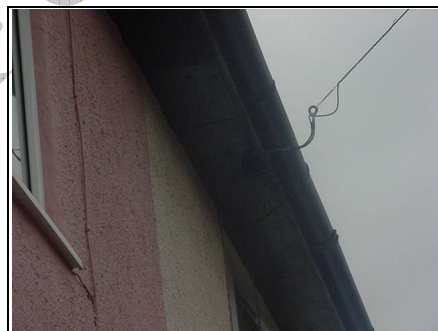
The fascias and soffits are timber or possibly asbestos. We would comment they look in average to slightly below average condition for their age, type and style.

Possible asbestos to soffit

ACTION REQUIRED: Please see our warnings with regard to asbestos and our comments in the Executive Summary. Please note we are not asbestos surveyors.

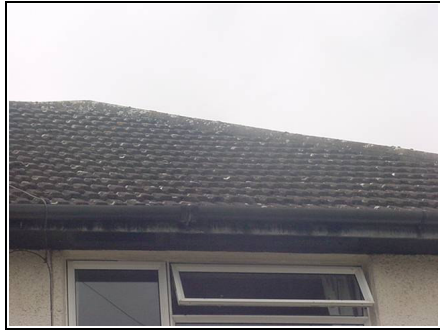
No trickle vent

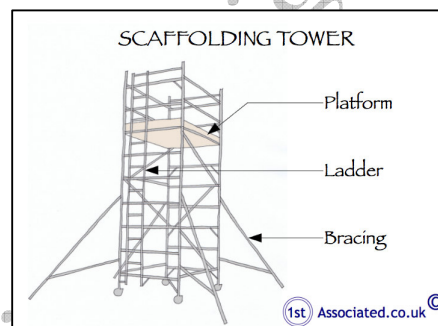
There is a lot of redecoration to this property that will be needed; we would recommend in the summer of 2013.

ANTICIPATED COST: A few thousand pounds, or a few weekends of hard work. Remember, some of the work will be high level so you may need a tower scaffold or similar. Please obtain quotations.

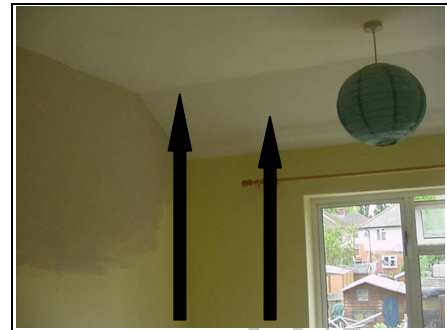
The rooms on the first floor have part of the room where the roof is, which means these areas are cold.

Cold areas on the first floor

ACTION REQUIRED: Please see our article on cold bridging in the Appendices in the Appendices.

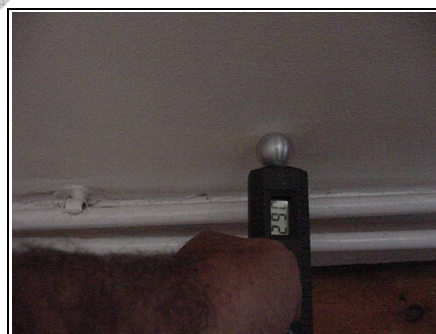
A visual inspection and tests with a moisture meter have been taken to the perimeter walls. In this particular case we have found slightly high readings just above the 60's; we typically expect readings up to a maximum of 60. This may be because of the high shingle we have mentioned to the front of the property, it may be because the property sits on a slight sloping site, or it may be because the floors are not being vented properly.

Testing for rising damp

ACTION REQUIRED: Please see our comments in the Executive Summary

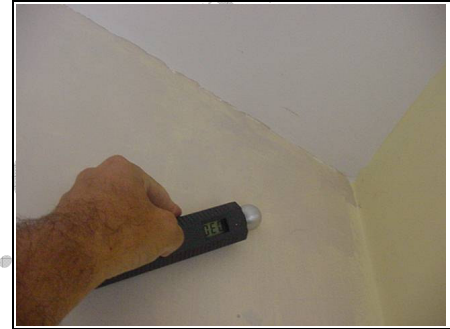
We used a damp meter on the external walls. We have found dampness in line with what we typically see for this age, type and style of property.

Testing for lateral dampness

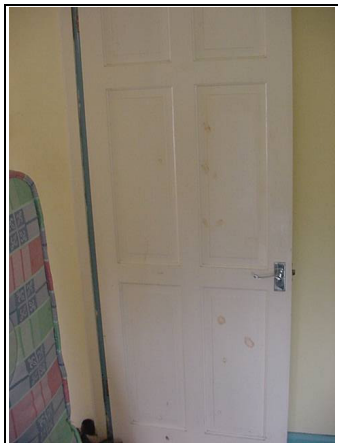
The doors are painted panel doors. We can see knots grinning through the paintwork.

Knots grinning through panel door

ACTION REQUIRED: Redecorate, although we were advised it had recently been redecorated. Unfortunately with knots grinning through it is often very hard to get rid of them if they were not treated properly originally.

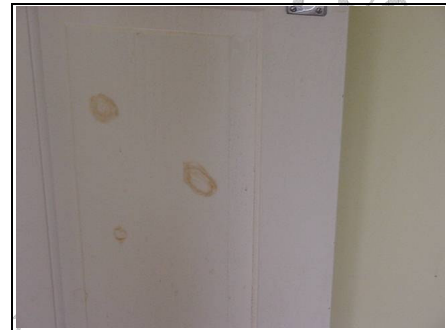
Close up of knots grinning through

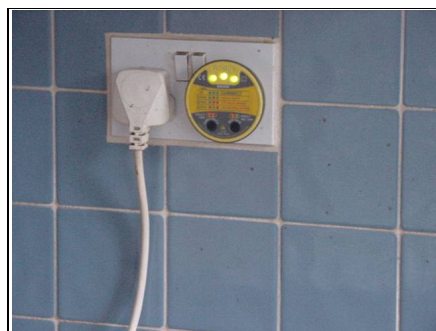
We carried out an earth test in the kitchen area to the socket point that is normally used for the kettle, this proved satisfactory.

Earth Test

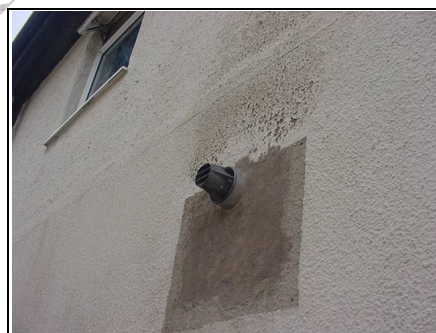
Flue from gas boiler

ACTION REQUIRED: As a matter of course it is recommended that the entire gas installation is inspected and made good, as necessary, by a Gas Safe registered contractor. Thereafter the installation should be serviced annually.

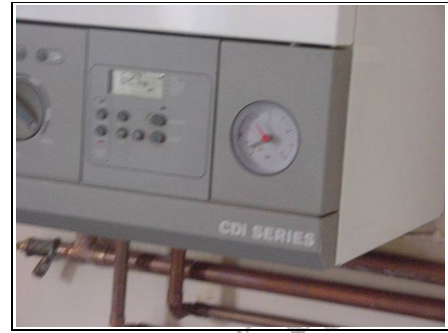
The wall mounted boiler was located in the kitchen on the right hand side. The manufacturers name was British Gas (we believe that companies do these under licence and noted it had a CBI series number on it). We do not see British Gas boilers very often.

Boiler

Our limited inspection of the hot water and central heating system revealed no evidence to suggest any serious defects but we would nevertheless recommend that the system be tested and overhauled before exchange of contracts and that a regular maintenance contract be placed with an approved heating engineer.

ACTION REQUIRED: We recommend overhauling the heating system.

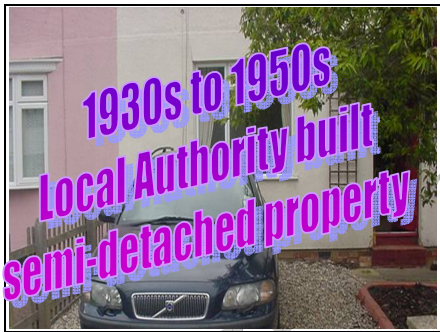
Off road parking

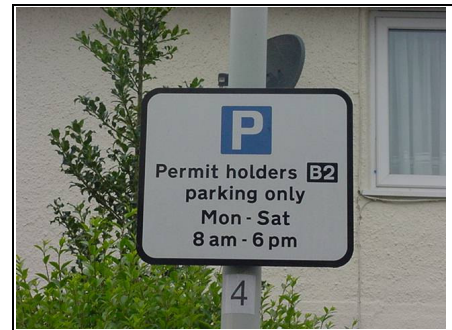
Permit parking hours which are apparently strictly enforced

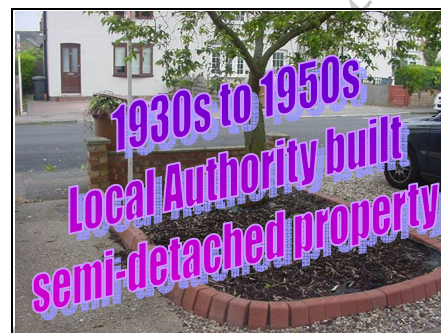
Front Garden

The front garden is a reasonable size garden with off road parking. It looks to have been newly improved.

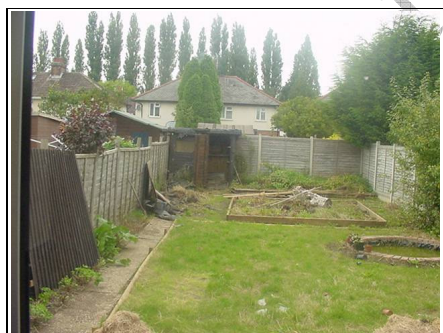
Rear Garden

This is a good sized garden, which looks to be only half finished. There is a shed at the rear of the garden which we were told was being taken away as fire wood and does not form part of the sale.

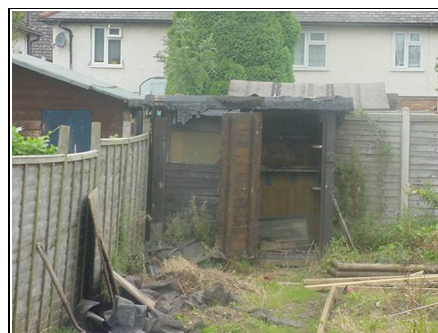
Shed at rear of garden
