# RESIDENTIAL BUILDING SURVEY

## Hertfordshire

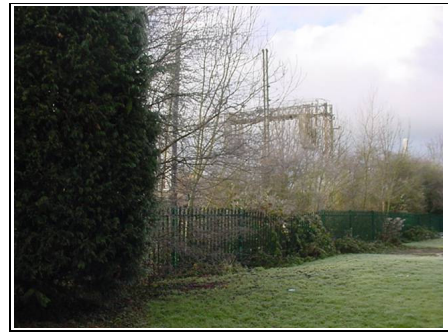
You may or may not be aware that there is a railway line to the rear of the property with quite a regular train service.

Railway line behind property

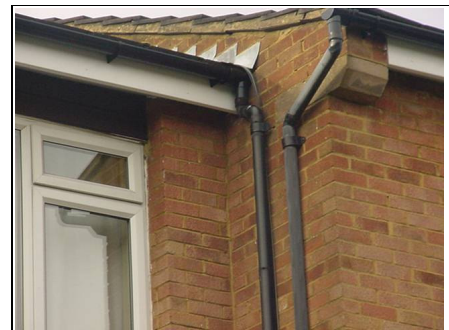
As this is a sloping site, we noted a step in the roof.

Step in roof

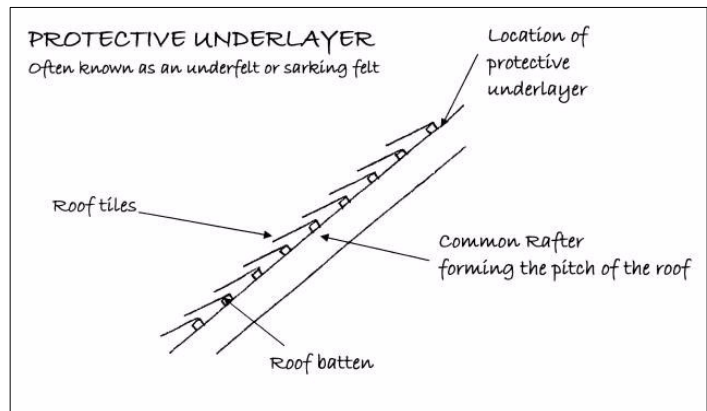
When we inspected the loft space we found a Hessian base Bitumen membrane. This type of membrane has been used since the 1960s. We generally found it to be in slightly below average condition, it's damaged in a few more places than we would expect. Interestingly where we could see the tile we noted dampness staining on it normally caused by wind driven rain, an accelerated wind affect can occur.

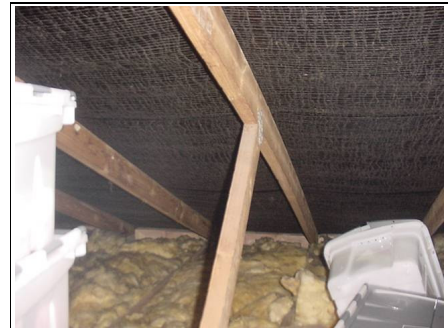
This photo shows the common rafters (the ones that form the pitch of the roof) and the dark area between is the underlayer.

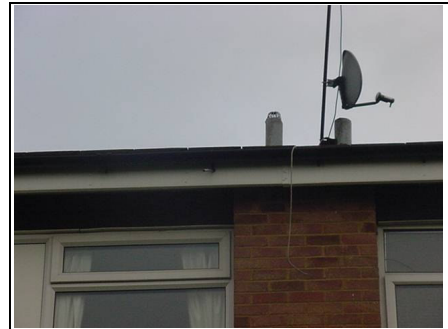
Flue

There is a plastic flue from the bathroom. There also should be a second flue from the boiler.

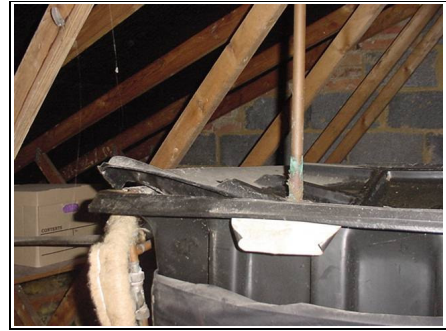
We found the roof timbers generally in average condition considering their age although there are signs of condensation. We have inspected the roof structure for:

Our examination was limited by the general configuration of the roof, the insulation and stored items. As mentioned what we could see was generally found to be in generally average condition, with some minor condensation and damp considering its age. It is feasible that there are problems in the roof that are hidden.

**ACTION REQUIRED:** Ideally add ventilation. There are a lot of stored items in the roof, the only way to be 100 per cent certain of its condition is to have the roof cleared and checked.

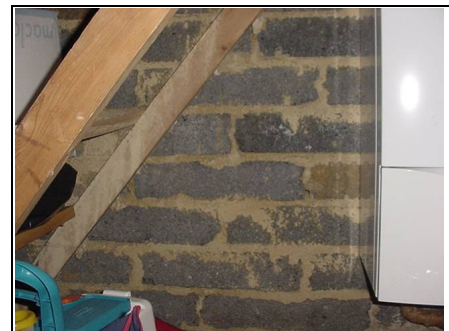
Block fire wall

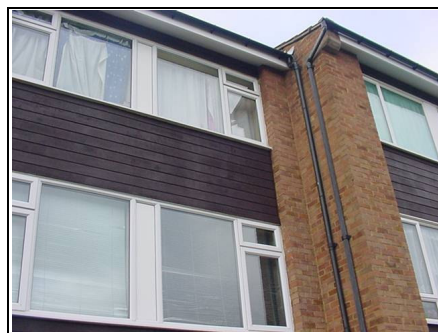
From ground level the property has plastic gutters and downpipes. These are the older style which are affected by sunlight and fade somewhat, they ultimately become brittle.

**ACTION REQUIRED:** We would always recommend that the gutters and downpipes are cleaned out, the joints are checked and the alignment checked to ensure that the gutters fall towards the downpipes. On a multi-occupied block such as this sometimes there are planned maintenance contracts in place to have them cleaned on a regular basis.

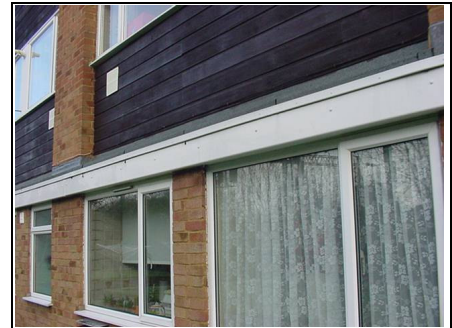
There is timber cladding to the front and rear of the property. This is likely to be a timber frame structure with some insulation and then plasterboard internally, possibly a block wall, however most cross wall constructions don't have a block wall. There is very poor thermal efficiency with regard to the walls

Cladding

**ACTION REQUIRED:** You can improve the efficiency by adding insulation.

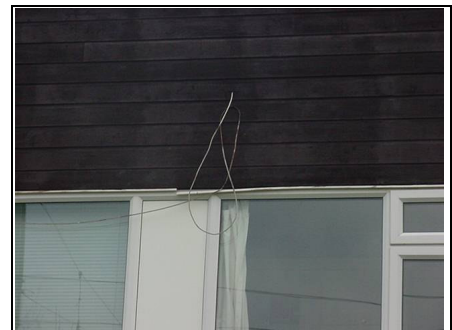
Close up of cladding

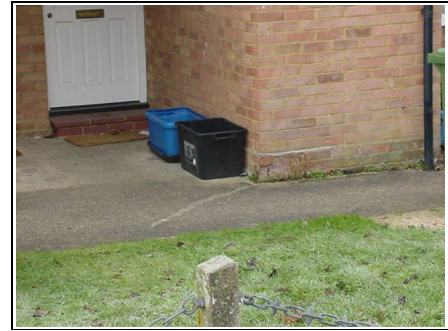
All modern properties should incorporate a damp proof course (DPC) and good building practice dictates that a differential of 150mm (6 inches) should be maintained between the damp proof course and ground levels. In this case we were able to see a thickening of the mortar indicating that a damp proof course is present as we would expect in this age of property.

Damp proof course

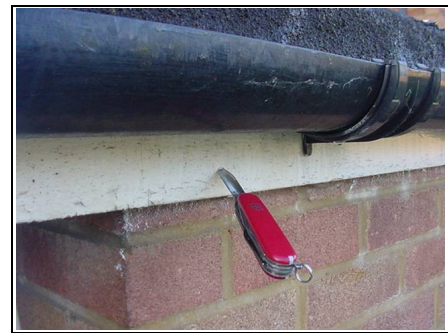
The property has painted timber fascias and soffits and these are in average condition, (which means there is likely to be some rot) although much of the fascia is hidden by the guttering.

Checking fascia at low level

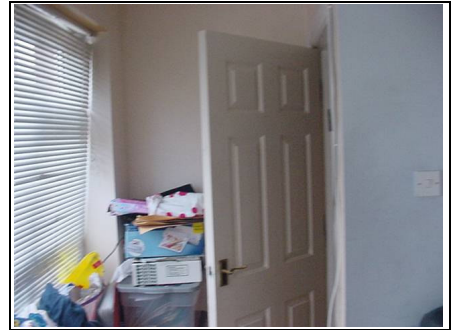
The property has hollow core doors. These are standard modern pressed hardboard doors and cannot be classed as a fire door.

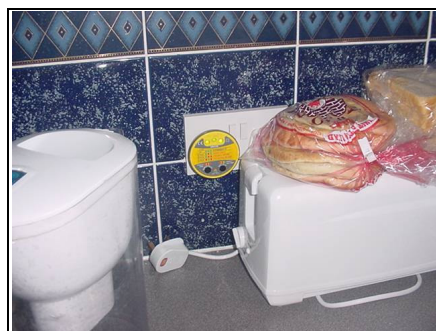
We carried out an earth test in the kitchen area to the socket point that is normally used for the kettle and this proved satisfactory.

Earth test

**ACTION REQUIRED:** As the property is changing occupancy an IEE report should be carried out by a NICEIC registered and approved electrical contractor.

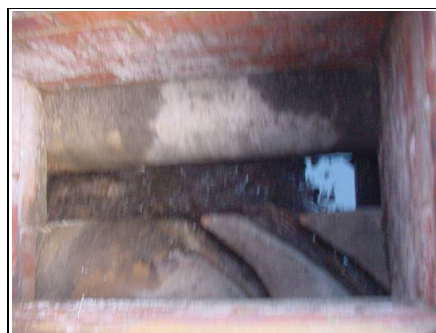
Manhole one

We duly lifted the man hole/ inspection chamber cover and found the drain to be clear, we noted it was finished in brick.

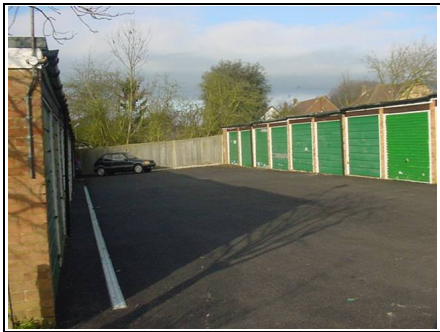
One of the best garage/parking spaces we have seen for a long time on this type of property. There was a lockable bollard to the entrance which is a great idea and a newly tarmaced area by the garages. The felt flat roofs were in reasonable condition.

Block of garages

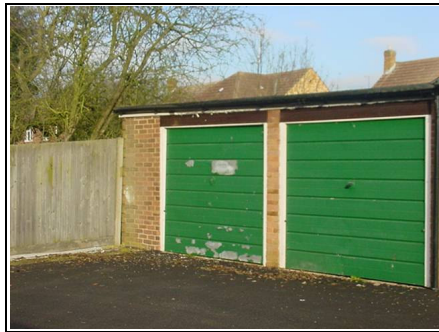
Yours is the end garage within the block
