# **RESIDENTIAL BUILDING SURVEY**

**Bury St Edmunds, Suffolk. IP33**

**FOR**

**Mr M**

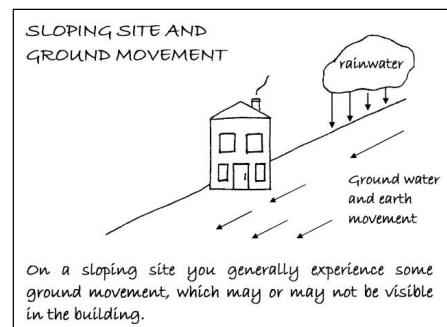
To the rear of the property we believe that whenever it rains it discharges to the rear of the property which can cause dampness.

**ANTICIPATED COST:** A few hundred pounds or it may be a DIY job; quotations required. You appreciate the sketch does over emphasize the slope!

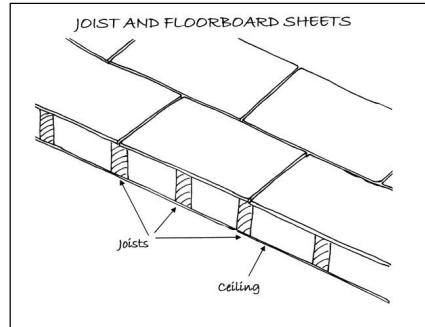
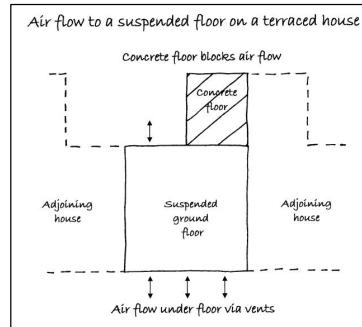
## **5) Dampness problems with the floor/walls**

There is some dampness in the property as we would expect in this age of property. We believe this has affected the joists in the first floor bedrooms, if you recall we showed you they both had above average deflection. We believe that the ground floor will be affected in the same way plus there is no through ventilation anymore as the rear floor is concrete.

**ACTION REQUIRED:** We would recommend that the floor is opened up to check its condition - both the ground floor to the front of the property and the first floor looking for woodworm etc.

**ANTICIPATED COST:** You may require vent to be added at ground floor level to allow through flow of air within the front room against the skirting and at first floor level you may require timbers adding such as herringbone strutting to make the floor more rigid; quotations required.

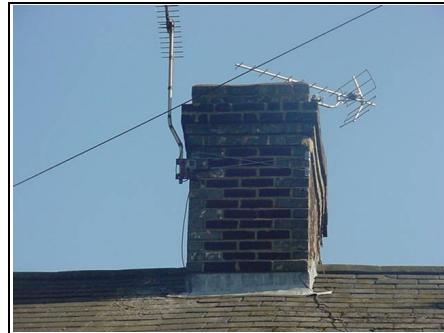
Left hand chimney

This chimney is brick finished with no chimney pots with lead flashings. From what we could see the chimney looks in average condition. Unfortunately we were unable to see the top of the chimney known as the flaunchings we therefore cannot comment upon them.

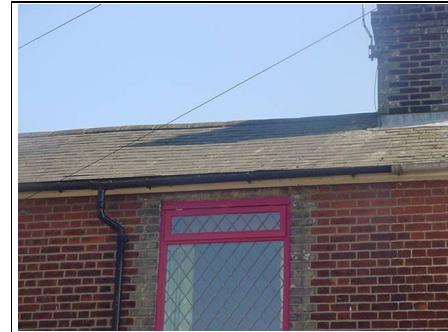
Main roof

The roof is pitched and clad with quarried slate. The slates sit fairly true and are generally in average condition considering the property's age, type and style. We can see no lead tingles which is an indication that the old fixings are rusting and that the roof is starting to deteriorate. Given the hessian in the roof it was probably re-roofed in the 1960s.

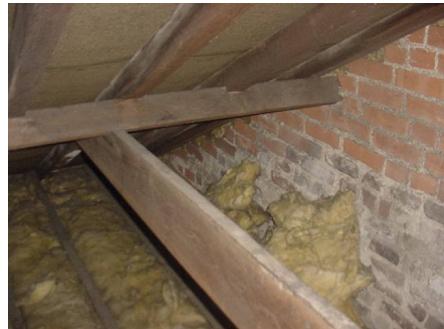
When we inspected the loft space we found a Hessian base Bitumen membrane. This type of membrane has been used since the 1960s. We generally found it to be in average condition, its damaged in a few more places than we normally find.

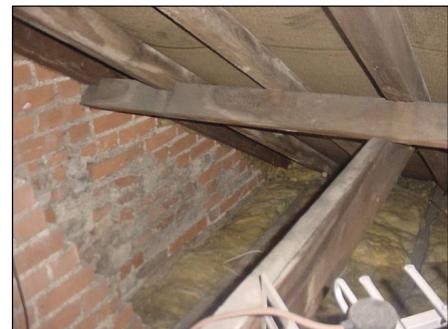
General view of roof structure

In the photo you can see some darker areas in the timbers this is where condensation staining is occurring it could equally be minor leaks coming in from wind driven rain through the roof. Please see our comments in the Executive Summary

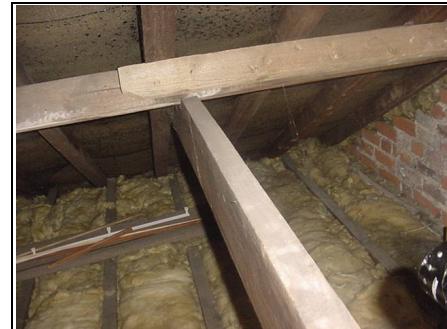
Roof timbers

We found the roof timbers generally in average condition considering their age with some staining due to condensation and possibly wind driven rain. We have inspected the roof structure for:

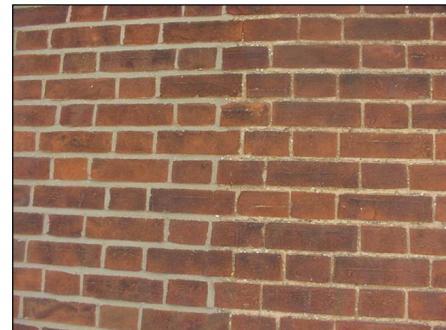
Brickwork

The property is brick built in a red brick originally in a lime mortar in that it is known as Flemish bond brickwork, which has been repointed in a cement mortar.

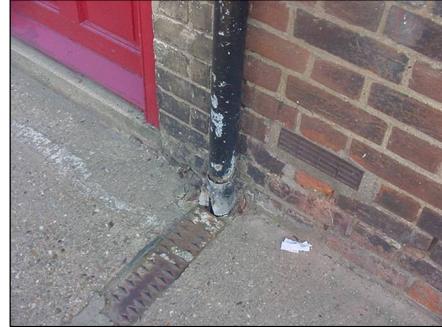
Airbrick at front of property

Air bricks are visible to the property. The air bricks allow an air flow through the wall (assuming they are kept clear), we can only assume that there have been problems with condensation in the property which is why the airbricks have been added.

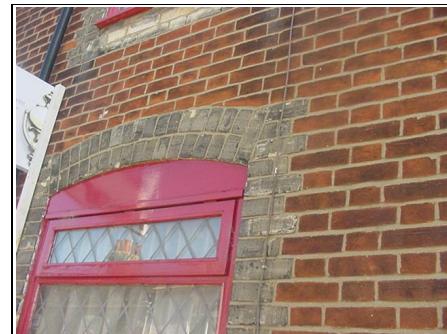
Double glazed window

The property timber double glazed windows with without draft seals and trickle vents. However the windows are also positioned very forward and almost flush with the property which we would not recommend.

Generally we consider the windows saveable, far better are now available.

We would draw your attention to the fact that sealed double glazed units can fail (particularly these early thin double glazing units) as a result of poor workmanship during installation. Failure of the seal leads to condensation between the two panes of glass and simply replacing the affected units may not provide a satisfactory long-term solution. In this case they are in average condition.

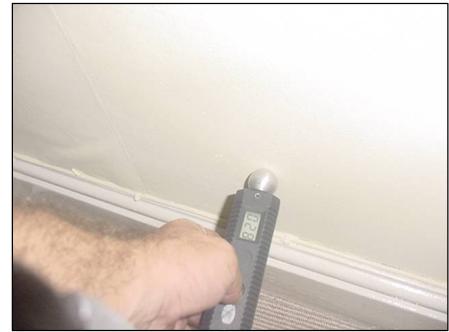
Testing for dampness

We carried out tests with an electronic damp meter and found average dampness considering the condition of the property.

**ACTION REQUIRED:** We recommend that you carry out the other items recommended earlier such as add ad hoc repointing and venting of the floor and this will help to reduce the dampness and then review together with living in the property.

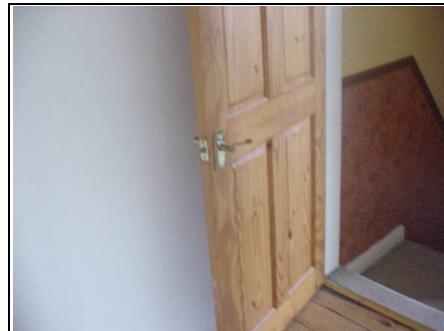
Internal door

The property has stripped wood panel doors. They are generally in reasonable condition, although they don't fit perfectly.

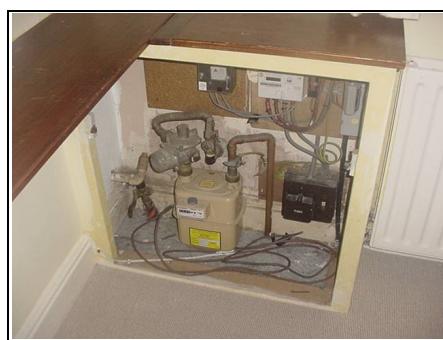
Electrics

The electric fuses and consumer units were located under the Lounge. We would date the fuse board as being from the 1970s and, whilst not the best now available, it is reasonable.

**ACTION REQUIRED:** NICEIC approved contractor to carry out an IEE

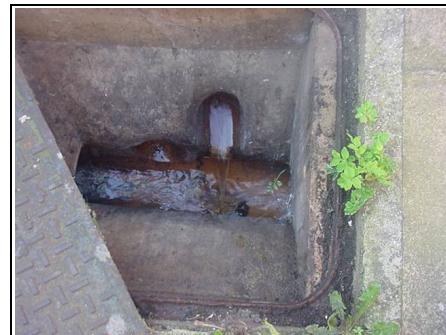
Rear drain

We duly lift the man hole/ inspection chamber cover and found the drain to be free flowing, from what we could see it was finished in concrete is a relatively shallow.

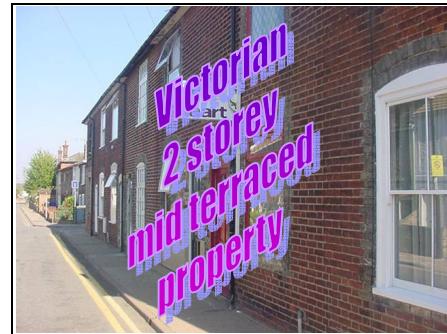
Parking is further up the road on a first come first served permit basis, however there does not look to be enough. There is no parking (double yellow lines) directly outside the house which can be good or can be bad.
