JOB REFERENCE: xxxxxxxxxxxxxx

RESIDENTIAL BUILDING SURVEY

Camden,
NW3

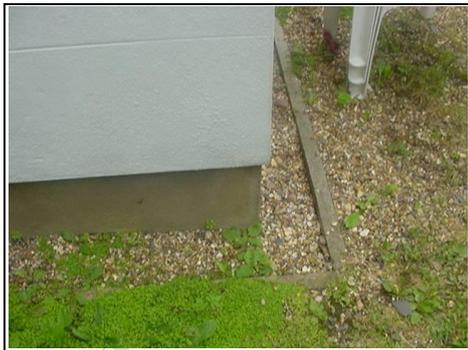
We can see what we believe to be a French Drain has been added to the side of the property and partly to the rear. We do not know when this was added (as the occupier could speak little English) or if it is a true French Drain.

Is this a proper French Drain?

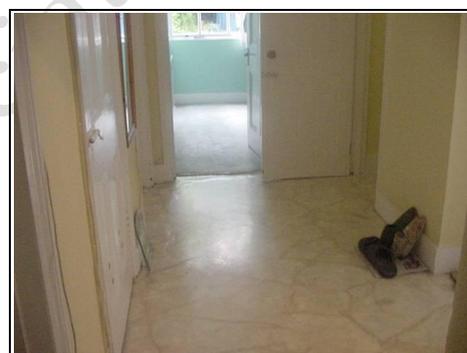
The timber floor has been partly replaced with concrete over the years. Unfortunately this usually means that there is no through flow of air under the floor.

The hallway has a concrete floor

ACTION REQUIRED: You need to open up the entirety of the suspended timber floor areas and check for wet rot, dry etc. ideally this should be carried out before you purchase the property.

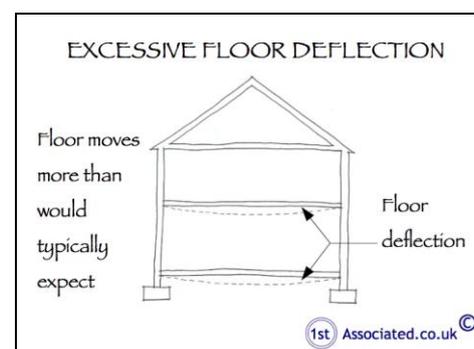
We can feel deflection in the floor that indicates deterioration has taken place and we could see that, when we lifted the carpet to the rear master bedroom, there is a problem with rotting floors beneath.

Deterioration in the floor

ANTICIPATED COST: Best case scenario is a few hundred pounds and the worst case scenario could be a major replacement of the floor which could range from £5,000 to £15,000 (five thousand to fifteen thousand pounds). This is dependent on how easy or difficult it is to replace the joists particularly bearing in mind the concrete floor; please obtain quotations.

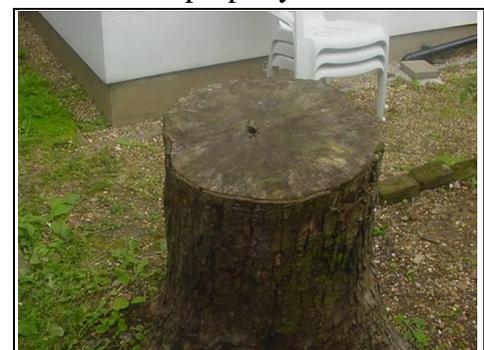
We believe the tree has had quite an effect on the property as we could see hairline cracking to the walls (this is partly due to age of the plaster) and we could also see movement to the doors and windows where they are out of square.

Tree stump

ACTION REQUIRED: We feel the best way to deal with this is for the landlord to put in an insurance claim with regard to movement on the property. This would then allow for monitoring for a year, which is what is recommended by the Building Research Establishment, rather than a one off inspection that you have had today.

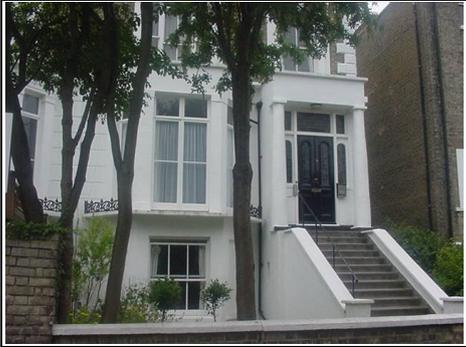
Whilst we are on the subject of trees we would just comment that the trees to the front of the property have caused cracking to the boundary wall. This will be a shared item and a shared cost to repair.

Trees to the front of the property

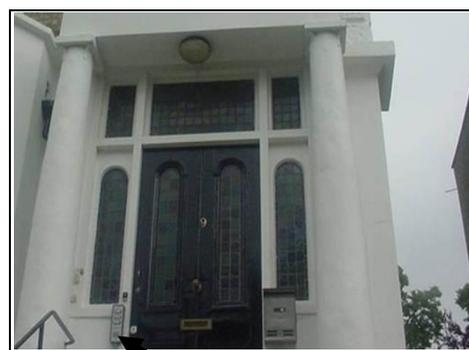
Whilst there is a voice entry system at the main door of the property we much prefer a video entry system for everyone. This can be combined with the fire alarm system.

Voice entry system

ACTION REQUIRED: Again this would be something a good property management company would be promoting.

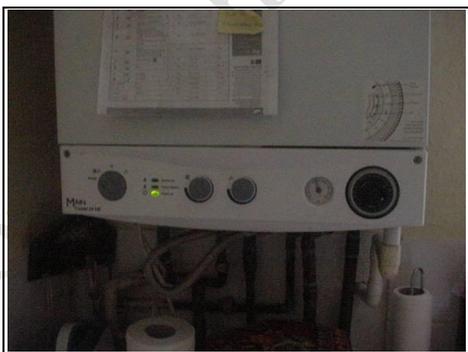
The boiler is a wall mounted dated Main boiler. We do not come across these that often. There are also some radiators on internal walls which is a system often used to save costs by plumbers which can in turn promote condensation, particularly in a rented property.

Main boiler

ACTION REQUIRED: Whether the boiler lasts much longer really depends on how frequently it has been serviced and so you do really need to obtain this information from the present owner.

ANTICIPATED COST: We would recommend basing costs on a worst case scenario and allow a sum of £2,000 - £3,000 (two thousand to three thousand pounds) to replace the boiler and £5,000 - £6,000 (five thousand to six thousand pounds) to replace the radiators and move them to under the windows; please obtain quotations.

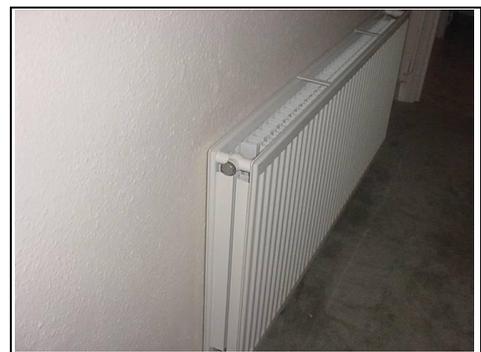
Radiator on internal wall

Radiators are more effective fitted under the windows rather than on internal walls as this promotes air flow around the property.

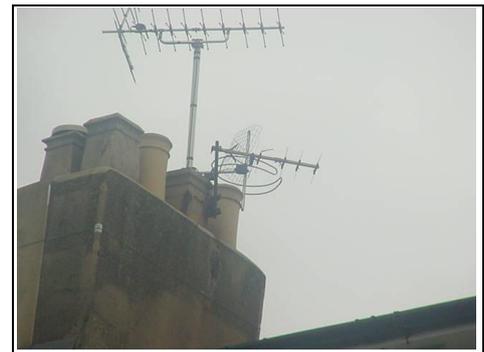
Chimney one (left centre)

This chimney is rendered and has a few chimney pots; we were unable to see the flashings. It was very difficult to see the chimney, however, the darkening of the render does indicate to us that dampness is getting in to it. We would best be able to see this problem if we gained access to the roof.

Unfortunately we were unable to see the flaunching, we therefore cannot comment upon them.

ACTION REQUIRED: Your landlord / managing agent should have a schedule with regard to problems and planned maintenance with regard to the chimneys.

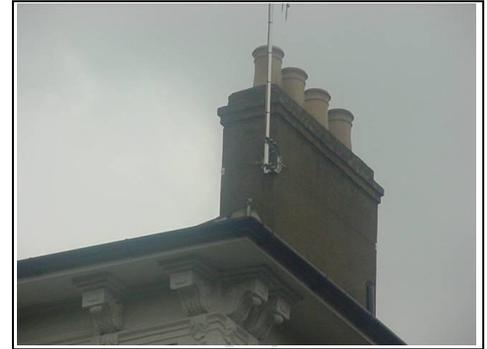
Chimney two (front right)

This chimney was also finished in render which looks to be slightly darker than we would expect indicating that it is taking in water. There are no obvious visual signs of the render coming away. Unfortunately again we could not see the flashings.

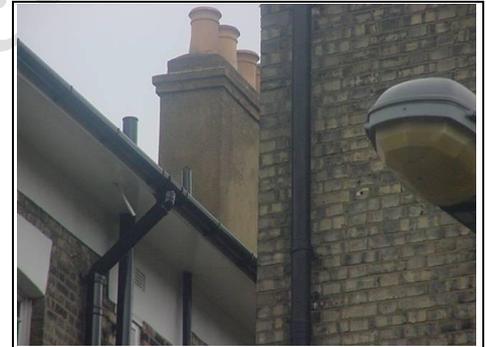
Chimney three- (rear right)

This is the chimney that we could see least of. However we could again see a darkening of the render indicating that dampness may be getting in.

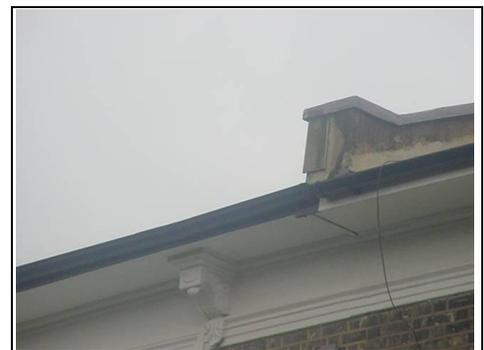
Parapet wall (left)

In this case there are rendered parapet walls to the left hand side with a coping stone. Again we would have been able to see if this was waterproof from within the roof which we have not been able to get into.

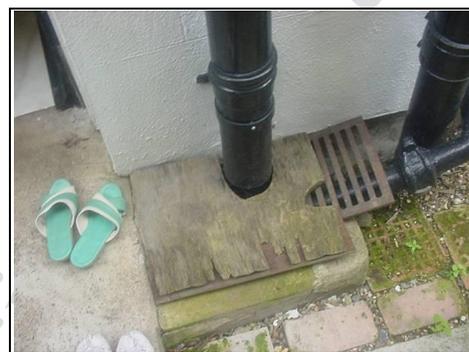
Cast iron and plastic downpipes

These are in average condition for their age, type and style cast iron of this age will need maintenance. If regularly maintained it can last longer than plastic, in our experience.

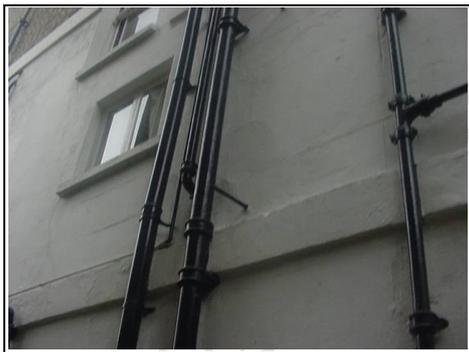
Soil and vent pipes

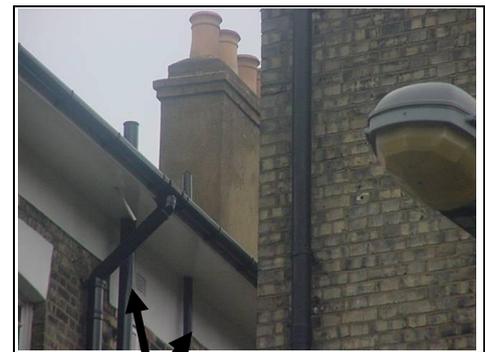
Soil and vent pipes

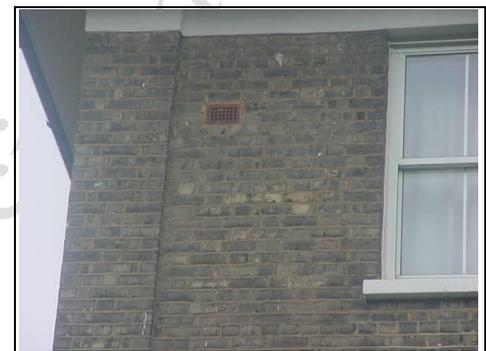
Brick work to upper property

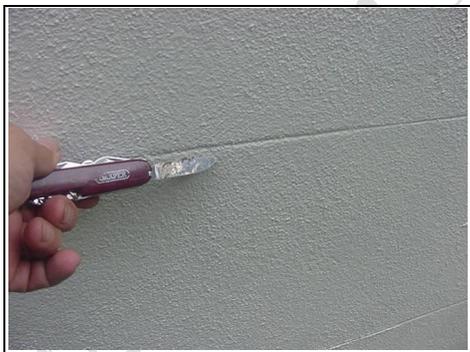
In other areas it is hand painted

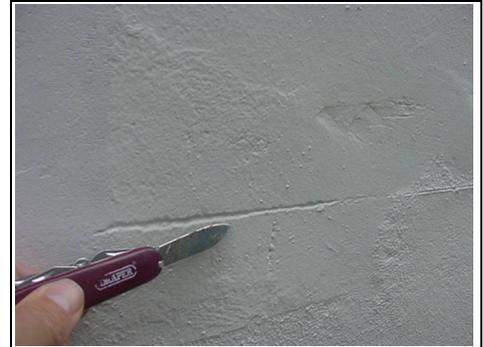
Stucco render with what appears to be a spray paint finish.

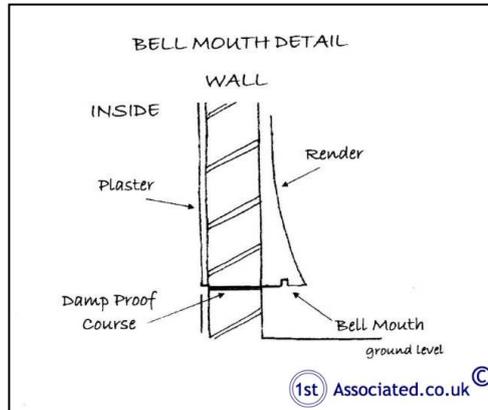
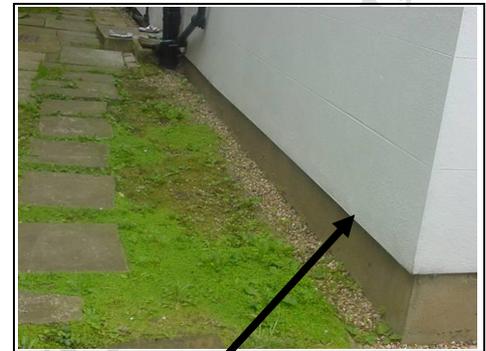
We were pleased to see a form of bell mouth detail to the base of the render.

Bell mouth detail

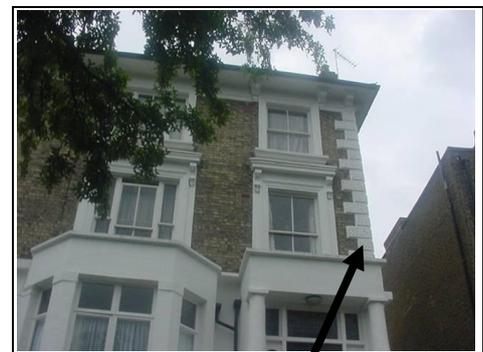
There is decorative rendering around the windows and to the quoins which add to the overall character of this property.

Quoins

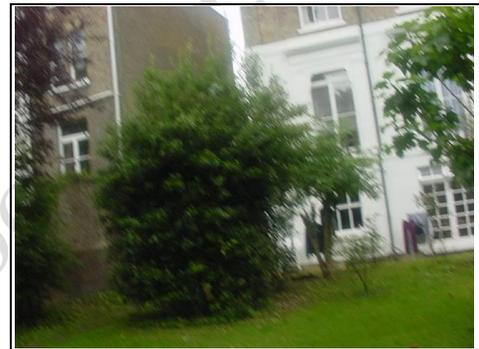
There are trees within what Insurance Companies would term as influencing distance of the property. We have spoken in the Executive Summary about the closeness of the tree to the right hand corner of the property but there are also additional trees still relatively close to the house. To the front of the property close to the boundary wall there are trees which have caused it to crack.

The trees to the rear of the property

ACTION REQUIRED: You need to obtain advice from your insurance company with regard to any premium that may occur and please see our comments within the Executive Summary about monitoring the property

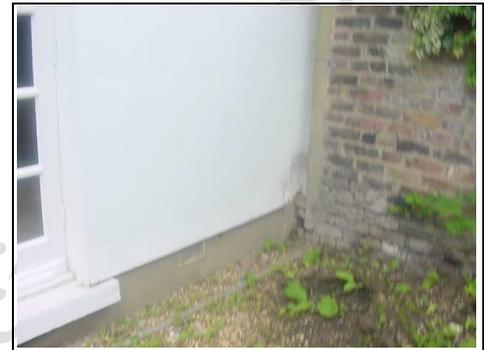
All modern properties should incorporate a damp proof course (DPC) and good building practice dictates that a differential of 150mm (6 inches) should be maintained between the damp proof course and ground levels. In this case, we cannot see a DPC because of the render. Your attention is drawn to the section of the report specifically dealing with dampness.

DPC not visible because of the render

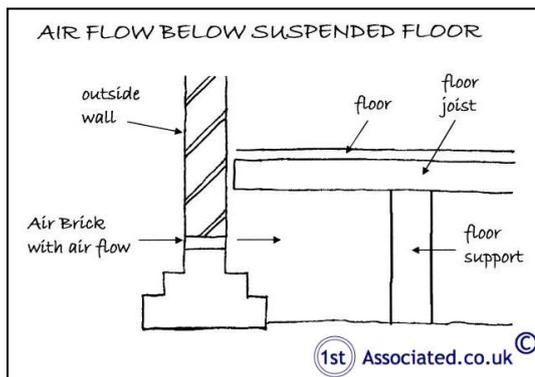
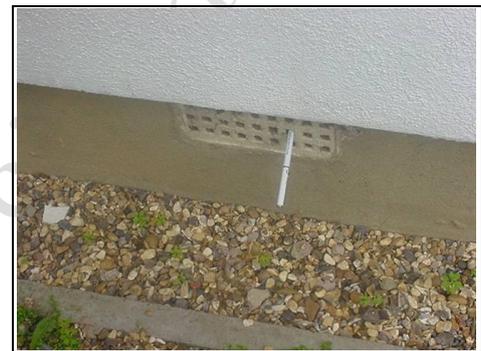
There are air bricks at low level. Air bricks are essential to have a through flow of air as this helps to reduce the chances of wet rot, dry rot and woodworm.

Air brick

ACTION REQUIRED: Please see our comments within the Executive Summary.

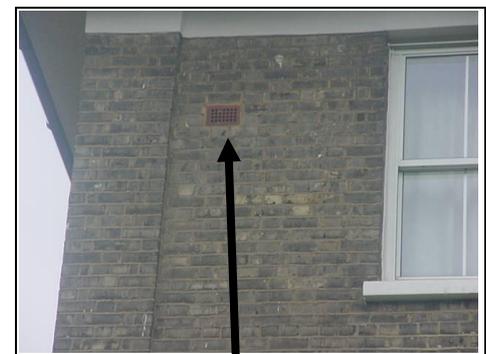
There are vents at high level on some of the flats. This does indicate that there may be condensation problems in these areas. This is a typical solution to that.

Airbrick at high level on upper flat

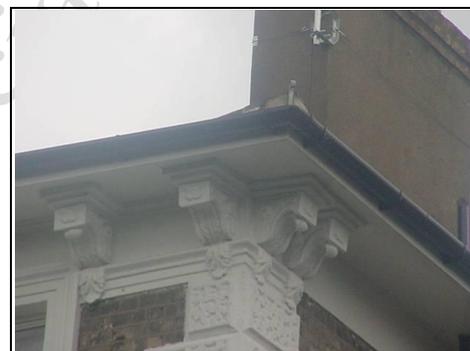
Fascias and soffits with corbels

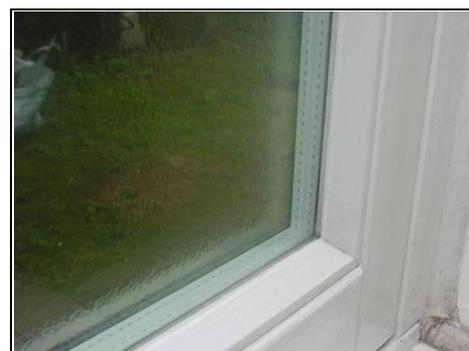
Double glazing in the new windows

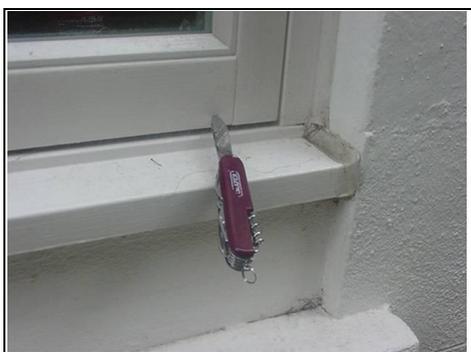
Knife test on fairly new windows

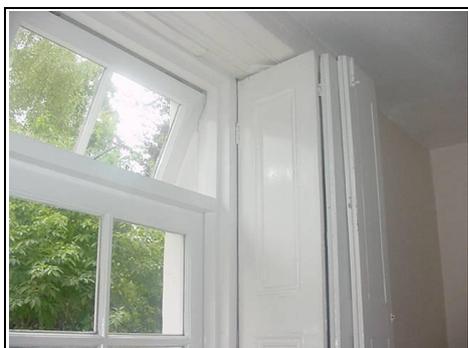
Shutters/blinds on the French Doors

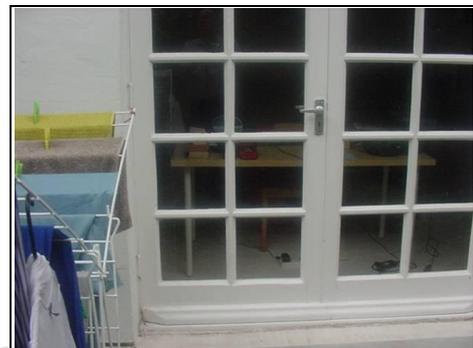
French doors (newish)

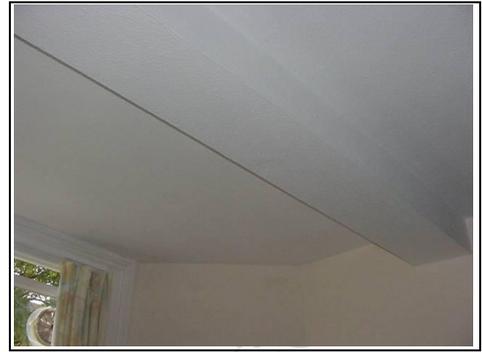
Wall has been removed

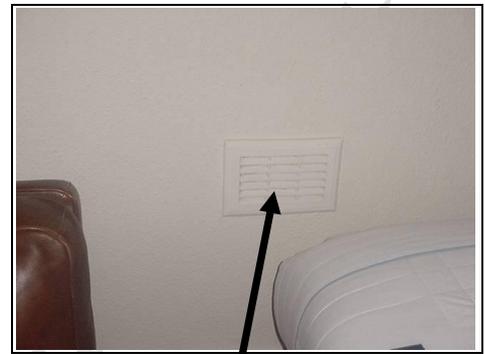
The chimney breasts are located to the left hand side (all directions given as you face the front of the property). We were pleased to see vents in the chimneys. Of course we cannot see the chimneys as they progress up through the property and do not know if they are vented throughout. These chimneys tend to get damp at high level and it can be affected by what people above and to the side of you do.

Vents to the chimneys

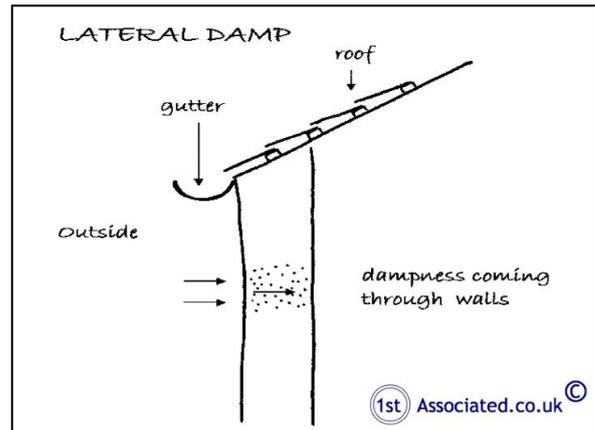
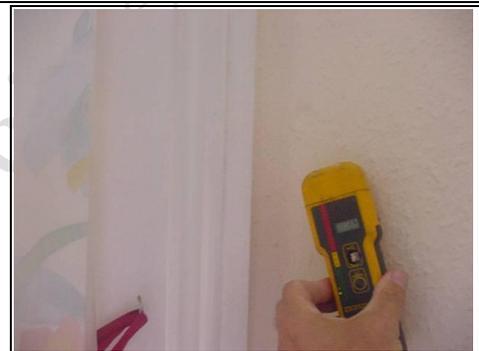
We used a damp meter on the external walls. We have not found dampness.

Testing for lateral dampness

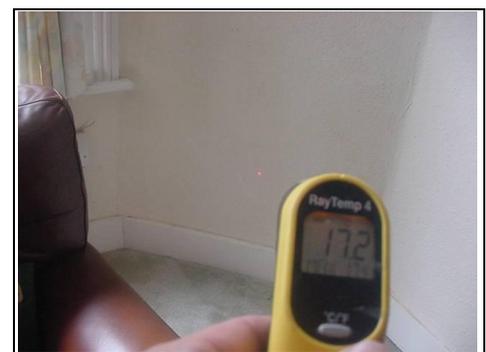
At the time of the inspection there were no obvious signs of condensation.

Checking for condensation

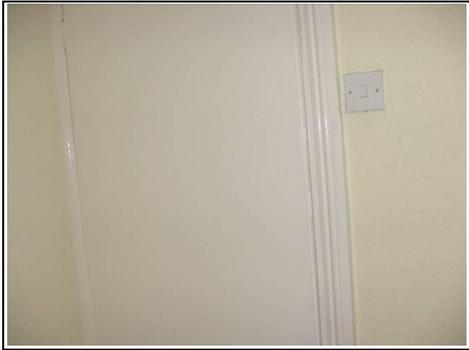
Timber door

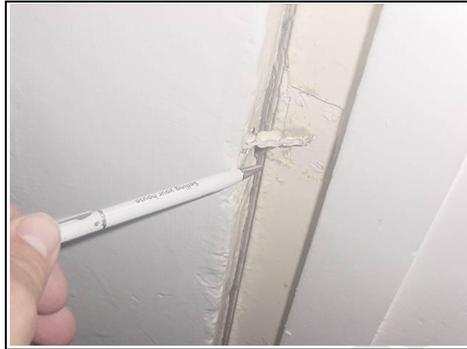
The property has substantial timber doors. We note some have Perko door closers and some have had them removed.

Perko door closer

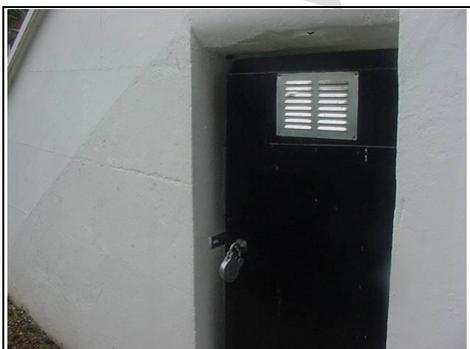
We found rubbish in the space and a few stored items. The gas meters are also located here and there is a rendered wall that has not been finished.

Under the stairs

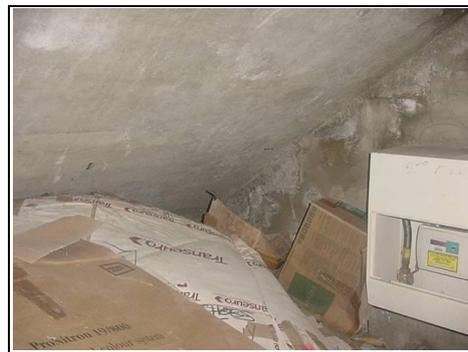
Dampness under the stairs

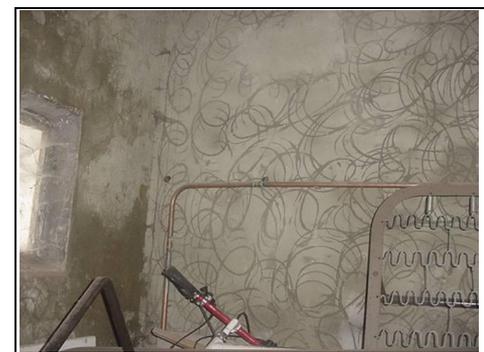
Scratch coat put on but not finished

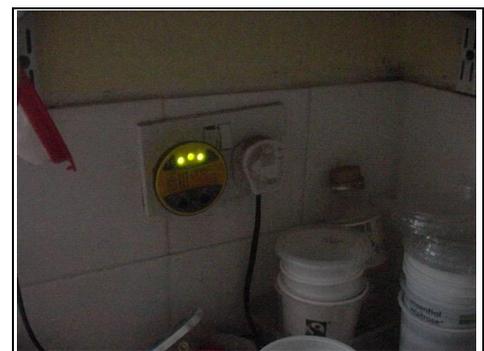
Earth Test

We carried out an earth test in the kitchen area to the socket point that is normally used for the kettle, this proved satisfactory.

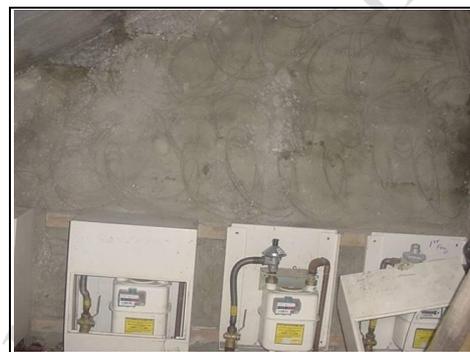
Gas meters

We are advised that the property has mains gas. The consumer unit is located under the stairs.

ACTION REQUIRED: As a matter of course it is recommended that the entire gas installation is inspected and made good, as necessary, by a Gas Safe registered contractor. Thereafter the installation should be serviced annually.

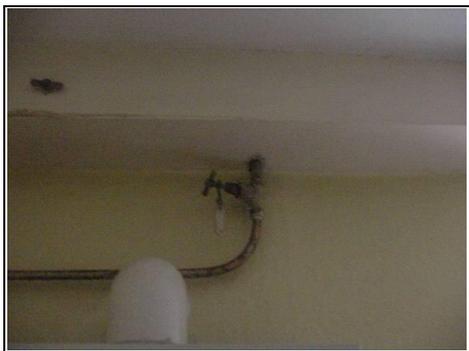
We noted two stopcocks, one in the kitchen and one in the W.C. but we did not test either of them.

Stopcock in the kitchen at high level

ACTION REQUIRED: Ask the owners to show you where they are (the owner's daughter did not want us to turn them off and on). However bear in mind her English is very limited.

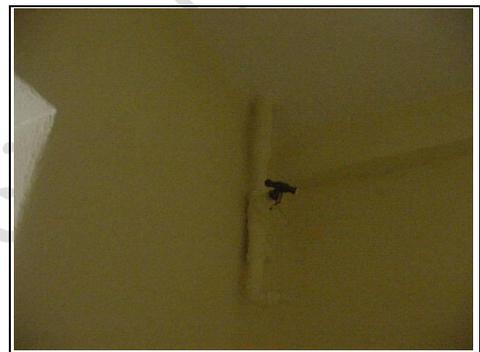
Stop cock in the W.C.

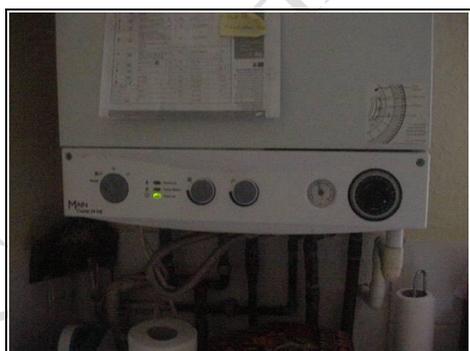
Boiler

The boiler was located in the kitchen, it is manufactured by Main and the model type is a Combi 24HE.

Our limited inspection of the hot water and central heating system revealed no evidence to suggest any serious defects but we would nevertheless recommend that the system be tested and overhauled before exchange of

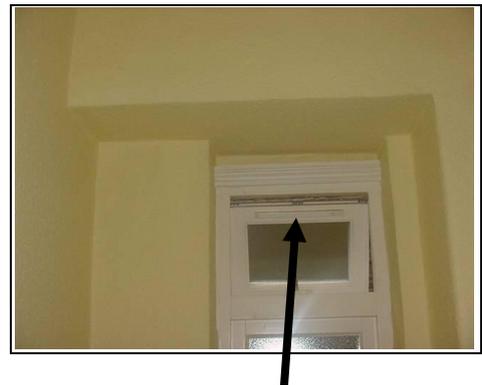
We would comment that the separate W.C. does not have the benefit of a wash hand basin. There is also no extract fan and we recommend this is added. There is a trickle vent in the window.

Trickle vent in window

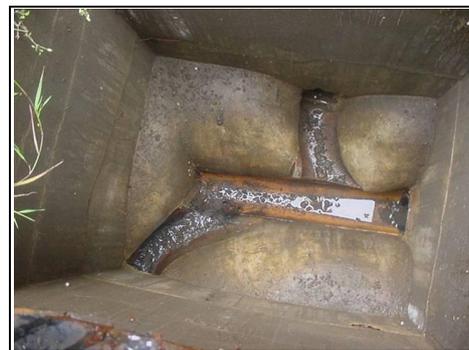
Manhole

We duly lifted the cover and found it to be free flowing at the time of our inspection.

From what we could see it is built from concrete rings. This means it is a replacement manhole.

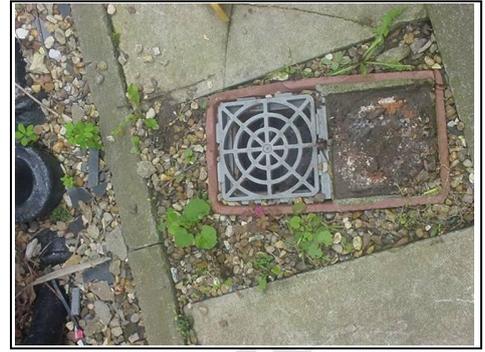
Manhole two

We could not lift the cover of this manhole.

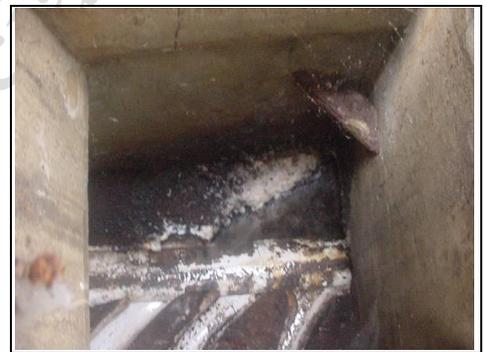
We duly lifted the cover and found it to be free flowing at the time of our inspection. This has a ceramic pipe that would have been reserved for the better drainage systems.

From what we could see it is brick built.

Manhole with ceramic pipe visible, which is the best sort of pipe.

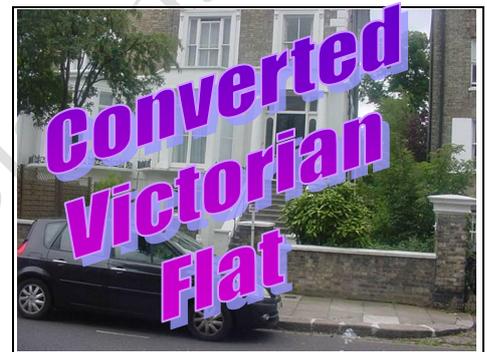
Parking is at the roadside on a first come first serve basis. There is a parking permits system in operation. We often find that with these areas that were designed before the car was used en mass that there can be difficulties parking outside or even near your property.

Parking at roadside

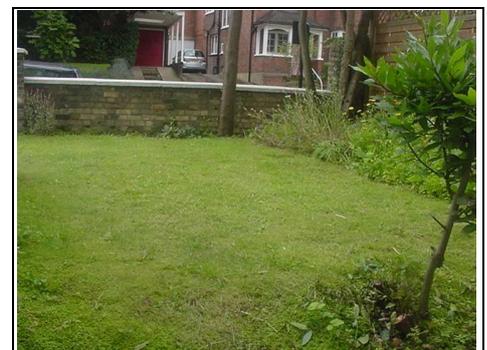
Front garden

The property has a front garden with a grassed area and trees. The garden drops away and lowers as it heads towards your flats. There is also a bin storage area to the right hand side (all directions given as you face the property). Please also note the problem with cracking to the boundary wall. Our concern is that where the wall is on a public footpath that there may be a liability.

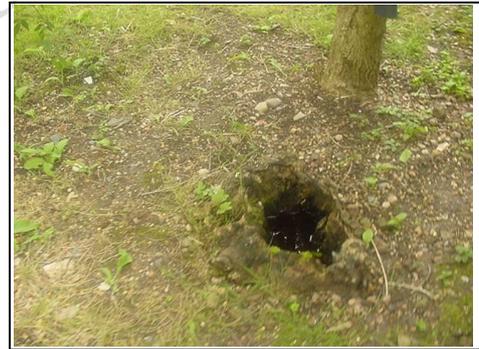
The rear garden is mainly grassed with some trees and a garden shed. This garden is in theory shared. Our main issues are the tree that we have commented on and the overall water logged nature of the garden.

Garden is very damp

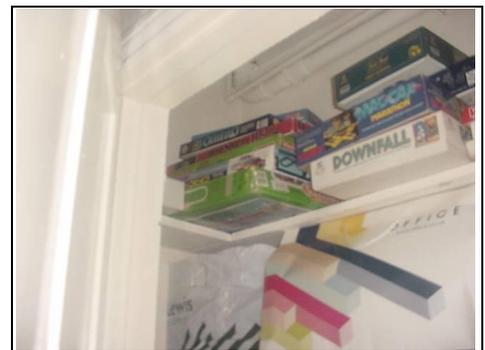
Unfortunately in this instance our inspection has been very limited as we did not have access to the roof or to the upper flats. We were also not able to open up the ground floor.

Stored items in cupboards
