# **RESIDENTIAL BUILDING SURVEY**

**Clophill, Bedfordshire, MK45**

**FOR  
Mr C**

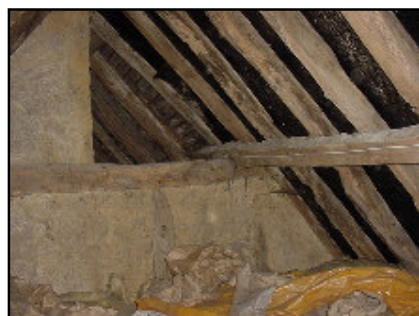
The clay roof to the front of the property undulates, as one would expect in a property of this age. When we were inspecting the roof structure we noted that one of the common rafters (these are the rafters that form the pitch of the roof) has moved. We suggest that this is repositioned. Do not get overly concerned about this, from our inspection we note that this type of work has previously been carried out.

General view of the roof

**ACTION REQUIRED:** A competent carpenter should be able to resolve this problem and check the other timbers. Approximately one day's work. Our main concern would be that the carpenter, if he is not careful, will cause more damage than good – the roof is fairly delicate.

**ANTICIPATED COST:** £250.

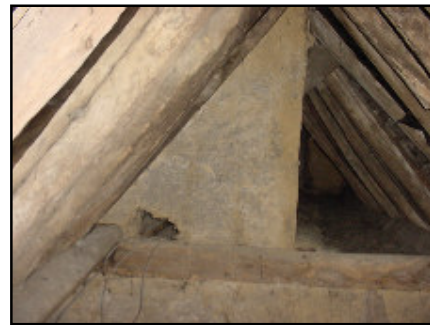
Some of the original wattle and daub on the left hand side and as you can see a completely different roof structure.

In both roofs there was approximately 100mm of insulation.

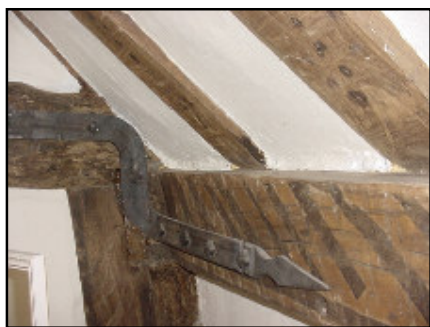
A nice example of a metal fixing within the property. How much good some of these fixings do to the structure overall is a whole topic on its own.

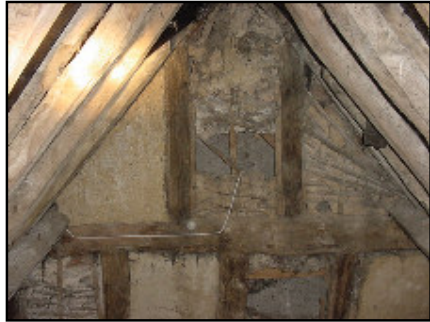
An example of the wattle and daub seen within the roof.

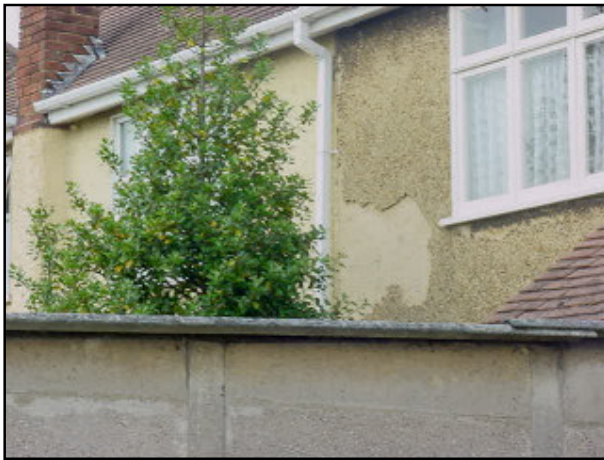
### **DON'T PANIC!**

**This is not your property, just an example of what can happen with rendered properties.**

To the right hand side of the bush you can see the render deteriorating. This can start to occur where hairline cracks are found within the render.

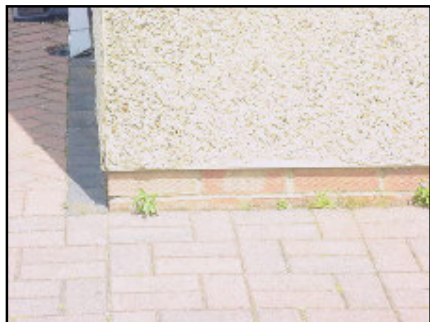
An example of render with correct bell-mouth detailing to the base.

What would improve the property greatly is to form a bell-mouth at the base of the property.

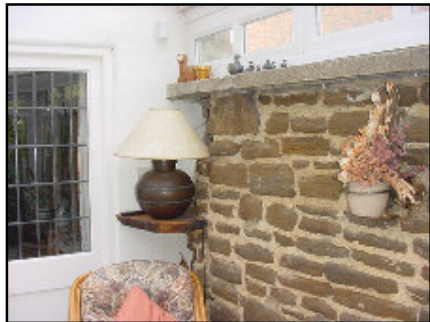
The sandstone has been used to make a feature within the conservatory.

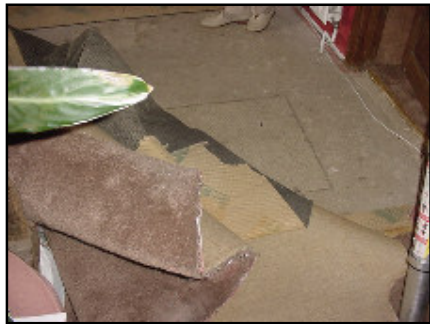
This would originally have been an earth floor which has had tiles added at a later date. It has now been replaced with a concrete floor throughout.

To the front of this we did get damp meter readings, as you would expect, which is capillary attraction from the dampness within the walls.

A photo of the concrete floor and the present owners feet!
