RESIDENTIAL BUILDING SURVEY

Norfolk

INTRODUCTION

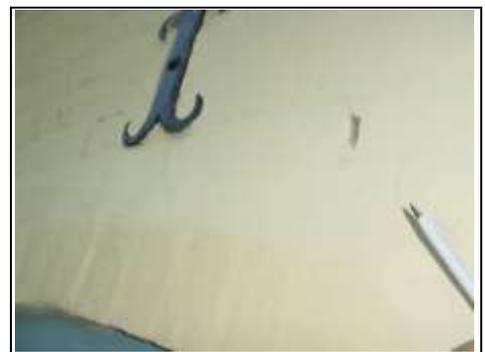
4) Movement in the property

We can see from the cracking in the property and the different bricks that have been used that there has been some movement in the property. Having discussed this with the owner during the question and answer session he advised that the property was underpinned to the

Cracking to walls

ACTION REQUIRED: The existing owner to place an insurance claim for the cracks that have been identified in this report. This will then allow the insurance company to carry out monitoring over a year which is the Building Research Establishment's recommendation rather than a one off inspection such as we have just made. It will also enable you to take on the insurance claim and limit your liability to the excess only. We consider this to be a requirement of purchasing the property.

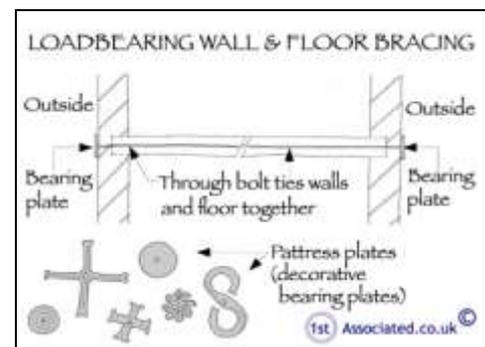
We can also see that tie bars have been added. Tie Bars were typically put into properties in the 1960's to put this into perspective of the long term nature of the problems in this property.

Where we've opened up the floors to inspect properties such as this we found that sometimes the tie bars have rusted away.

ACTION REQUIRED: We would recommend that the first floor is opened up and inspect to see the condition of the timber and the tie bar within it. We would be more than happy to return to do this or it could be carried out using digital photos and these emailed on.

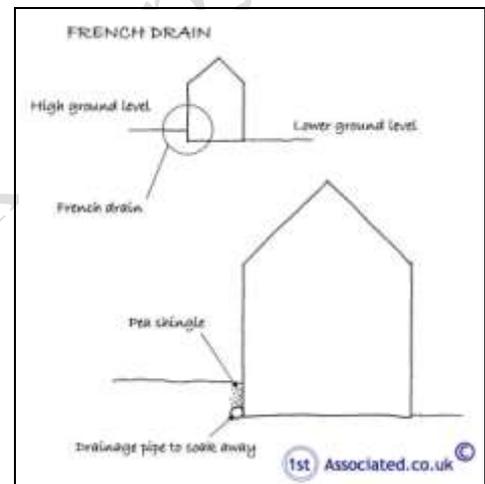
8) Lateral dampness

We can see staining within the master bedroom indicating lateral dampness is getting in. We also suspect from the different colours of yellow paint externally that there have been areas of paint deterioration over the years that have let in dampness.

It should be noted when you do repaint that a paint that allows the property to breath should be used, not a plastic based paint.

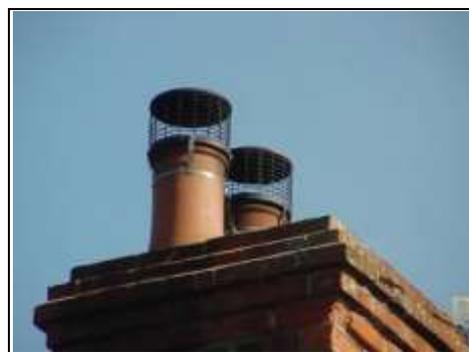
Close up of chimney pots – pots have protectors on to stop rain from coming in

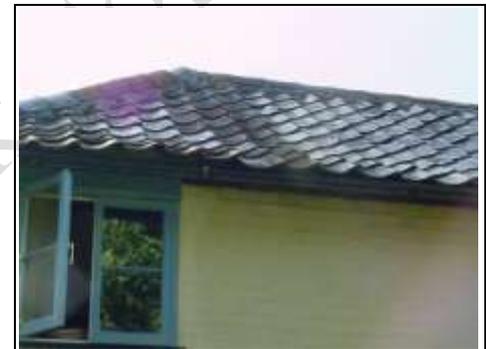
The roof has a pantile roof covering, considering the age of the pantiles we believe they are in slightly below average condition. Some of the ridge tiles are starting to spall if you look at the photo these are ones that are a brighter red colour. You should watch the ridge for deterioration and also exposed areas such as the eaves.

Pantile roof

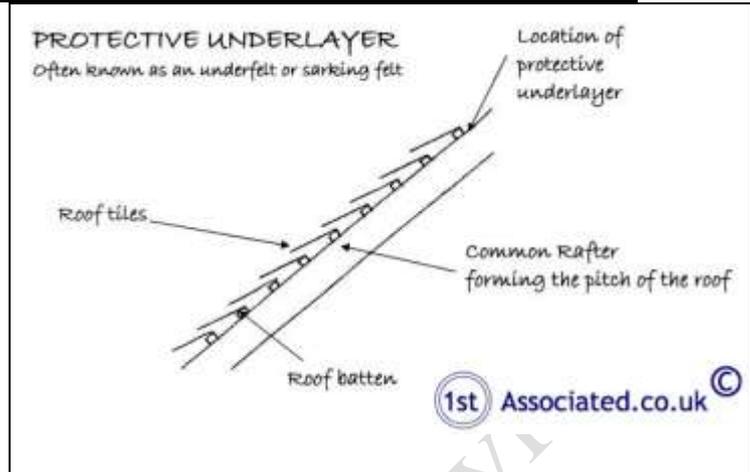
When we inspected the loft space we found a Hessian base Bitumen membrane. This type of membrane has been used since the 1960s. We generally found it to be in average condition, its damaged in a few more places than we normally find.

This means that there was probably some work carried out in the 1960's/1970's on this roof.

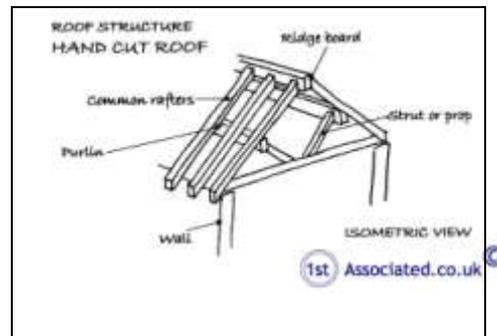
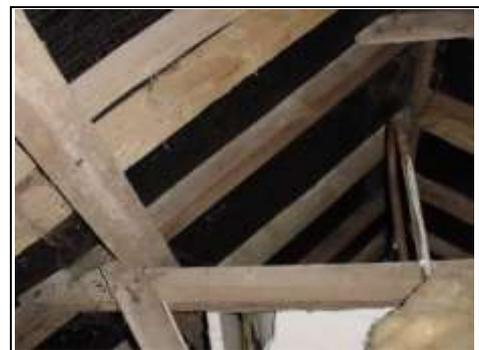
This type of roof structure has what is known as a cut timber roof. This is a roof that is purpose made and hand built on site with hand cut timbers (rather than machine cut). This is an old roof structure many old timbers and repairs with more modern timbers. We cannot categorically confirm that there are no defects as we have not been able to access all the roof; however its configuration is in line with what we typically see.

View of roof

We found the area of the roof timbers that we could see generally in average condition considering their age albeit that it had woodworm as we would expect. We have inspected the roof structure for:

ACTION REQUIRED: Open up the right hand side section so that we can view the timbers.

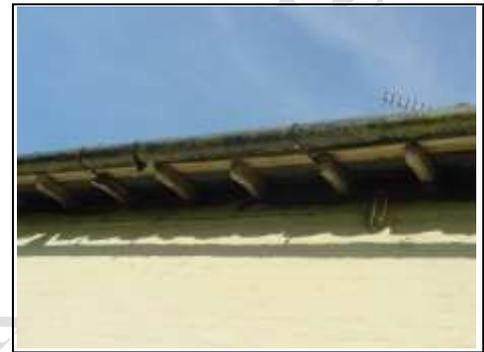
From ground level the gutters and downpipes looked to be plastic and appeared in reasonable condition. There may be some minor leaks, but we feel that most people could live with these. It is notoriously difficult to secure gutters on this type of exposed rafter feet detail to the end of the roof.

ACTION REQUIRED: We would always recommend that the gutters and downpipes are cleaned out particularly as you have got some nearby trees they are likely to fill with leaves, twigs, etc. We would also recommend the joints are checked and the alignment checked to ensure that the gutters fall towards the downpipes.

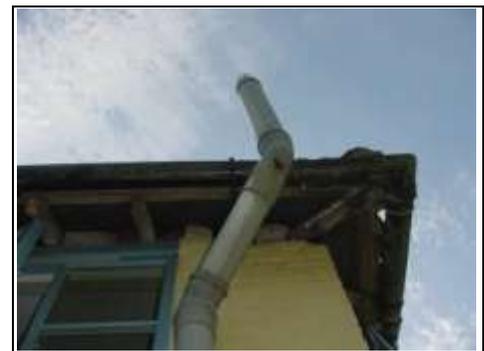
We could see a plastic soil and vent pipe. Generally the waste pipes and soil stack appear to be satisfactory where a surface inspection is possible, although in some parts they run in ducts and cannot be inspected.

Soil and vent pipe

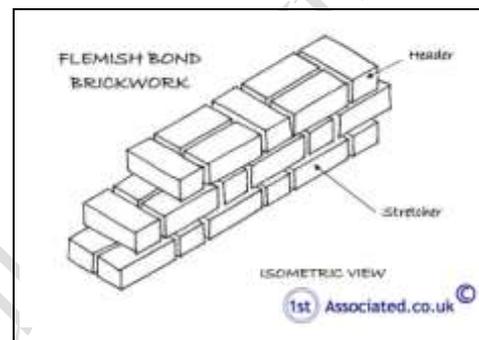
The brickwork is built in Flemish bond brickwork, which has had the original lime mortar repointed in cement and painted. Often the brickwork is carried out to try and reduce dampness.

Painted brickwork

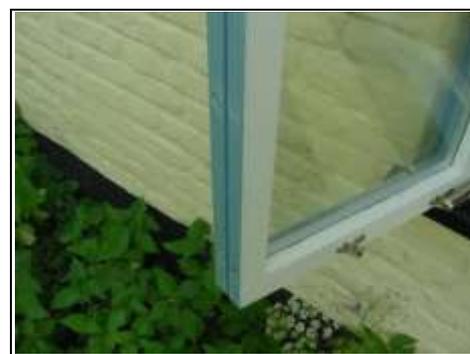
The property has modern double glazed windows which were installed in 2009, which generally look to be of a reasonable quality. We would draw your attention to the fact that sealed double glazed units can fail, particularly as a result of poor workmanship during installation particularly prevalent in timber windows where they move at a different rate to the actual glass double glazed unit. Failure of the seal leads to condensation between the two panes of glass and simply replacing the affected units may not provide a satisfactory long-term solution.

Double glazed windows

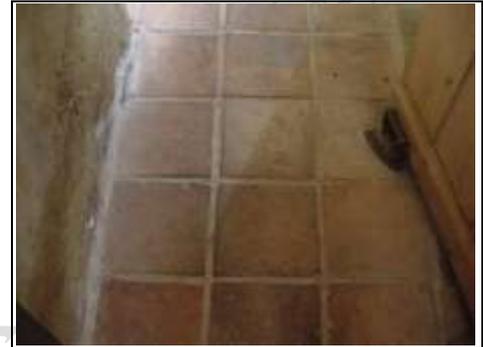
The floors are finished with a tile and carpet finish. The tiles are likely to be directly onto earth in this age of property. We lifted the carpet and found there was timber underneath this. We suspect tiles are underneath this and then directly onto earth again. It is likely there will be some dampness. Only major work costing many thousands of pounds with the replacement of the floor would make the floor dry to modern standards. You have to consider this is part of the character of older properties which we feel you have to make a decision whether it is acceptable before you buy the property.

Quarry tile floor to kitchen

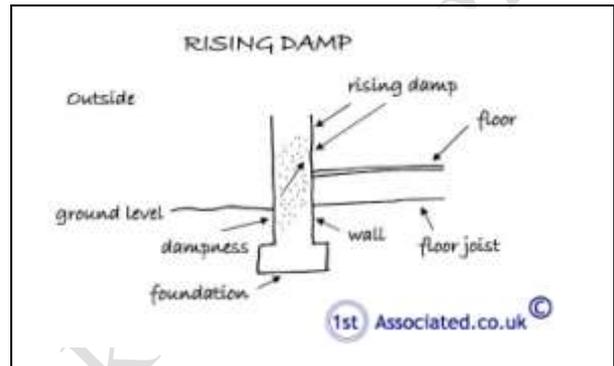
The readings we obtained indicated that there is some dampness in the property. It is located throughout but we had higher readings towards the front of the property in the right hand side. You should bear in mind that these readings have been taken during warm weather so it is only likely to get worse in the colder, wetter months.

ACTION REQUIRED: Please see our recommendations in the executive summary but you do need to accept that dampness in this age of property is part of the property's character.

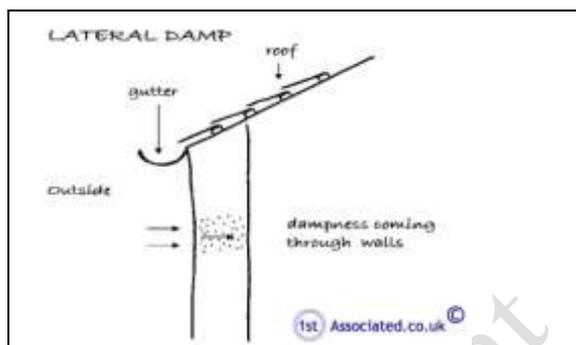
Tests were taken with a moisture meter at random points to internal walls, floors and other surfaces. Whilst we got damp readings these were in line with what was expected for this type of construction. The area of staining within the main bedroom we think is due to a leaking gutter or tiles above.

ACTION REQUIRED: You need to check the gutter, the tiles above and also the painted brickwork in this area.

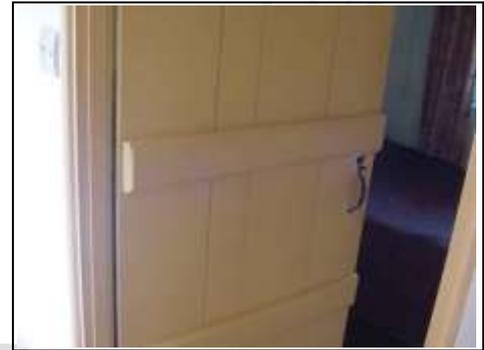
The property has painted timber ledge doors, this is the traditional construction.

Typical ledge brace door

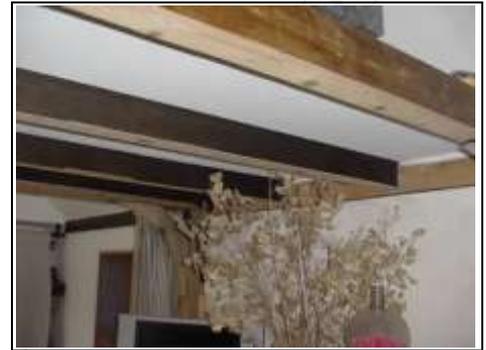
The owner explained there is limited storage in which meant they put the false part ceiling within the master bedroom. (This has therefore limited our view in this area). We would suggest an opening is made in the roof from this side to check the roof timbers.

Underside of storage system

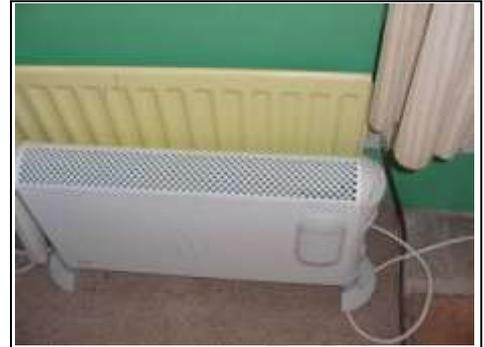
We noted that there are a fair number of single panel radiators, which may not warm the property to the heat that you desire. In most modern installations double panel radiators are used and often double panel convection radiators, which are more efficient.

Single panel radiators supplemented with electric heaters

Heat is very subjective you may wish to live in the building before you change the radiators.

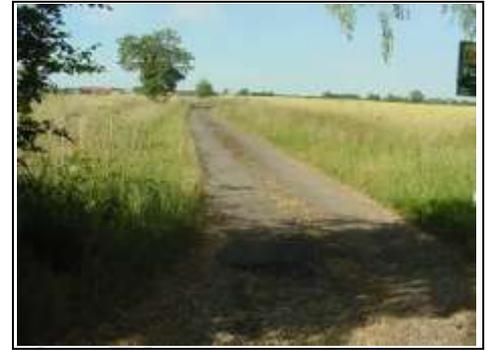
Access driveway/private road
