# RESIDENTIAL BUILDING SURVEY

xxxxxxxxxx,  
Cricklewood,  
London,  
NW2 xxx

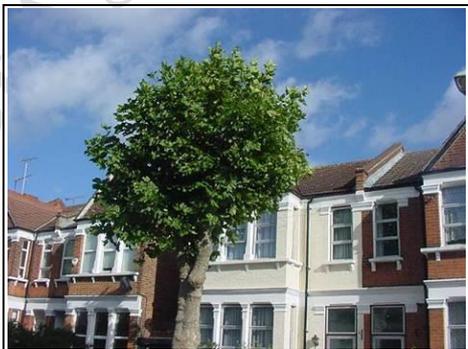
Tree adjacent to next doors property

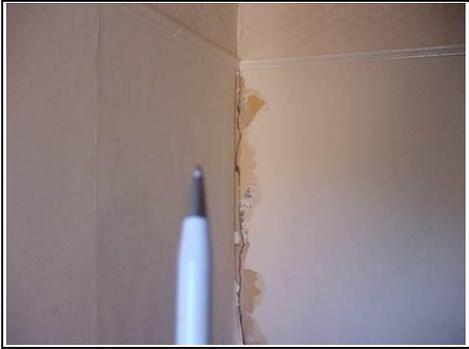
1.1.1) We can see cracking internally between the front and middle bedroom and cracking to the room in the roof space.

Crack in the middle bedroom top of the wall

**ACTION REQUIRED:** Ideally we would like the owner to specifically advise how long the cracking has been in the property and provide any photographic evidence they have to back up their comments. Your Legal Advisor to specifically ask in writing if they were aware of the cracks and how long have they been present.

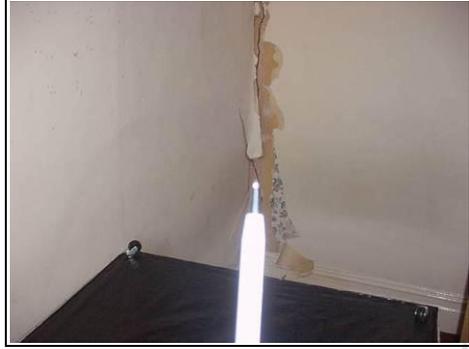
Crack in the middle bedroom bottom of the wall

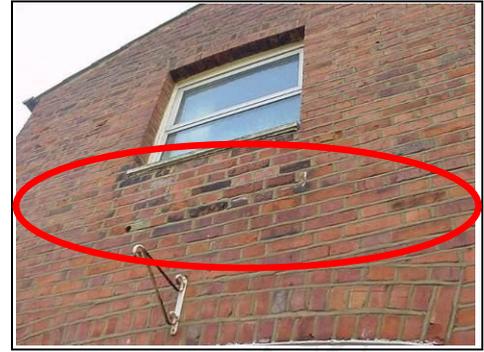
1.1.3) There is also some bulge/undulation to the rear wall.

Bulging in the rear wall

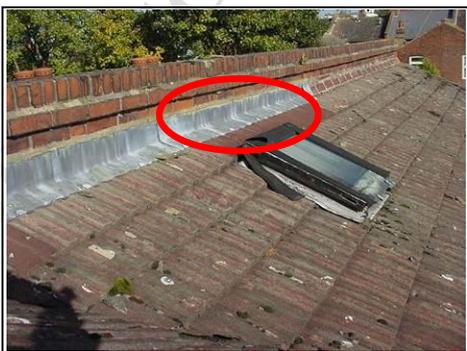
We note that the rear chimney has been removed as we could physically see where the tiles change colour. We also believe there has been a chimney removed to the right hand side as well. This will have affected the floor structure and this is why there is more deflection in the floor then we would expect.

Dark tiles show where chimney may have been removed

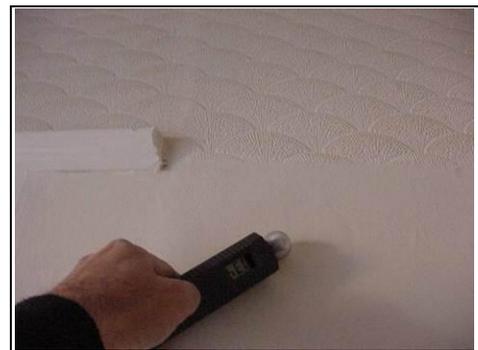
The picture rail indicates where the other chimney has been removed on the right hand side

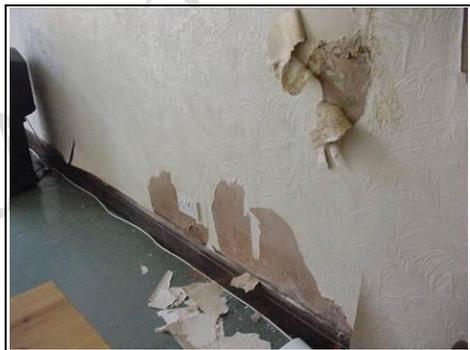
There is a suspended timber floor to the ground floor of the property. We can see to the rear room of the property that part of the floor has been replaced with concrete. This then stops a free flow of air underneath the floor which is needed to minimise wet rot and dry rot. This in turn is why, we believe, we are getting high damp meter readings in this area as any dampness under the floor cannot go anywhere and is simply using the concrete floor slab like a large piece of blotting paper and absorbing into it. This then gets into the adjoining walls.

Dampness

**ACTION REQUIRED:** For the dampness in the property the timber floor should be vented which is easier said than done. You can put running vents internally or you can add a vent through the concrete floor (yes this will involve digging up the concrete floor from what we can see). This will be in the new kitchen area and possibly the old kitchen allowing a through flow of air. There is an outside chance that these vents are already in place and are simply blocked. The air bricks that we can see to the rear of the property are low and could effectively be acting as gutters and so some modification needs to be made.

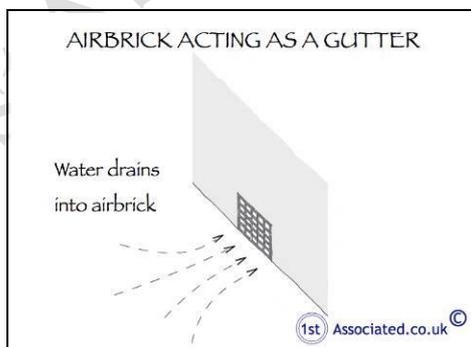
Airbricks acting as gutters

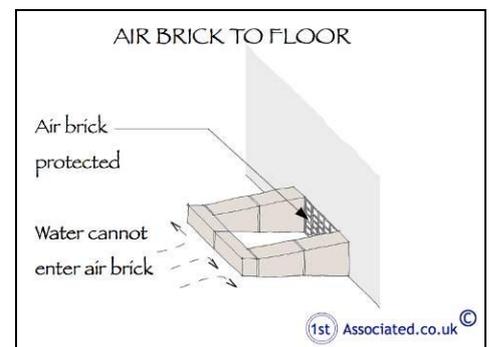
Air brick protected

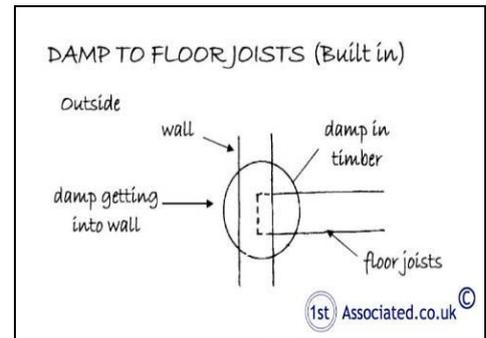
We have already mentioned that chimneys have been removed and there may well be wet rot to the embedded floor joists. We carried out an impact test (which is literally jumping up and down on the floor) and found the front and the middle bedrooms deflect more than we would expect.

Damp to floor joists

**ACTION REQUIRED:** We would like to open up the floors to check the condition of the timbers but we would need permission to do.

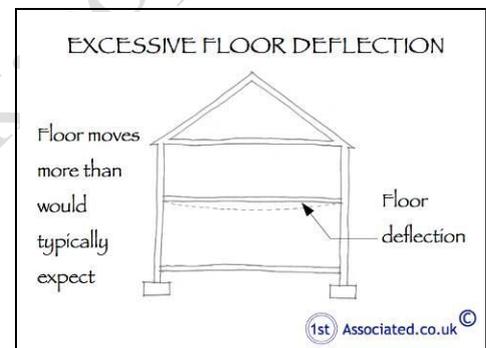
Deflection

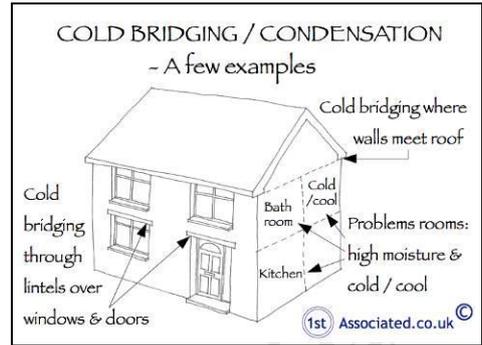
Cold bridging is caused by a colder element in the structure allowing coldness to pass through the structure much quicker when warm moist air is present in the property.

Cold bridging and condensation

**ACTION REQUIRED:** The area needs to be ventilated better however part of the construction is that there are cold elements (such as lintels) in it which have to be considered part of the characteristic of the building unless you want to go the expense of removing them.

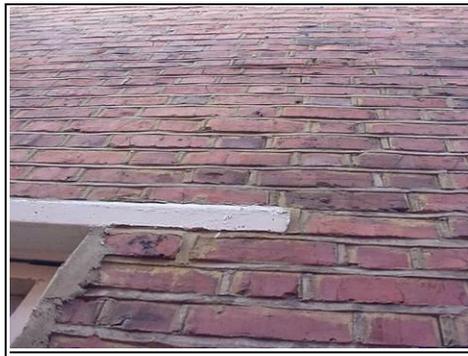
Exposed lintels to the window on the side of the property

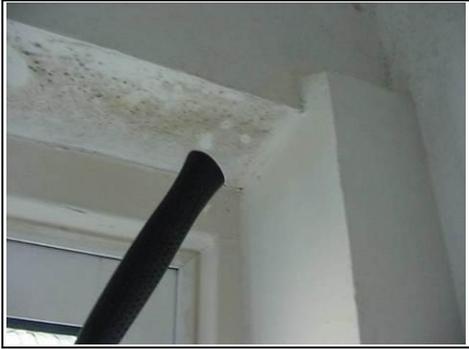
Poor ventilation causes cold bridging

The area is vented but not enough. We would recommend a large humidity controlled extract fan is added

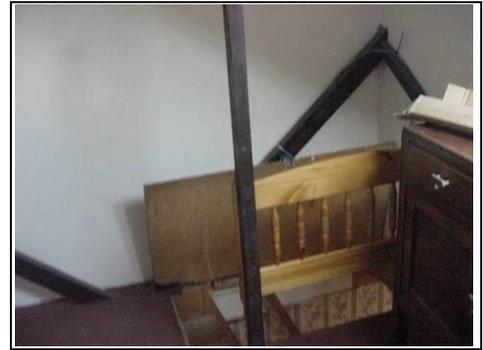
Room in the roof

There is a fairly small room in the roof which looks unlikely to be a legal conversion i.e. approved by the Local Authority. It is however worth checking this as you can get various rights over time. To make it into an official, Local Authority approved, habitable room you will need to have Building Regulations that will look at things such as;

1. The safety of the room if a fire occurs
2. The strength of the floor. This usually means the replacing of ceiling joists with floor joists
3. Staircase access

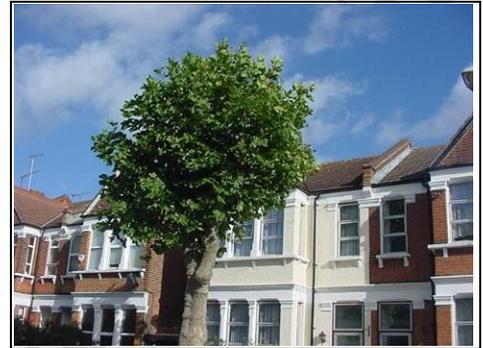
As you are aware the neighbours property has been underpinned. From the description given by the neighbour it would seem to be a very deep underpinning and as mentioned earlier he believes it was related to the adjacent tree which is still there. He did comment that the council have had a claim made against them by the insurance company regarding the tree.

The tree is still there

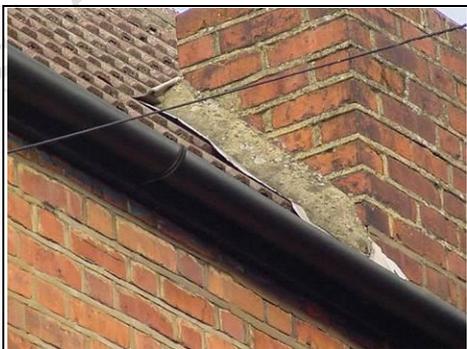
Our concern is the cement flashing although it does appear to have a lead or metal underneath it. We do find that cement does crack over time and allow dampness in.

Cement flashing needs repairs

**ACTION REQUIRED:** Repair the flashing and periodically inspect the chimney.

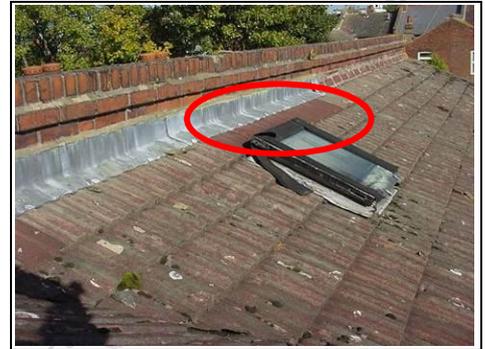
Chimney two we believe would have been to the right hand side and chimney three would have been to the rear left hand side of the property. Both have been removed. We always prefer for properties to have their chimneys intact as we feel often they are part of the integral structure.

Where chimney has possibly been removed

**ACTION REQUIRED:** Regarding chimney three which is the rear left hand side you need to check whether next door has removed their chimney or not as it may affect this property . Please see our comments within the Executive Summary.

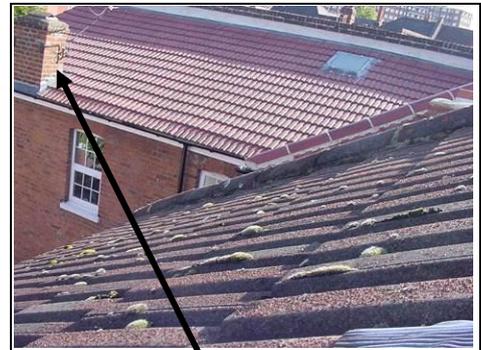
You can see on a neighbouring property that this chimney is still intact and shows where it would have been on your property.

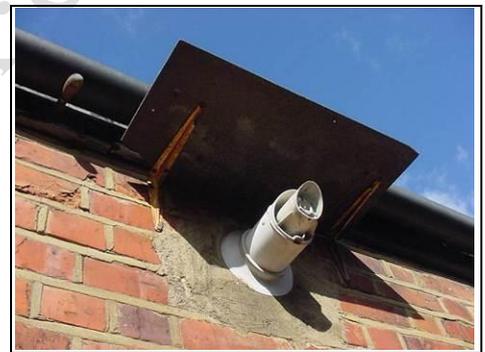
The property has a plastic flue from the rear bedroom Vaillant boiler. There is possibly an asbestos board above the top of it which we have mentioned earlier.

Asbestos deflective board above flue

**ACTION REQUIRED:** Please see our warning about asbestos within the Executive Summary

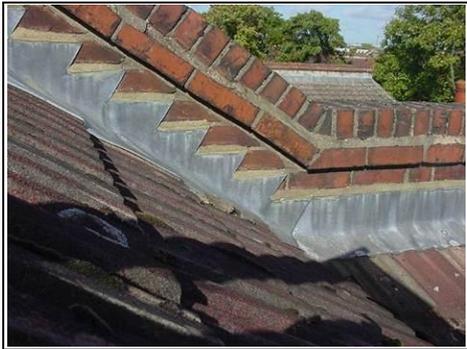
Parapet wall left hand side

In this case there is a parapet wall to the left hand side built from brick with a lead flashing. From what we could see we would comment that generally it is in average condition. We were pleased to see that the lead work was stepped. We can see some cement mortar is coming away. In a perfect world this would be repointed.

**ACTION REQUIRED:** We recommend re-pointing before the winter of 2014.

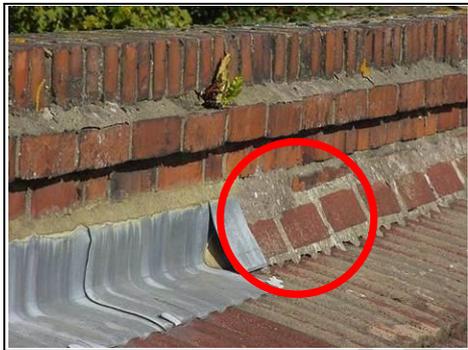
We noted that a section of the parapet wall has a tile on edge which in our experience leads to dampness getting in the property. In fact we could see dampness getting in that area.

Where the lead flashing becomes tiles on edge

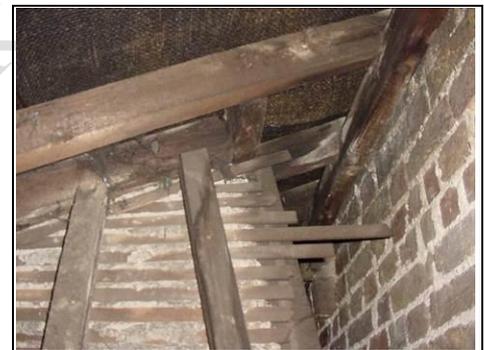
Damp getting in where the timber is against the wall

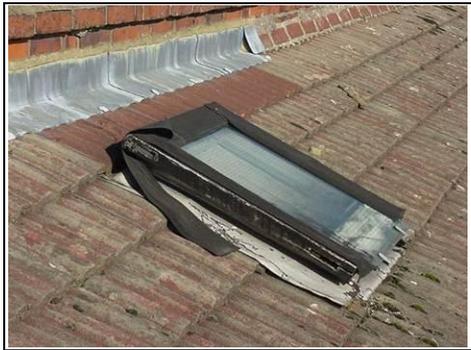
This purpose made roof window looks to have been repaired over the years with what appears to be Flashband. We could not see any damp staining inside.

Roof window has been repaired

**ACTION REQUIRED:** A replacement window may be the easiest way to make this watertight.

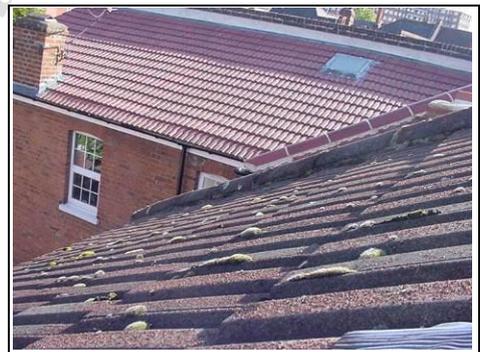
Moss on the concrete tiles  
Excessive moss can block drains

**ACTION REQUIRED:** Carry out periodic inspections and maintenance of the roof, as required.

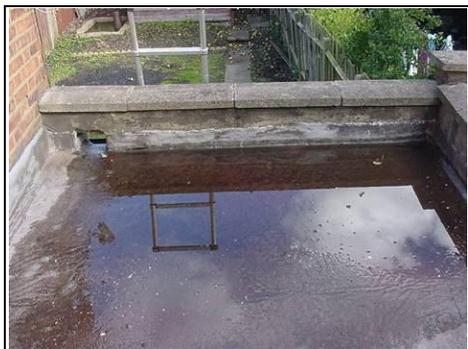
This roof is asphalt covered onto a timber decking. We would consider asphalt to be the best material for flat roofs. Unfortunately the roof is flat and there is ponding visible on it, ironically, just in front of the rear drain.

Ponding around the drain point

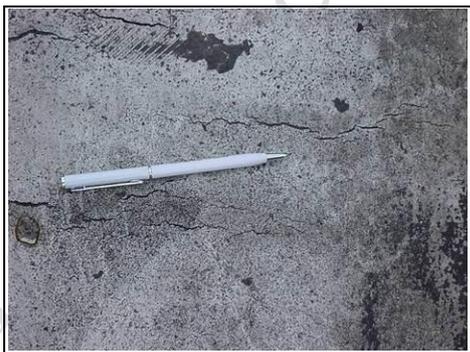
The asphalt is ageing. We can see this by the cracking in the asphalt.

Bitumen has been put on the cracks to try and save them and to stop water getting in

A lot of heat can be lost from older flat roofs which are typically known as cold roofs and which should, at some point, be upgraded to an insulated warm roof. In this case you could also add insulation cut to falls which means you could have a good fall on the roof. We believe the roof will need to be replaced in the next five to ten years. Of course you may have to carry out repairs in the meantime.

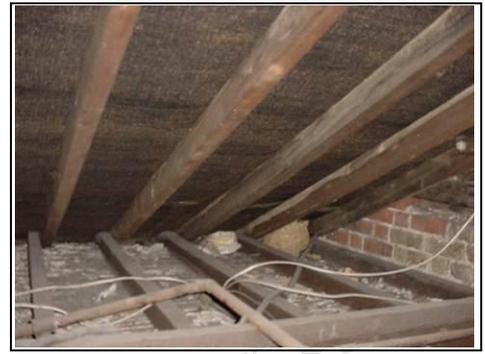
General view of inside of the rear roof

Our examination was limited by the general configuration of the roof, the old water tanks and an old boiler. What we could see was generally found to be in below average condition, because of the dampness, for its age, type and style. It is, however, feasible that there are problems in the roof that are hidden and we are concerned we could not view main roof properly.

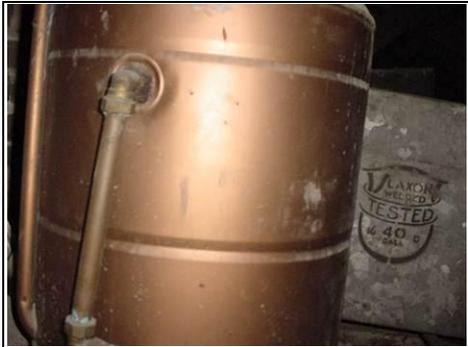
There is a collection of water tanks in the roof space including at least two cast iron tanks. There is also an old boiler. These are often left in the roof as it is hard to remove them as they need to be cut up to fit through the loft hatch.

Old boiler and cold water tank behind

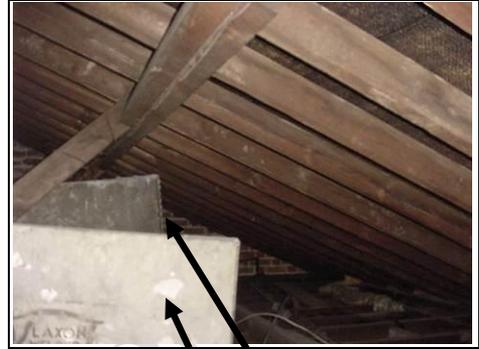
Two old water tanks

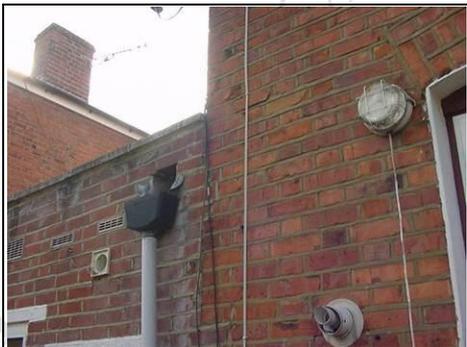
Hopper head to the rear flat roof  
which we unblocked

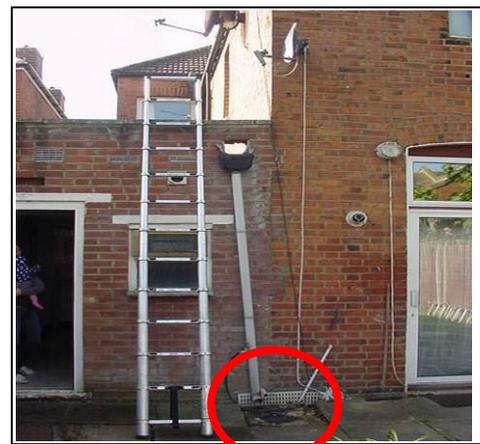
We had to put in a separate heading for this as we have not come across drains that have been added in this manner. We can see to the rear of the property there is rainwater and foul water discharging into a DIY standard drain which in turn goes into the drains on the right hand side.

Interesting drain arrangement

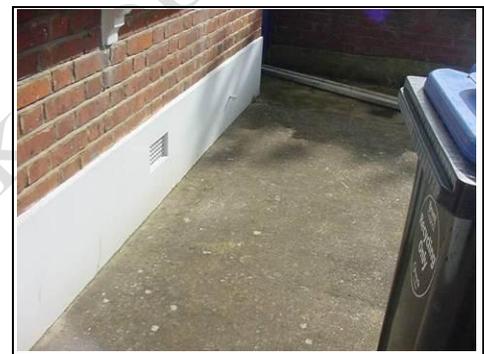
All modern properties should incorporate a damp proof course (DPC) and good building practice dictates that a differential of 150mm (6 inches) should be maintained between the damp proof course and ground levels. In this case, cannot see a DPC as it is hidden by the plinth but it is likely to be slate in this era of property.

The plinth is hiding the damp proof course

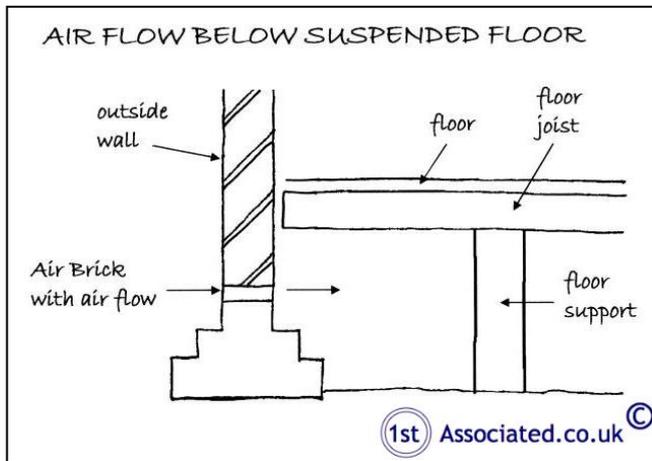
The property has a suspended timber floor which is blocked in part. Air bricks are essential to have a through flow of air as this helps to reduce the chances of wet rot, dry rot and woodworm.

Air brick to the rear of the property acting as a gutter

**ACTION REQUIRED:** Please see our comments in the Executive Summary

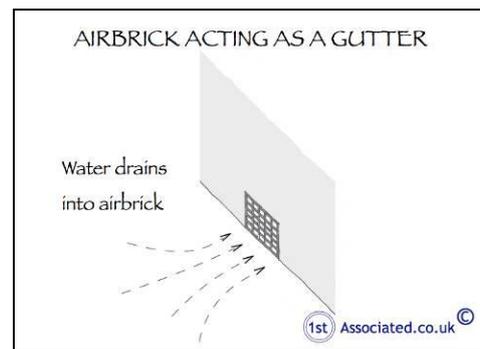
Air brick acting as a gutter

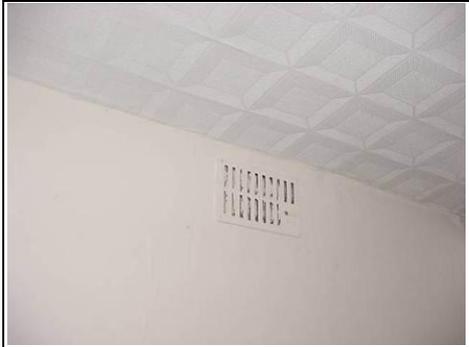
There are a few high level air bricks/vents at high level that we believe were added at a later date. They were probably added to try and resolve the problems of mould and cold bridging in the property.

Air vent

**ACTION REQUIRED:** Please see our comments within the Executive Summary.

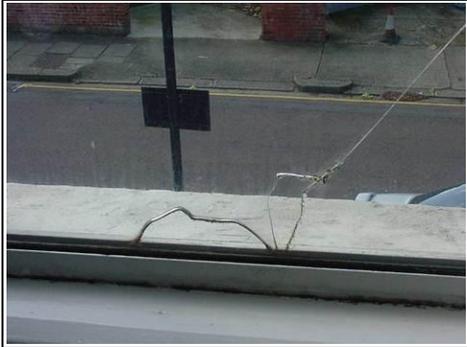
There is the odd pane of broken glass and also some misted windows. The main issue is the rotting timber which we recommend is replaced.

Broken glass in window

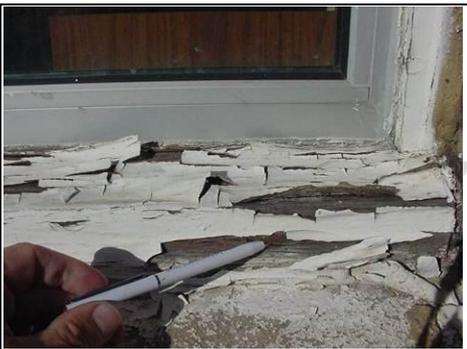
Plastic window in a timber frame with rotting sill

**ACTION REQUIRED:** Replace the timber.

**ANTICIPATED COST:** To replace the timber would be approximately £2,000 - £5,000 (two thousand to five thousand pounds). It may be more economical to replace the windows.

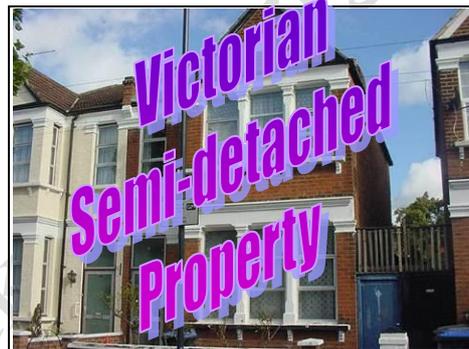
There is a fair amount of white painting around the window areas although not as much as next door who have painted their entire brickwork white. This is something we would not recommend as:-

1. It stops the bricks from breathing and dissipating any dampness.
2. It means you have to paint it every four to five years.

Fair amount of external decoration

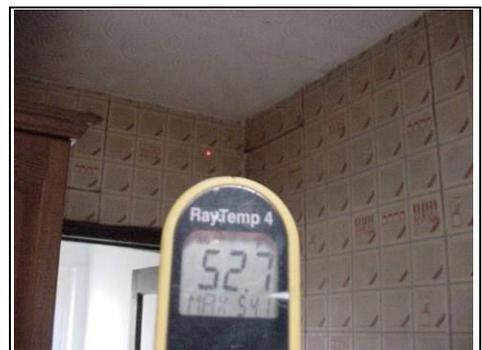
At the time of the inspection there were obvious signs of condensation in the rooms on the right. There were also misted windows which is a form of condensation.

Surface temperature Testing for condensation and cold bridging

**ACTION REQUIRED:** Please see our comments within the Executive Summary regarding cold bridging.

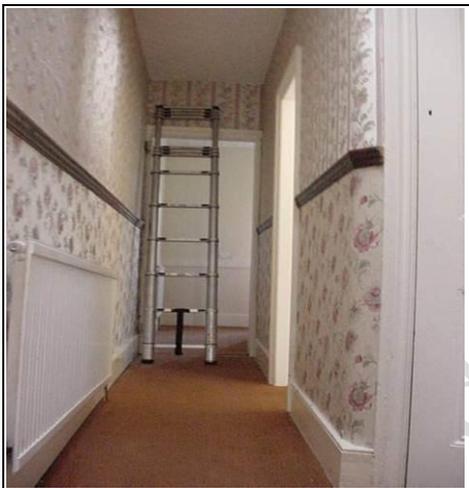
The doors are painted panel doors. We can see from these that there has been historic movement in the property (the frames show where there has been movement).

The door frame is out of square showing historic movement in the property

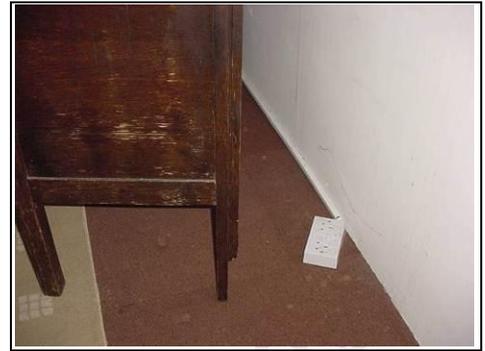
The socket points are surface mounted in many cases. Re-wiring would allow them to be bedded.

Electric socket point hanging off in the room in the roof

**ACTION REQUIRED:** As the property is changing occupancy an Institute of Electrical Engineers (IEE) test and report should be carried out by a NICEIC registered and approved electrical contractor or equivalent.

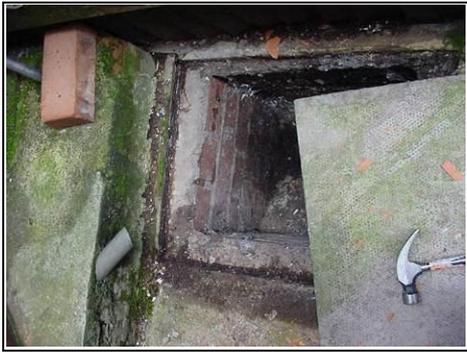
We duly lifted the cover and found it to be free flowing / blocked at the time of our inspection. There is a paving slab acting as a cover, this needs to be replaced.

Manhole – middle right  
Paving slab covers the manhole

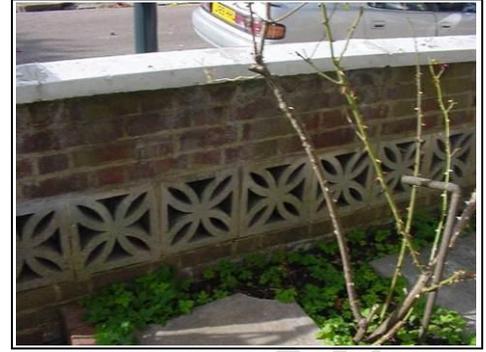
The front garden has been concreted /paved and is used for bin storage. There are a few plants in the borders. We can see some movement to the left hand wall and some step cracking.

Front wall

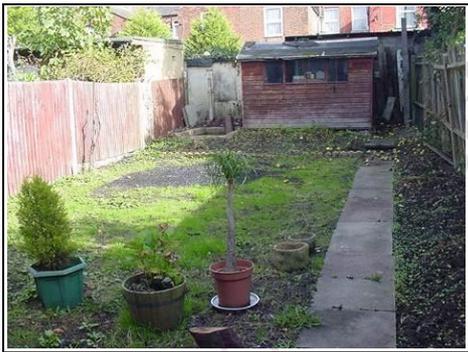
The rear garden is in need of work. There is a shed and a pond to the end of the garden. The grass has not grown in the centre which to us indicates either there has been a fire or there was once a tree there. The right alley way is covered in moss so does not get much light.

Rear garden

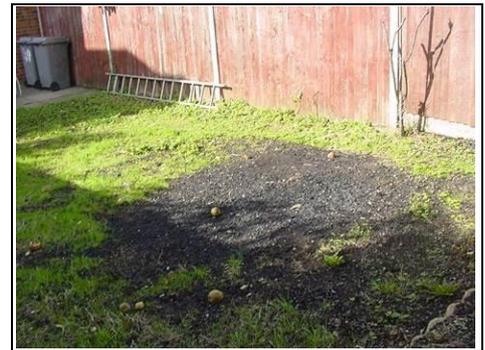
Was there a tree here?

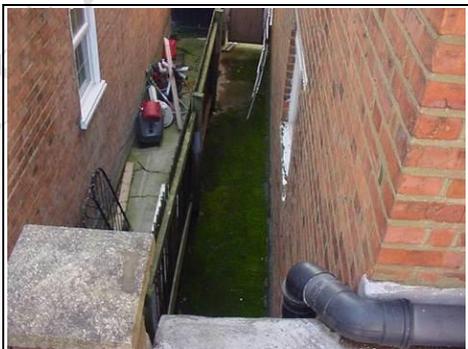
Alley way to the right hand side covered in moss

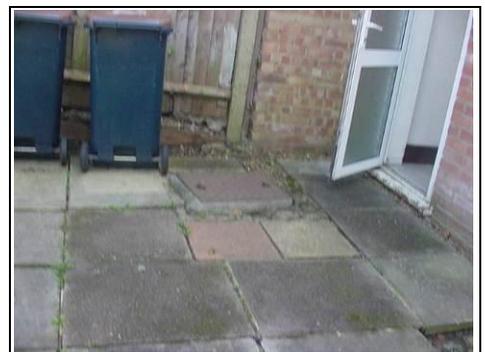
Patio area would benefit from improvement and levelling
