RESIDENTIAL BUILDING SURVEY

Croydon, Surrey CR0

Mr O

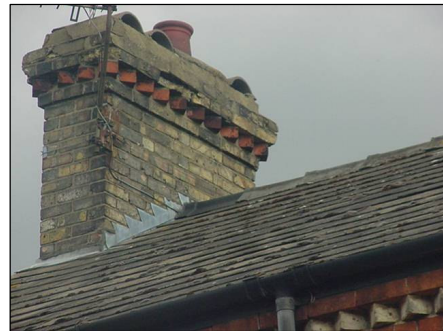
Left hand chimney

This chimney is brick finished with one chimney pot and three hog backs (which are used where a chimney is being vented) with lead flashings. From what we could see the chimney looks in average condition. Unfortunately we were unable to see the top of the chimney known as the flaunchings we therefore cannot comment upon them.

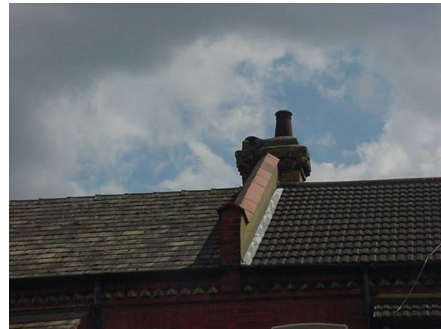
Parapet wall

It is a brick finished parapet wall which has a coping stone and generally looks in reasonable condition as viewed from ground level.

Finally, we were only able to see approximately fifty percent of the parapet wall, therefore we have made our best assumptions based upon what we could see. A closer inspection may reveal more.

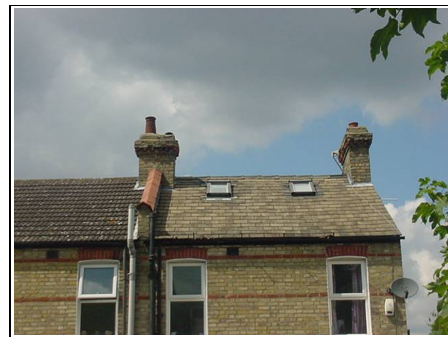
The roof we believe it pitched and we believe it is clad with an asbestos based slate, it is always difficult to identify 100% and it may be a worn natural slate. The dangers of asbestos have been well documented (search the internet) The amount of asbestos content varies dependent upon slate type. The slates sit fairly true and are generally in average condition considering the property's age, type and style.

Main roof from rear

ACTION REQUIRED: We would recommend an asbestos sample and check is carried out by a recommended reputable asbestos company and we would also recommend that you budget for replacing the roof due to people's perception of problems rather than actual problems.

ACTION REQUIRED: Please see our comments in the Executive Summary.

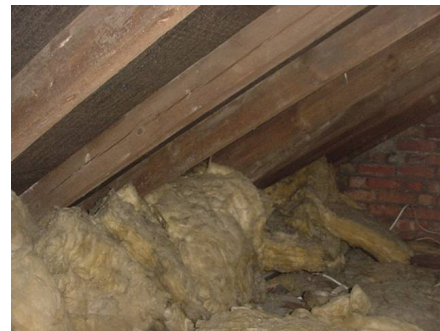
When we inspected the loft space we found a Hessian base Bitumen membrane. This type of membrane has been used since the 1960s. We generally found it to be in average condition, it is damaged in a few more places than we normally find.

This photo shows the common rafters (the ones that form the pitch of the roof) and the dark area between is the underlayer.

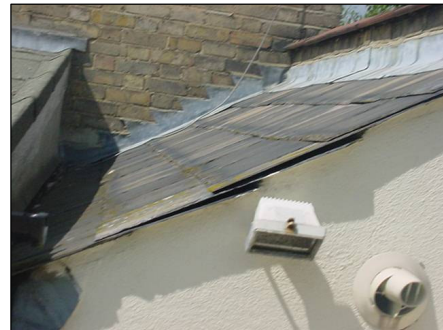
The valley gutter to the rear is an area we would expect dampness to get into as it is a weak area ideally sections should be removed altogether by redesigning the pitch. We feel that ultimately it will let water in and you will need to regularly clear this section as well as if it backs up it will cause dampness to come into the property.

The roof is part pitched and part flat, the pitched roof is slate. Please see our comments in the Executive Summary where we highlight the problem of this valley gutter.

Valley gutter to the pitched roof

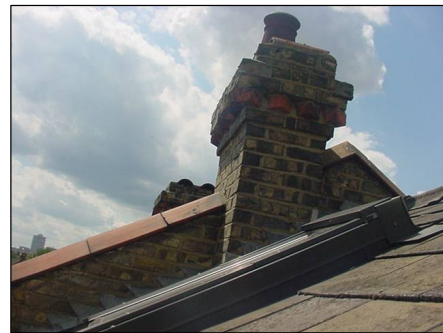
The side of the roof light

There are two roof lights to the rear of the property and were pleased to see they had blinds in them however we would comment that in our experience sooner or later all roof lights leak. They are purpose made ones with the metal outer casement and a timber inside.

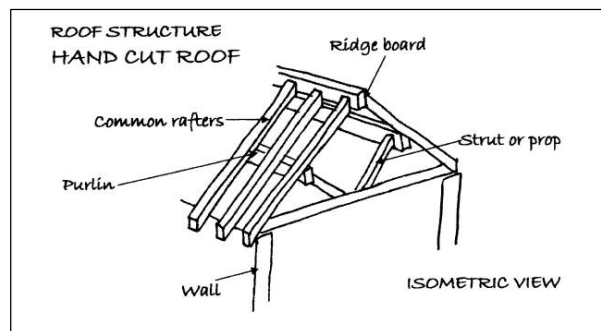
As our view was limited due to the room being formed in the roof we would make an educated guess based on our knowledge of this age of construction that the property has a cut timber roof. This may or may not have been amended when the room in the roof was formed but suspect that it has not been other than to accommodate the roof light.

The timbers that we could see were slightly smaller than we would normally expect (please see previous photograph) and therefore term the roof a lightweight roof. You do need to be careful if you ever decide to reroof the property.

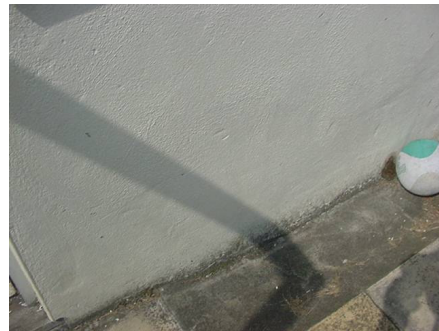
Render

There is a relatively small area of render to the rear of the property which is finished in a smooth faced painted render. We have carried out a tap test to the render at low level (literally hitting the render with the back of a hammer) to try to establish if there are any hollow areas. We have found this is to be in average condition for this age of property.

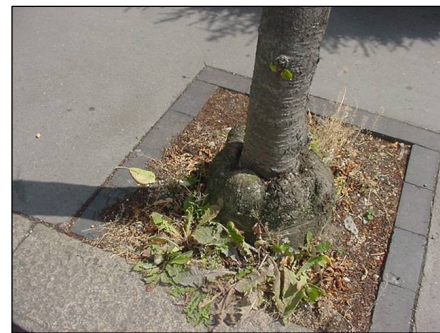
Close up of the tree

ACTION REQUIRED: Contact Local Authority if trees not regularly maintained.

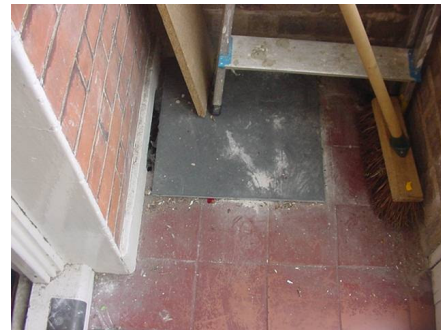
In this case we were unable to say if there was a damp proof course (DPC) or not due to a render plinth to the property to the front and render to the rear. We suspect that the reason this was commonly used was when a slate damp proof course was added.

Render plinth

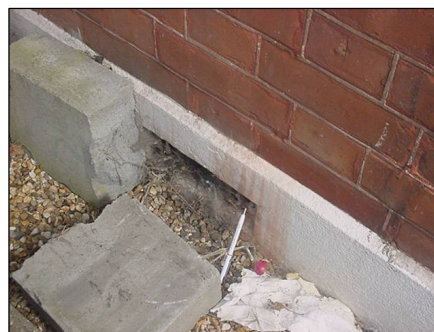
We noted that the airbricks to the front of the property have been blocked they have been partly built over to the rear of the property within the dining room area. This lack of ventilation together with the relatively high ground level in the area means that dampness is likely to be under the floor. We suspect that some of the timbers will have suffered from rot.

Air bricks are visible to this property. To help reduce decay a through vent is required under the floor; we recommend airbricks are checked to ensure you have a through.

Airbrick to the front of the property

ACTION REQUIRED: We would recommend that you open up a section of the floor, ideally before you purchase the property, to check the condition of the timbers. We would be more than happy to comment on any photos that you may email to us. We would also be keen to see copies of any woodworm treatment and any wet rot/dry rot treatment.

ACTION REQUIRED: Please see our comments in the Executive Summary

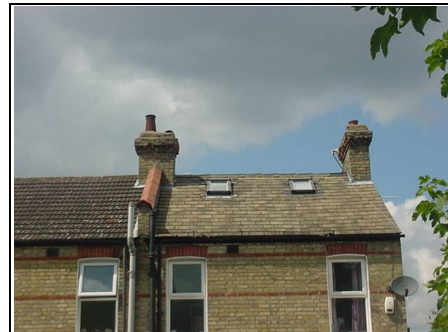
The fascia board is hidden by the guttering and typically in this age of property there is a painted timber soffit.

Fascia board hidden by guttering

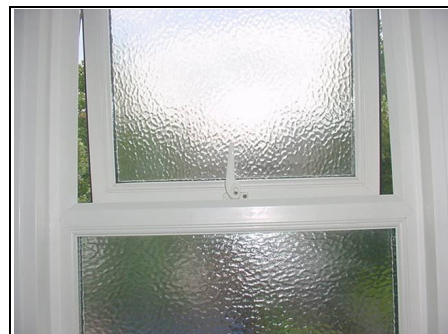
The property has plastic, double glazed windows, which generally look to be of an average quality for the year made. We did not see any trickle vents indicating the windows are pre 1990s

Double glazed window

to condensation between the two panes of glass and simply replacing the affected units may not provide a satisfactory long-term solution. In this case they are in average condition.

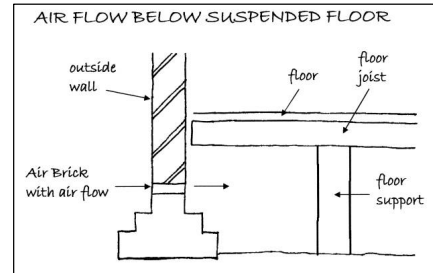
We had a limited view of the main floor and in fact the only area we could see is under the stairs. Based on our knowledge of this age of construction, we believe that the ground floor construction is predominantly a suspended timber floor. This type of floor needs air circulation under it to reduce deterioration from wet rot and dry rot; please see our comments in these sections.

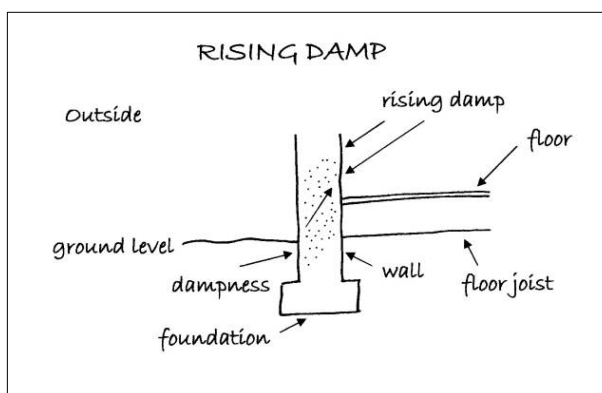
We carried out various tests with an electronic damp meter and found slightly high readings which we attribute to the lack of ventilation under the floor.

ACTION REQUIRED: Ensure that the floor is suitably ventilated, please see our comments within this report.

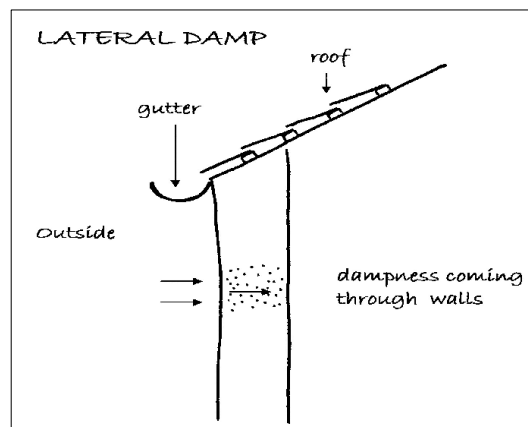
The readings we obtained indicated that there is no lateral dampness but as the property is poorly pointed this area may allow dampness in.

ACTION REQUIRED: Repoint

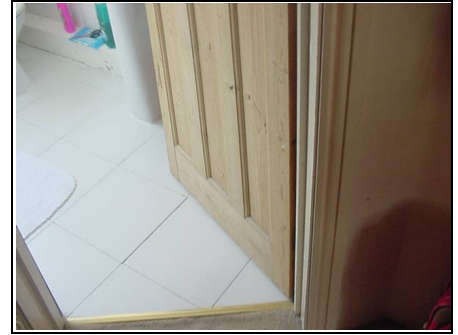
Timber internal door

The property has solid timber panelled doors.

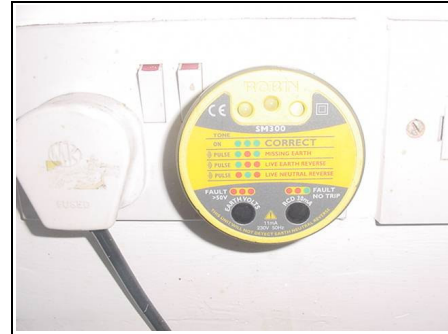
Earth Test

We carried out an earth test in the kitchen area to the socket point that is normally used for the kettle, this proved satisfactory.

ACTION REQUIRED: As the property is changing occupancy an IEE report should be carried out by a NICEIC registered and approved electrical contractor.

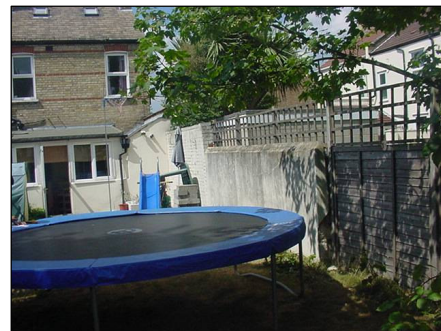
A reasonable size rear garden taken up mainly by a trampoline! There is also a right of way access to the rear.
